Transport & Works Act Order (TWAO) Anglia Route GRIP 2 Review

Cambridgeshire Stage1 Road Safety Audit

Report Number 367516/RPT014

August 2016

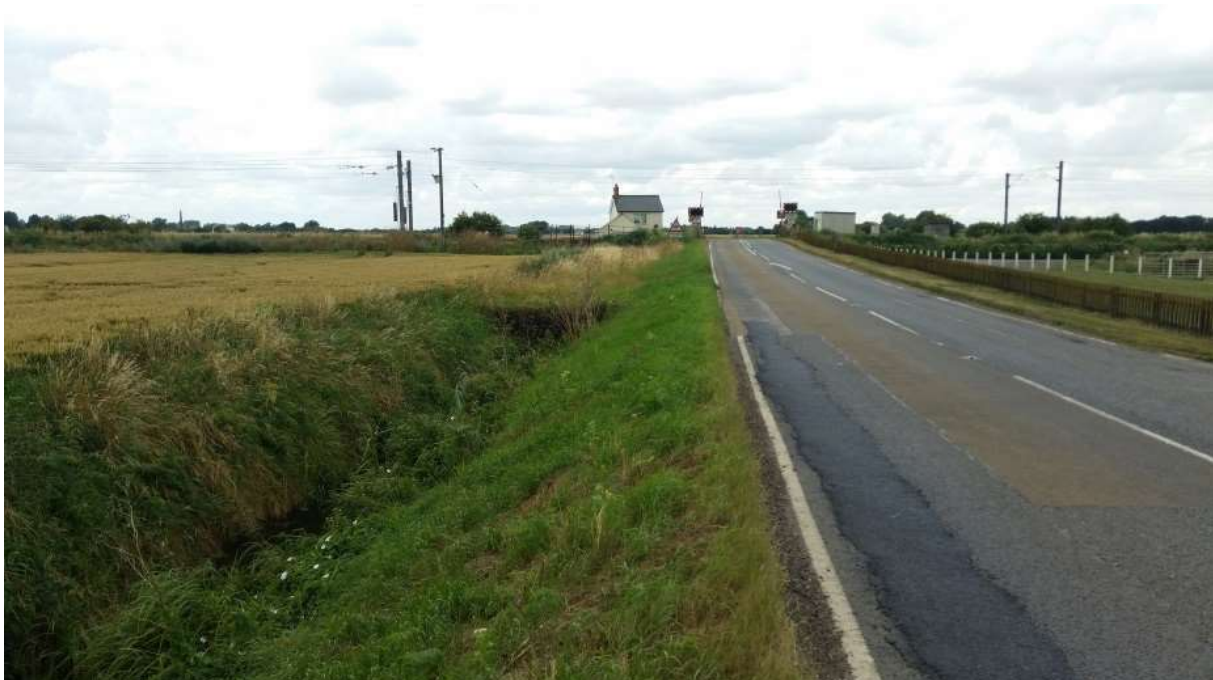
Location: A1123 Newmarket Road.

Summary: Risk of vehicle collisions with pedestrians.

The A1123 Newmarket Road carriageway is narrow and the verge is also narrow due to a steep embankment which is likely to result in pedestrians walking within the carriageway. Vehicle speeds were observed to be high along this section which may give drivers limited time to react to pedestrians within the carriageway, possibly resulting in collisions between vehicles and pedestrians. Alternatively, drivers may swerve to avoid a pedestrian in the carriageway with a risk of head-on vehicle collisions as a result.

Figure 2.1: Narrow carriageway and verge with steep embankment.

It is recommended that a footway is provided for pedestrians. If this cannot be achieved then an alternative route should be identified.

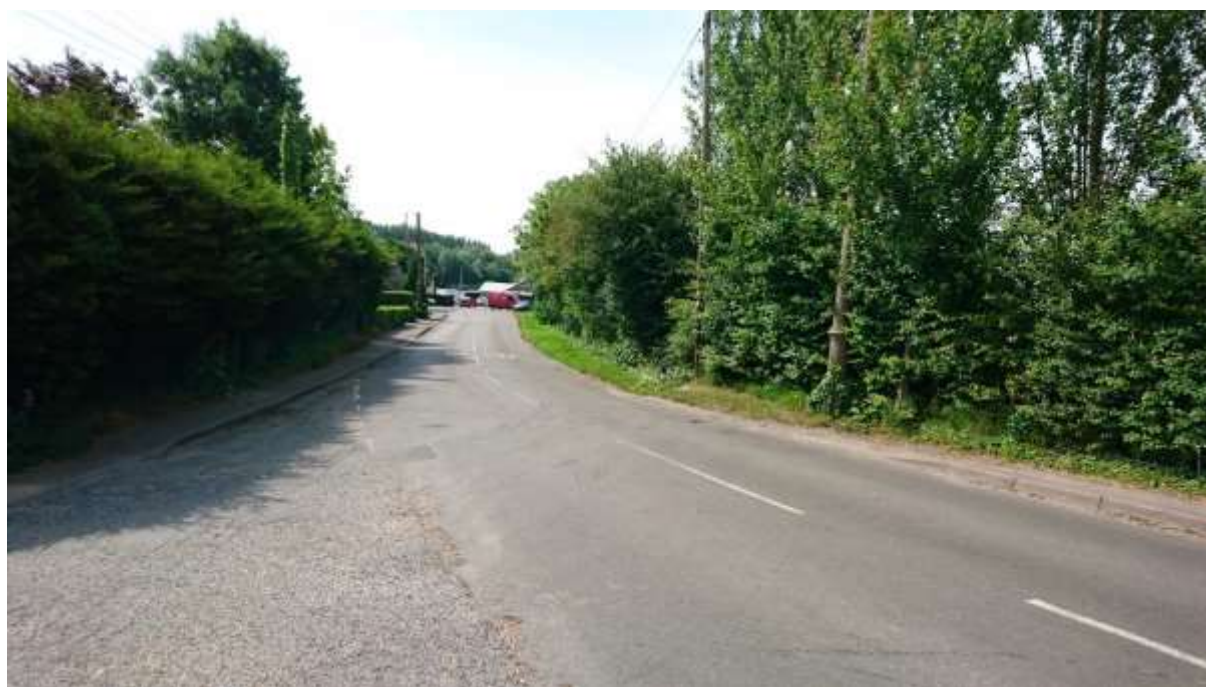
Location: Station Road.

Summary: Lack of footway for pedestrians.

Diverted pedestrians will be required to continue along Station Road; it is the Audit Team's opinion that existing footway provisions are poor and traffic flow and vehicle speeds were observed to be high. Combined, this increases the risk of collisions between pedestrians and vehicles. The likely desire line along Station Road will be on the western side along an existing verge. This was observed to be undulating and difficult to walk on increasing the risk of trips and falls.

Figure 2.2: Poor pedestrian facilities on Station Road.

It is recommended that the existing footway on the western side of Station Road is extended for the length of the diversion.

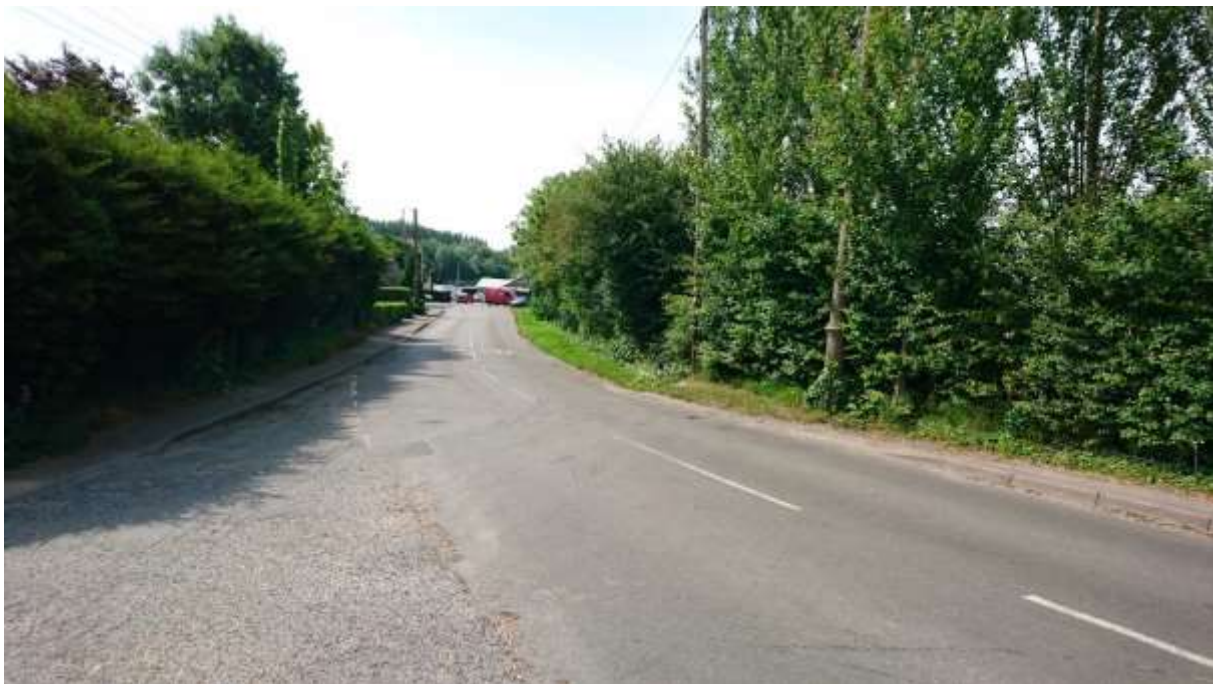
Location: Station Road.

Summary: Lack of footway for pedestrians.

Diverted pedestrians will be required to continue along Station Road; it is the Audit Team's opinion that existing footway provisions are poor and traffic flow and vehicle speeds were observed to be high. This is of particular concern at the point where pedestrians are required to cross Station Road to use the existing footways. This is in close proximity to a blind bend and visibility to the south on the western side is further restricted by an existing lamp column. Combined, this increases the risk of collisions between pedestrians and vehicles.

Figure 2.3: Hazardous crossing locations on Station Road.

It is recommended that the existing footway on the western side of Station Road is extended for the length of the diversion.

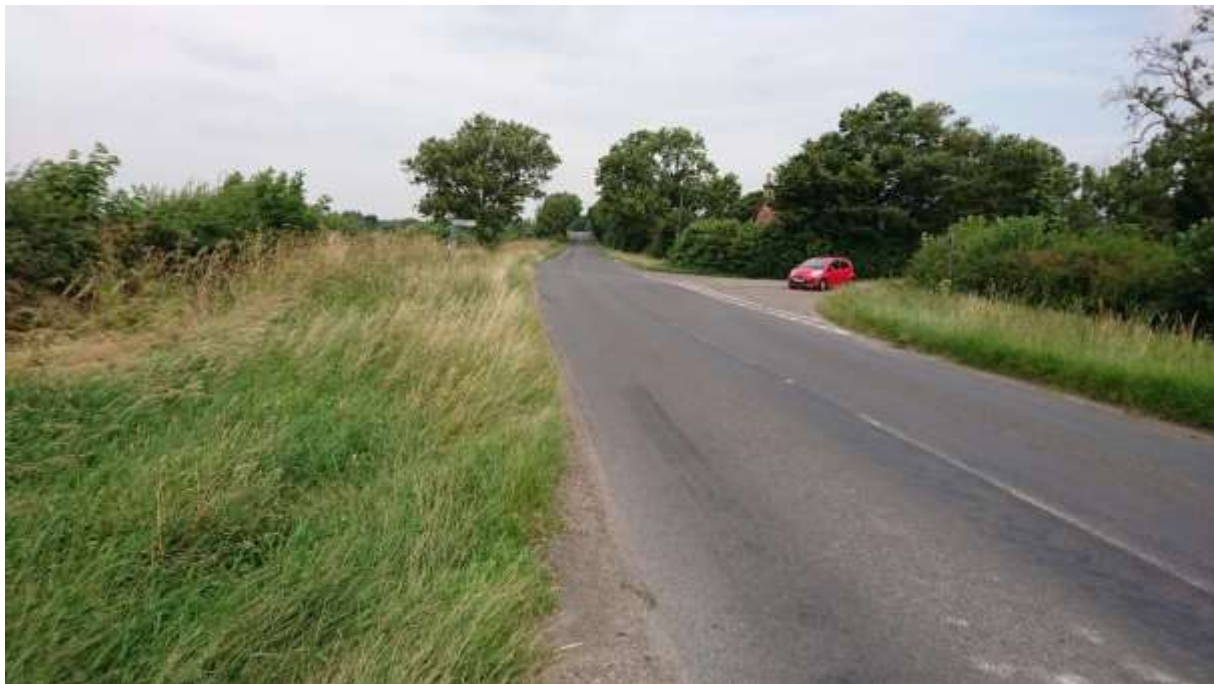
Location: London Road.

Summary: Risk of pedestrian conflict with vehicles.

Pedestrians will be diverted along the eastern side of London Road resulting in the need to cross the junction of Shelford Road; this is a wide junction mouth with vehicles turning at speed due to the relaxed radii. Furthermore, there appears to be limited verge width available on the eastern side of London Road south of the railway which may result in pedestrians walking within the carriageway. Both situations increase the risk of collisions between pedestrians and vehicles.

Figure 2.4: Wide junction mouth for pedestrians to cross.

It is recommended that pedestrians continue along the western side of London Road and cross to the east north of the Shelford Road junction. Visibility from the railway bridge is good in both directions with a wide hardstanding on either side, and would be a suitable location for pedestrians to cross.

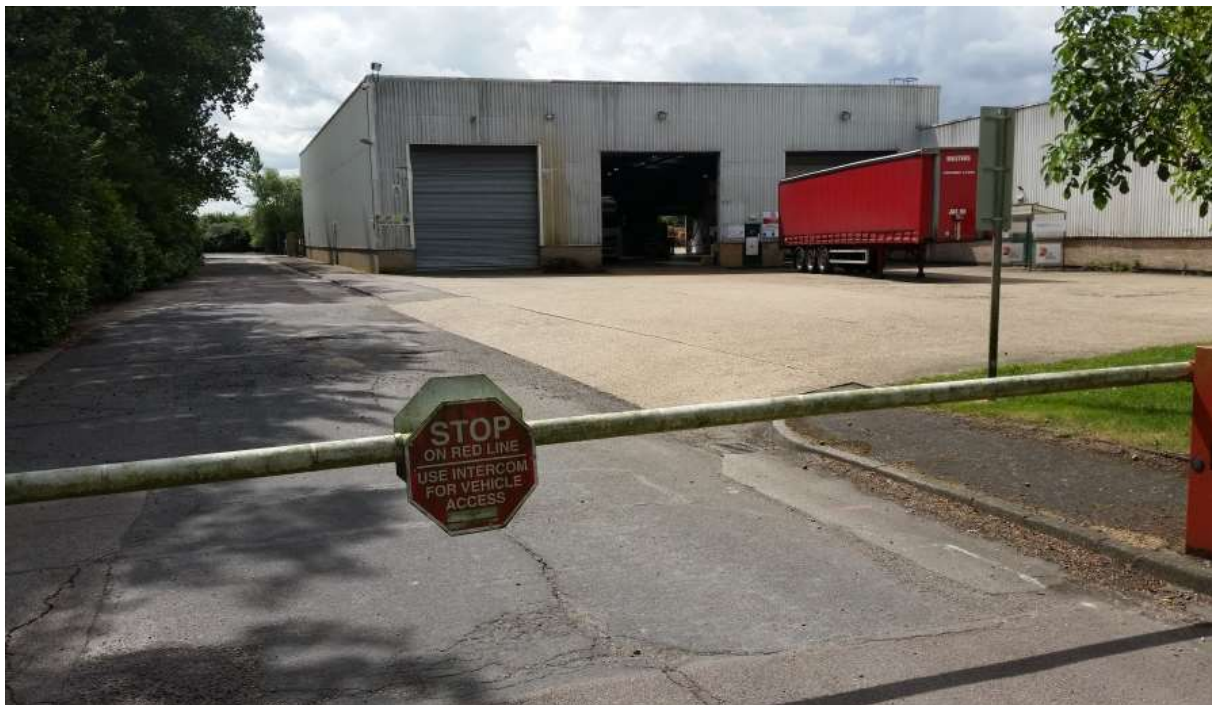
Location: Queen Adelaide.

Summary: Risk of vehicle collisions with pedestrians.

The red and blue routes both appear to direct pedestrians along an industrial site access road where HGV movements are taking place. HGV drivers may not be aware of pedestrians walking within the site which could result in conflict between vehicles and pedestrians, particularly when crossing the access to the warehousing units where large vehicles will be reversing.

Figure 2.5: Pedestrians directed through industrial site.

It is recommended that a footpath is provided for pedestrians on the eastern side of the access road so that they are segregated from the industrial site traffic. If this cannot be achieved then an alternative route should be identified.

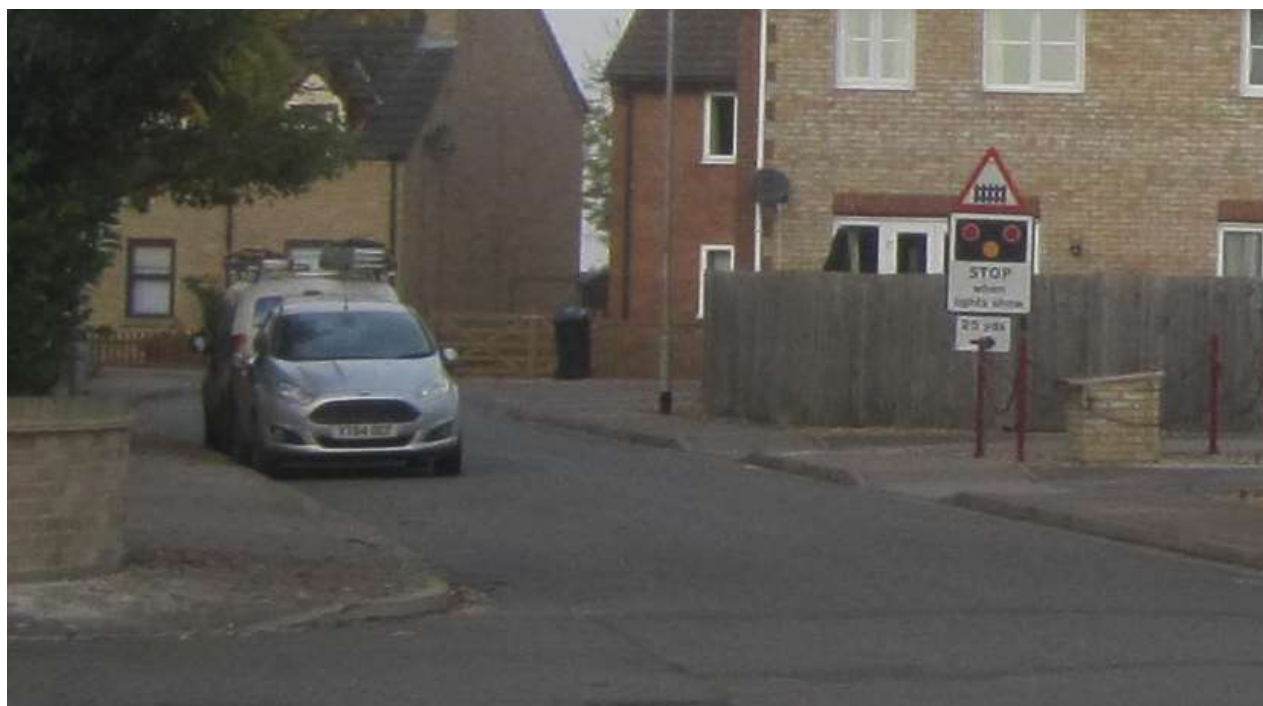
Location: Padnal.

Summary: Risk of pedestrian trip collisions.

The proposed diversion route will likely result in pedestrians crossing Padnal between the accesses to a small residential car park. Full height kerbs are present at this location which may lead to trip type injuries.

Figure 2.6: Padnal looking north.

It is recommended that a crossing point is provided on Padnal featuring dropped kerbs and tactile paving.

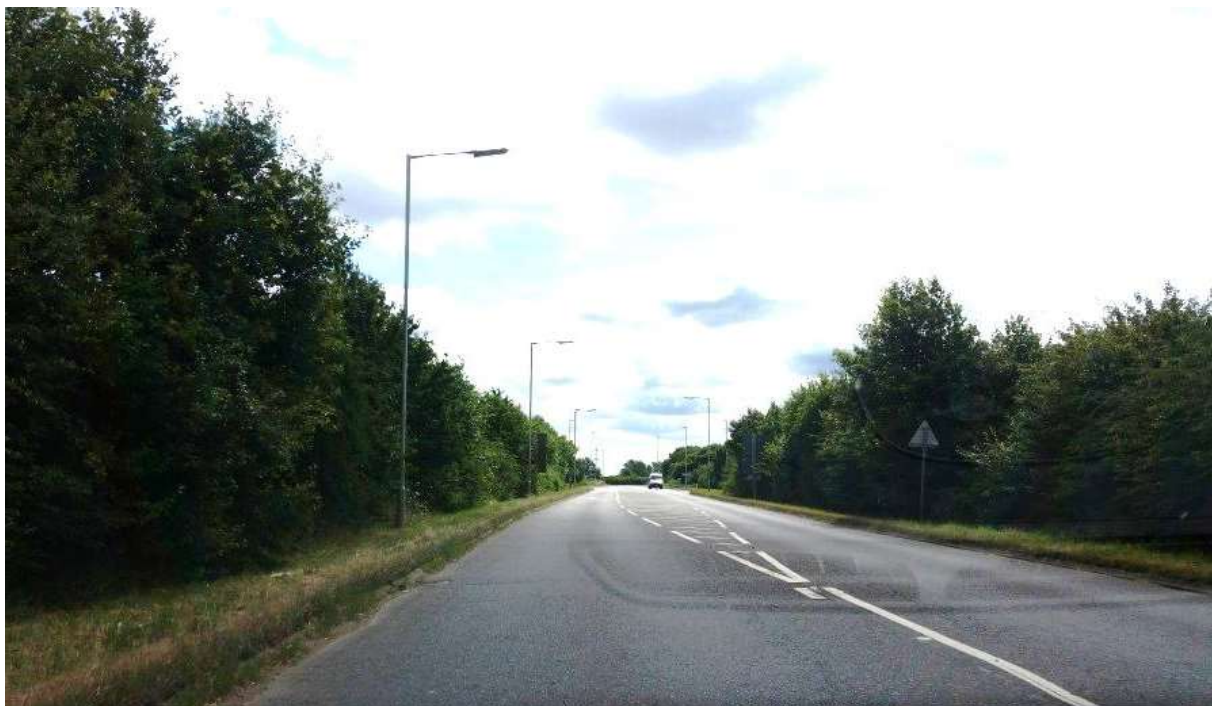
Location: A10.

Summary: Risk of vehicle collisions with pedestrians.

No footways are present along this section of the A10 and although there is a relatively flat wide verge there are a number of signs placed within the verge which could force pedestrians into the carriageway. The A10 is a primary route and vehicle speeds and traffic flows were observed to be high which may give drivers limited time to react to pedestrians within the carriageway and could result in conflict between pedestrians and vehicles. Furthermore, should a pedestrian trip or slip and fall in the carriageway there is a risk of vehicle strikes and serious injuries.

Figure 2.7: Lack of footway along A10.

It is recommended that a footway is provided for pedestrians.

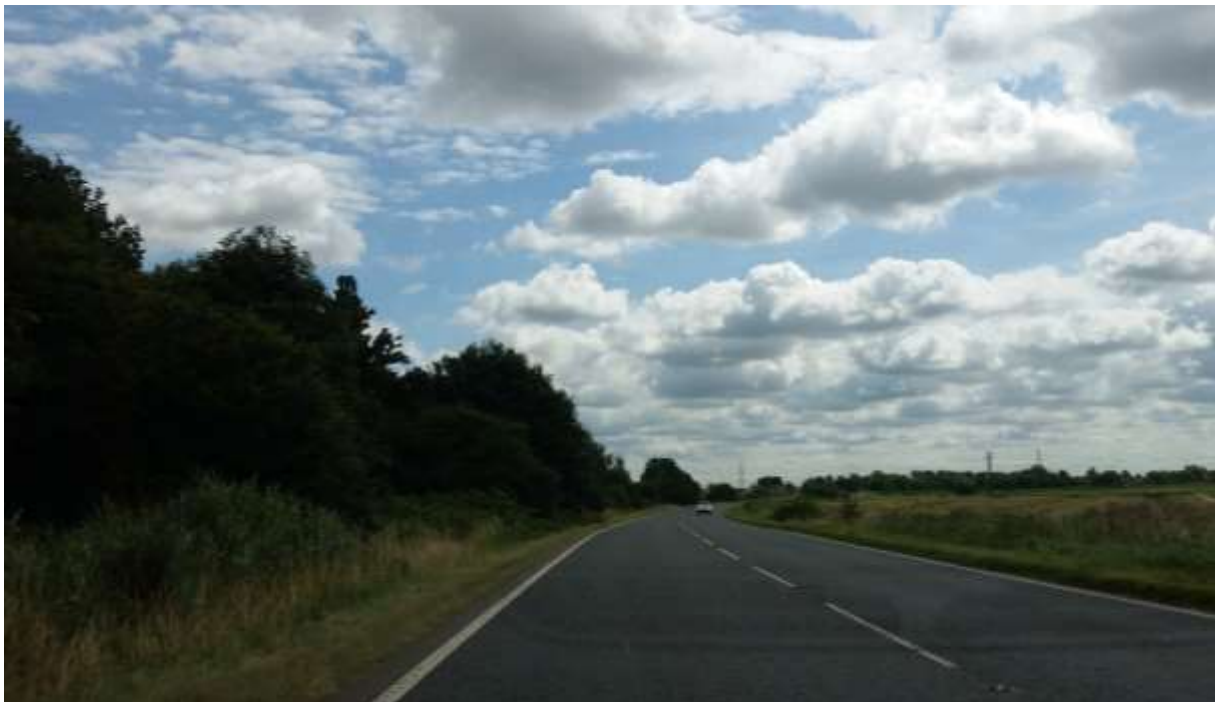
Location: A10.

Summary: Risk of vehicle collisions with pedestrians.

No footways are present along this section of the A10 and although there is a relatively flat wide verge there are a number of signs placed within the verge which could force pedestrians into the carriageway. The A10 is a primary route and vehicle speeds and traffic flows were observed to be high which may give drivers limited time to react to pedestrians within the carriageway and could result in conflict between pedestrians and vehicles. Furthermore, should a pedestrian trip or slip and fall in the carriageway there is a risk of vehicle strikes and serious injuries.

Figure 2.8: Lack of footway along A10.

It is recommended that a footway is provided for pedestrians.
