THE NETWORK RAIL
(ESSEX AND OTHERS
LEVEL CROSSING REDUCTION)
ORDER

#### **SUSAN TILBROOK**

SUPPLEMENTARY PROOF OF EVIDENCE RELATING TO MATTERS RAISED IN JOHN RUSSELL'S LETTER DATED 12TH OCTOBER 2017

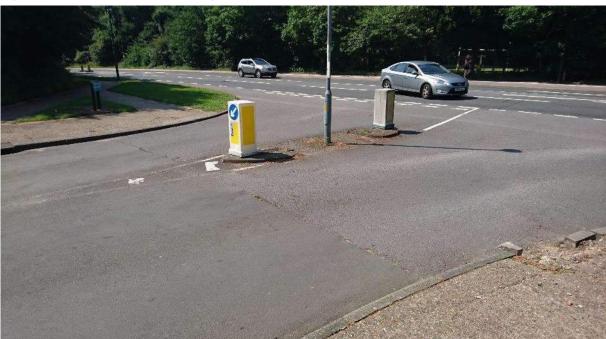
It is proposed that the alternative route will require pedestrians to cross Elizabeth Way to the southern side and continue along an existing footway. This footway crosses Herons Wood at a point where no appropriate crossing point is provided. This may result in trips or falls, or conflicts between pedestrians and vehicles. Furthermore, there is a segregated footway / cycleway along the length of the northern side of Elizabeth Way that would remove the need for pedestrians to cross any carriageways. Therefore, the proposed route unnecessarily increases the risk of collisions between crossing pedestrians and vehicles.

Figure 2.1: Lack of appropriate crossing facility on Herons Wood.

It is recommended that the route continues along the northern side of Elizabeth Way.

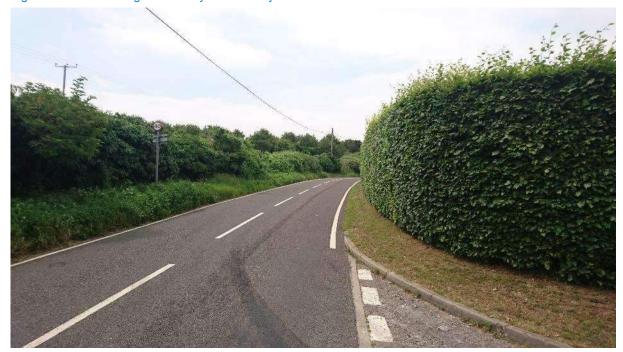
It is proposed that pedestrians will walk along a section of Littlebury Green Road where no footway or notable verge is present; this will result in pedestrians walking in the carriageway. A high volume of traffic was observed on Littlebury Green Road travelling at high speeds and visibility is restricted by the highway geometry and vegetation, particularly to the west of Goodwins Close. These factors may result in collisions between pedestrians and vehicles.

Figure 2.3: Lack of verge or footway on Littlebury Green Road.

It is recommended that a suitable footway is provided.

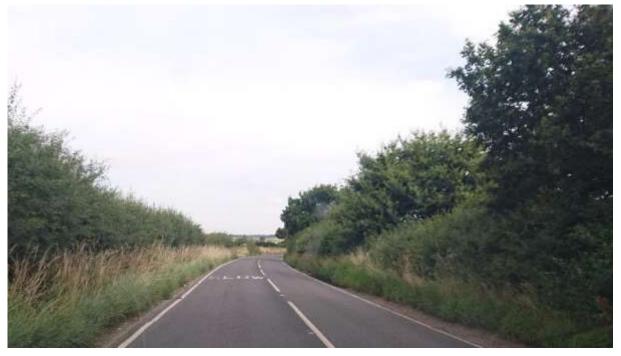
It is proposed that pedestrians will walk along a section of St Marys Lane where no footway or notable verge is present; this will result in pedestrians walking in the carriageway. A high volume of traffic was observed on St Marys Lane travelling at high speeds and visibility is restricted by the highway geometry. These factors may result in collisions between pedestrians and vehicles.

Figure 2.4: Lack of verge or footway on St Marys Lane.

It is recommended that a suitable footway is provided or that the Blue Route Option is utilised.

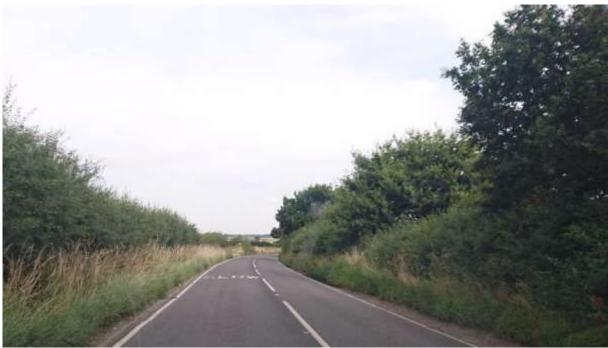
It is proposed that pedestrians will walk along a section of St Marys Lane where no footway or notable verge is present; this will result in pedestrians walking in the carriageway. A high volume of traffic was observed on St Marys Lane travelling at high speeds and visibility is restricted by the highway geometry. These factors may result in collisions between pedestrians and vehicles.

Figure 2.5: Lack of verge or footway on St Marys Lane.

It is recommended that a suitable footway is provided or that the Blue Route Option is utilised.

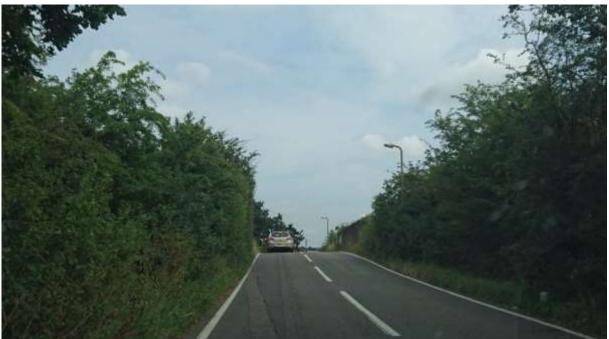
It is proposed that pedestrians will walk along a section of St Marys Lane where no footway or notable verge is present; this will result in pedestrians walking in the carriageway. A high volume of traffic was observed on St Marys Lane travelling at high speeds and visibility is restricted by the highway geometry and the railway road bridge. These factors may result in collisions between pedestrians and vehicles.

Figure 2.6: Lack of verge or footway on St Marys Lane.

It is recommended that a suitable footway is provided or that the Blue Route Option is utilised.

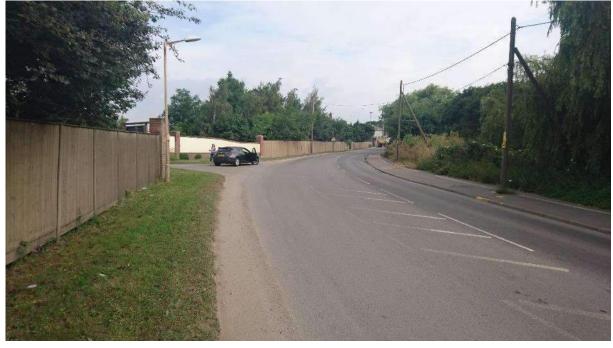
It is proposed that pedestrians will walk along a section of Pitsea Hall Lane on the western side of the carriageway where no footway or notable verge is present; this will result in pedestrians walking in the carriageway. A high number of HGVs generally travelling at excessive speeds were observed on Pitsea Hall Lane. This may lead to an increased risk of collisions between pedestrians and vehicles.

Figure 2.7: Lack of verge or footway on western side of Pitsea Hall Lane.

It is recommended that suitable crossing facilities are provided to allow pedestrians to cross to the eastern side and utilise the existing segregated footway / cycleway. Vegetation clearance will need to be untaken to provide a suitable footway / cycleway width.

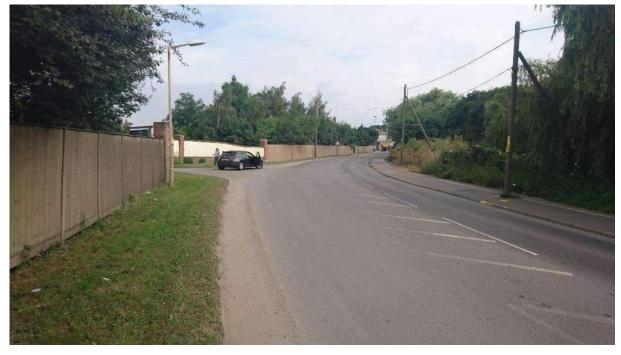
It is proposed that pedestrians will walk along a section of Pitsea Hall Lane on the western side of the carriageway where no footway or notable verge is present; this will result in pedestrians walking in the carriageway. A high number of HGVs generally travelling at excessive speeds were observed on Pitsea Hall Lane. This may lead to an increased risk of collisions between pedestrians and vehicles.

Figure 2.8: Lack of verge or footway on western side of Pitsea Hall Lane.

It is recommended that suitable crossing facilities are provided to allow pedestrians to cross to the eastern side and utilise the existing segregated footway / cycleway. Vegetation clearance will need to be untaken to provide a suitable footway / cycleway width.

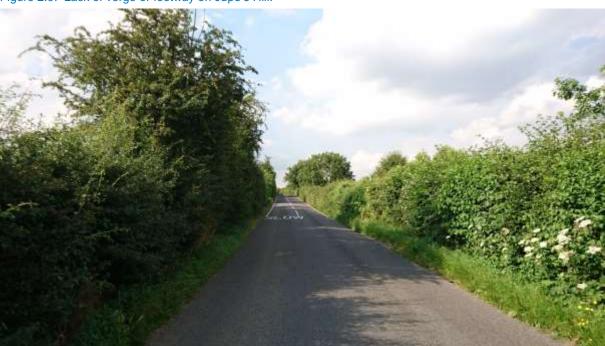
It is proposed that pedestrians will walk along a section of Jupe's Hill between Oldhouse Farm and Willow Cottage where no footway or notable verge is present; this will result in pedestrians walking in the carriageway. Whilst traffic flows were observed to be low, speeds were excessive with visibility restricted by a road bridge. These factors may result in collisions between pedestrians and vehicles.

Figure 2.9: Lack of verge or footway on Jupe's Hill.

It is recommended that a suitable footway is provided or that the Blue Route Option is utilised.

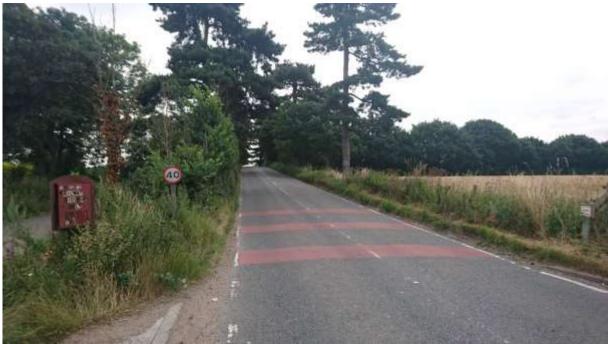
It is proposed that pedestrians will walk along a section of Ockendon Road where no footway or notable verge is present; this will result in pedestrians walking in the carriageway. A high volume of traffic was observed on Ockendon Road travelling at high speeds despite the 40mph speed limit and visibility is restricted by the highway geometry and the railway road bridge. These factors may result in collisions between pedestrians and vehicles.

Figure 2.2: Lack of verge or footway on Ockendon Road.

It is recommended that a suitable footway is provided. This should extend to Pea Lane with a dropped kerb provided at a suitable position to allow pedestrians to join the carriageway on Pea Lane.

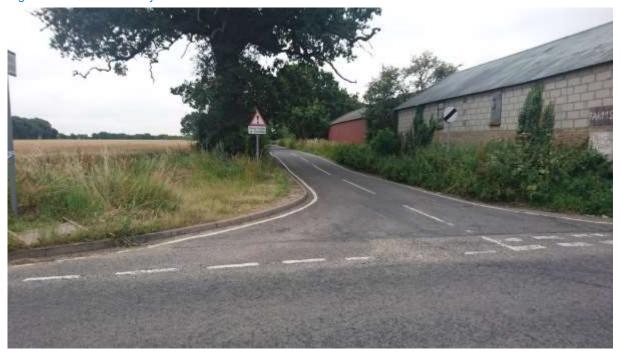
It is proposed that pedestrians will walk along the length of Pea Lane where no footway or notable verge is present; a high volume of traffic was observed travelling at high speeds and visibility is restricted by the highway geometry and vegetation. These factors may result in collisions between pedestrians and vehicles.

Figure 2.3: Lack of footway on Pea Lane.

It is recommended that a suitable footway is provided along Pea Lane or that the Red Route is utilised taking into consideration issues raised in **Section 2.3**.

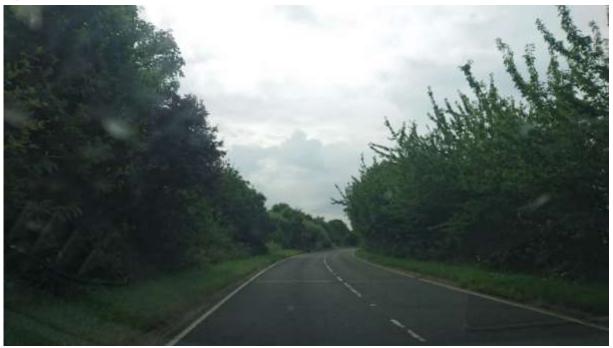
It is proposed that pedestrians will walk along a section of Dennis Road and West Road where no footway is present; pedestrians walking in the verge for extended periods of time may be vulnerable to trips and falls or choose to walk in the carriageway. A high volume of traffic was observed travelling at high speeds and visibility is restricted by the highway geometry and vegetation. These factors may result in collisions between pedestrians and vehicles.

Figure 2.4: Lack of footway on Dennis Road.

It is recommended that a suitable footway is provided on Dennis Road and West Road.

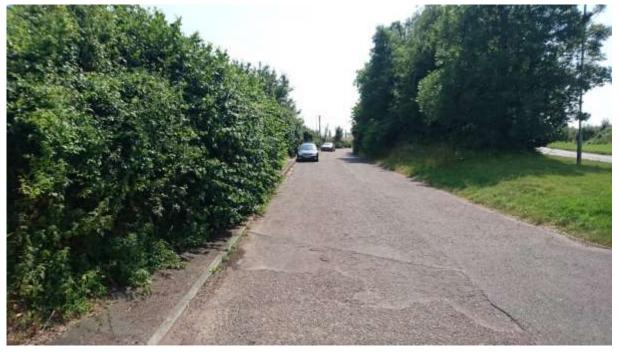
It is proposed that pedestrians will walk along an existing footway on the eastern side of the A1184. At a point where the footway follows the back of the layby adjacent to The Gates, excessive vegetation encroachment prevents the footway from being used. Pedestrians stepping into the carriageway to pass the vegetation may be struck by passing vehicles increasing the risk of personal injury.

Figure 2.5: Overgrown footway along back of layby.

It is recommended that suitable vegetation clearance is undertaken at this location.

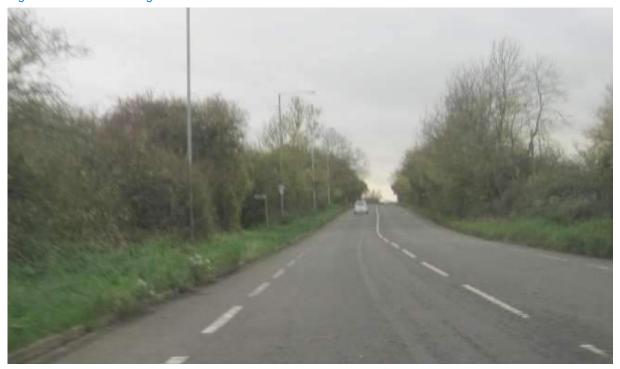
The available verge width on Southend Road appeared restricted which could force pedestrians into the carriageway where they are at risk of collisions with vehicles. A cycleway is also present on Southend Road and cyclists may swerve to avoid pedestrians in the carriageway potentially resulting in conflict either between pedestrians and cyclists or between cyclists and vehicles.

Figure 2.6: Restricted verge width.

It is recommended that a suitable footway are provided along Southend Road.

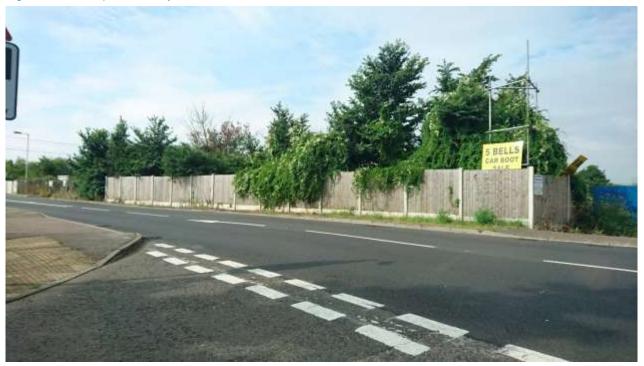
The footway along the western side of High Road is incomplete in the vicinity of Fobbing Level Crossing. As such, pedestrian will either continue along the verge or cross unnecessarily to the eastern side before crossing back again. Both scenarios increase the risk of trips and falls or collisions with passing vehicles.

Figure 2.7: Incomplete footway.

It is recommended that an additional section of footway is provided on the western side of High Road to the north of the railway, to remove the incomplete section of footway.

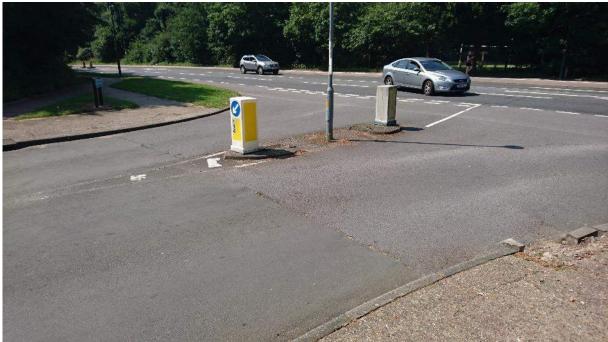
It is proposed that the alternative route will require pedestrians to cross Elizabeth Way to the southern side and continue along an existing footway. This footway crosses Herons Wood at a point where no appropriate crossing point is provided. This may result in trips or falls, or conflicts between pedestrians and vehicles. Furthermore, there is a segregated footway / cycleway along the length of the northern side of Elizabeth Way that would remove the need for pedestrians to cross any carriageways. Therefore, the proposed route unnecessarily increases the risk of collisions between crossing pedestrians and vehicles.

Figure 2.1: Lack of appropriate crossing facility on Herons Wood.

It is recommended that the route continues along the northern side of Elizabeth Way.

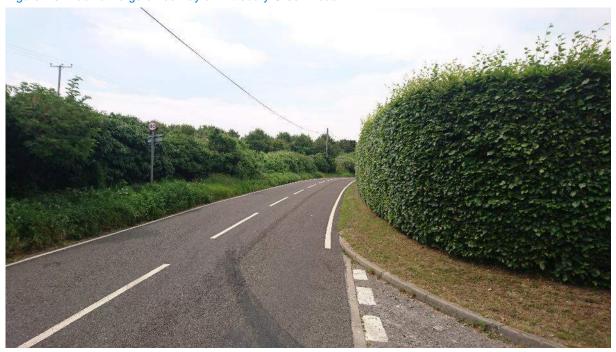
It is proposed that pedestrians will walk along a section of Littlebury Green Road where no footway or notable verge is present; this will result in pedestrians walking in the carriageway. A high volume of traffic was observed on Littlebury Green Road travelling at high speeds and visibility is restricted by the highway geometry and vegetation, particularly to the west of Goodwins Close. These factors may result in collisions between pedestrians and vehicles.

Figure 2.3: Lack of verge or footway on Littlebury Green Road.

It is recommended that a suitable footway is provided.

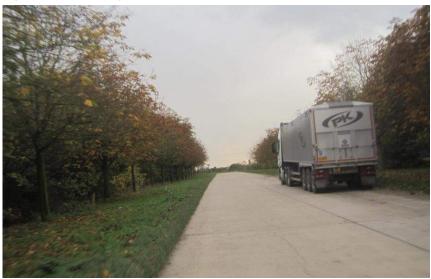
The diversion route guides pedestrians along the Bulls Lodge Quarry access road which is heavily used by large vehicles. Although the access road is wide and has good forward visibility, it is not recommended that pedestrians walk within the carriageway as any collision with a large vehicle is likely to result in serious injury to pedestrians.

Figure 2.4: Bulls Lodge Quarry access road.

It is recommended that a compacted footpath is provided and set back from the access road to encourage pedestrians to stay clear of the carriageway.

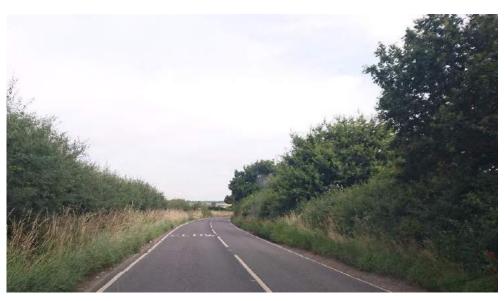
It is proposed that pedestrians will walk along a section of St Marys Lane where no footway or notable verge is present; this will result in pedestrians walking in the carriageway. A high volume of traffic was observed on St Marys Lane travelling at high speeds and visibility is restricted by the highway geometry. These factors may result in collisions between pedestrians and vehicles.

Figure 2.6: Lack of verge or footway on St Marys Lane.

It is recommended that a suitable footway is provided or that the Blue Route Option is utilised.

Agreed – Therefore an alternative solution (red route referred to in 2.29 above) is under consideration. However, if this is found to be unsuitable, this level crossing will be removed from the project.

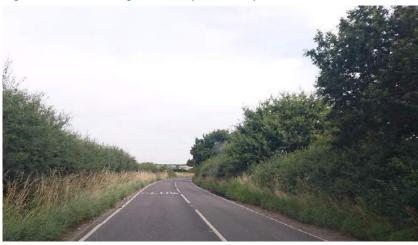
It is proposed that pedestrians will walk along a section of St Marys Lane where no footway or notable verge is present; this will result in pedestrians walking in the carriageway. A high volume of traffic was observed on St Marys Lane travelling at high speeds and visibility is restricted by the highway geometry. These factors may result in collisions between pedestrians and vehicles.

Figure 2.7: Lack of verge or footway on St Marys Lane.

It is recommended that a suitable footway is provided or that the Blue Route Option is utilised.

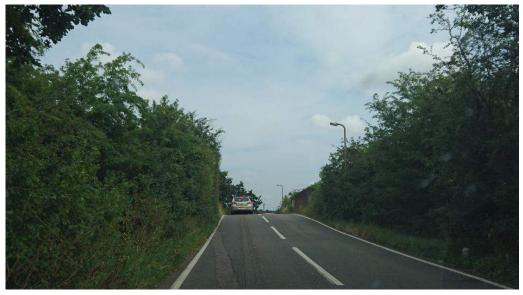
It is proposed that pedestrians will walk along a section of St Marys Lane where no footway or notable verge is present; this will result in pedestrians walking in the carriageway. A high volume of traffic was observed on St Marys Lane travelling at high speeds and visibility is restricted by the highway geometry and the railway road bridge. These factors may result in collisions between pedestrians and vehicles.

Figure 2.9: Lack of verge or footway on St Marys Lane.

It is recommended that a suitable footway is provided or that the Blue Route Option is utilised.

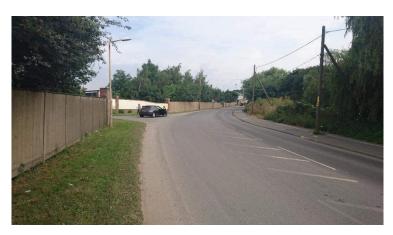
It is proposed that pedestrians will walk along a section of Pitsea Hall Lane on the western side of the carriageway where no footway or notable verge is present; this will result in pedestrians walking in the carriageway. A high number of HGVs generally travelling at excessive speeds were observed on Pitsea Hall Lane. This may lead to an increased risk of collisions between pedestrians and vehicles.

Figure 2.10: Lack of verge or footway on western side of Pitsea Hall Lane.

It is recommended that suitable crossing facilities are provided to allow pedestrians to cross to the eastern side and utilise the existing segregated footway / cycleway. Vegetation clearance will need to be untaken to provide a suitable footway / cycleway width.

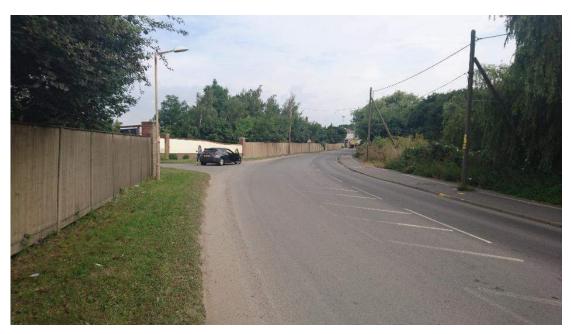
It is proposed that pedestrians will walk along a section of Pitsea Hall Lane on the western side of the carriageway where no footway or notable verge is present; this will result in pedestrians walking in the carriageway. A high number of HGVs generally travelling at excessive speeds were observed on Pitsea Hall Lane. This may lead to an increased risk of collisions between pedestrians and vehicles.

Figure 2.11: Lack of verge or footway on western side of Pitsea Hall Lane.

It is recommended that suitable crossing facilities are provided to allow pedestrians to cross to the eastern side and utilise the existing segregated footway / cycleway. Vegetation clearance will need to be untaken to provide a suitable footway / cycleway width.

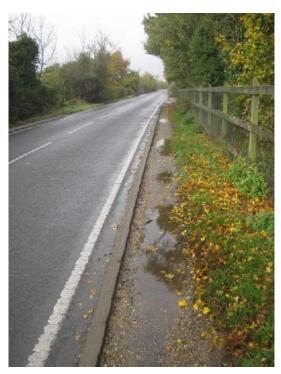
The proposed diversion will run along the north eastern verge of the Arlesford Road and where the wide verge narrows the surface of the existing narrow verge is uneven with a lower worn area and a raised unworn area presenting a level difference. The worn area also features numerous pot holes. There is a risk of pedestrians tripping on the uneven surface and falling into the carriageway, at risk of collisions with vehicles.

Figure 2.13: Alresford Road north eastern verge.

A suitable level hardstanding should be provided to reduce the risk of pedestrians tripping.

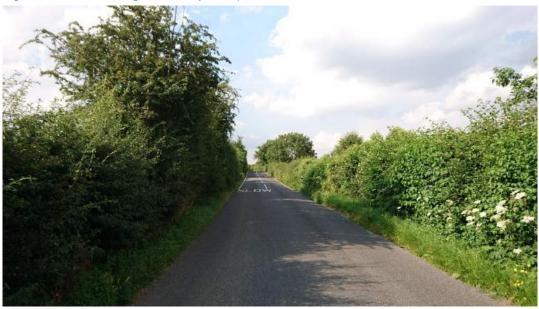
It is proposed that pedestrians will walk along a section of Jupe's Hill between Oldhouse Farm and Willow Cottage where no footway or notable verge is present; this will result in pedestrians walking in the carriageway. Whilst traffic flows were observed to be low, speeds were excessive with visibility restricted by a road bridge. These factors may result in collisions between pedestrians and vehicles.

Figure 2.15: Lack of verge or footway on Jupe's Hill.

It is recommended that a suitable footway is provided or that the Blue Route Option is utilised.

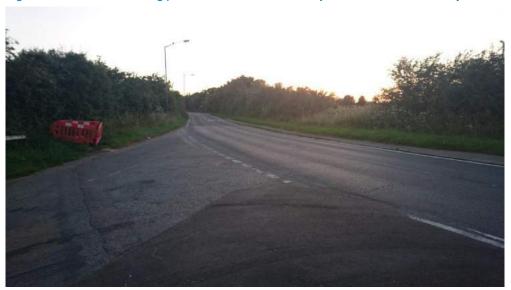
Figure 2.16: Lack of crossing point on Harwich Road at its junction with Little Bromley Road.

It is recommended that an appropriately positioned crossing point is installed on Harwich Road.

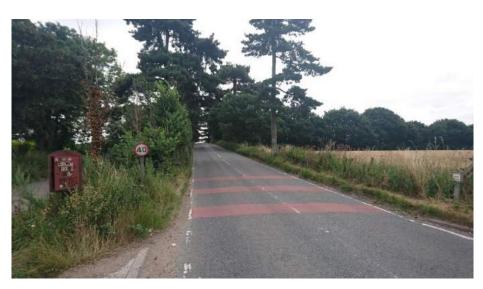
Figure 2.17: Lack of verge or footway on Ockendon Road.

It is recommended that a suitable footway is provided. This should extend to Pea Lane with a dropped kerb provided at a suitable position to allow pedestrians to join the carriageway on Pea Lane.

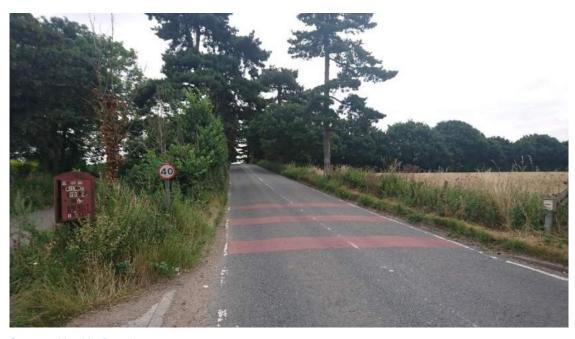
Figure 2.18: Lack of verge or footway on Ockendon Road.

It is recommended that a suitable footway is provided. This should extend to Pea Lane with a dropped kerb provided at a suitable position to allow pedestrians to join the carriageway on Pea Lane.

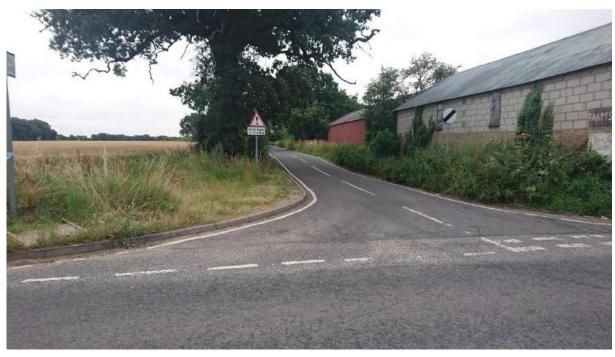
Figure 2.19: Lack of footway on Pea Lane.

It is recommended that a suitable footway is provided along Pea Lane or that the Red Route is utilised taking into consideration issues raised in **Section 2.65**.

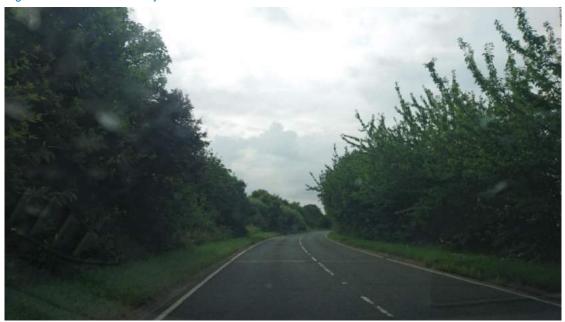
and visibility is restricted by the highway geometry and vegetation. These factors may result in collisions between pedestrians and vehicles.

Figure 2.20: Lack of footway on Dennis Road.

It is recommended that a suitable footway is provided on Dennis Road and West Road.

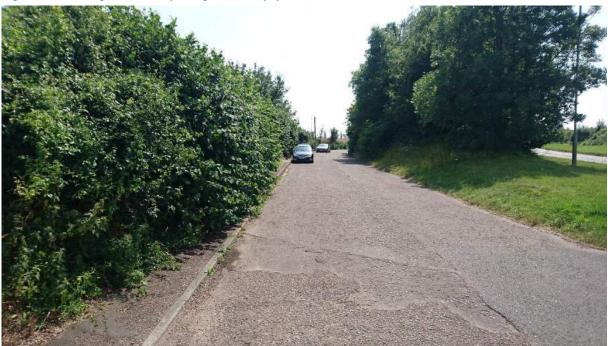
Figure 2.21: Overgrown footway along back of layby.

It is recommended that suitable vegetation clearance is undertaken at this location.

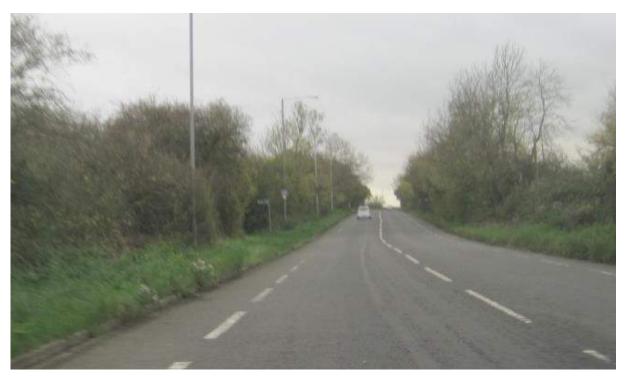
Figure 2.23: Restricted verge width.

It is recommended that a suitable footway is provided along Southend Road.

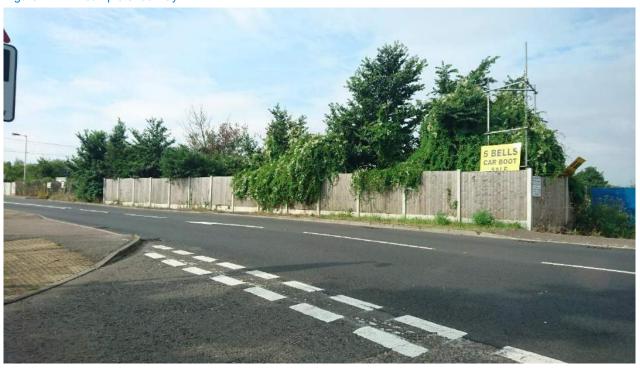
Figure 2.24: Incomplete footway.

It is recommended that an additional section of footway is provided on the western side of High Road to the north of the railway, to remove the incomplete section of footway.
