**KEATS HOUSE,
26-28 ST THOMAS'S STREET
LONDON**

**PROPOSED FAÇADE DISMANTLING
METHODOLOGY**

ROBERT GREER – PAYE

29th November 2018

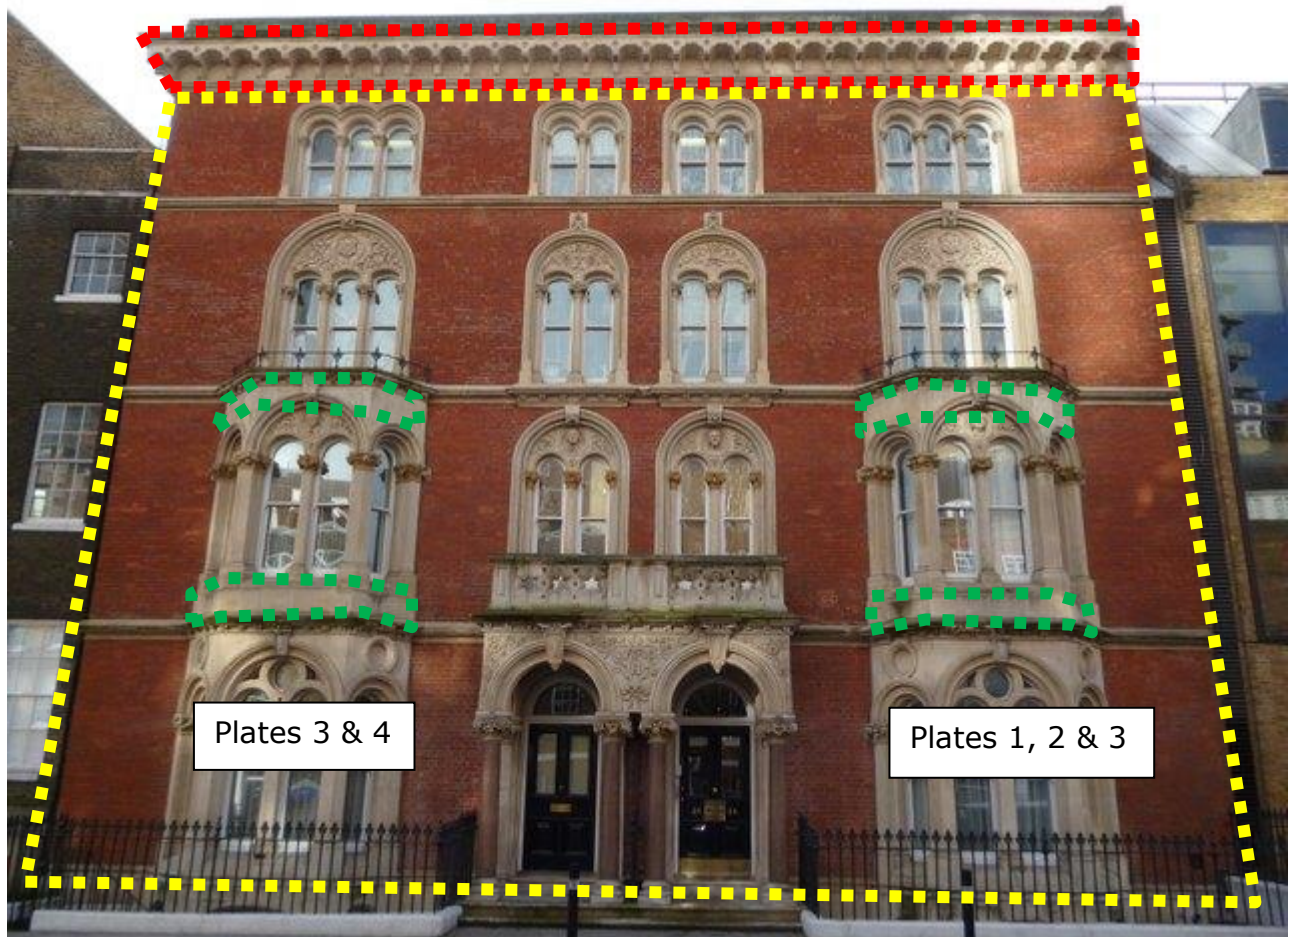
The area highlighted in yellow was scanned to determine the depth of brickwork construction.

The area highlighted in green was scanned to determine the depth of stone wall construction

The area highlighted in red was scanned to determine the depth of the cornice capping section of the wall.

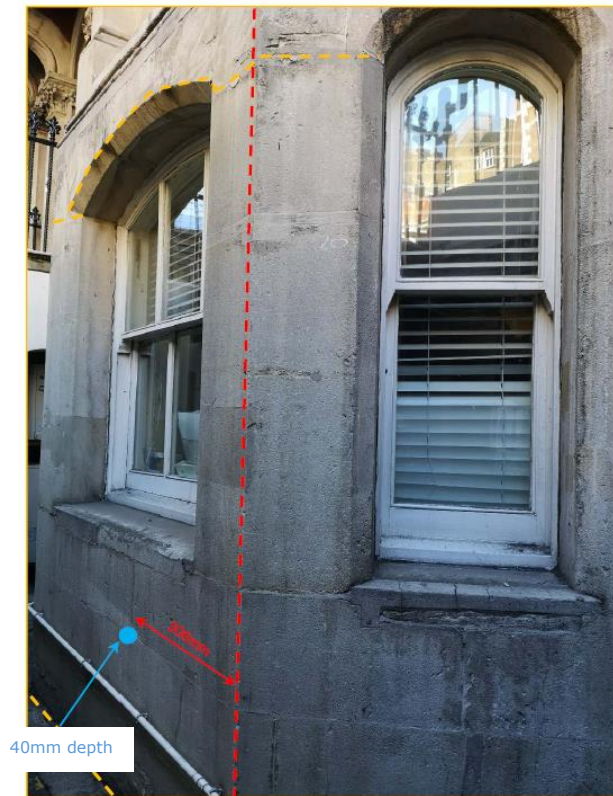
Plate 1

The photographic plates (1-5) on the following pages record the GPR survey of the flat surfaced masonry within the basement level where we were able to accurately determine the depth of wall construction and location of any extraneous metalwork (fixings).

A number of metallic features were detected within the flat areas of masonry with varying masonry cover between 20mm – 120mm as shown on the following images:

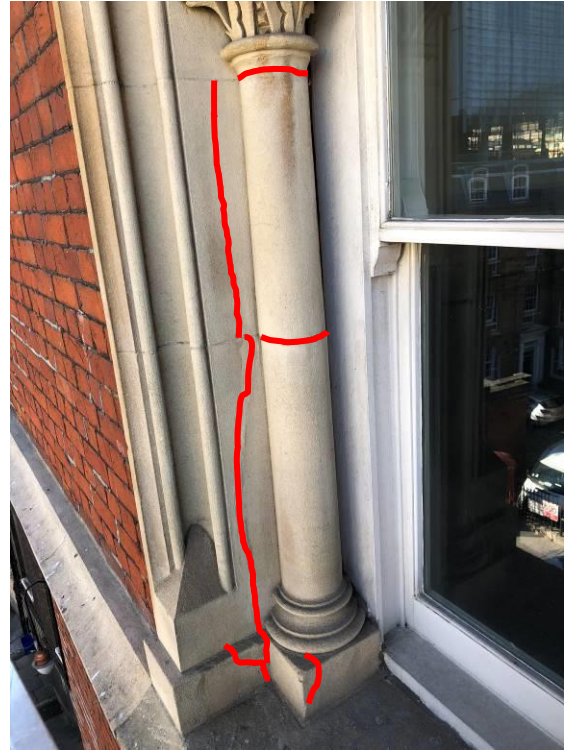
- A Fracturing to window reveal
typical of the cracking force of
the corrosion expansion of a
metal restraint cramp – ‘dog
cramp’.

Carefully dismantling and reconstructing the façade would allow all of the ferrous fixings to be located and replaced with a more appropriate permanent stainless steel restraint fixing without damaging the appearance of the stone façade.

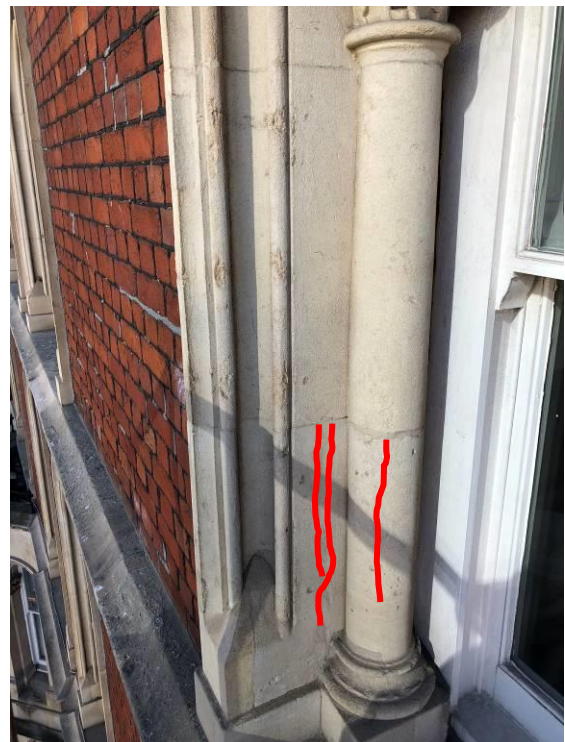
- B Fracturing to window reveal
typical of the cracking force of
the corrosion expansion of a
metal restraint cramp – ‘dog
cramp’.

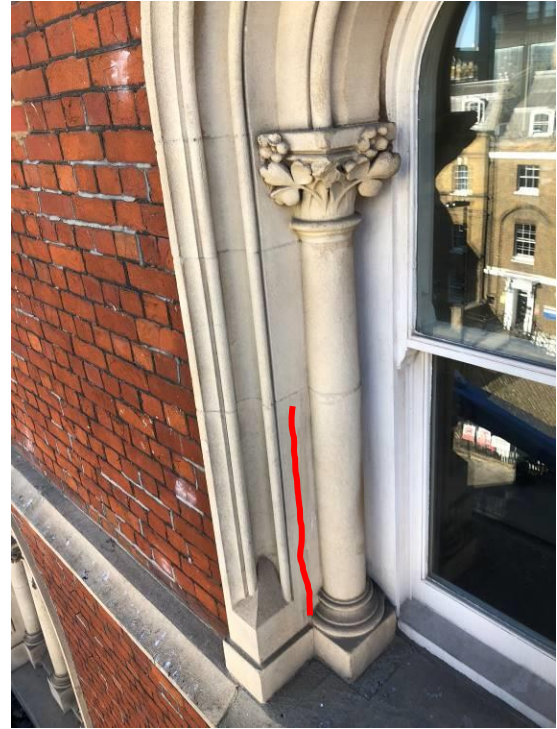
- C Fracturing to window reveal typical of the cracking force of the corrosion expansion of a metal restraint cramp - 'dog cramp'.

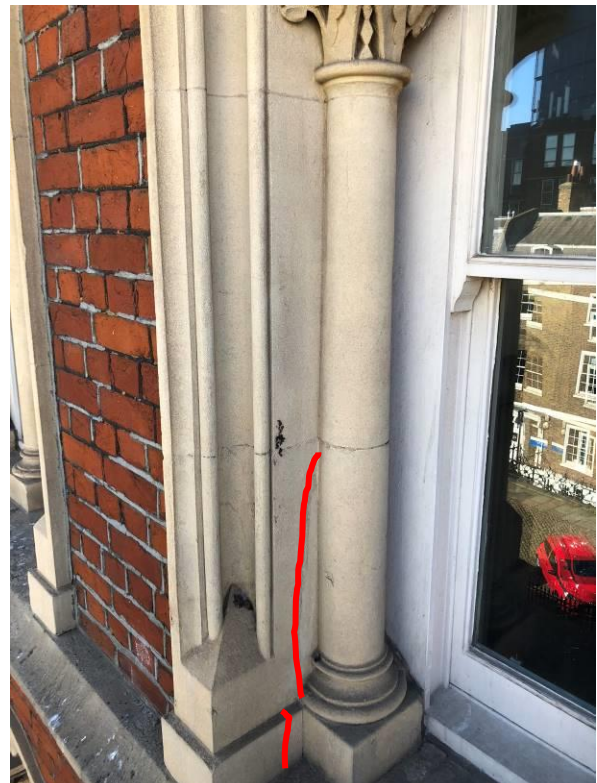
- D Fracturing to window reveal typical of the cracking force of the corrosion expansion of a metal restraint cramp - 'dog cramp'.

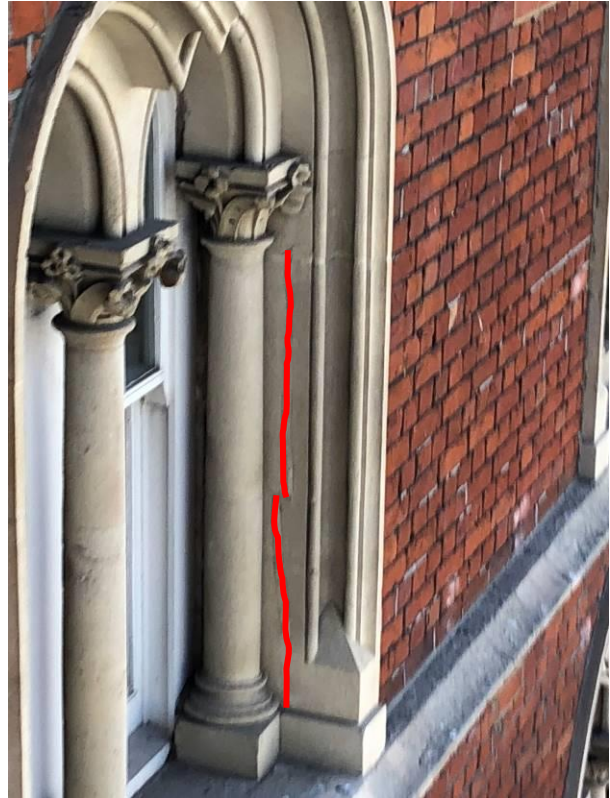
- E Fracturing to window reveal typical of the cracking force of the corrosion expansion of a metal restraint cramp - 'dog cramp'.

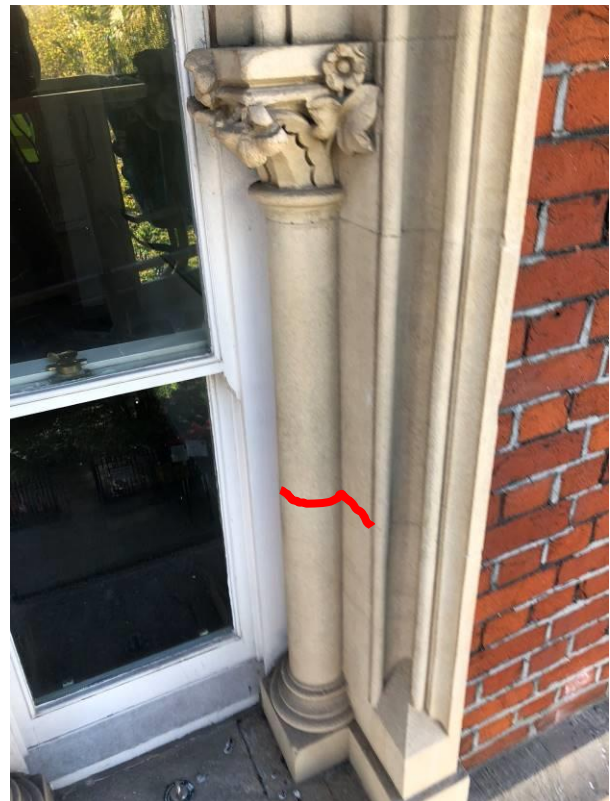
- F Fracturing to window reveal typical of the cracking force of the corrosion expansion of a metal restraint cramp - 'dog cramp'.

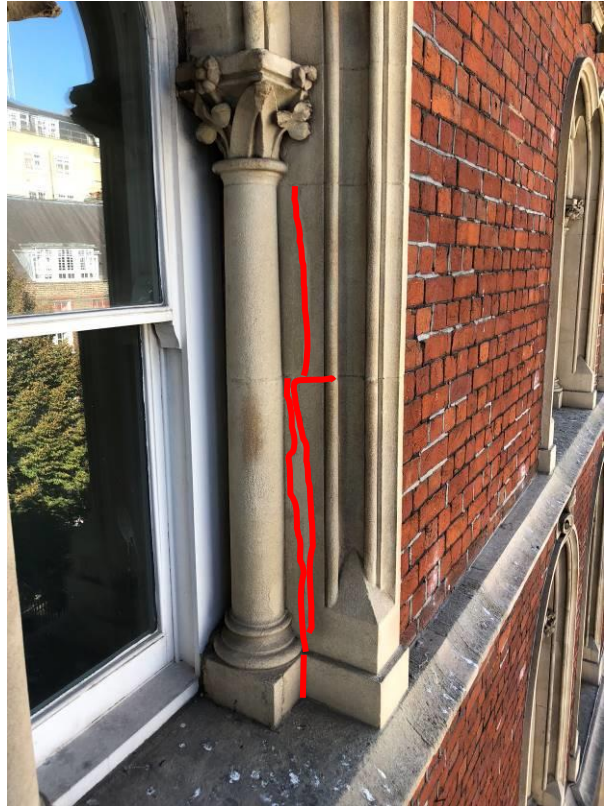
- G Fracturing to window reveal typical of the cracking force of the corrosion expansion of a metal restraint cramp - 'dog cramp'.

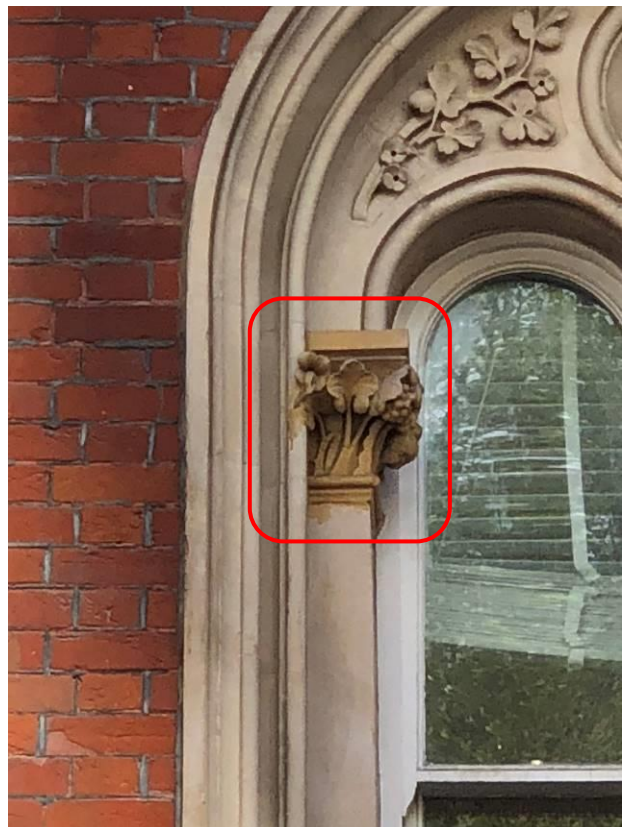
- H The jamb capitals have been coated with some form of impermeable liquid. The application is not precise so we assume that the intention was to consolidate and protect the stone rather than provide a different surface appearance.

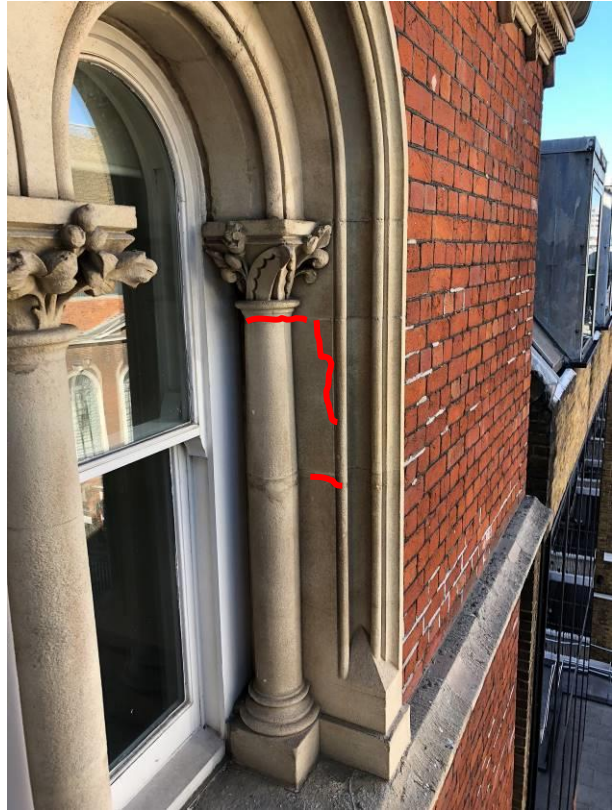
- I Fracturing to window reveal typical of the cracking force of the corrosion expansion of a metal restraint cramp - 'dog cramp'.

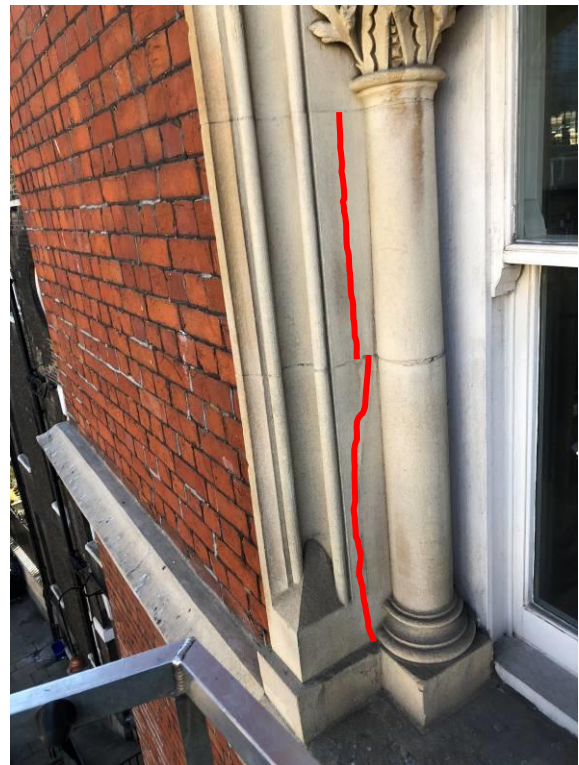
- J Fracturing to window reveal typical of the cracking force of the corrosion expansion of a metal restraint cramp - 'dog cramp'.

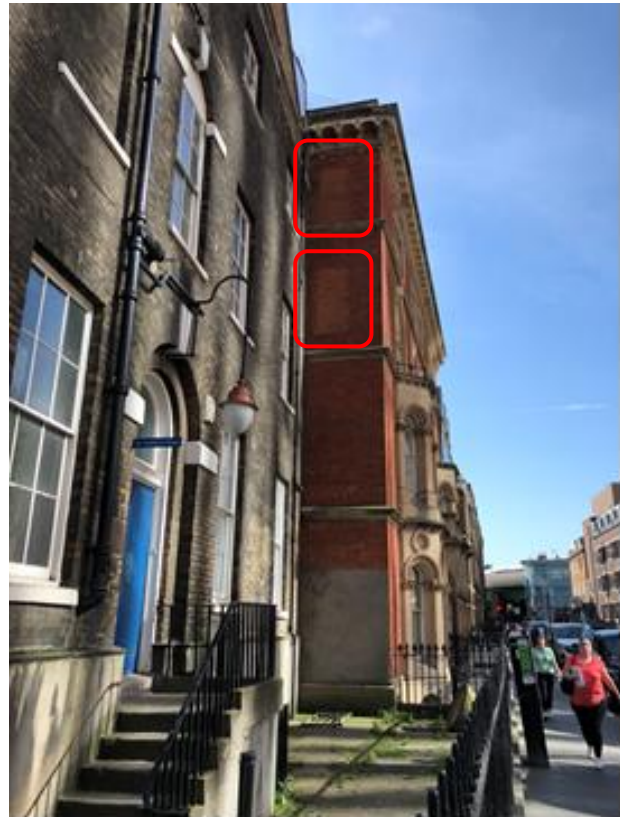
- K On the east return to the façade, two windows have been infilled with new brickwork.

The size, surface texture and brick colour do not match the original.

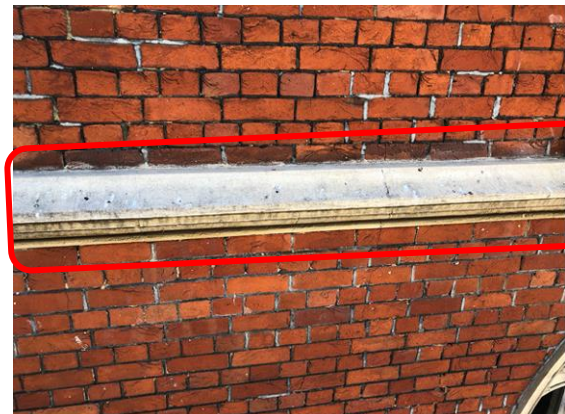
- L Most of the horizontal stone bands have been restored with a cementitious mortar.

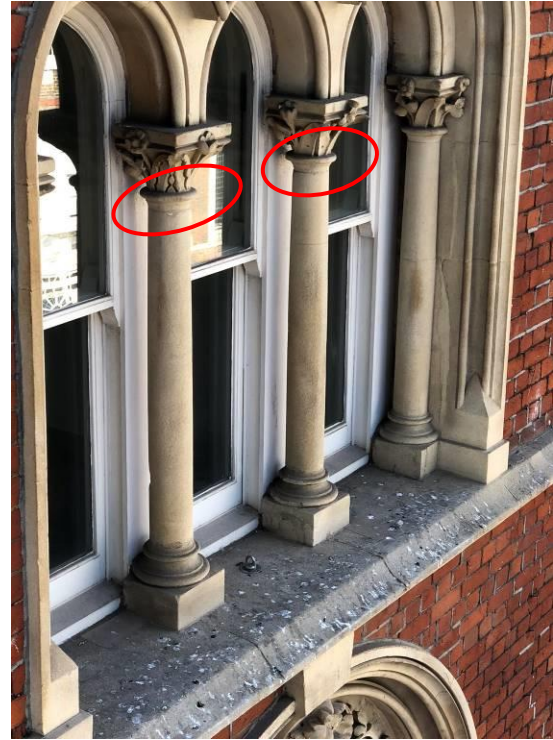
- M The bed joint between the column and capital has displaced with evidence of repointing / repair.

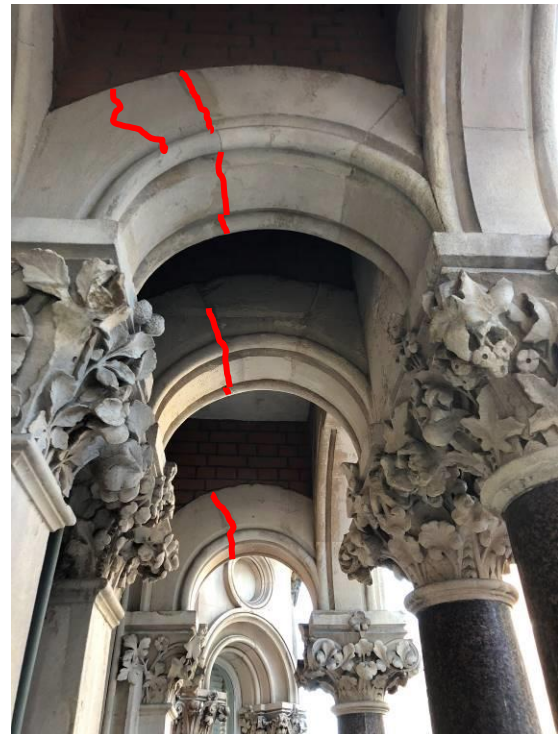
- N3.4 The internal arches to the entrance portico have fractured which would suggest that the arch has moved

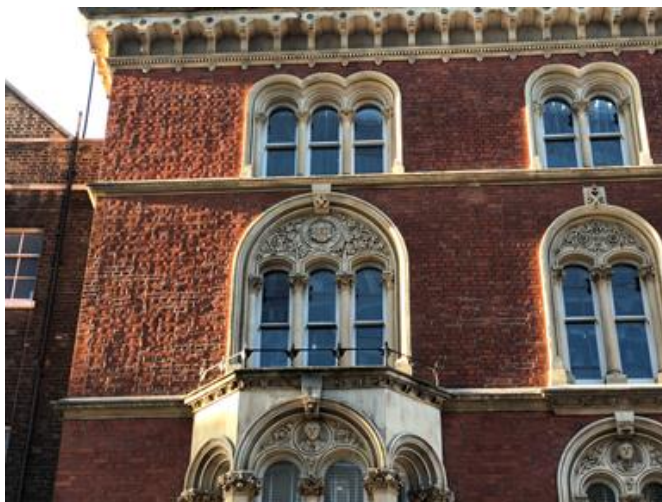
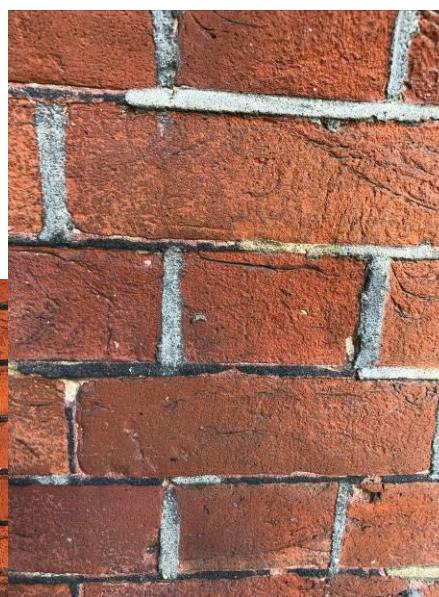
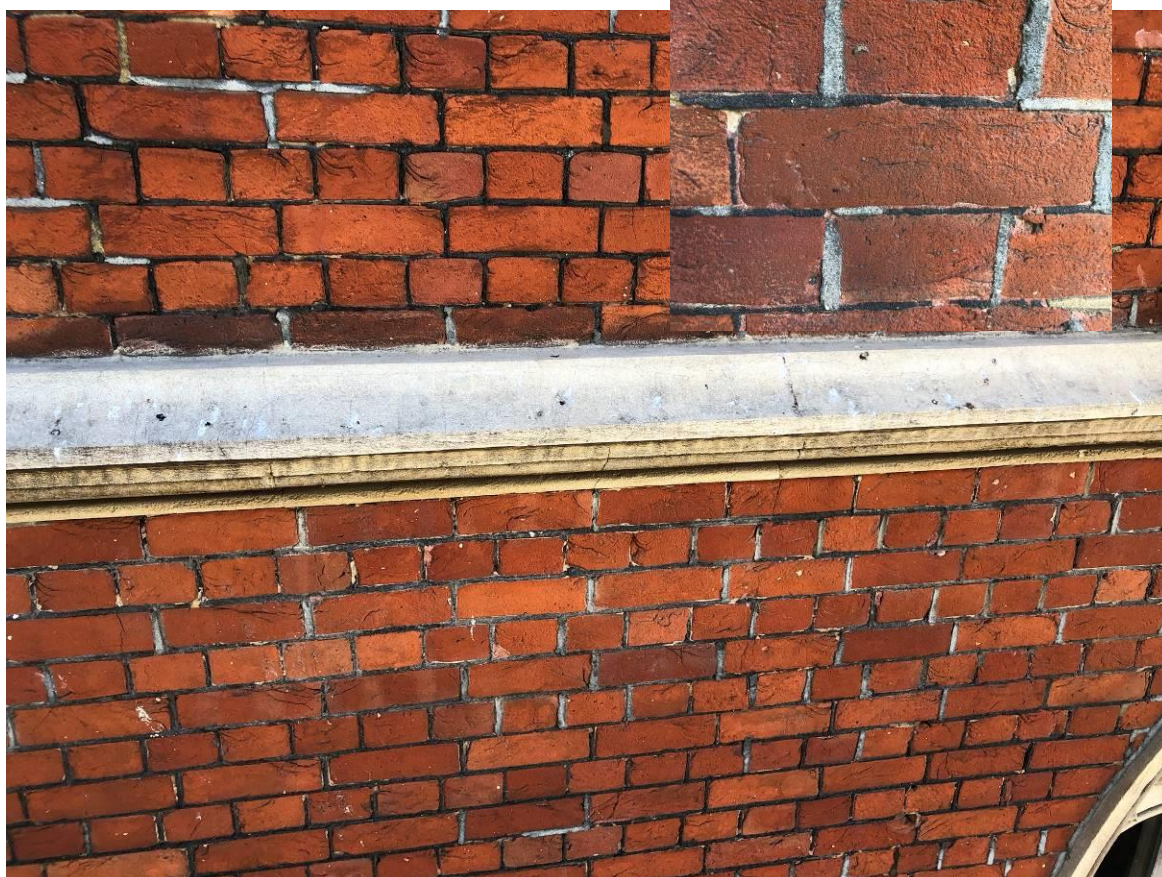
The bricks are a soft handmade imperial light / medium red brick.

The bricks would appear to be porous with a loose and friable surface and a very thin fired skin indicative of a low firing temperature.

There is a high proportion of bricks with fractures.

The brickwork joints are relatively tight at 6-8mm with a range of pointing styles including

- Red stopping mortar
- Black tuck point
- Black mortar pointing
- Grey repair mortar

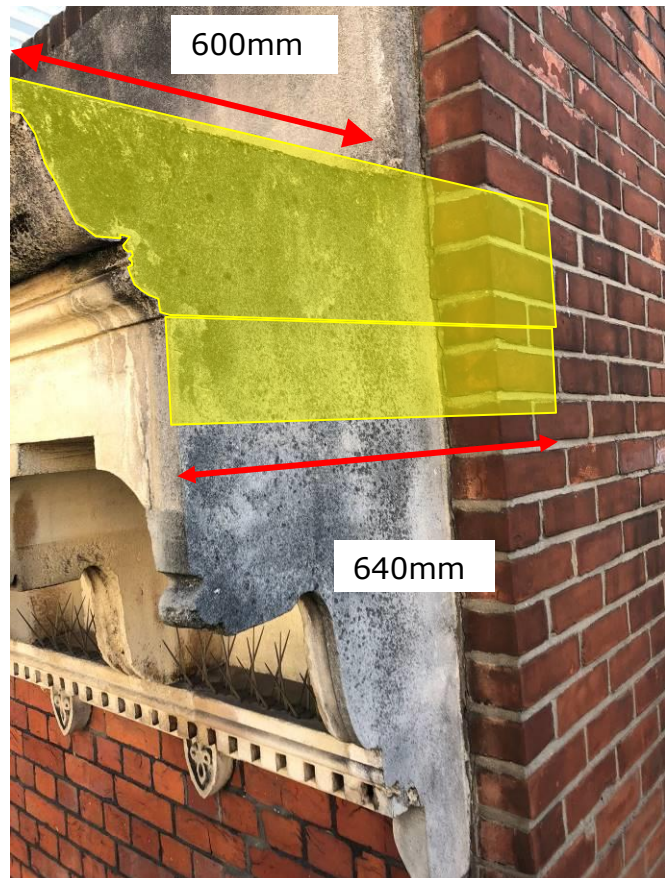
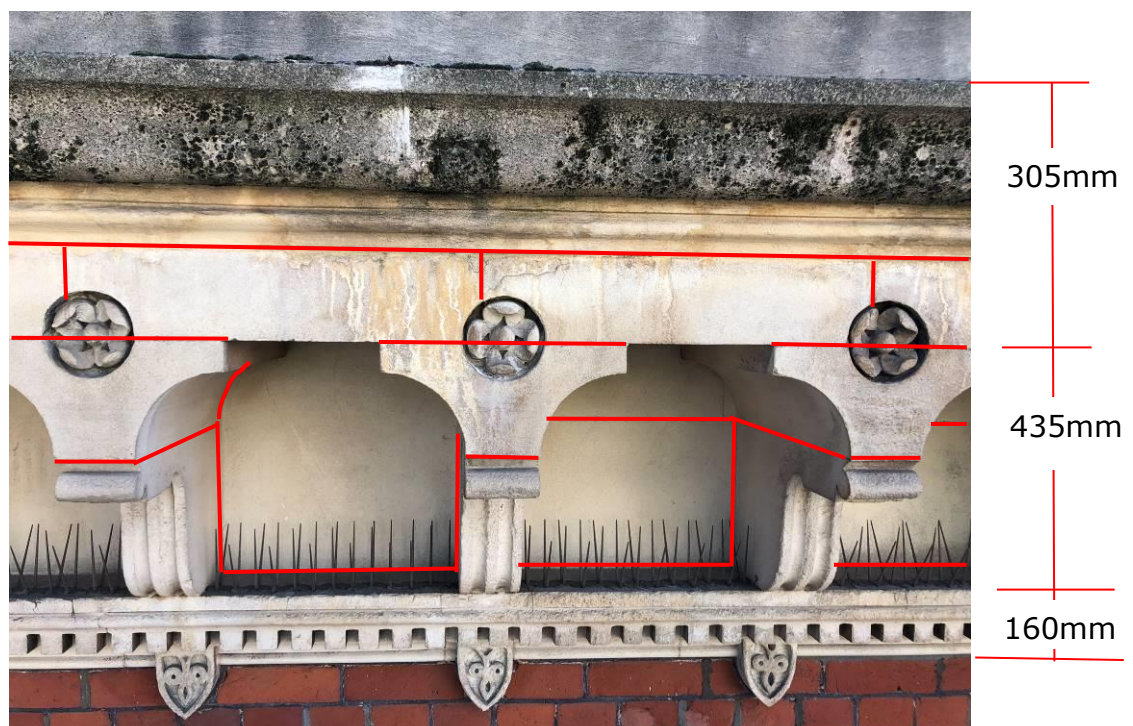
The cornice is constructed in five courses of stone with the lower three courses providing a corbelling support to the fascia and cornice course.

The sky surface has a considerable fall of 50mm but is uncovered with extensive staining.

On similar projects this cornice would be covered with code 6 lead and a welged drip to provide long term protection to the façade.
