PROTECTED LEVEL CROSSING RISK ASSESSMENT

Anglia Route
Level Crossing Narrative Risk Assessment
Dimmock's Cote AHB
Planned 4th April 2022

This is a risk assessment for Dimmock's Cote AHB level crossing.

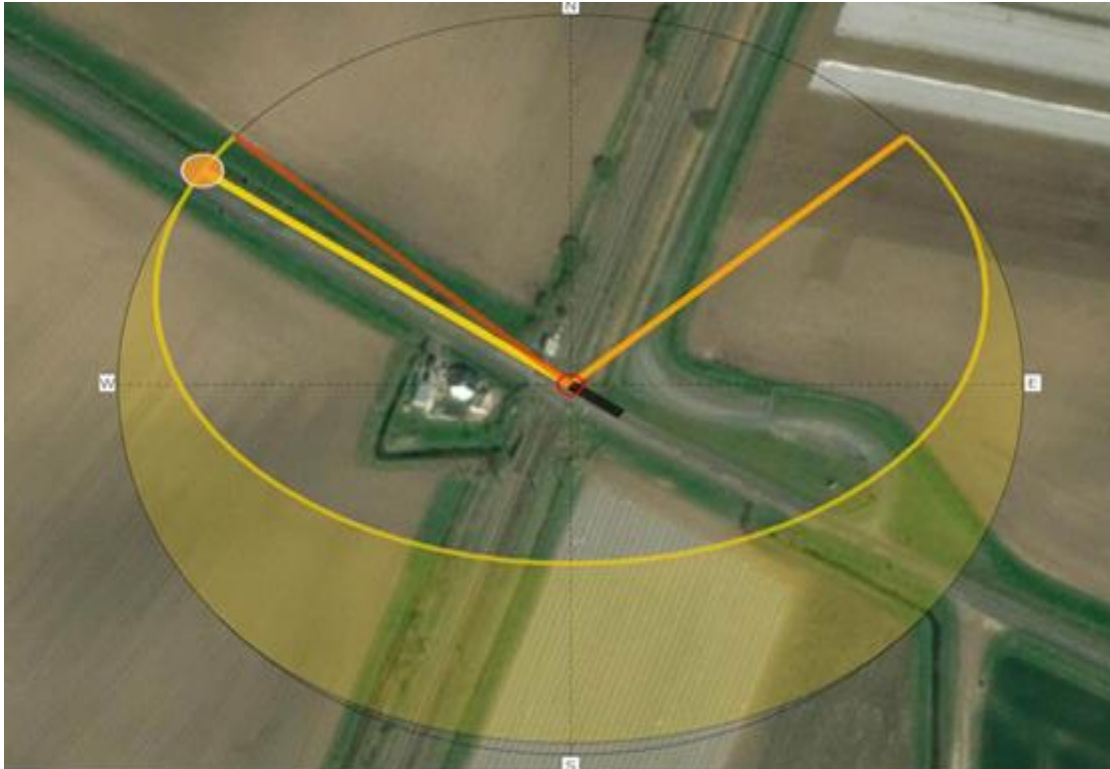
Longest Day June 21st.

Below is the output from the Sun Calc application, which shows the lines of sunrise and sunset angles at two times of year (longest day June 21st & shortest day December 21st) when low sun would align with the rail approaches and might impact on the sighting.

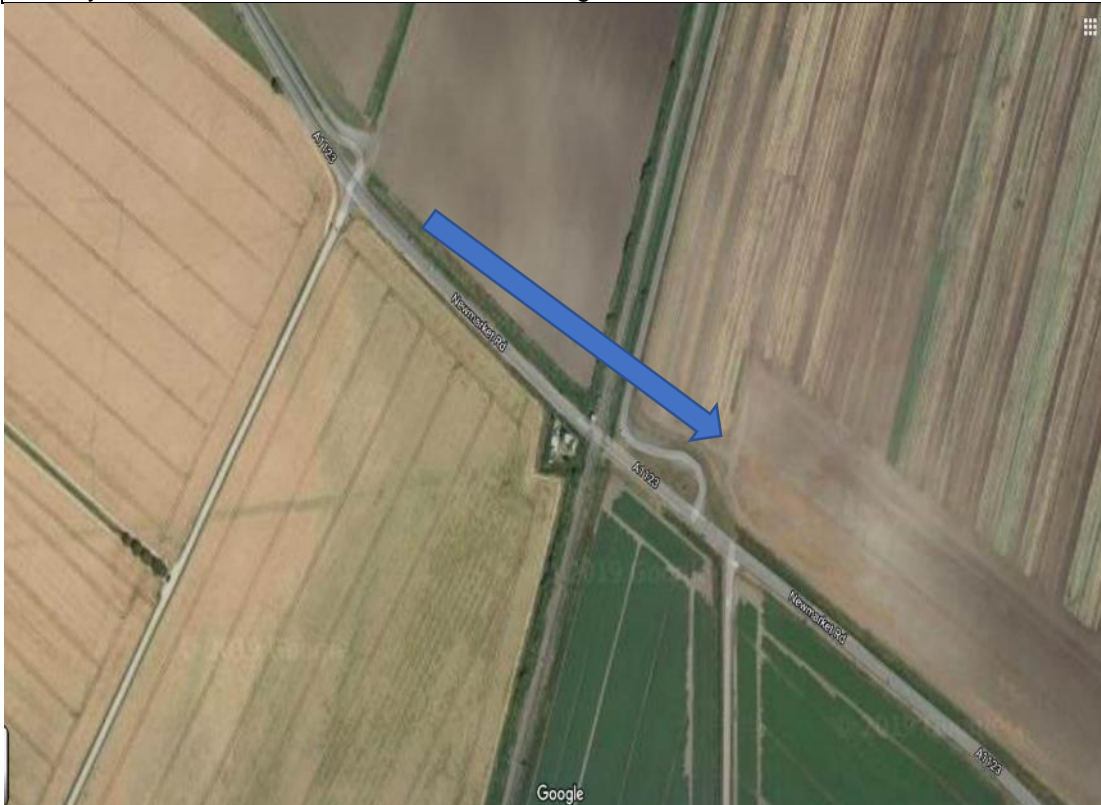
The crossing is located on the main line with trains running from Ely to Cambridge. The line is dual track with trains operating in both directions during normal service operation. The line speed in both directions is 75mph. Dimmock's Cote AHB is located between Ely and Waterbeach Railway Stations. No known new developments within the vicinity of the crossing, this has been checked with East Cambridgeshire County Council and Network Rail Town Planning.

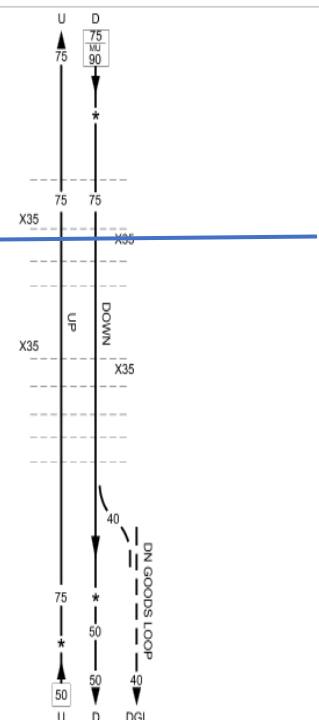
Sectional appendix extract.

The sectional appendix shows X35 either side of Dimmock's Cote AHB, this is a requirement for trains travelling in the wrong direction can only travel at a maximum of 35MPH over the crossing.

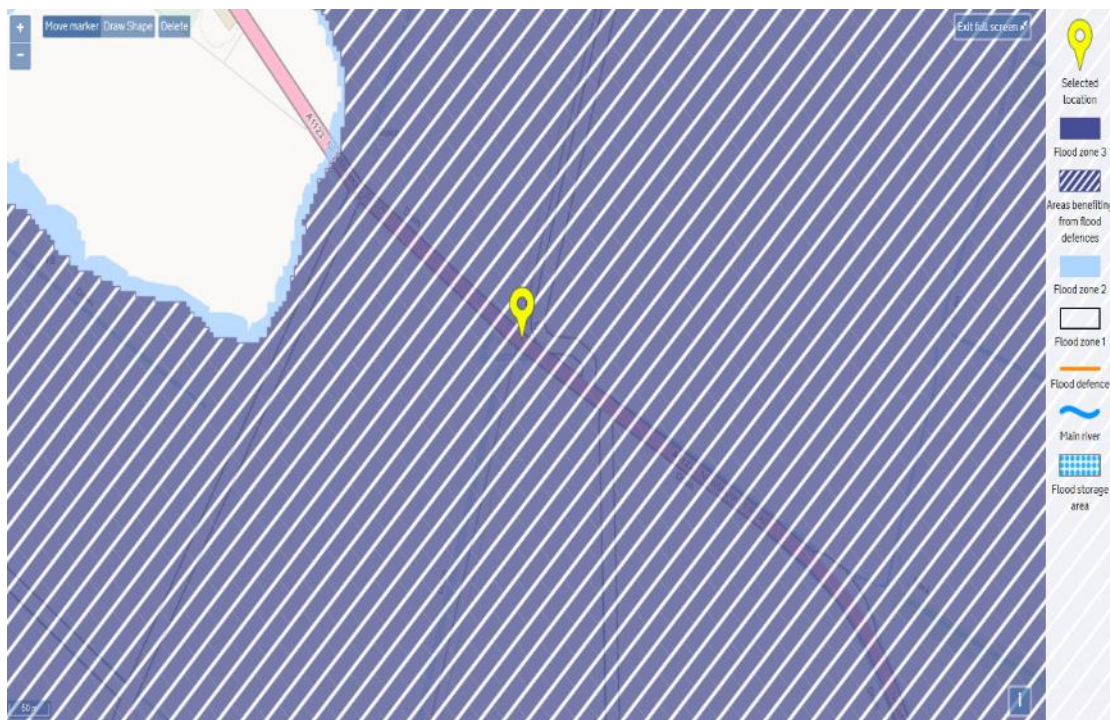
ANNEX A – ADDITIONAL PHOTOGRAPHS**Additional Photographs****Flood zone map.**

There is also a layby just before the crossing on the left, this crossing falls in the Flood zone territory which means there is a chance that the crossing could flood due to its location, and that it is located by two rivers close by but again this has never been known to happen.
