PROTECTED LEVEL CROSSING RISK ASSESSMENT

This is a risk assessment for Croxton AHB level crossing.

Crossing Details	
Name	Croxton AHB
Type	AHB
Crossing status	Public Highway
Overall crossing status	Open
Route name	ANGLIA
Engineers Line Reference	ETN – 96m 46ch
OS grid reference	TL902868
Number of lines crossed	2
Line speed (mph)	40 (TSR)
Electrification	No electrification present
Signal box	Cambridge PSB – Thetford workstation

Risk Assessment Details	
Name of assessor	Darren Lincoln
Post	LCM
Date completed	25-10-2021
Next due date	24-01-2023
Email address	darren.lincoln@networkrail.co.uk
Phone number	07824411923

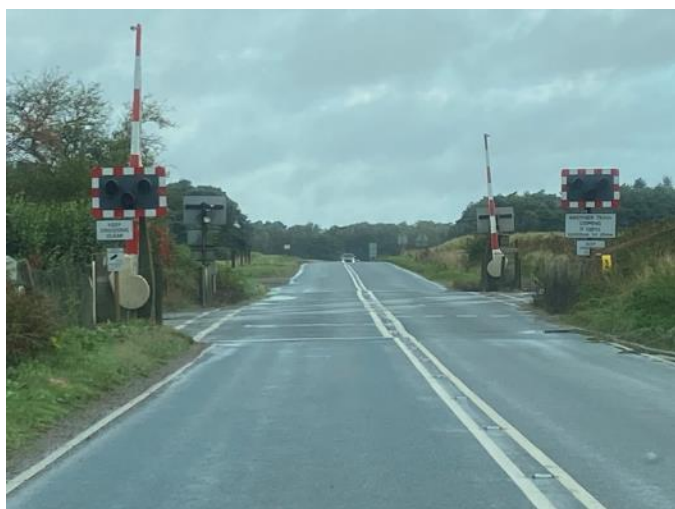
Up side crossing approach

From the South West direction (up side) the road curves approximately 200meters before crossing, given road speed and curvature vehicles approaching from this direction would have little time to react upon crossing activation this may account for the high barrier strike incident rate. Heavy sun glare can be an issue at certain times of year

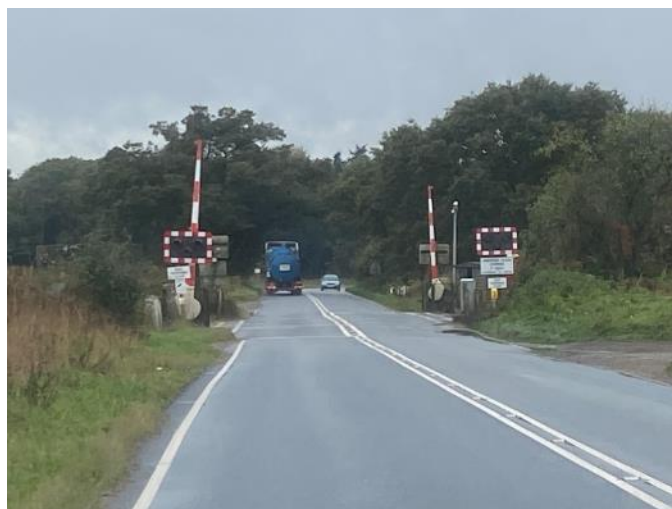
Down side crossing approach

From the North West direction (down side) the road is straight until you pass over the crossing and its bends towards the right, from this direction heavy sun glare can be an issue at certain times of year.

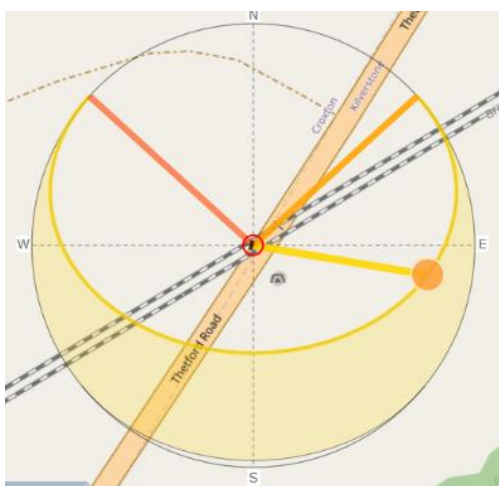
At Croxton AHB level crossing the orientation of the road/path from the north is 205°; the orientation of the railway from the north to the up line in the up direction is 260°. Crossing is in the top 100 of crossings at risk of sun glare list.

Longest day

Long sun hoods - Given the heavy sun glare on approaches, long sun hoods fitted alongside the previously installed LED wig wags would aid visibility of road traffic signal lights (wig wags). This option should be considered as part of the MCBOD upgrade.

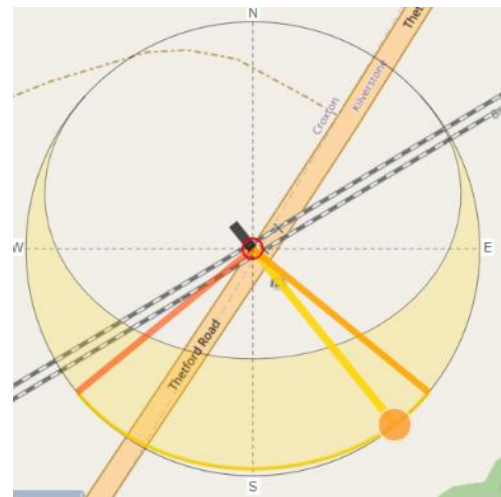
Shortest day

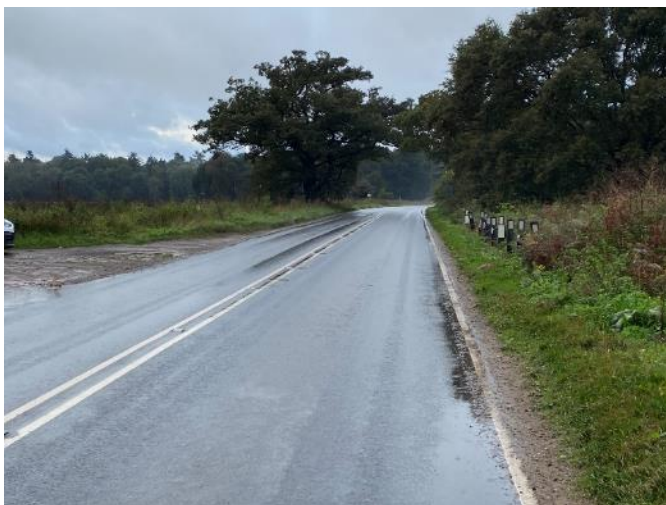
One of the approach roads to Croxton AHB level crossing is assessed as being long and straight. There are prominent features on the approach to the level crossing that could distract drivers.

side crossing approach (reverse view)

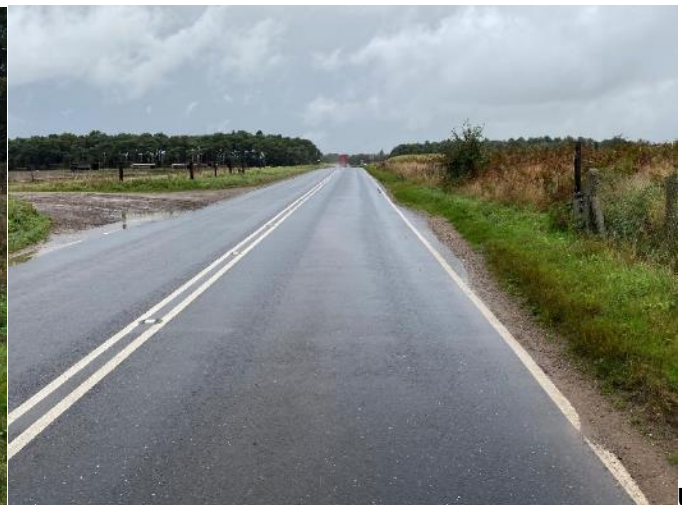
Down side crossing approach (reverse view)

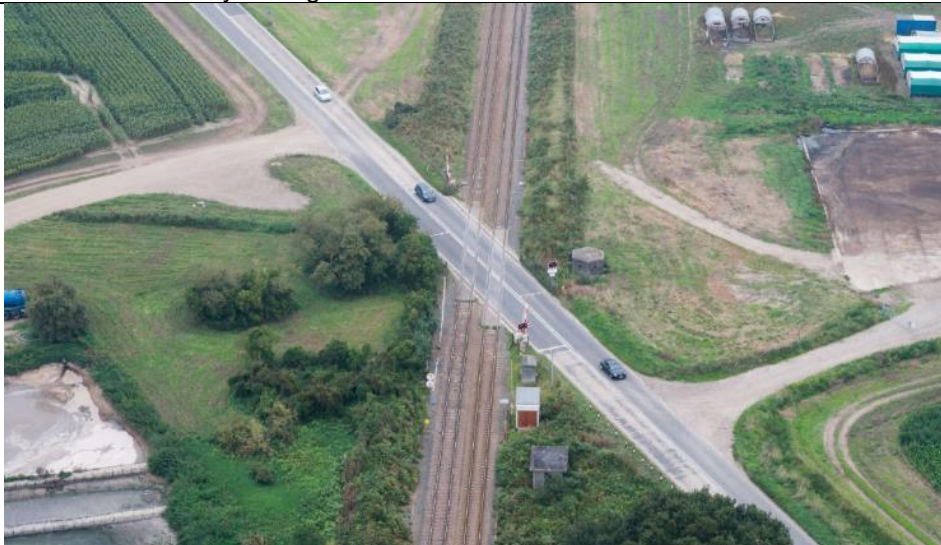
There is a number of accesses to fields on approach to this level crossing, but no evidence of blocking back during visits or census carried out by Intelligent Data Collection Limited
