M4 Corridor around Newport

Appendix SS10.3

Bat Roost Surveys of Buildings and
Structures 2016

M4CaN-DJV-EBD-ZG_GEN-AX-EN-0048

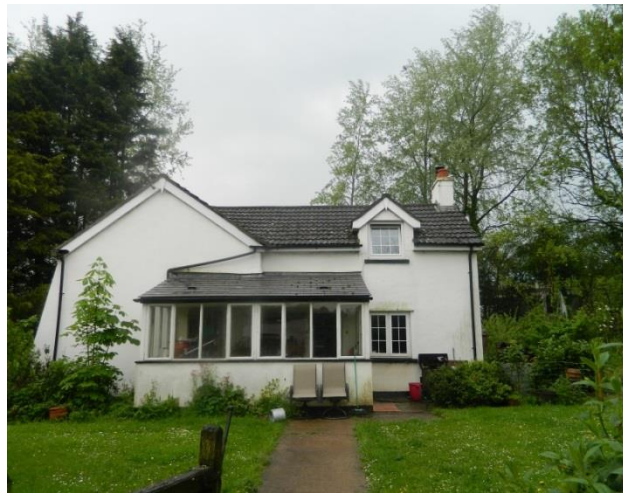
Building Name	Roost assessment	Notes	Photographs	
Barecroft House	Confirmed roost Common pipistrelle summer day roost (up to two bats)	Residential house (<i>Plate 1</i>). Generally tight fitting roof tiles and modern plastic soffit boxes affording a limited number of potential roost locations for bats. Potential roost locations were noted under lead flashing adjacent to south facing dormer windows (<i>Plate 2</i>) and gaps between roof tiles along the east facing roof edge (<i>Plate 1</i>).	<i>Plate 1 – eastern elevation</i>

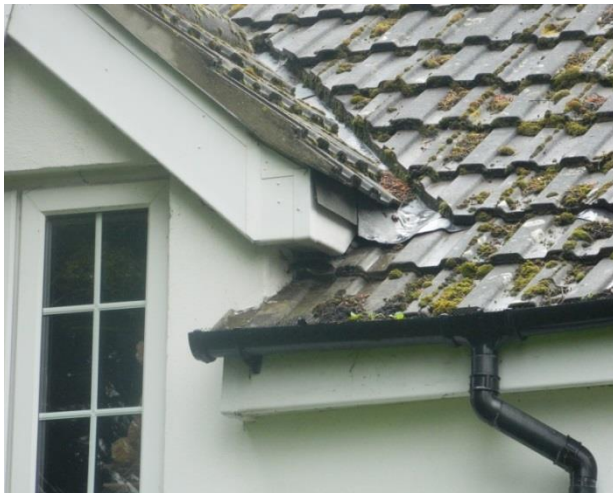
<i>Plate 2 at south facing elevation</i>

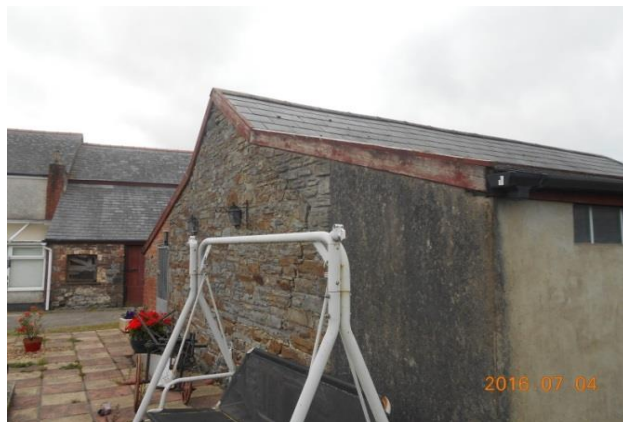
Fair Orchard Farm	Confirmed roost The main building at Fair Orchard Farm (including B2, B3, B4, B5 and B7) is a common pipistrelle summer day roost (up to eight bats).	<u><i>Building 1a and 1b</i></u> Two farm sheds with no loft space. Gaps under barge boards suitable for bats to access (<i>Plate 3</i>). <u><i>Building 2 - confirmed roost</i></u> This is the northern section of the main building complex. An open circular window on the east-facing gable end provides access into the building (<i>Plate 4</i>). An open door used by nesting birds (swallow) also allows access for bats into a small side room of the building. There is no apparent access into the main building from the small side room. Gaps under barge boards and lead flashing provide potential roosts. Deteriorating brick work at the top of wall to west side of building (<i>Plate 5</i>) provides cracks and potential access under soffit box. Gaps above a large door also provide potential access for bats into the main building (<i>Plate 6</i>). Occasional raised tiles provide potential bat roosts/access. <u><i>Building 3 – confirmed roost</i></u> This is the residential section of the main building complex (<i>Plate 7</i>) and forms the middle part of the main farm building complex. Relatively recent renovations, including new brick work, roof, windows and soffit box provide few potential roost locations. <u><i>Building 4 – confirmed roost</i></u> To the south of the residential section there is a series of apparently interconnected stables and sheds (<i>Plate 8</i>). Potential access for bats is available over a door, through open windows and broken and damaged	<i>Plate 3 – south facing elevation</i>

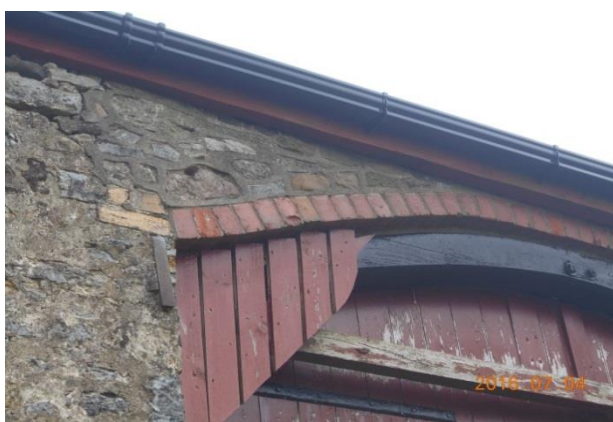
<i>Plate 6 top of door and gaps within fascia boards of B2</i>

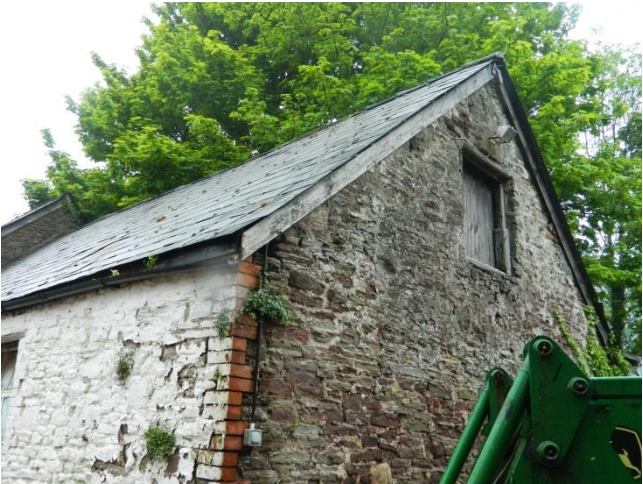
Building Name	Roost assessment	Notes	Photographs	
Berryhill Farm	<p>Confirmed roost</p> <p>Building 1 is considered to be a common pipistrelle maternity roost (up to 68 bats observed); Building 2 is considered to likely to be a long eared maternity roost (up to nine bats observed) and a summer day roost for a small number of soprano pipistrelle bats (one bat observed); Building 4 is considered to be a summer day roost for common pipistrelle bats (up to two bats observed).</p>	<p><u>Building 1 – confirmed roost</u> According to the owner this large residential property is approximately 400 years old. A common pipistrelle maternity roost is present within the roof of a southern extension of the main building and bats were known by the owner to emerge from gaps under the barge boards of the west facing gable end (<i>Plate 15</i>).</p> <p><u>Building 2 – confirmed roost</u> Building containing domestic utilities (southern) and garage (northern part) (<i>Plate 16</i>). Permanently open garage door to west side of building affords access into the building with numerous potential roost sites including above the southern wall and between large wooden beams (<i>Plate 17</i>). The skeleton of a dead bat was found (DNA result brown long eared), feeding remains (red underwing moth and painted lady butterfly) and a small number of scattered single droppings (DNA testing confirmed common pipistrelle) were found.</p> <p><u>Building 3 – confirmed roost</u> Owner stated building is an old ‘calf’ shed and about the same age as main building (<i>Plate 18</i>). Numerous access locations were noted including raised/missing roof and ridge tiles; open windows; open stable doors; gaps above doors; missing sky light; and under barge/fascia boards around all of building.</p> <p><u>Building 4 – confirmed roost</u> Old shed currently used for making cider with numerous potential roost locations (<i>Plate 19</i>). Potential roost locations were noted including openings around gable end upper level opening; behind broken barge boards; raised/missing roof tiles and ridge tiles; under barge/fascia boards around all of building; and through open window.</p> <p><u>Building 5</u> Corrugated steel barn open to the north. Provides negligible potential for roosting bats.</p> <p><u>Building 6</u> Single storey shop building and attached ‘lean-to’ shed. Roof, fascia, barge boards, lintels and above doors inspected all around building and found to be very tight with no potential access locations.</p> <p><u>Building 7</u> Corrugated steel container in use as storage shed (<i>Plate 20</i>). Access locations into internal space over door however steel construction provides poor roosting potential for bats due to daily temperature fluctuations.</p>	<p><i>Plate 15 west facing gable end of annex (maternity colony of common pipistrelle)</i></p>

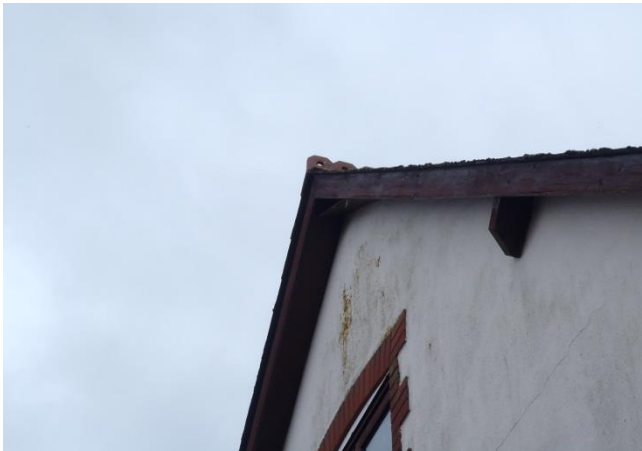
Building Name	Roost assessment	Notes	Photographs	
The Conifers	<p>Confirmed roost</p> <p>Common pipistrelle maternity roost (up to 55 bats observed);</p> <p>Brown long-eared summer day roost (up to three bats observed)</p> <p>Soprano pipistrelle summer day roost (for a single bat observed).</p>	<p><u>Building 1 – confirmed roost</u> This two storey house has a high pitched roof and associated more recent stone clad extension to the south side (<i>Plate 21</i>). The main building is fairly tight with potential access provided under the eaves on the south west corner of the building and a large potential access into the south facing gable end soffit box where the underside of the soffit has come away from the main structure (<i>Plate 22</i>). The southern extension provides a wide range of potential roost features including</p> <ul style="list-style-type: none">- gaps at the top of the wall above the stone wall and window on the west facing gable end (<i>Plate 23</i>);- gaps between barge boards and hanging tiles to the doorway porch (<i>Plate 23</i>);- gaps within the south facing gable end (<i>Plate 24</i>). <p>Other potential bat roost features include raised tiles; lifted lead flashing; and an opening into the soffit box above the east facing ground floor door.</p> <p><u>Building 2</u> Garage with open garage door. This building is very tight throughout and affords little potential for roosting bats (<i>Plate 25</i>).</p> <p><u>Building 3</u> Framed glass structure with swimming pool. This building offers no potential for roosting bats (<i>Plate 26</i>).</p>	<p><i>Plate 21 west facing elevation of main building and southern extension</i></p>	<p><i>Plate 22 open soffit box on south facing elevation of main building</i></p>

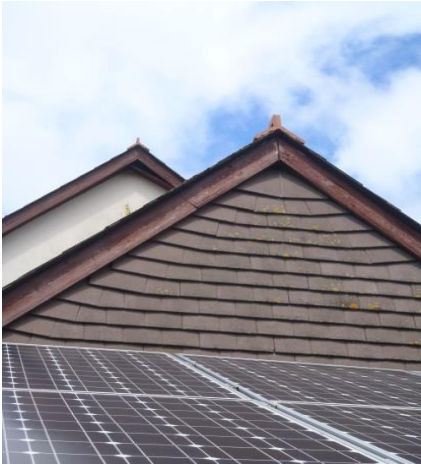
<p><i>Plate 23 west facing elevation of southern extension</i></p>	<p><i>Plate 24 hanging tiles and gaps into fascia on south facing gable end of southern extension</i></p>

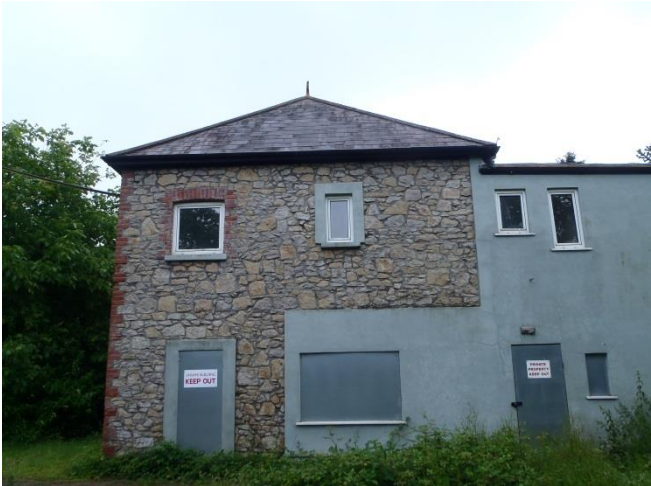
Building Name	Roost assessment	Notes	Photographs	
Undy House	<p>Confirmed roost</p> <p>Common pipistrelle summer day roosts (single bats observed from each building).</p>	<p><u>Building 1 - confirmed roost</u> Building boarded up with metal window covers to prevent access (<i>Plate 27</i>). Generally all features around building were noted as tight with the only potential roost features noted being broken tiles on west side of roof. Southern extension to building was noted as having no roof and protected with plastic sheets therefore potential features may have been present between this section and the main building (<i>Plate 28</i>).</p> <p><u>Building 2 – confirmed roost</u> Old derelict building surrounded by shrubs and collapsed to the north side (<i>Plate 29</i>) (showing southern elevation). Significant sagging of the roof provides potential roost features. The windows are missing allowing access into the main building, which is likely to contain a variety of features suitable for both crevice dwelling and hanging bats.</p>	<p><i>Plate 27 west facing elevation of B1</i></p>

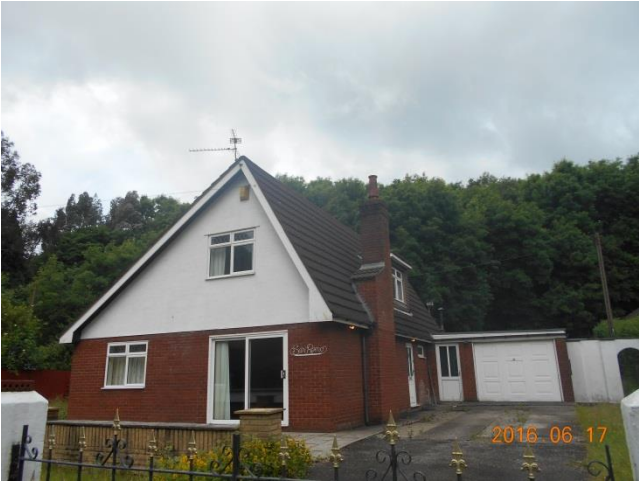
Building Name	Roost assessment	Notes	Photographs
San Remo	<p>Confirmed roost</p> <p>Common pipistrelle summer day roost (up to eight bats observed during surveys)</p>	<p>Residential property disused at time of survey (<i>Plate 30</i>). Roof tiles are generally tight with little access potential, however missing hanging tiles and lead flashing around both the east and west dormers are features that provide potential for roosting bats. Other features on this building included openings (through wood rot) into soffit box on both north and south sides; under plastic fascia; and into open door on west side that allow access into space between roof tiles and lining (<i>Plate 31 / Plate 32</i>).</p>	<div><p><i>Plate 30 southern elevation</i></p>

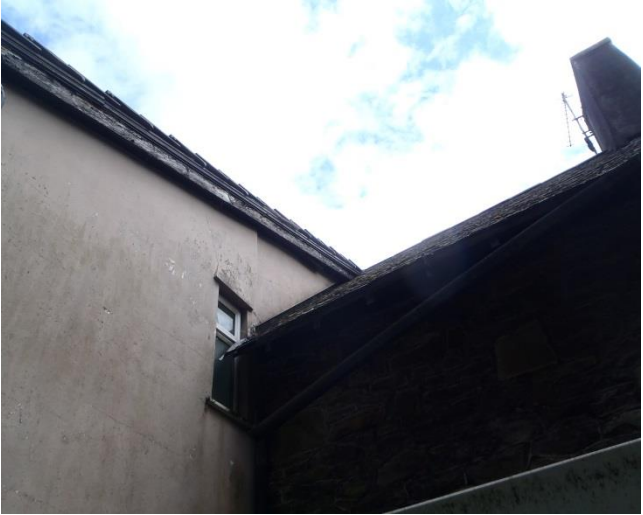
Berryhill Cottage	Confirmed roost	Common pipistrelle and soprano pipistrelle were observed emerging / re-entering gaps under barge / fascia boards during surveys.
White Cottage	High suitability	Openings into soffit box and openings into torn roof felt under eaves provide a wide number of roost sites with significant potential for numerous bats to utilise
Myrtle House	Low suitability	Opening in wood clad building provide opportunities for individual bats to roost opportunistically.
Quarry Cottage	Low suitability	Potential for individual bats to roost opportunistically were noted in small gap within ridge tile and within small gap under soffit box along western

</div> <div><p><i>Plate 35 open soffit box and gaps into barge boards at northern and eastern elevations</i></p>

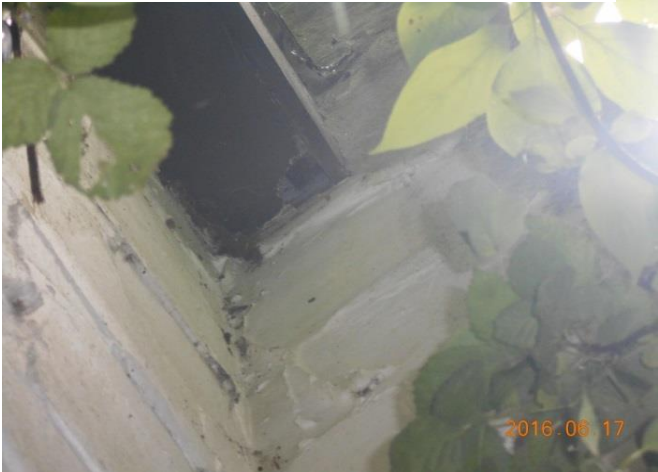
<p><i>Plate 38 opening into soffit box at western elevation</i></p>

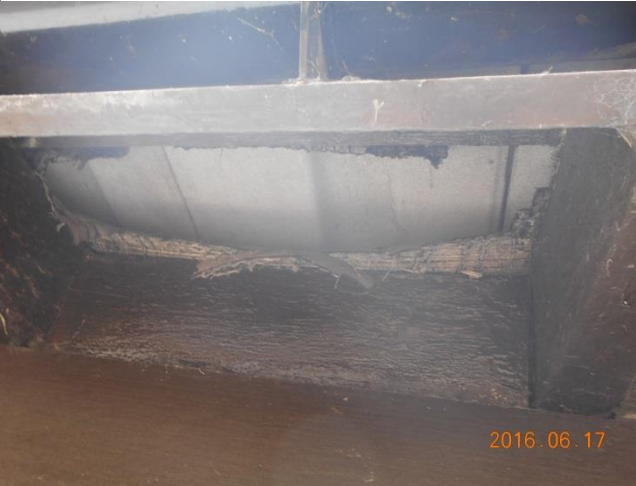
<p><i>Plate 40 opening into roofing felt under eaves of garage</i></p>

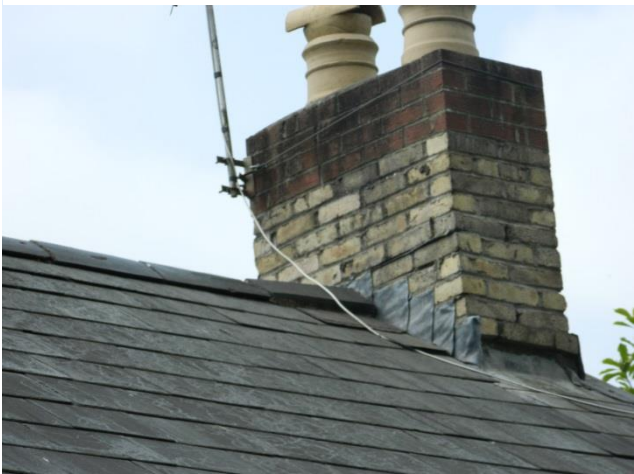
<p><i>Plate 48 raised ridge tile</i></p>

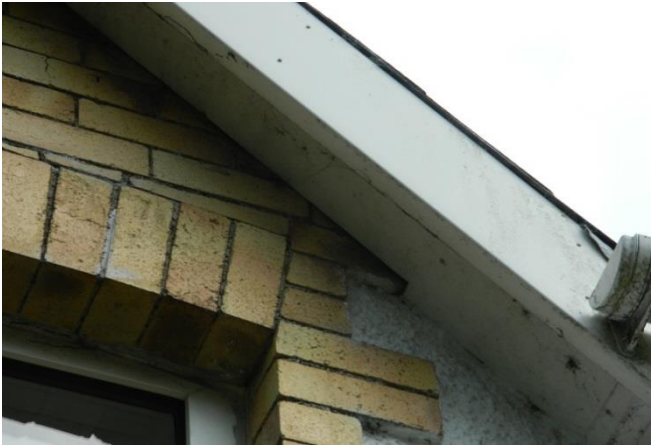
<p><i>Plate 49 gap into soffit box on eastern elevation</i></p>

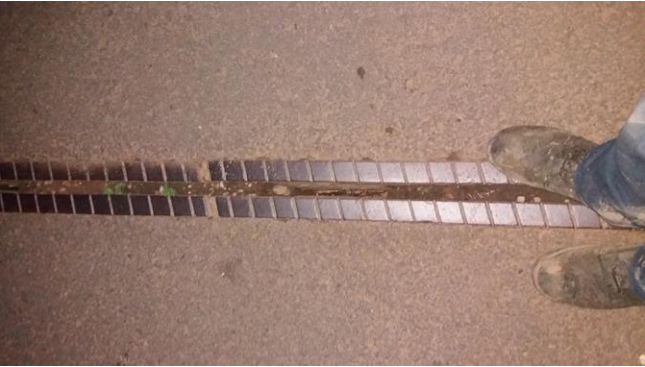
Pound Hill M4 Overbridge	Low suitability	Concrete motorway bridge. Potential roost features noted within expansion joints (<i>Plate 55</i>) (showing gaps from above) that although were open to the road section were filled with debris providing gaps with shelter either side. Very noisy and subject to constant vibration.	<p><i>Plate 55 gaps into expansion crack from surface of Pound Lane</i></p>

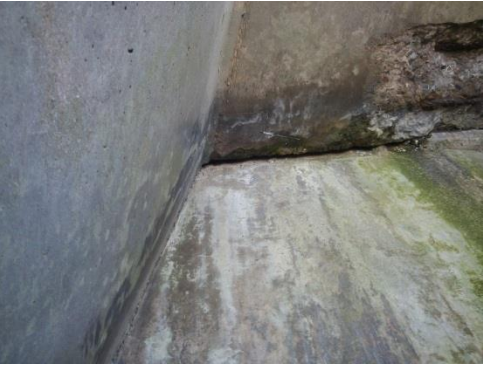
<p><i>Plate 56 expansion crack</i></p>

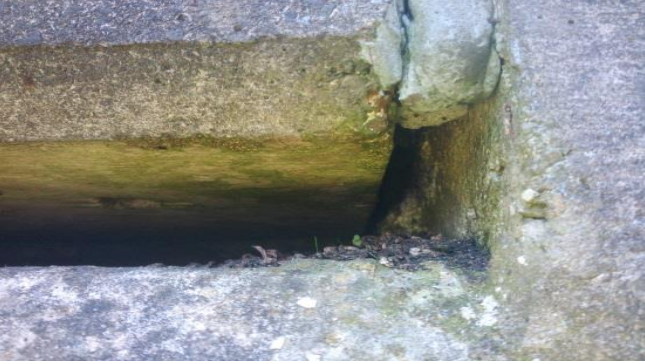
A48 (M)bridge over M4	Low suitability	Concrete motorway bridge. Potential roost features noted within expansion joints (<i>Plate 57</i>) that although were open to the road section were filled with debris providing gaps with shelter either side. Very noisy and subject to constant vibration.	<p><i>Plate 57 expansion joints</i></p>

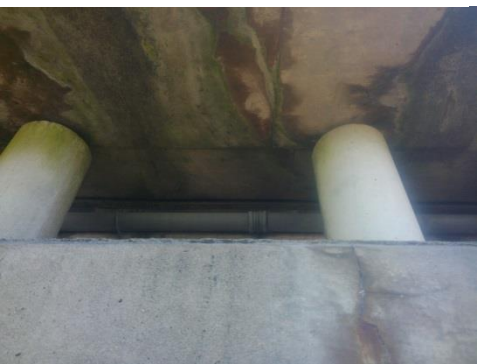
<p><i>Plate 58 expansion joints</i></p>
