Risk Assessment for Waterbeach AHB Level Crossing

Doc: J1171-138/Doc04

No: 157001-SRK-REP-ESS-000003

Date: 15th November 2019

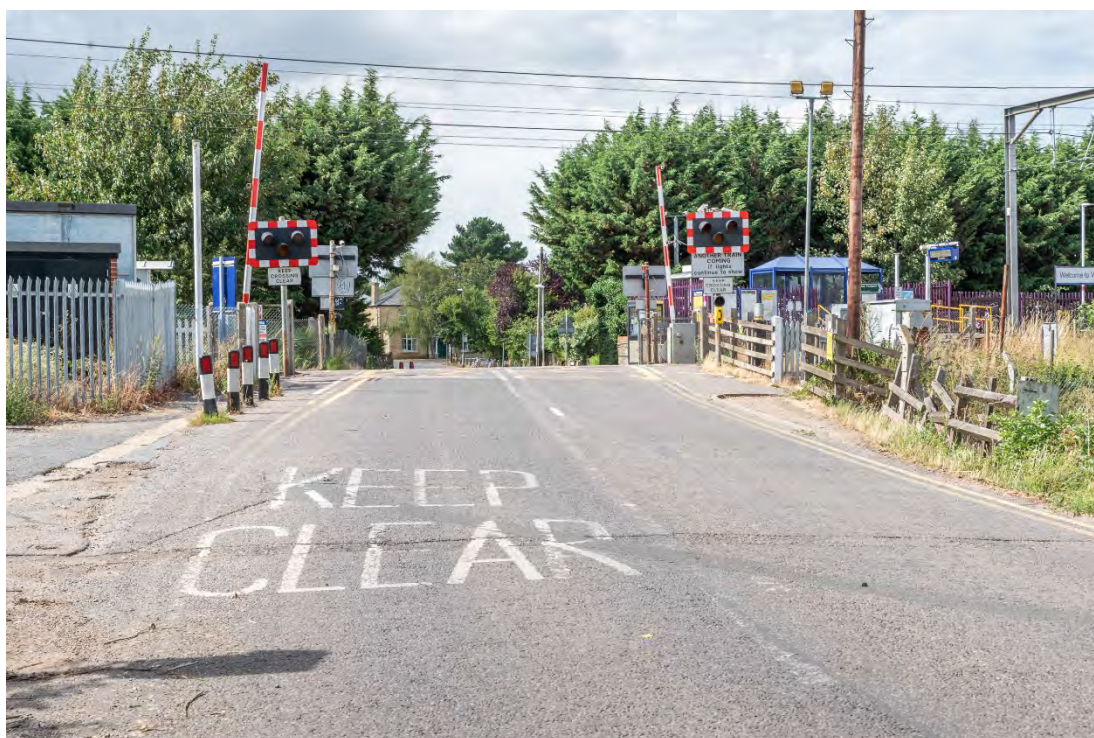
Figure 1 Current crossing equipment

Figure 1 shows the configuration of the crossing, viewed from the east. *Figure 3* provides the relevant extract from the sectional appendix covering the crossing. *Table 1* presents details of the location and operation of the crossing.

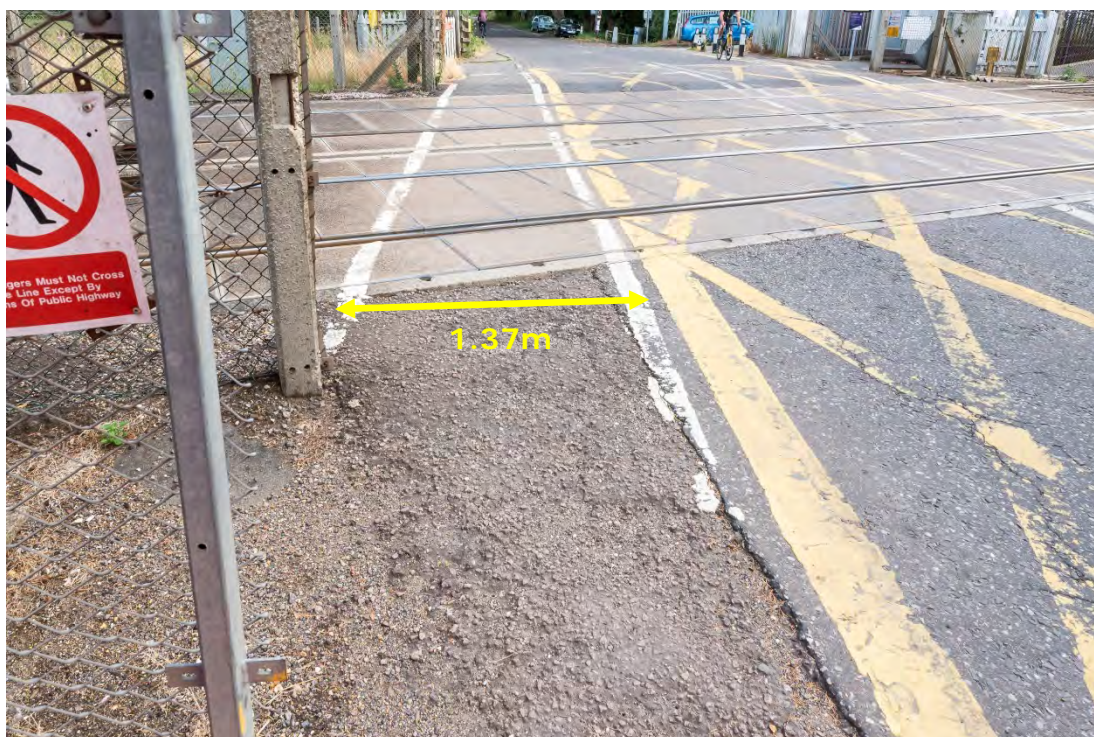
Figure 9 Footway – North side

There are footways on both sides of the crossing as seen in *Figure 1*. The footway on the north side (*Figure 9*) varies between 1.37m and 1.05m wide (the footway is narrowed by the fence at the ZN corner). The footway on the south side (*Figure 10*) varies between 1.40m and 0.90m wide (the footway is narrowed by the grass at the ZO corner). There is a slight trip hazard at the west sill beam on the north footway (*Figure 12*).

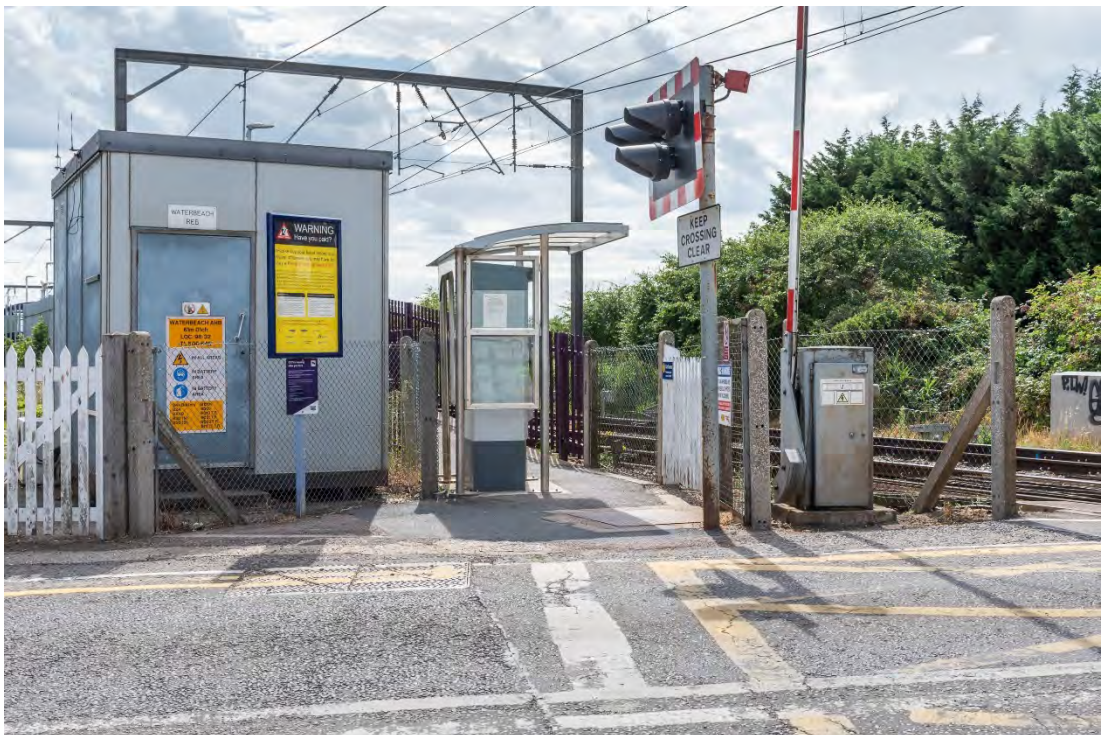
Figure 14 View of Standing Red Man from Up platform exit

The Up platform of Waterbeach station and the station car park are on the south east side of the crossing and the Down platform is on the northwest side. The town is to west. There is no footbridge so pedestrian access between the platforms requires use of the crossing. The exits from both platforms are below the RTLs, however as standing red man lights are only provided on the offside of the road these are not well orientated for pedestrians exiting the platforms (*Figure 14* and *Figure 16*).

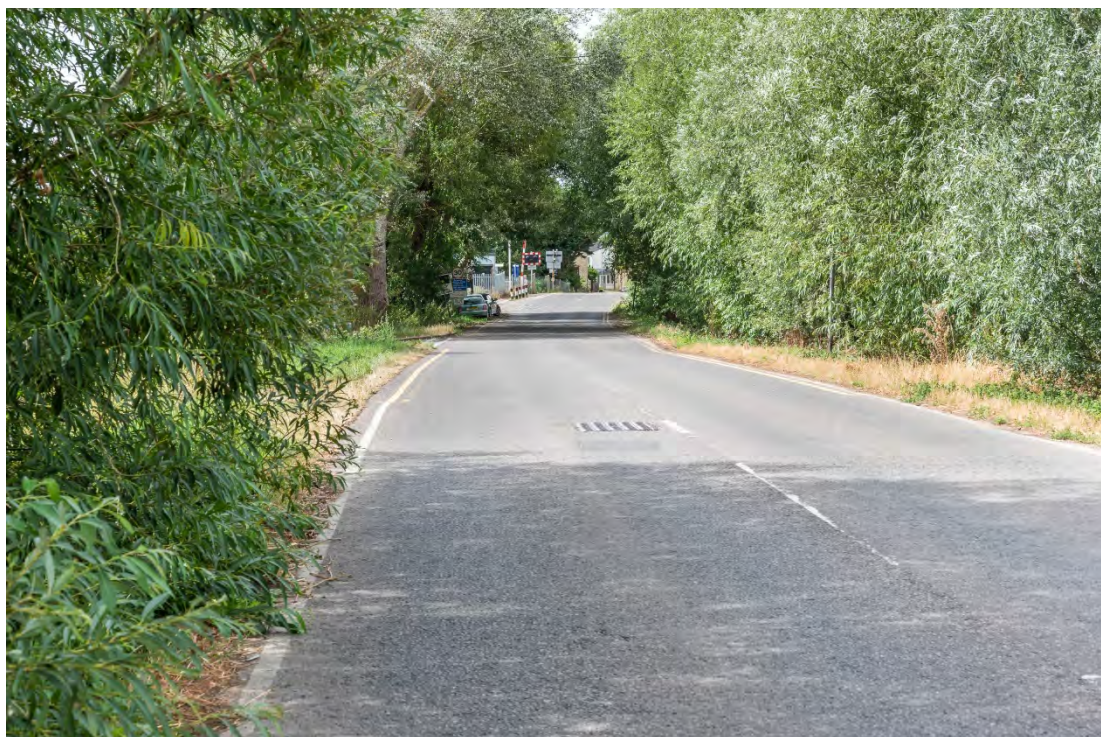
Figure 19 View approaching crossing from the east - intermediate

The distant, intermediate and close road approaches from the east are shown in *Figure 18* to *Figure 21*. It can be seen in *Figure 18* that the crossing is visible from the distant signage.

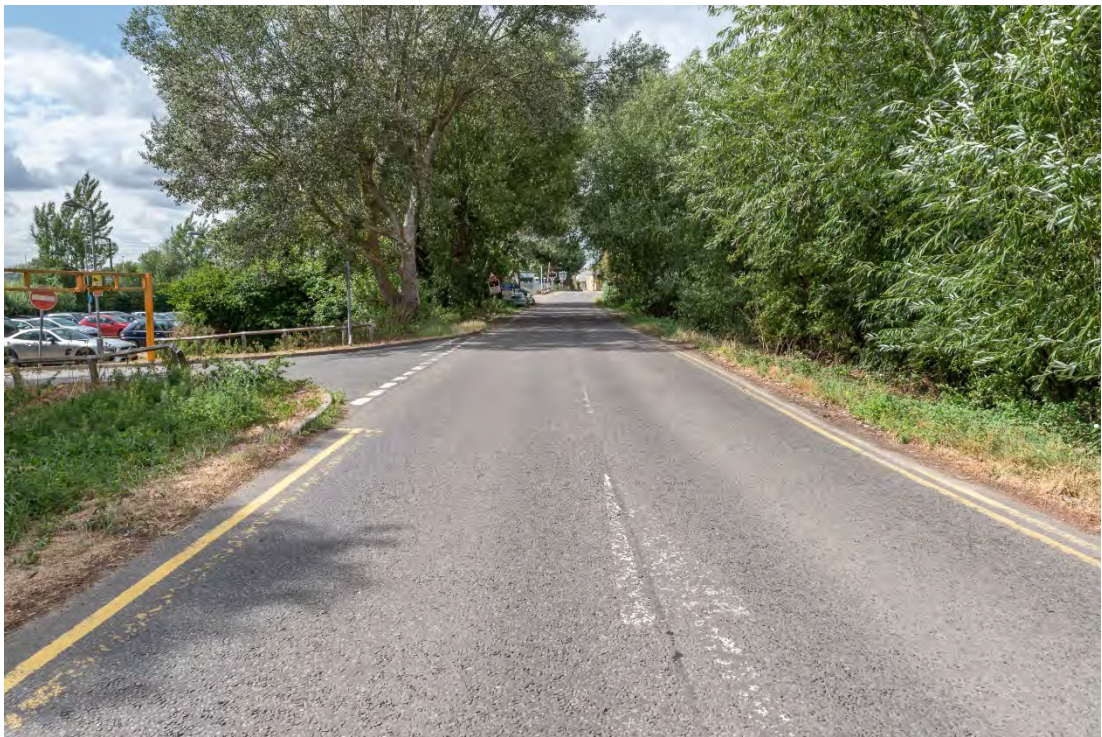
Figure 20 View approaching crossing from the east - intermediate

1. The road is straight on the approach.
2. There is a station car park on the left, 90m east of the crossing (*Figure 22*).
3. There is a gate on the right 50m east of the crossing (*Figure 23*).
4. Vehicles park on the left, 40m east of the crossing (*Figure 20*).
5. There are bus stops on both sides of the road 15m east of the crossing.
6. There is a Network Rail depot on the left, 14m east of the crossing (*Figure 24*). This has Keep Clear road markings.
7. There is a rail access gate on the right, by the line of the crossing (*Figure 26*).
8. The near side RTL is visible from beyond 150m on the approach. Trees obscure the view of the offside RTL until 80m east of the crossing.
9. The level crossing signage had good conspicuity at the time of the site visit.

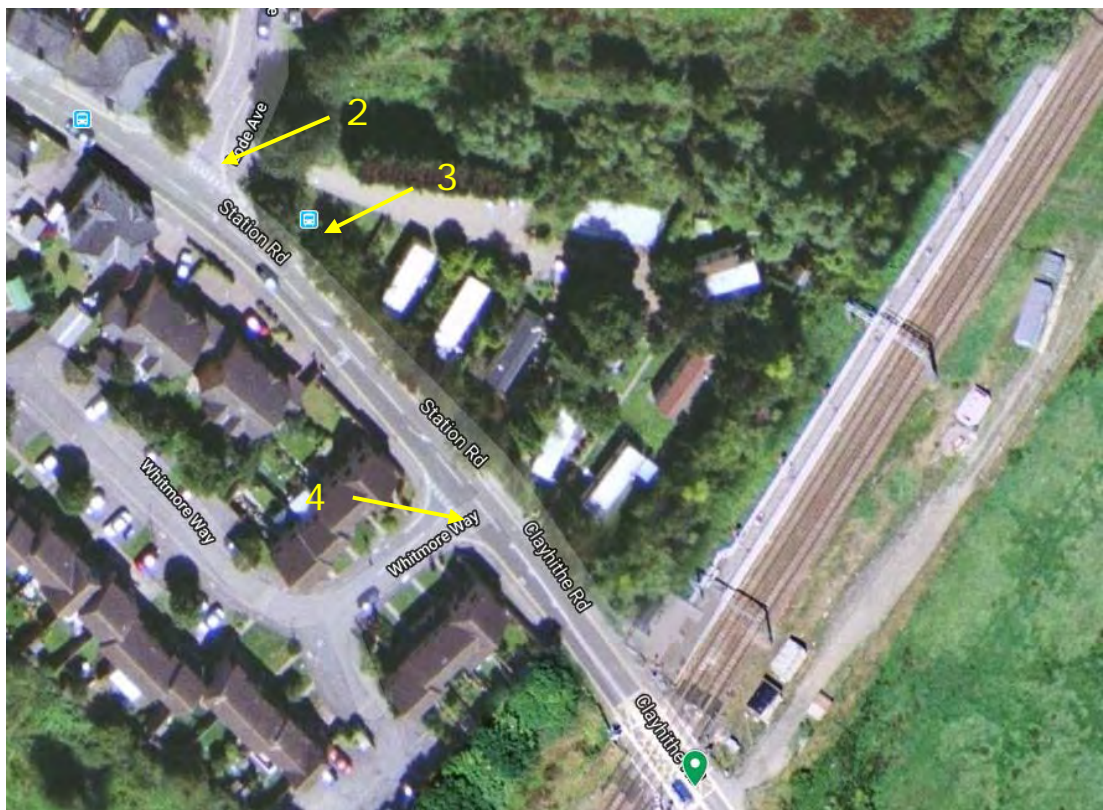
Figure 27 Key features on the western approach to the crossing

A 30mph speed limit applies on the road approach from the west. During the 9-day census the 85th percentile speed of approach was 34.2mph. The key features of the approach are:

A plan of the key features is shown in *Figure 27*; the numbers in the figure refer to the above numbered list of features.

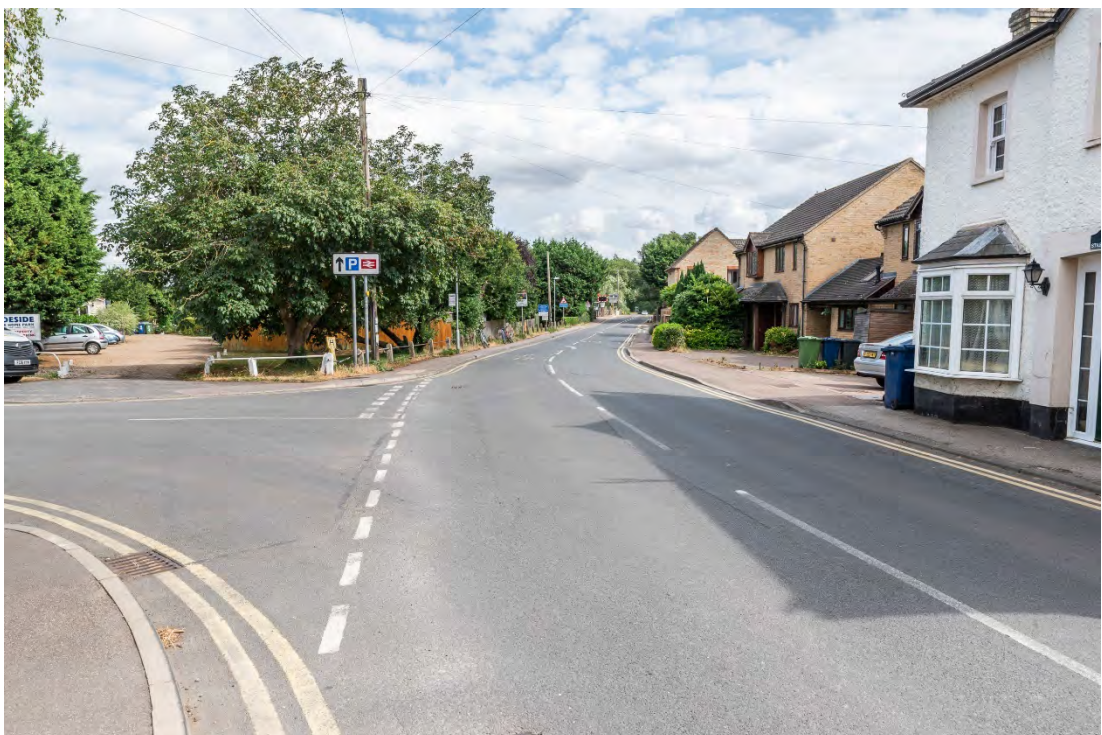
Figure 29 View approaching crossing from the west - intermediate

1. The road has a bend to the right on the approach, 85m west of the crossing.
2. There is a junction with Lode Avenue on the left, 93m west of the crossing (*Figure 32*).
3. There is a bus stop on the left, 80m west of the crossing (*Figure 29*).
4. There is a junction with Whitmore Way on the right, 32m west of the crossing (*Figure 34*).
5. The nearside RTL is visible from 125m on the approach, but due to the bend the offside RTL is not visible at this point. At 86m the offside RTL becomes partially visible, however it is partially obscured by vegetation until around 75m west of the crossing.
6. The level crossing signage was partially obscured by vegetation growth at the time of the site visit (*Figure 29*).
7. The crossing has a skew of 65°.

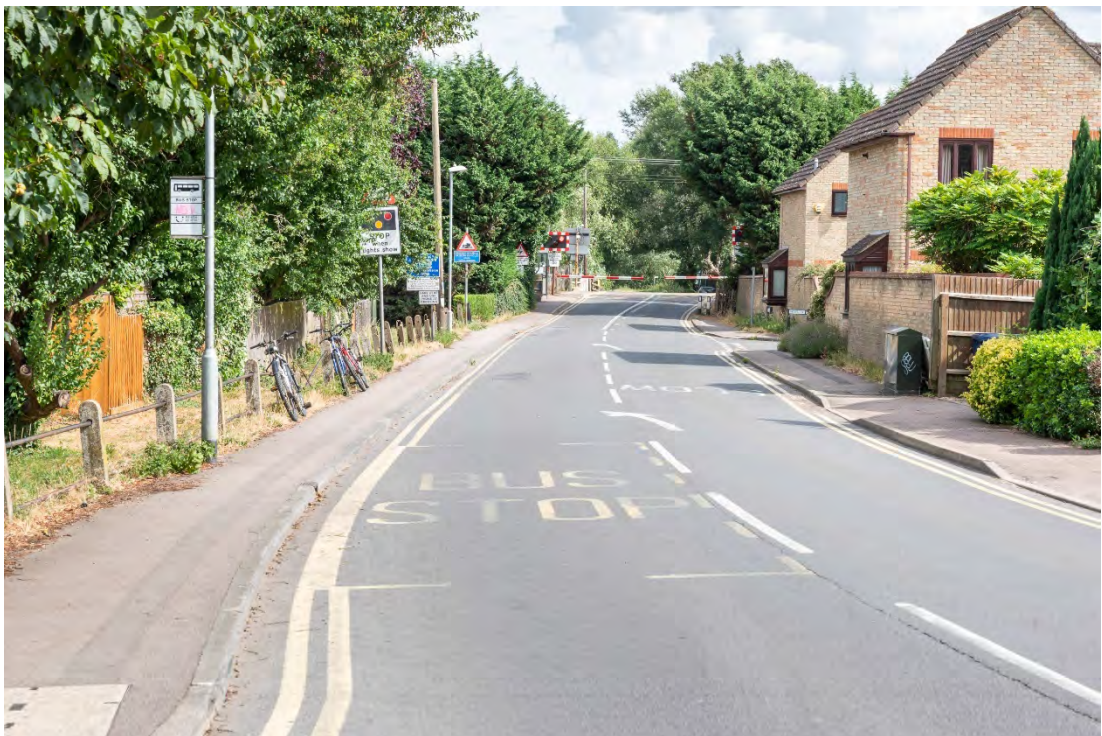
Figure 30 View approaching crossing from the west - intermediate

The distant, intermediate and close road approaches from the northwest are shown in *Figure 28* to *Figure 31*.

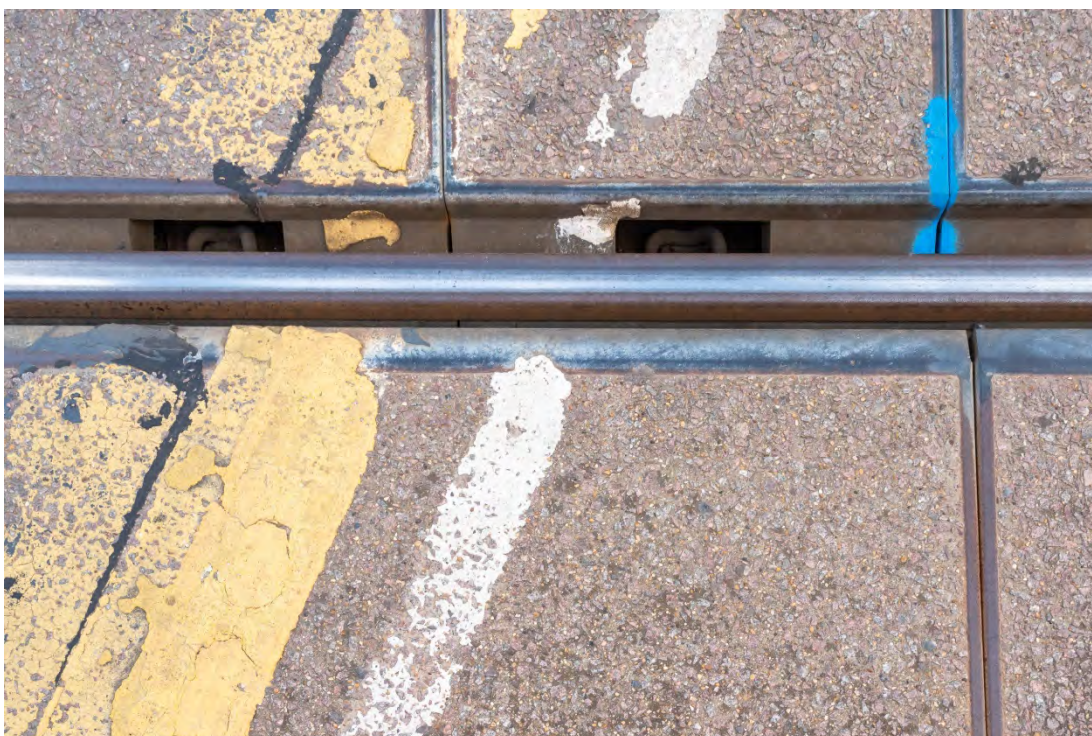
Figure 36 Crossing skew 65°

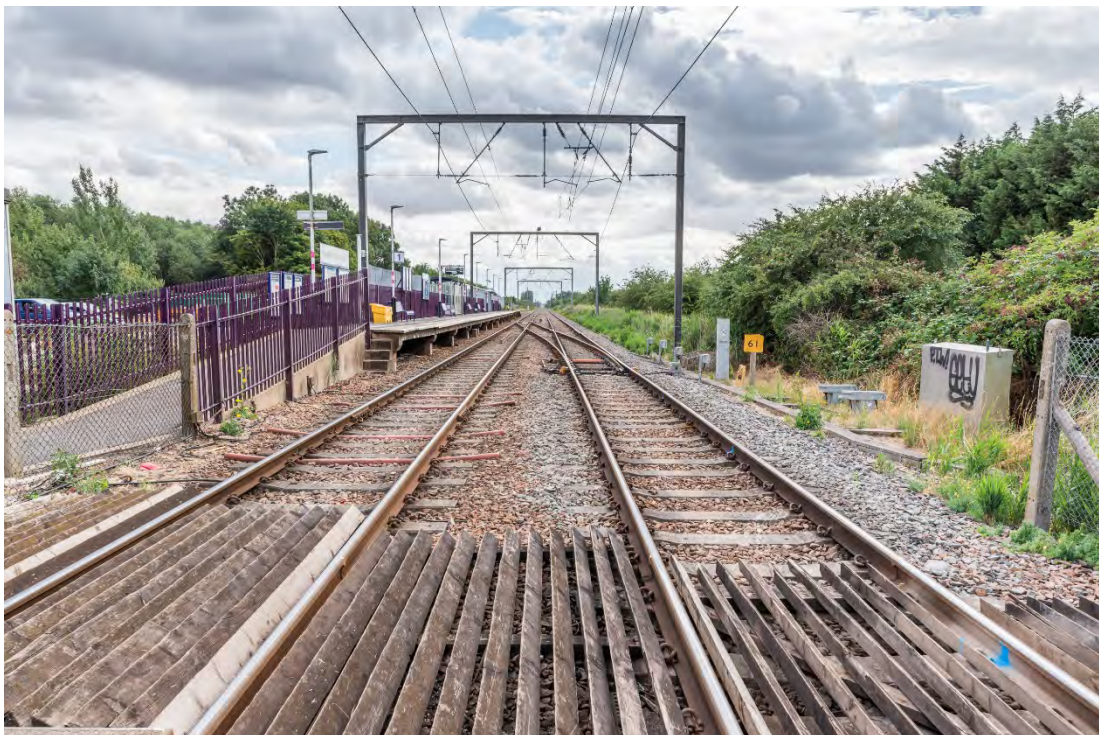
Figure 39 View of Down rail approach (looking towards Cambridge)

The crossing is located between Bishops Stortford and Ely North Junction. There are two tracks at the crossing, and it is electrified by overhead line. It is a moderately utilised stretch of line with a weekday average of 178 trains. There are approximately 176 passenger trains in each direction and the remainder are freight trains. The line speed is 75mph along this stretch of track.

For trains travelling in the Up direction, in the unlikely event of a derailment following hitting a vehicle on the crossing, the OHL stanchions and station platform may exacerbate the potential derailment consequences.

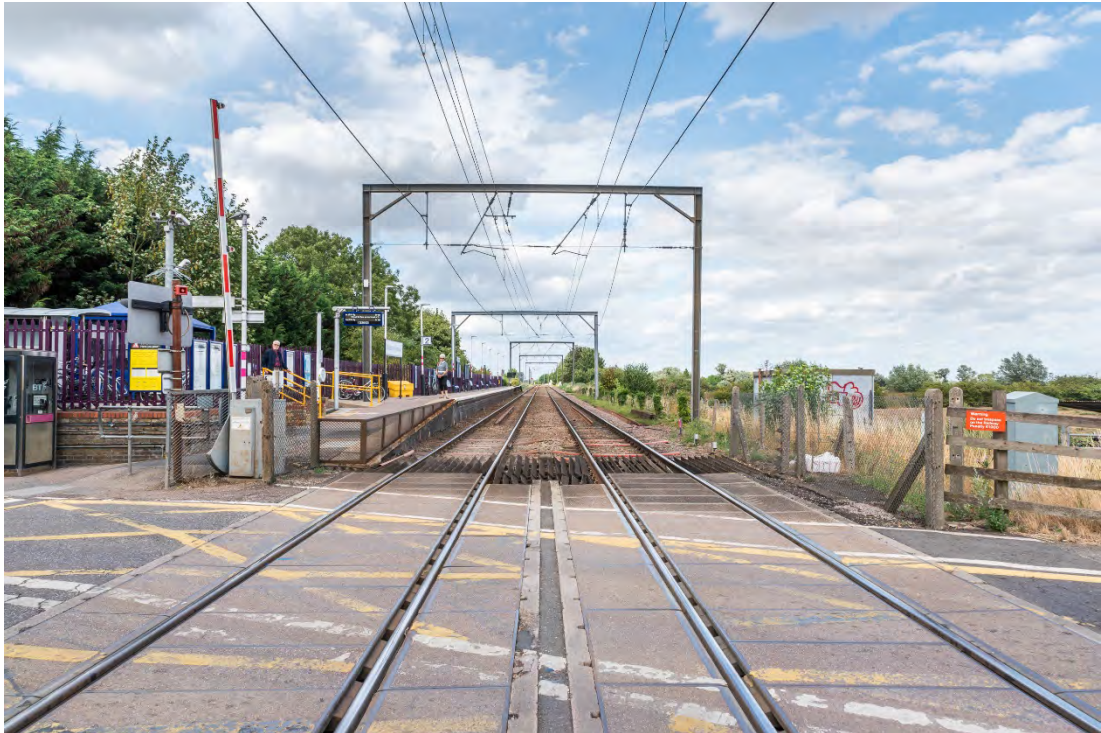
Figure 40 View of Up rail approach (looking towards Ely)

Trains travelling south are travelling in the Up direction towards Cambridge.

For trains travelling in the Down direction, in the unlikely event of a derailment following hitting a vehicle on the crossing, the OHL stanchions and station platform may exacerbate the potential derailment consequences.
