PROTECTED LEVEL CROSSING RISK ASSESSMENT

Level Crossing Narrative Risk Assessment

Milton Fen AHB Crossing

Planned 4<sup>th</sup> December 2021

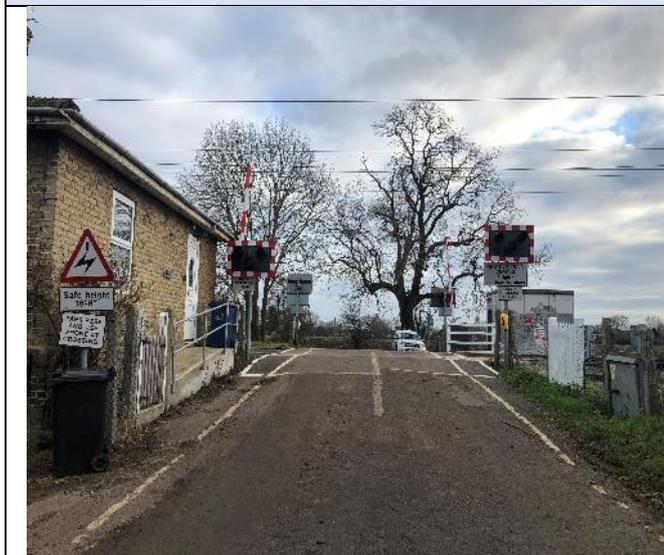
**Downside crossing approach.**

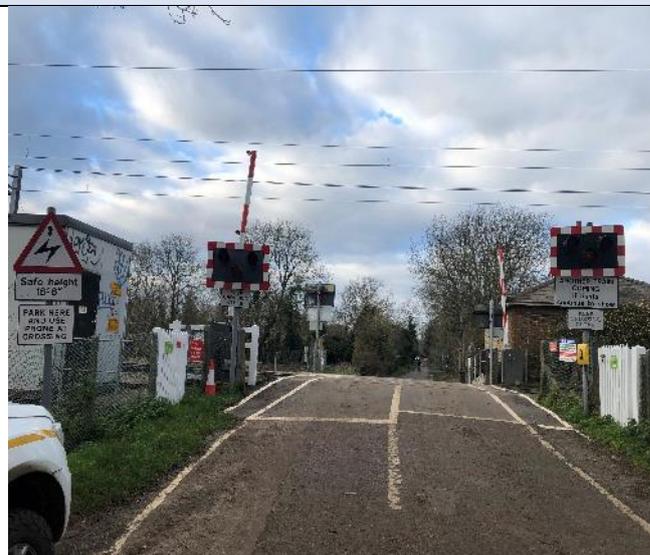
**Upside crossing approach.**

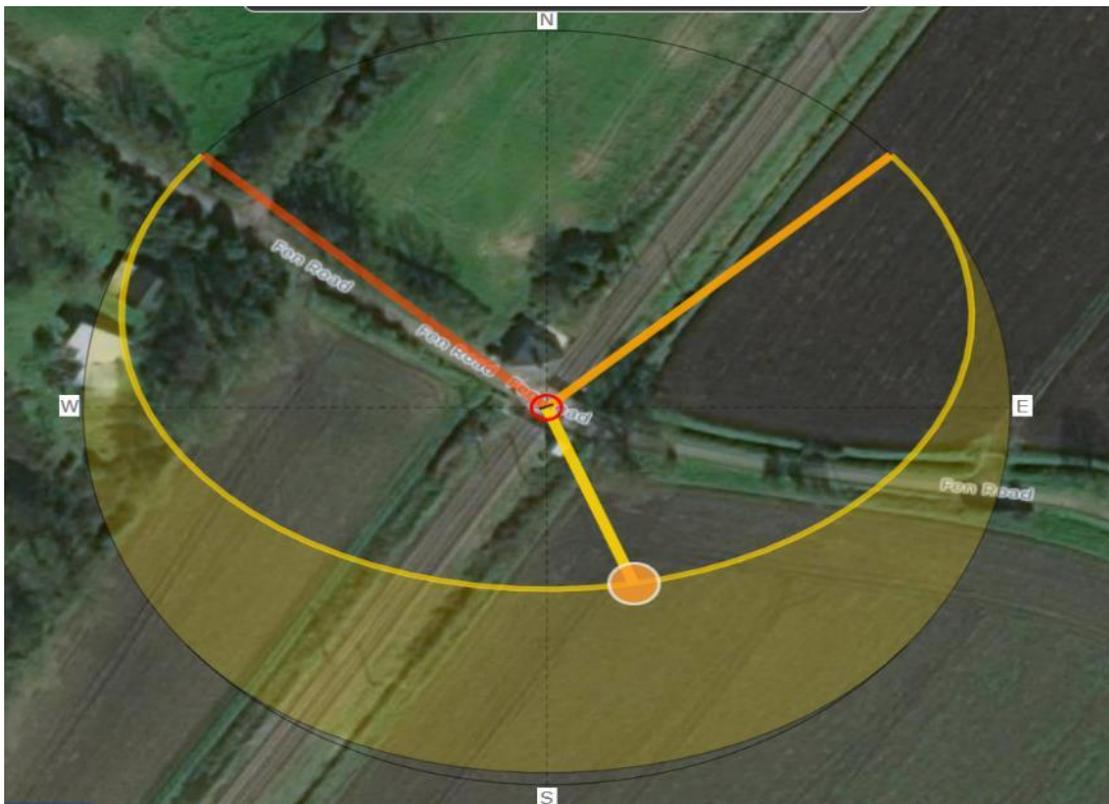
**Longest Day June 21<sup>st</sup>.**

Below is the output from the Sun Calc application, which shows the lines of sunrise and sunset angles at two times of year (longest day June 21st & shortest day December 21st) when low sun would align with the rail approaches and might impact on the sighting.

The thin orange curve is the current sun trajectory, and the yellow area around is the variation of sun trajectories during the year. The closer a point is to the centre, the higher is the sun above the horizon.

Sun glare could be an issue on the approach to the crossing from the North during the summer months, but the crossing is fitted with LED wig wags that mitigate against this.

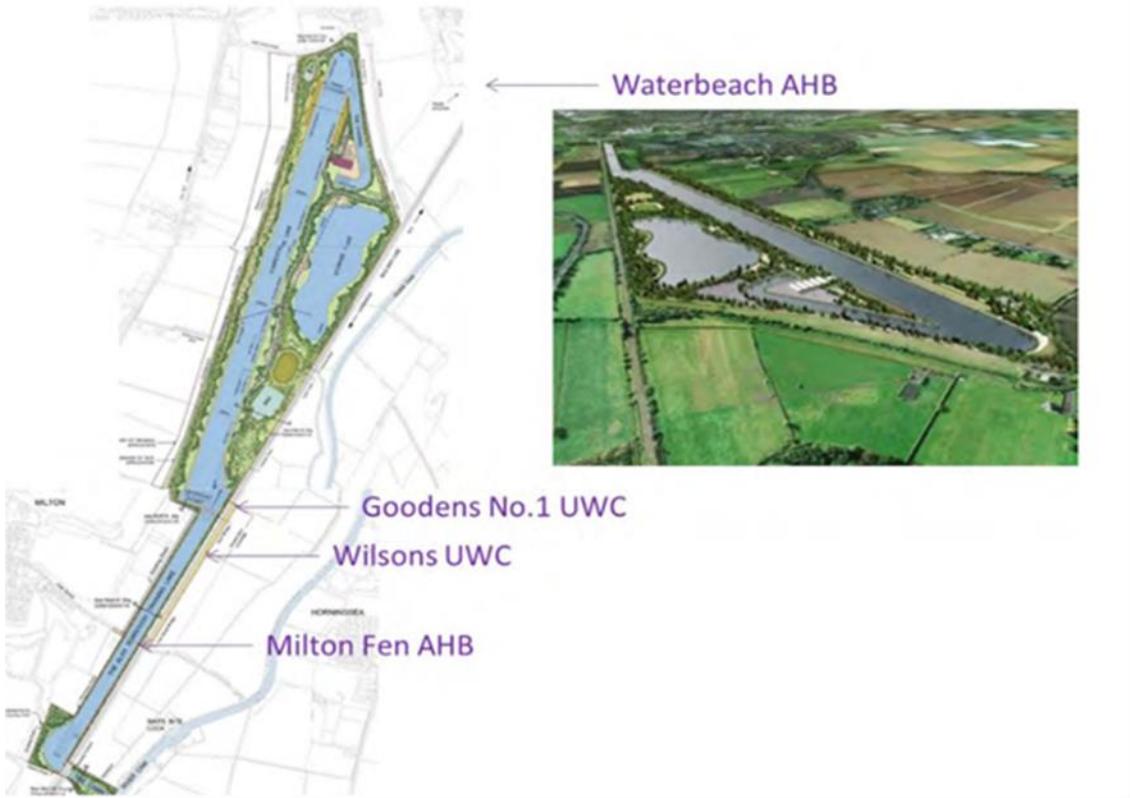
Possible Sports complex which would close 3 crossings.

There are no immediate planned or apparent developments at present near the crossing which may lead to a change or increase in use or risk to the level crossing but there is a project looking at a leisure facility/rowing lake that could close 3 crossings (see map in additional photos).
