**THE NETWORK RAIL (LEEDS TO MICKLEFIELD
ENHANCEMENTS) ORDER**

Level Crossing Safety Proof of Evidence

Document Reference	CD.7.23
Author	Andrew Cunningham on behalf of Network Rail
Date	February 2024

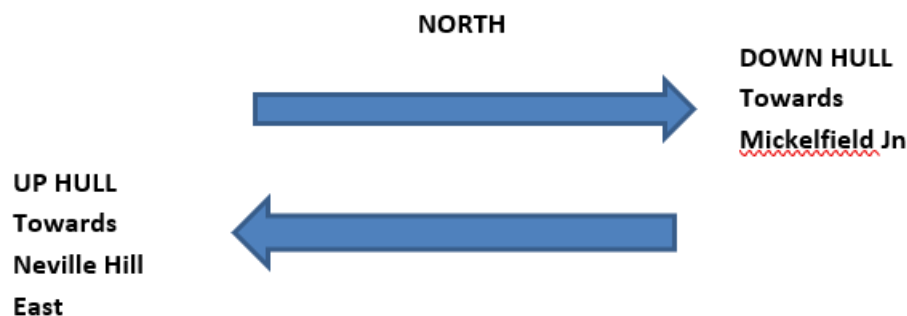
Figure 1 railway layout

- 2.1.4 All of the Crossing traverses two operational railway lines running between Micklefield and Neville Hill which both have a 90mph line speed.
- 2.1.5 The direction of travel for trains towards London, is known as the 'Up' line and the direction of travel for trains away from London is known as the 'Down' line. Specific to the site, which links Leeds with York, and Leeds with Selby and Hull, the 'UP' line is the direction of travel towards Leeds and the 'Down' line is in the direction to Hull, as shown in Figure 1, below) Land located directly adjacent to the 'UP' line is known as the 'UP Side' and the land adjacent to the Down line is the 'Down Side'.

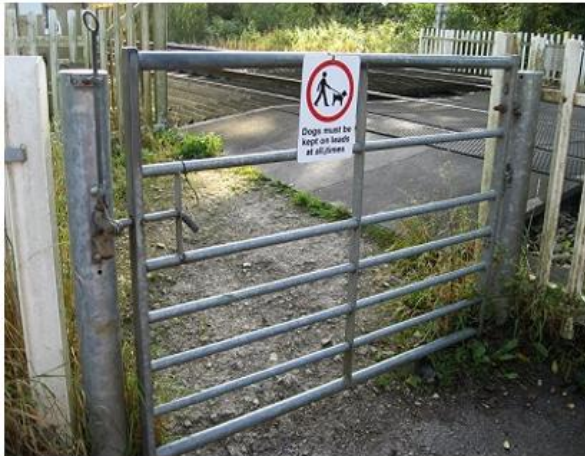
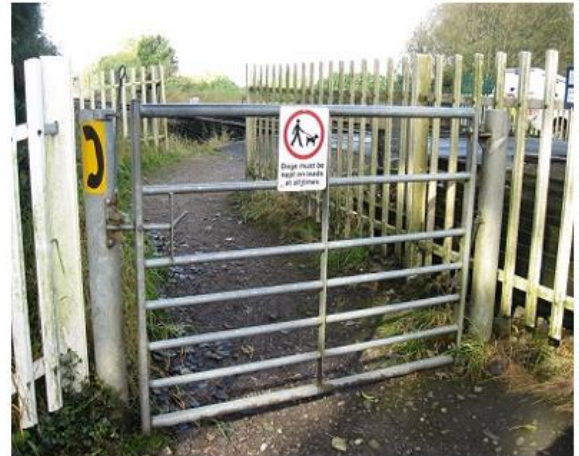
- 3.3.4 From the crossing gate to the crossing surface is of unmade type. The Crossing Deck is of hard rubber STRAIL construction with acme sheets between the panels.

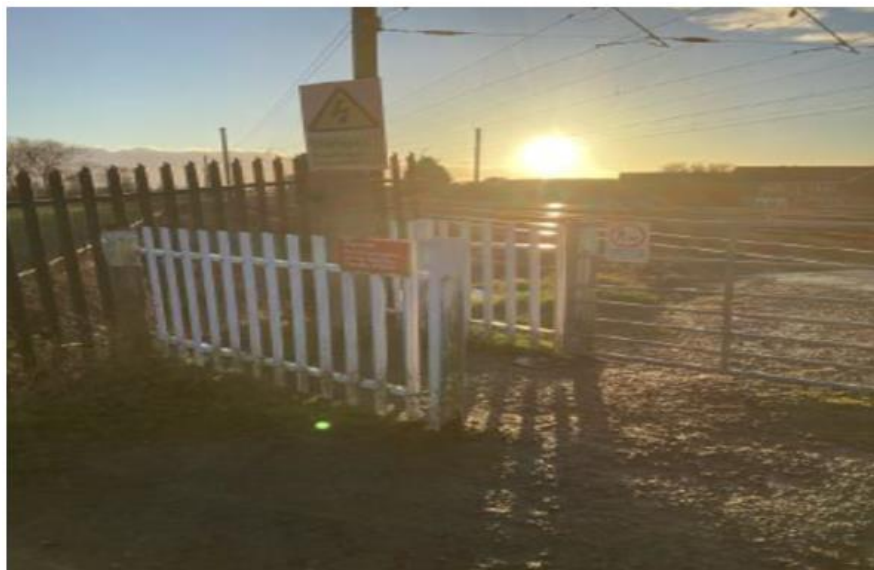
3.6.7 Photograph showing sun behind an MSL level crossing.

3.6.8 Heavy rain, fog or snow can also affect the visibility of the MSLs.

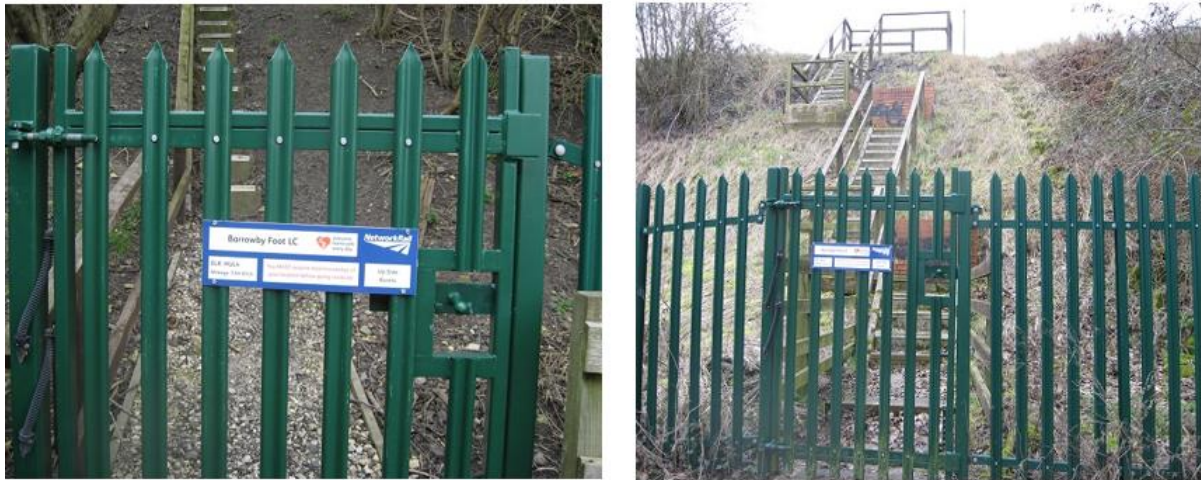
4.3.4 Photographs of the gate approaches to Barrowby Footpath level crossing

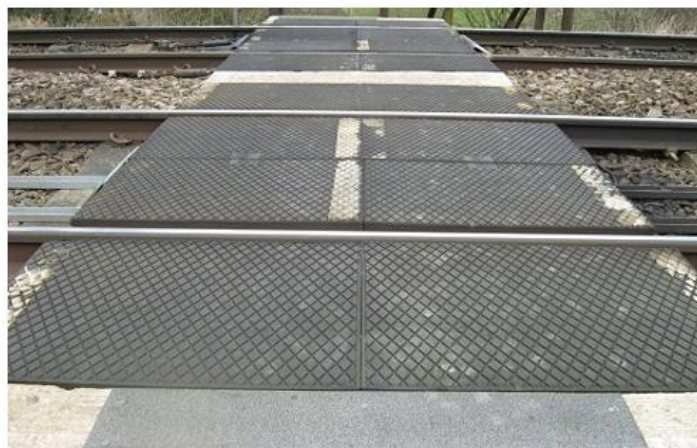
4.3.5 The crossing deck is accessed by climbing unmarked steps and a steep approach up to rail level from the decision points on either side. This effectively lowers the traverse speed of a pedestrian, thereby increases the time taken to cross. The Crossing has hard rubber Strail decking with tarmac/concrete infills between the panels.

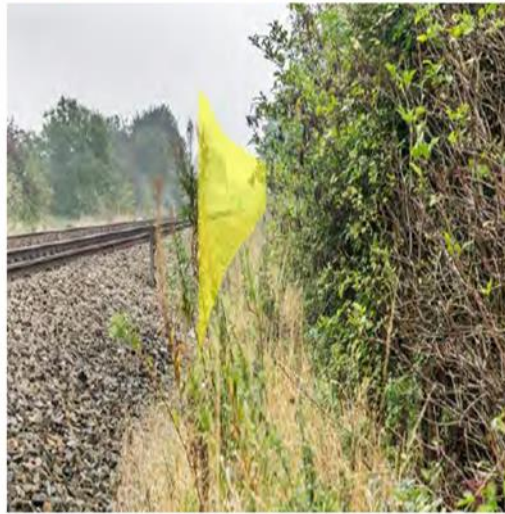
Sighting - Up side, Up train approach

4.4.3 The yellow shaded images show the impact of the OHLE stanchions at this location when installed, this will significantly impact on current sighting of approaching trains.

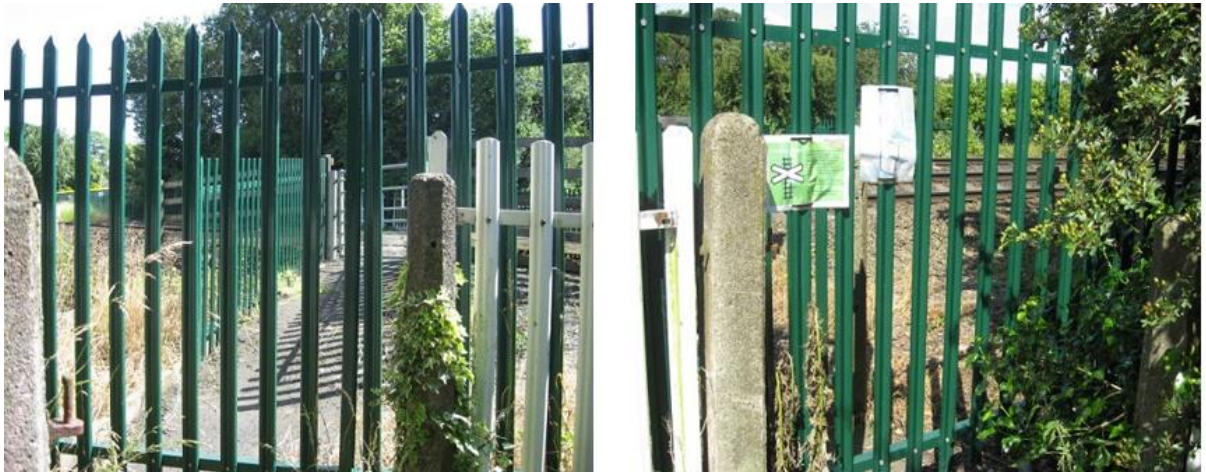
- 5.3.4 The aerial view shows that the former timber deck has also been lifted which would be replaced (along with the gates) if the Crossing was to be reopened.

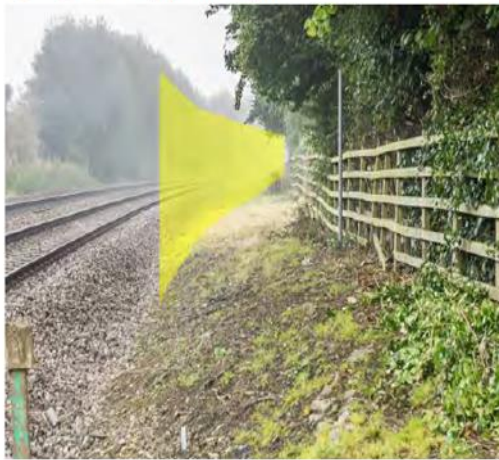
Sighting - Up side, Up train approach

- 5.4.4 The erection of the OHLE Stanchions will further restrict sighting of approaching trains should it reopen; the above images shaded in yellow show the impact of OHLE stanchions on the crossing sighting when installed.
- 5.4.5 Prior to its temporary closure Network Rail had undertaken an NRA for the Crossing as part of the ongoing risk assessment regime. The most recent NRA for the Crossing was dated 21/08/2017. As the crossing is currently closed, the score of the current risk assessment is M13 (0.0 FWI).
- 5.4.6 At the time of the previous risk assessment in 2017 before the crossing was closed, the risk score was C3 (0.00669795) There are 944 level crossings on the North & East Route and the Garforth Moor crossing is ranked number 29. However, if you compare this level crossing to other crossings of a similar type it was ranked 6 out of 288.

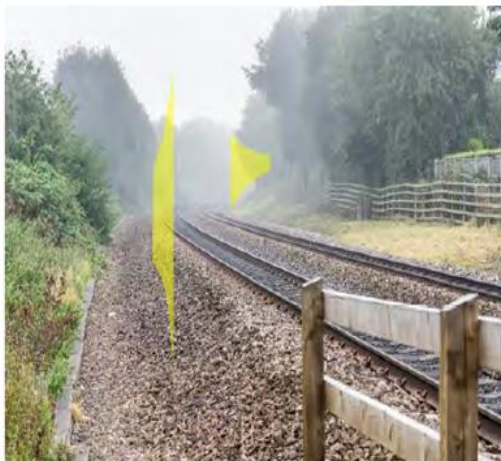
Sighting - Down side, Up train approach

train and when stood in the Down cess looking for an up direction train with a required distance of 462m, the achievable is 240m.

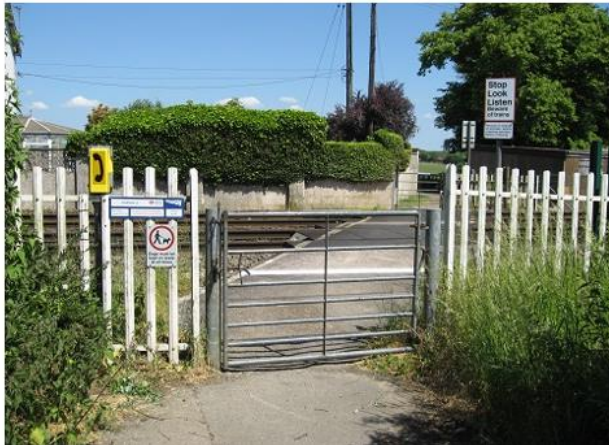
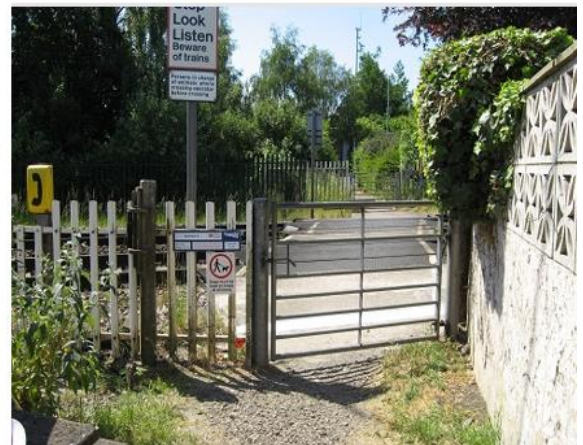
- 6.2.3 The photographs below show the wicket gate arrangement located on Network Rail's lineside boundary fence on the North and South approaches to the Crossing.

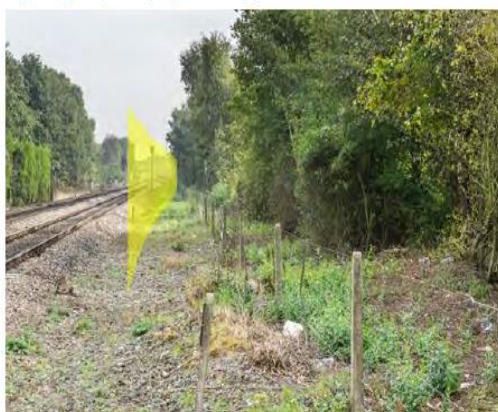
Sighting - Up side, Up train approach

- 6.3.1 Sighting of approaching trains from the Decision Point is restricted at this crossing, as is shown in the photographs below:

- 6.3.2 The above images shows the impact of OHLE on sighting, the yellow shaded area shows the position of OHLE stanchions once they have been installed.
- 6.3.3 The sighting distance is compliant for pedestrian users stood at the decision point of 2m. the sighting for Equestrian users at 3m is deficient and so telephones are installed for these users.
- 6.3.4 Peckfield Level Crossing, in its existing arrangement, has had 8 instances of telephone failures between 2008-2018.
- 6.3.5 The close proximity to Micklefield Station means that trains stopping at the Station will be approaching the Crossing either accelerating or decelerating. Other express trains that do not stop will be travelling at line speed. This introduces the risk from variation in speed of approaching trains.

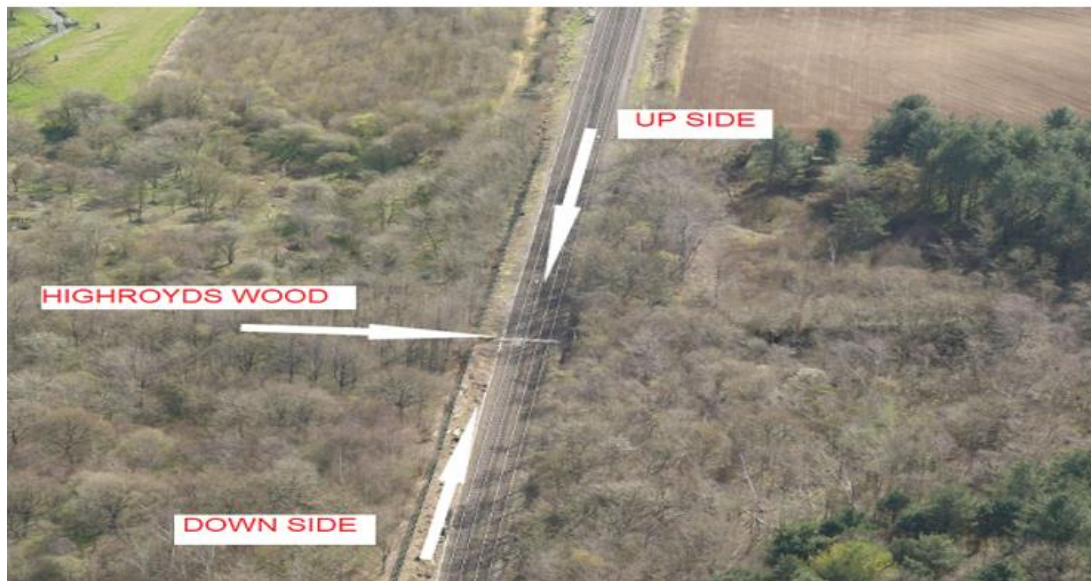
- 7.1.1 The Crossing, which carries a public footpath, is located in the middle of Highroyds Wood. The crossing provides an access from one side of Highroyds Wood to the other. It is located to the east of Micklefield in West Yorkshire. The environment surrounding the footpath has dense vegetation.
- 7.1.2 Micklefield Station is 880 yards to the West of the crossing. South Milford station is 2 miles 1144 yards to the East of the Crossing. The footpath connects several other footpaths in the local PRoW network, both to the North and South of the railway.
- 7.1.3 Figure 2 railway layout at Highroyds wood Footpath

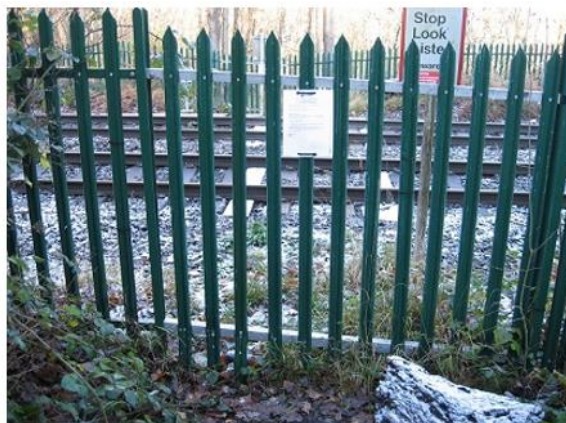
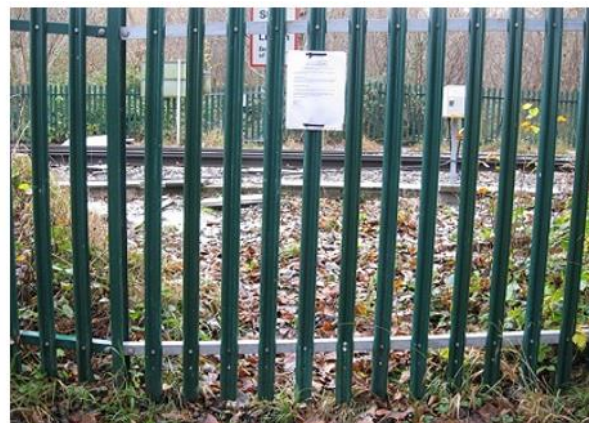
7.3.2 Photographs of the fencing to Footpath level crossing

photographs in Figure 10 below, show the crossing closed out of use to prevent unauthorised access.

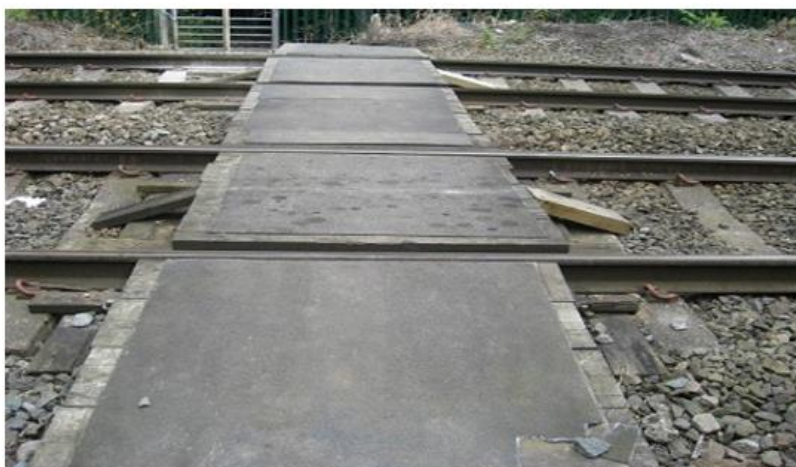
7.3.3 The Crossing decking is of wooden ACME panel type.

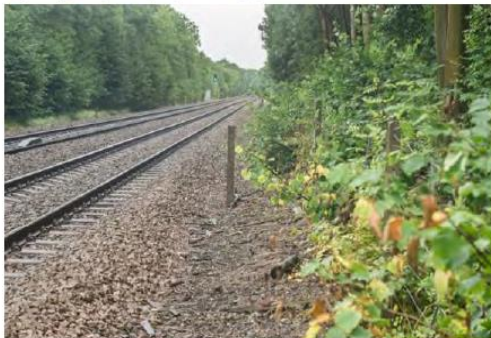
Sighting - Up side, Up train approach

- 7.5.11 Sighting is non-compliant when stood in the up cess looking for Down direction trains. The sighting is obstructed further when trains are stood close to the crossing.
