THE NETWORK RAIL

(CAMBRIDGE LEVEL CROSSING REDUCTION)

PROOF OF EVIDENCE

JOHN PREST

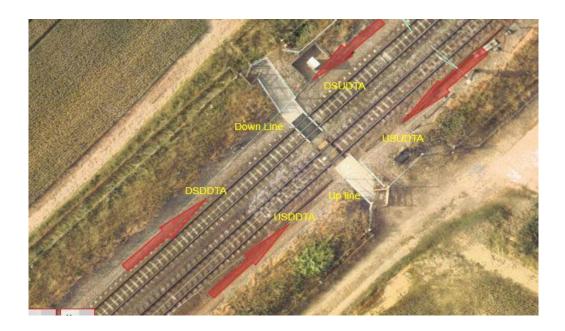
3.12 The picture below is a typical layout of a crossing to help explain the terminology used to assess sighting distances.

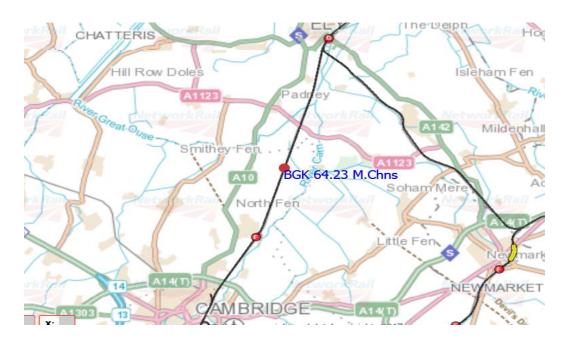
6.3 An aerial view of C01 Chittering Footpath crossing can be seen below.

- 6.4 The track on the left is the down line from London and the track on the right is the up line to London. Trains would normally run down from London on the left hand line that is from the bottom of the picture to the top. Trains would normally run up to London on the right hand side, which is from the top of the picture to the bottom.

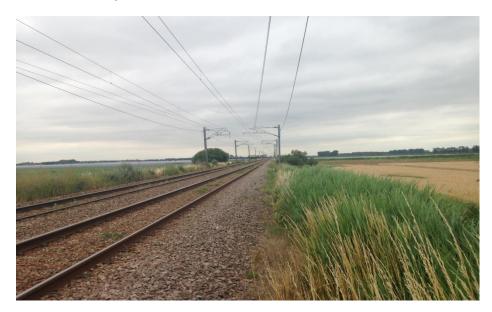
6.9 The photograph below is taken looking northward, from the up side (East) at a train approaching in the up direction (from the North). The trains usually approach on the closest set of lines (right hand side).

- 6.13 As can been from the table above (6.8), C01 Chittering crossing does have sufficient sighting to meet industry standards in all directions. C01 Chittering crossing is on a long straight section of the railway as shown in the photographs above. This means the sighting for a user to see an approaching train is very good when weather conditions are favourable. Sighting distances however, will be severely reduced when the weather is poor e.g. raining or foggy.

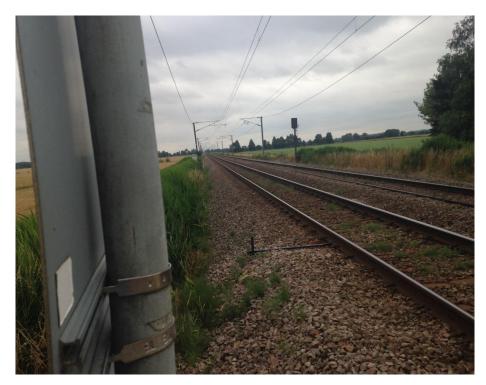
6.10 The photograph below is taken on the up side (east), looking south, the train usually approaches on the furthest (right hand side) set of lines.

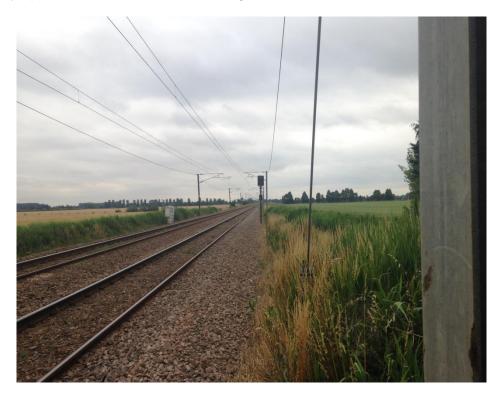
6.11 The photograph below is taken on the down side (west) looking south; the train usually approaches on the closest line (right hand side) set of lines.

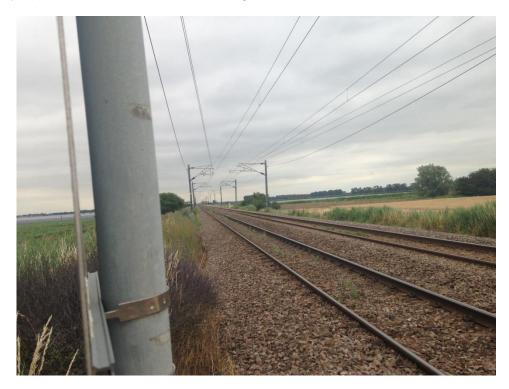
6.12 The photograph below is taken on the down side (west) looking north, the train usually approaches on the furthest line (right hand side) set of lines.

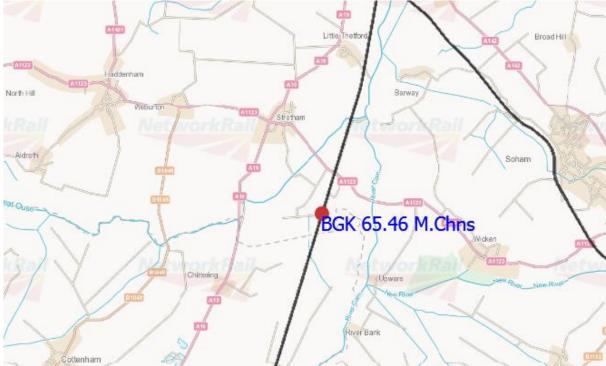
7.3 Aerial views of C02 Nairn's No.117 Level crossing can be seen below.

- 7.4 The track on the left is the down line from London and the track on the right is the up line to London. Trains would normally run down from London on the left hand line that is from the bottom of the picture to the top. Trains would normally run up to London on the right hand side, which is from the top of the picture to the bottom.

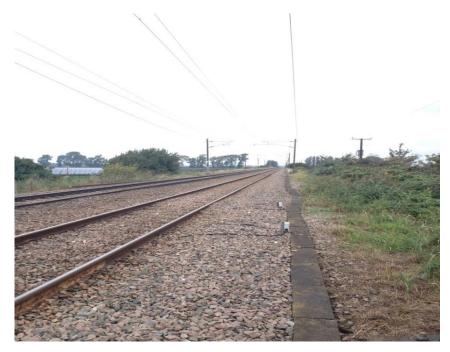
7.9 The photograph below is taken looking eastward, from the up side at a train approaching in the up direction. The trains usually approach on the closest set of lines (right hand side).

- 7.13 As you can see from the table above (7.8), C02 Nairns No.117 crossing location is on a straight piece of track which means that the crossing does have sufficient sighting to meet industry standards in all directions.
- 7.14 Following the risk assessment, an optioneering exercise was carried out to consider options for eliminating, reducing, mitigating or managing risk at this crossing. These options considered were:

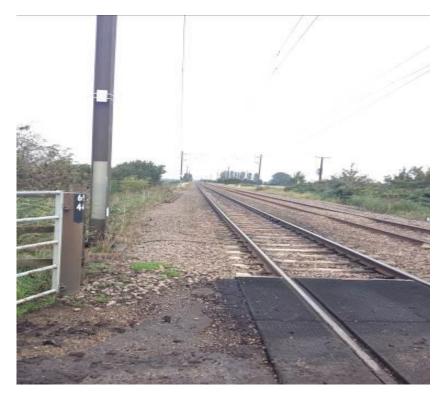
7.10 The photograph below is taken on the up side, looking west, the train usually approaches on the furthest (right hand side) set of lines.

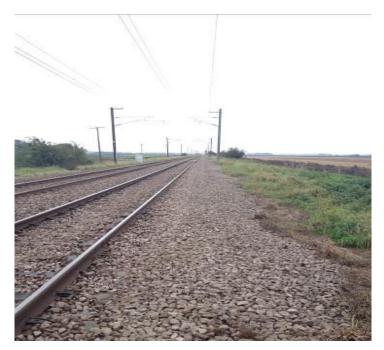
7.11 The photograph below is taken on the down side looking west, the train usually approaches on the closest line (right hand side) set of lines.

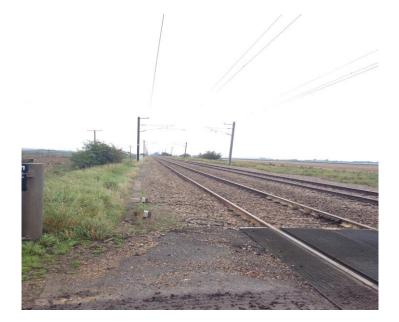
7.12 The photograph below is taken on the down side looking east, the train usually approaches on the furthest line (right hand side) set of lines.

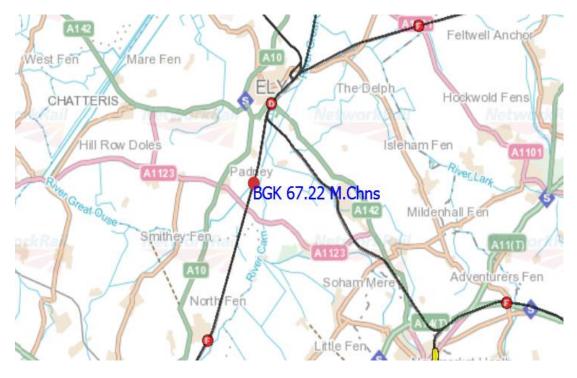
- 8.4 The left side of this track is the down line from London and the right side of this track is the up line to London. Trains would normally run down from London that is from the bottom of the picture to the top. Trains would normally run up to London, which is from the top of the picture to the bottom.

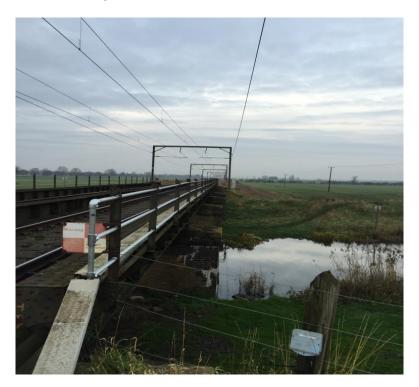
8.9 The photograph below is taken looking northward, from the up side (East) at a train approaching in the up direction (from the north). The trains usually approach on the closest set of lines (right hand side).

- 8.13 As can be seen from the table above (8.8), C03 West River Bridge footpath crossing does have sufficient sighting to meet industry standards in all directions, when weather conditions are not adverse.
- 8.14 Following the risk assessment, an optioneering exercise was carried out to consider options for eliminating, reducing, mitigating or managing risk at this crossing. These options considered were:

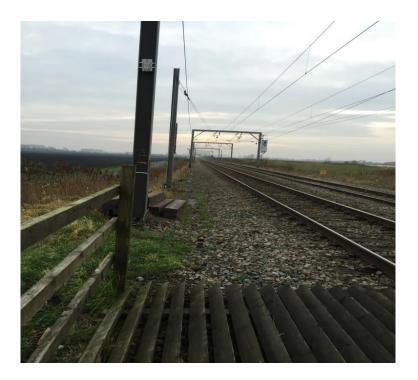
8.10 The photograph below is taken on the up side (east), looking south, the train usually approaches on the furthest (right hand side) set of lines

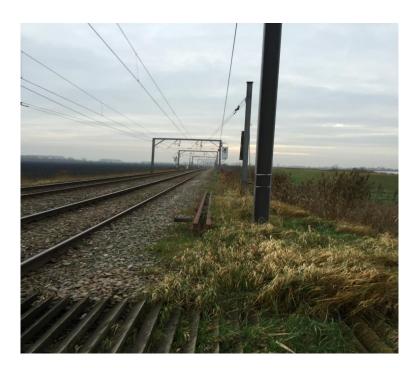
8.11 The photograph below is taken on the down side (west) looking south; the train usually approaches on the closest line (right hand side) set of lines.

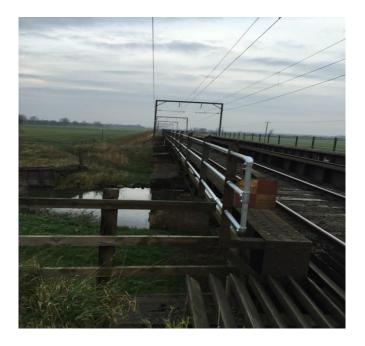
8.12 The photograph below is taken on the down side (west) looking north, the train usually approaches on the furthest line (right hand side) set of lines

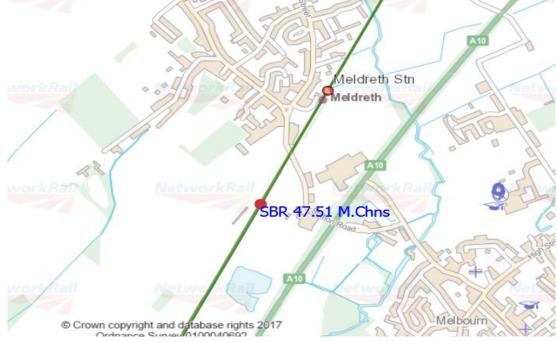
9.3 Aerial views of C04 No.20 Footpath crossing can be seen below.

- 9.4 The track on the left is the down line from London and the track on the right is the up line to London. Trains would normally run down from London on the left hand line that is from the bottom of the picture to the top. Trains would normally run up to London on the right hand side, which is from the top of the picture to the bottom.

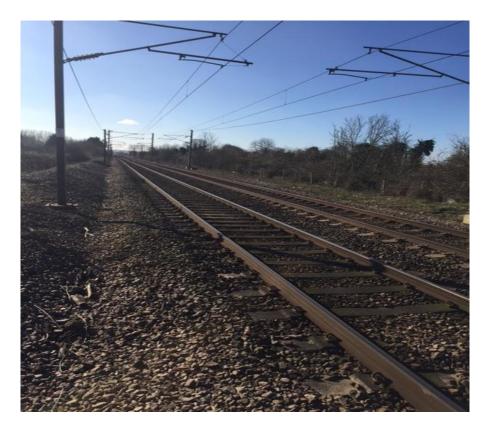
9.10 The photograph below is taken on the up side (east), looking south, the train usually approaches on the furthest (right hand side) set of lines.

on a long straight section of the railway as shown in the photographs above. This means the sighting for a user to see an approaching train is very good when weather conditions are favourable. Sighting distances however, will be severely reduced when the weather is poor e.g. raining or foggy.

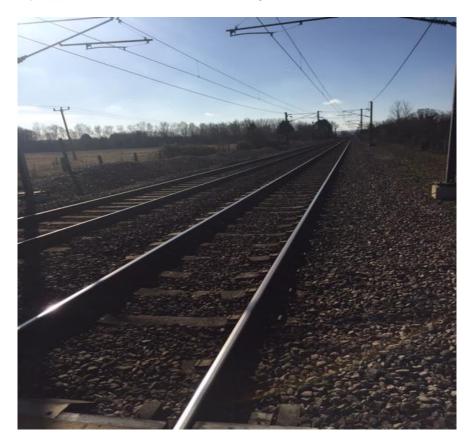
9.11 The photograph below is taken on the down side (west) looking south; the train usually approaches on the closest line (right hand side) set of lines.

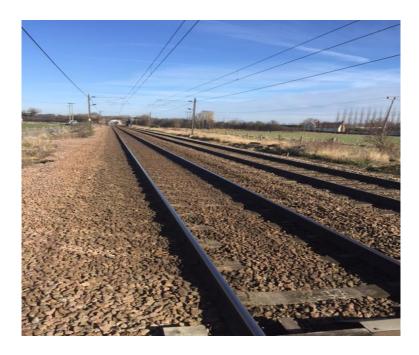
9.12 The photograph below is taken on the down side (west) looking north, the train usually approaches on the furthest line (right hand side) set of lines.

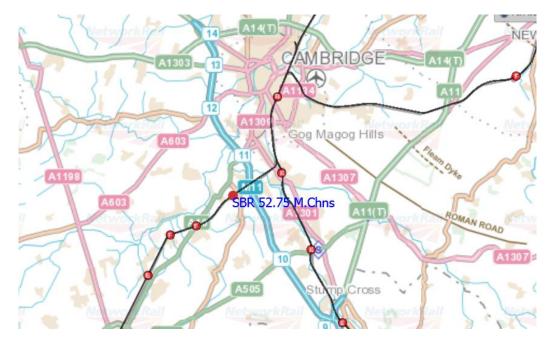
10.3 Aerial views of C07 No.37 Footpath crossing can be seen below.

- 10.4 The track on the left is the down line from London and the track on the right is the up line to London. Trains would normally run down from London on the left hand line that is from the bottom of the picture to the top. Trains would normally run up to London on the right hand side, which is from the top of the picture to the bottom.

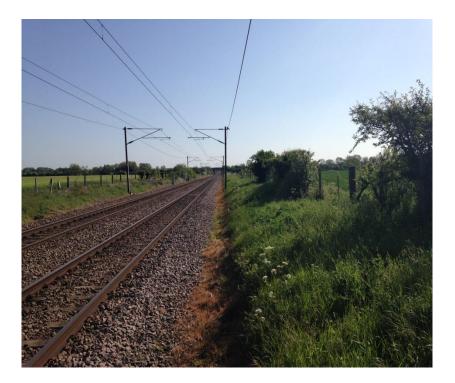
10.9 The photograph below is taken looking northward, from the up side (east) at a train approaching in the up direction (from the north). The trains usually approach on the closest set of lines (right hand side).

- 10.13 As can been from the table above (10.8), C07 No.37 crossing does have sufficient sighting to meet industry standards in all directions. C07 No.37 crossing is on a long straight section of the railway as shown in the photographs above. This means the sighting for a user to see an approaching train is very good when weather conditions are favourable. Sighting distances however, will be severely reduced when the weather is poor e.g. raining or foggy.
- 10.14 Following the risk assessment, an Optioneering exercise was carried out to consider options for eliminating, reducing, mitigating or managing risk at this crossing. These options considered were:

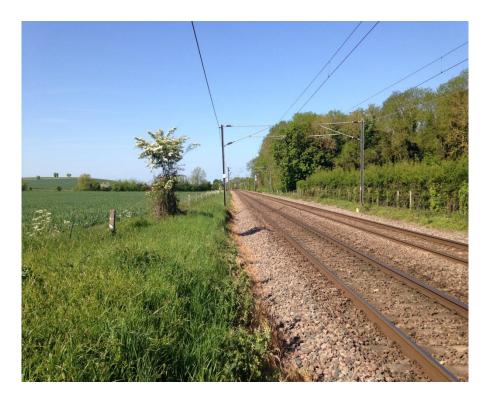
10.10 The photograph below is taken on the up side (east), looking south, the train usually approaches on the furthest (right hand side) set of lines.

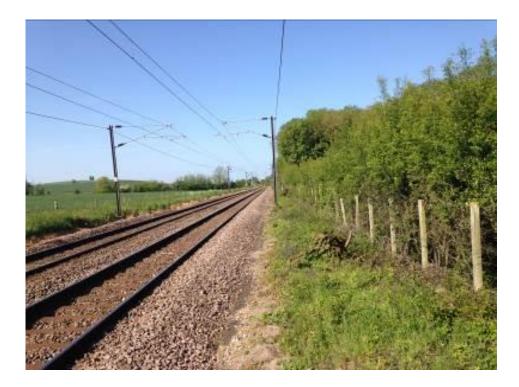
10.11 The photograph below is taken on the down side (west) looking south; the train usually approaches on the closest line (right hand side) set of lines.

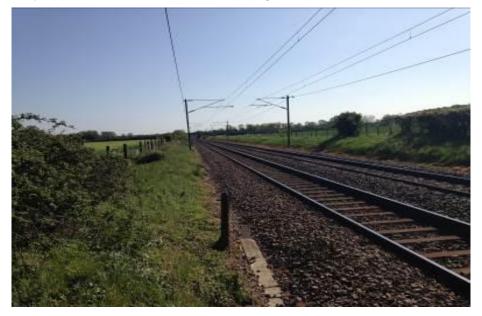
10.12 The photograph below is taken on the down side (west) looking north, the train usually approaches on the furthest line (right hand side) set of lines.

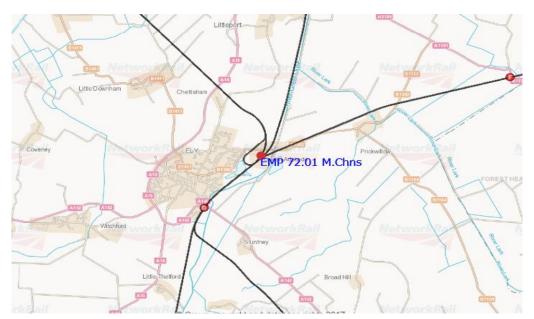
11.3 Aerial views of C08 Ely North Junction FPS can be seen below.

- 11.4 The track on the left side is the down line from London to Peterborough normally running from bottom to top and the track on the right side is the up line from Peterborough to London normally running from top to bottom.

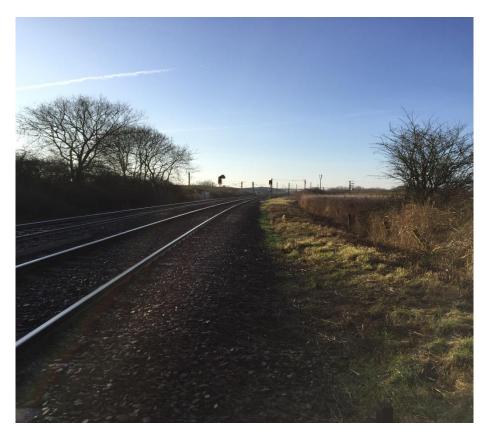
11.9 The photograph below is taken looking southward, from the down side (west) at a train approaching in the down direction (from the south). The trains usually approach on the closest set of lines (right hand side).

- 11.13 As can be seen from the table above (11.8), C08 Ely North Junction does have sufficient sighting to meet industry standards in all directions. C08 Ely North Junction FPS is on a curved section of the railway as shown in the photographs above. This means the sighting for a user to see an approaching train is sufficient when weather conditions are favourable. Sighting distances however, will be severely reduced when the weather is poor e.g. raining or foggy, or if vegetation is not constantly managed on the curves.
- 11.14 Following the risk assessment, an optioneering exercise was carried out to consider options for eliminating, reducing, mitigating or managing risk at this crossing. These options considered were:

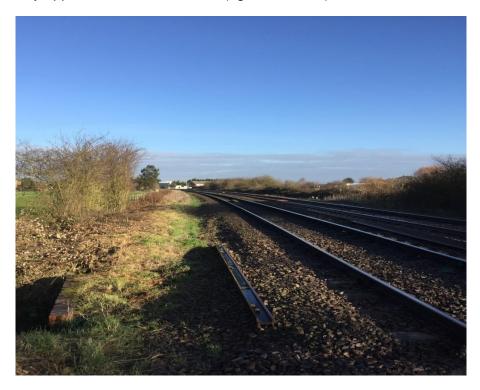
11.10 The photograph below is taken on the down side (west), looking north, the train usually approaches on the furthest (right hand side) set of lines.

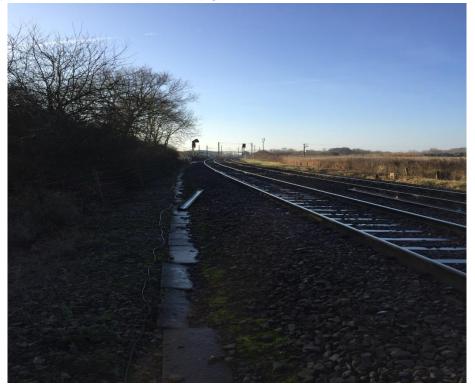
11.11 The photograph below is taken on the up side (east) looking south, the train usually approaches on the furthest line (right hand side) set of lines.

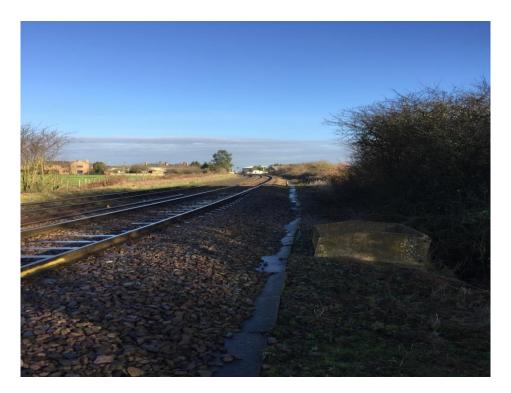
11.12 The photograph below is taken on the up side (east) looking north, the train usually approaches on the nearest line (right hand side) set of lines.

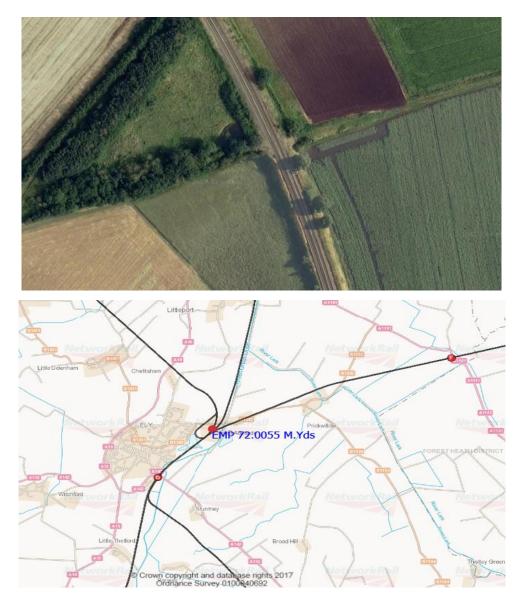
12.3 Aerial views of C09 Second Drove FPS can be seen below.

12.4 The track on the left hand side is the down line from London to Peterborough normally running from right to left and the track on the right hand side is the up line from Peterborough to London normally running from left to right.

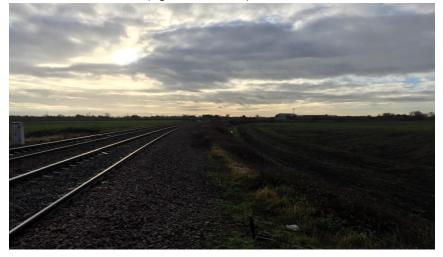
12.9 The photograph below is taken looking southward, from the down side (west) at a train approaching in the down direction (from the south). The trains usually approach on the closest set of lines (right hand side).

- 12.13 As can be seen from the table above (12.8), C09 Second Drove FPS does have sufficient sighting to meet industry standards in all directions but the crossing still has whistle boards installed as a mitigation measure. C09 Second Drove FPS is sighted to the centre of a curve section of the railway as shown in the photographs above. This means the sighting for a user to see an approaching train is sufficient when weather conditions are favourable. Sighting distances however, will be severely reduced when the weather is poor e.g. raining or foggy. This crossing has whistle boards as a mitigation measure.
- 12.14 Following the risk assessment, an optioneering exercise was carried out to consider options for eliminating, reducing, mitigating or managing risk at this crossing. These options considered were:

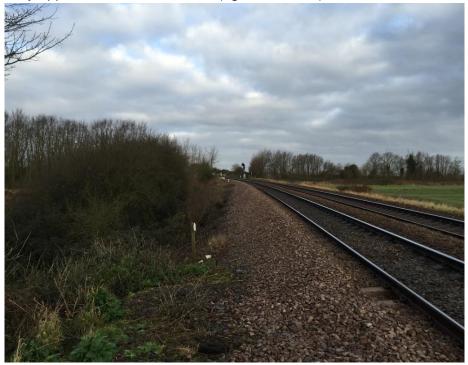
12.10 The photograph below is taken on the down side (west), looking north, the train usually approaches on the furthest (right hand side) set of lines.

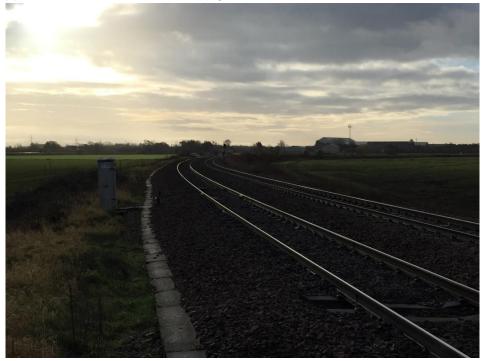
12.11 The photograph below is taken on the up side (east) looking south, the train usually approaches on the furthest line (right hand side) set of lines.

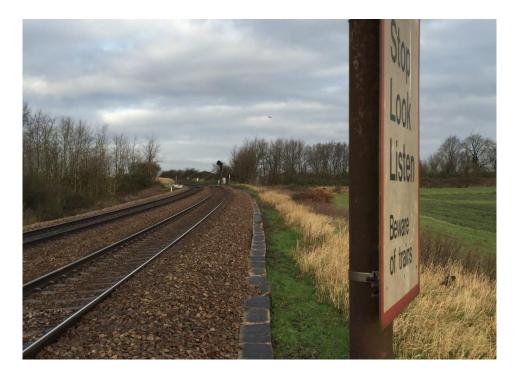
12.12 The photograph below is taken on the up side (east) looking north, the train usually approaches on the nearest line (right hand side) set of lines.

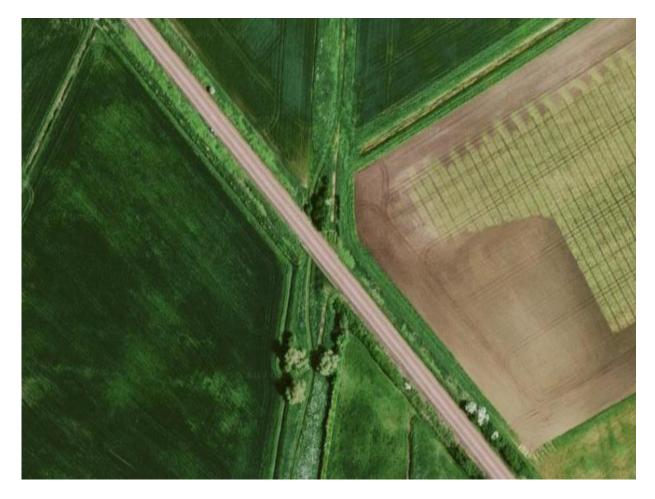
- 13.4 The track at the top of the picture is the up line from Peterborough to London running from left to right and the track on the bottom is the down line from London to Peterborough running from right to left.

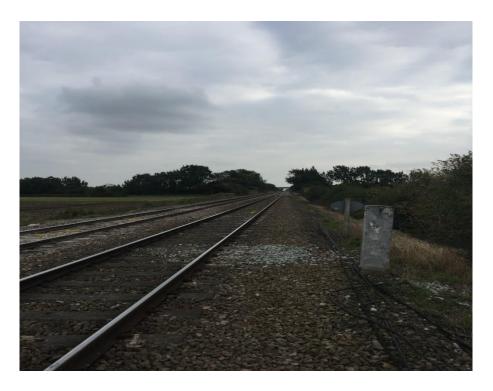
13.9 The photograph below is taken looking Eastward, from the down side (south) at a train approaching in the down direction (from the east). The trains usually approach on the closest set of lines (right hand side).

- 13.13 As can be seen from the table above (13.8), C10 COFFUE DROVE user worked crossing with telephones does have some non-sufficient sighting aspects to meet industry standards and so Telephones installed are the mitigation.
- 13.14 Following the risk assessment, an optioneering exercise was carried out to consider options for eliminating, reducing, mitigating or managing risk at this crossing. These options considered were:

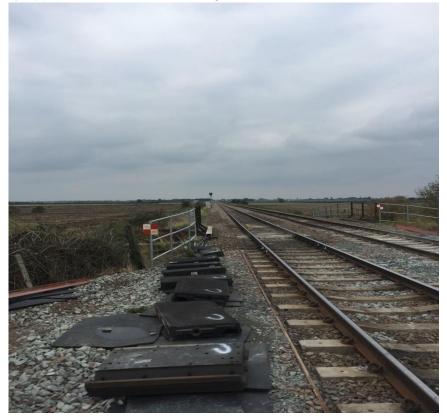
13.10 The photograph below is taken on the down side (south), looking west, the train usually approaches on the furthest right hand side (west) set of lines.

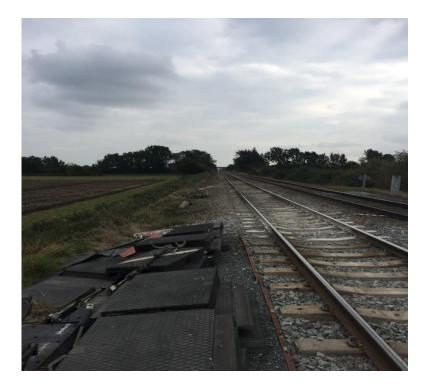
13.11 The photograph below is taken on the up side (north) looking east; the train usually approaches on the furthest line (right hand side) set of lines

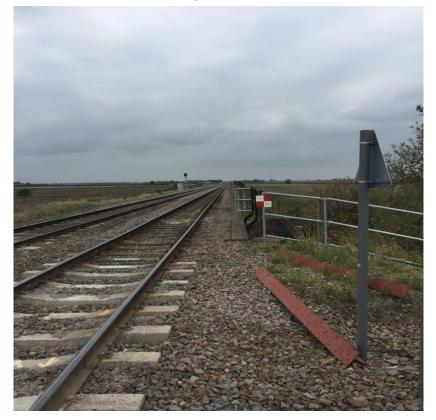
13.12 The photograph below is taken on the up side (north) looking west, the train usually approaches on the nearest line (right hand side) set of lines.

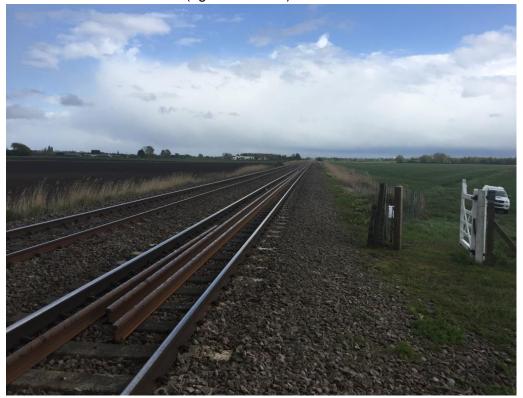
14.9 The photograph below is taken looking eastward, from the down side (south) at a train approaching in the down direction (from the east). The trains usually approach on the closest set of lines (right hand side).

- 14.13 As can be seen from the table above (14.8), C11 FURLONG DROVE FPG/Byway does have sufficient sighting to meet industry standards in all directions. C11 FURLONG DROVE FPG/Byway is on a long straight section of the railway as shown in the photographs above. This means the sighting for a user to see an approaching train is very good when weather conditions are favourable. Sighting distances however, will be severely reduced when the weather is poor e.g. raining or foggy.
- 14.14 Following the risk assessment, an Optioneering exercise was carried out to consider options for eliminating, reducing, mitigating or managing risk at this crossing. These options considered were:

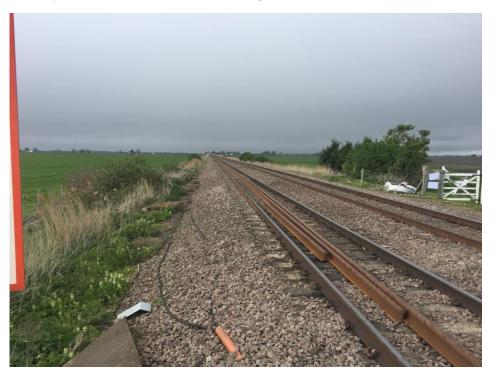
14.10 The photograph below is taken on the down side (south), looking west, the train usually approaches on the furthest (right hand side) set of lines.

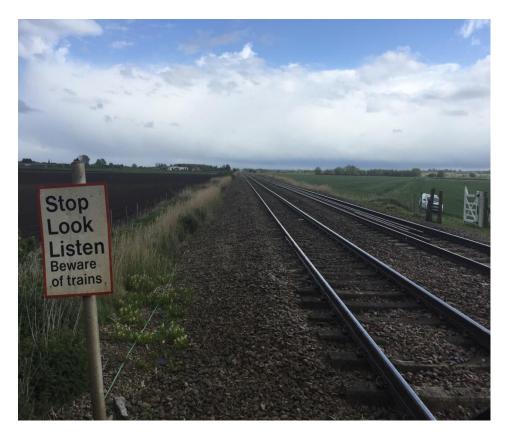
14.11 The photograph below is taken on the up side (north) looking east, the train usually approaches on the furthest line (right hand side) set of lines.

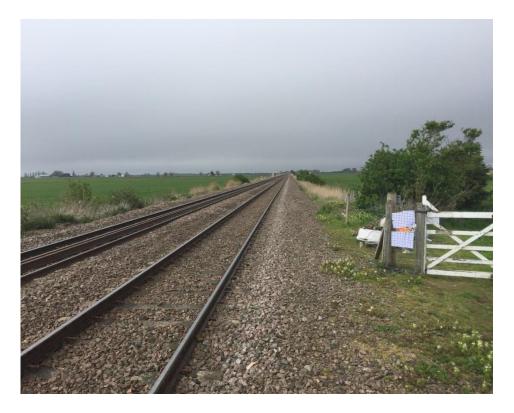
14.12 The photograph below is taken on the up side (north) looking west, the train usually approaches on the nearest line (right hand side) set of lines.

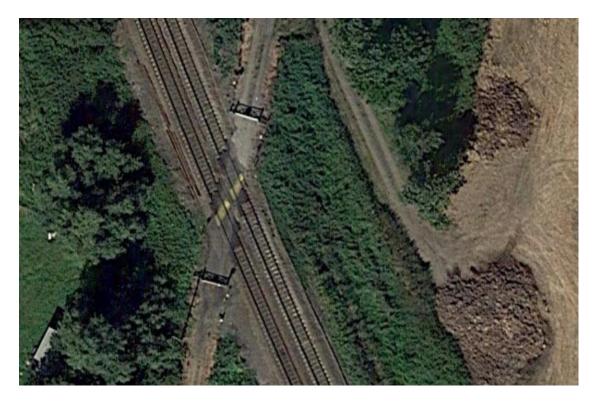
- 15.4 The track to the right is the up line from Peterborough to London running from top to bottom and the track to the left is the down line from London to Peterborough running from bottom to top.

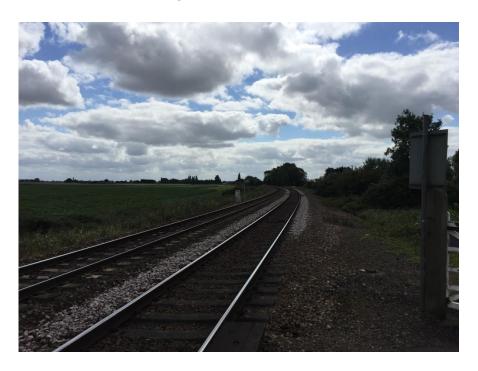
15.8 The photograph below is taken looking eastward, from the down side (south) at a train approaching in the down direction (from the east). The trains usually approach on the closest set of lines (right hand side).

- 15.12 As can be seen from the table above (15.7), C12 SILT DROVE user worked crossing with telephones does have some non-sufficient sighting aspects to meet industry standards and so telephones installed are the mitigation.
- 15.13 Following the risk assessment, an Optioneering exercise was carried out to consider options for eliminating, reducing, mitigating or managing risk at this crossing. These options considered were:

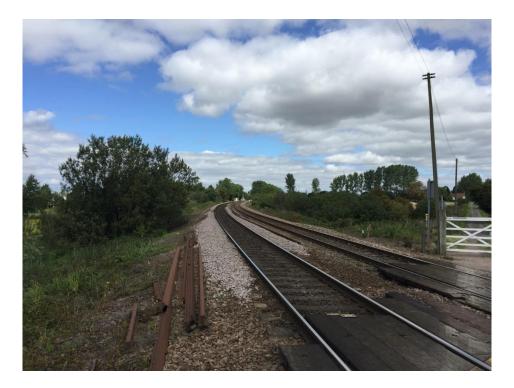
15.9 The photograph below is taken on the down side (south), looking west, the train usually approaches on the furthest right hand side (west) set of lines.

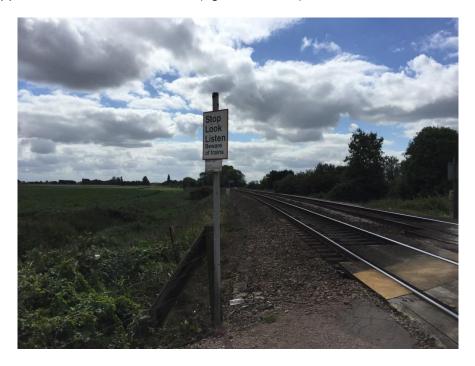
15.10 The photograph below is taken on the up side (north) looking east; the train usually approaches on the furthest line (right hand side) set of lines

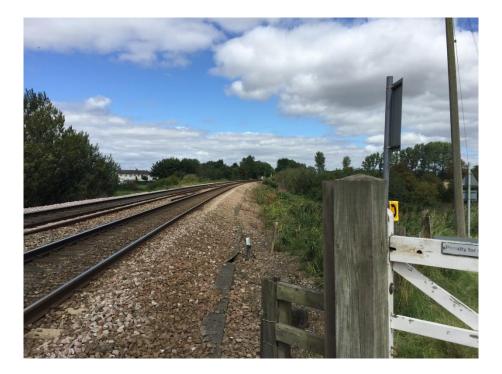
15.11 The photograph below is taken on the up side (north) looking west, the train usually approaches on the nearest line (right hand side) set of lines.

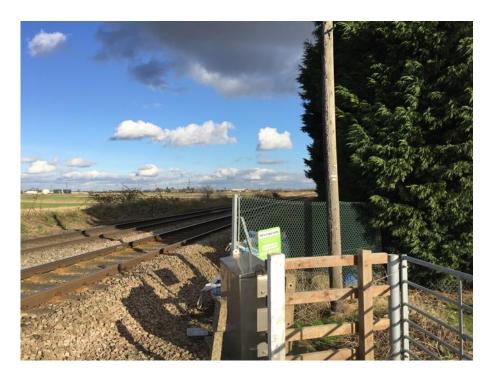
16.8 The photograph below is taken looking eastward, from the down side (south) at a train approaching in the down direction (from the east). The trains usually approach on the closest set of lines (right hand side).

- 16.12 As can be seen from the table above (16.7), C13 MIDDLE DROVE USER WORK CROSSING WITH TELEPHONES & MWL has insufficient sighting aspects in all directions to meet industry standards and so MWL and telephones are installed as the mitigation.
- 16.13 Following the risk assessment, an optioneering exercise was carried out to consider options for eliminating, reducing, mitigating or managing risk at this crossing. These options considered were:

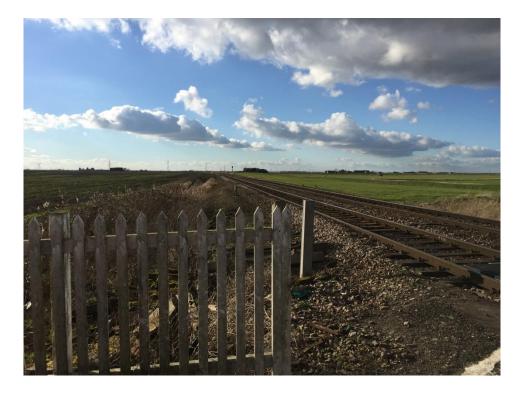
16.9 The photograph below is taken on the down side (south), looking west, the train usually approaches on the furthest right hand side (west) set of lines.

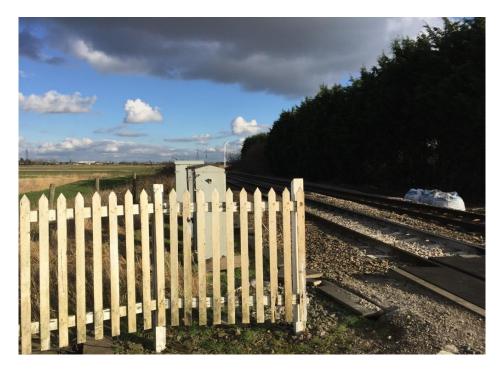
16.10 The photograph below is taken on the up side (north) looking east; the train usually approaches on the furthest line (right hand side) set of lines

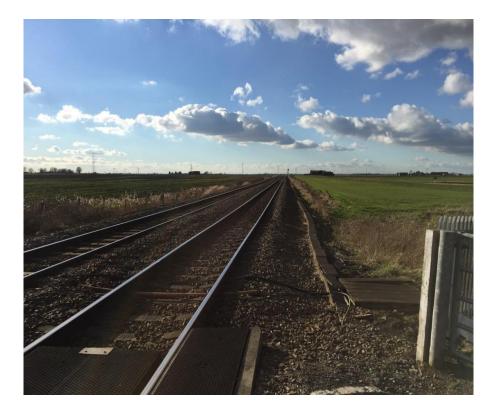
16.11 The photograph below is taken on the up side (north) looking west, the train usually approaches on the nearest line (right hand side) set of lines.

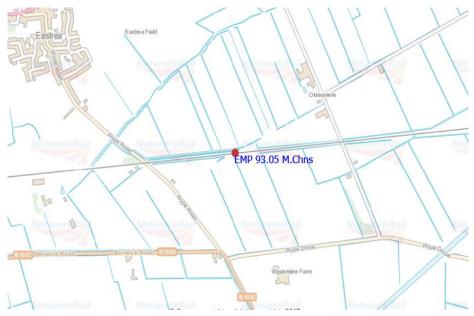
- 17.4 The track at the bottom is the down line from London to Peterborough normally running from right to left and the track at the top is the up line from Peterborough to London normally running from left to right.

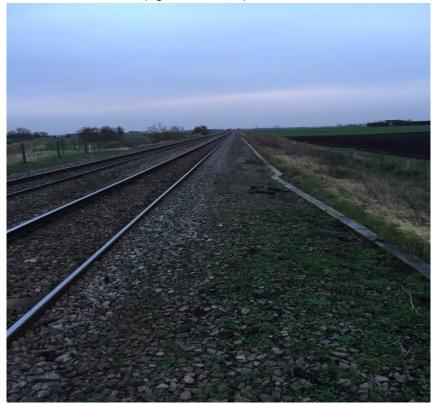
17.9 The photograph below is taken looking eastward, from the down side (south) at a train approaching in the down direction (from the east). The trains usually approach on the closest set of lines (right hand side).

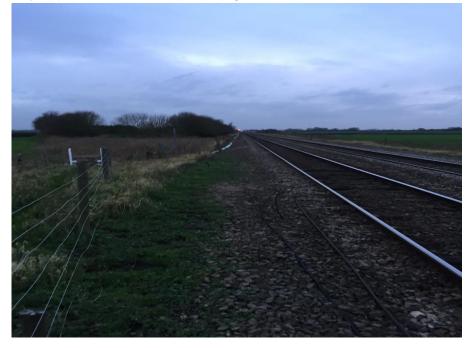
17.10 The photograph below is taken on the down side (south), looking west, the train usually approaches on the furthest (right hand side) set of lines.

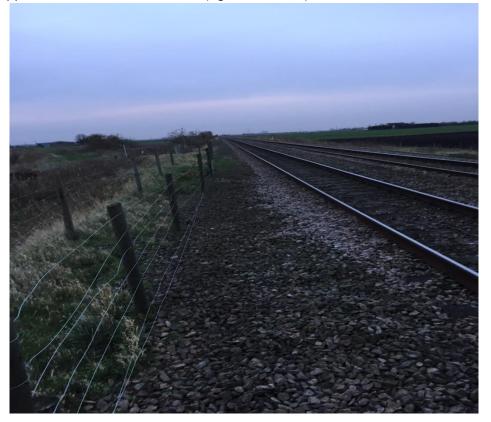
17.11 The photograph below is taken on the up side (north) looking east, the train usually approaches on the furthest line (right hand side) set of lines.

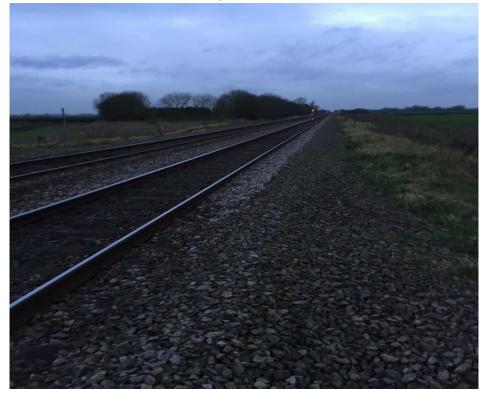
17.12 The photograph below is taken on the up side (north) looking west, the train usually approaches on the nearest line (right hand side) set of lines.

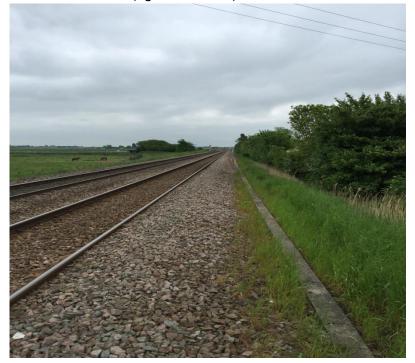
18.9 The photograph below is taken looking eastward, from the down side (south) at a train approaching in the down direction (from the east). The trains usually approach on the closest set of lines (right hand side).

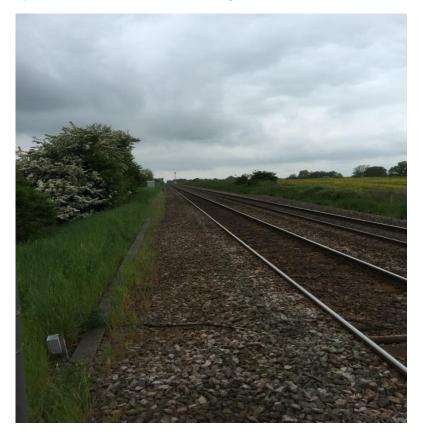
18.10 The photograph below is taken on the down side (south), looking west, the train usually approaches on the furthest (right hand side) set of lines.

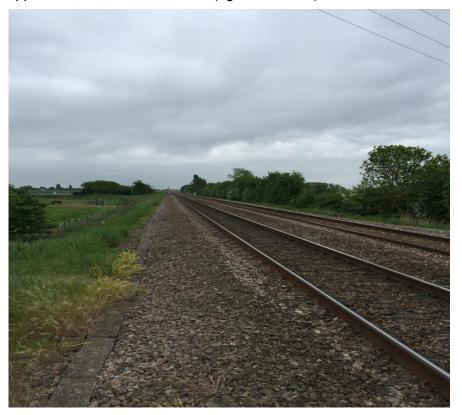
18.11 The photograph below is taken on the up side (north) looking east, the train usually approaches on the furthest line (right hand side) set of lines.

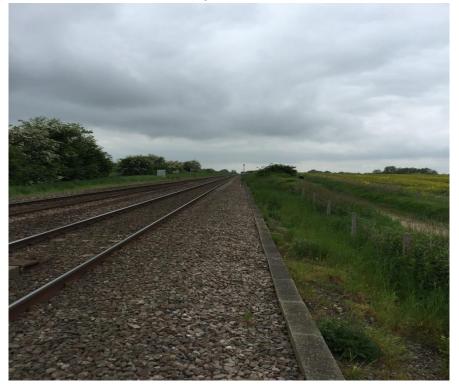
18.12 The photograph below is taken on the up side (north) looking west, the train usually approaches on the nearest line (right hand side) set of lines.

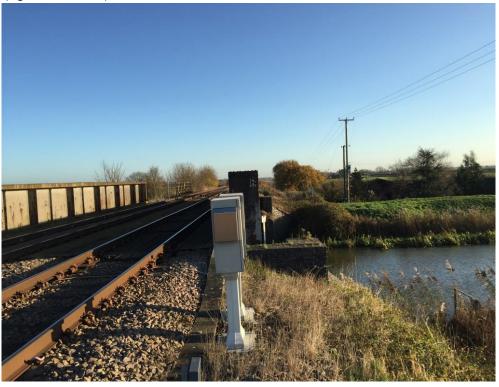
19.9 The photograph below is taken from the up side (South) at a train approaching in the up direction (from the East). The trains usually approach on the closest set of lines (right hand side).

19.13 As can been seen from the table above (19.8), C16 Prickwillow 1 level crossing does not have sufficient sighting to meet industry standards for up side looking toward up direction train approaching and down side looking toward up direction train approaching in these directions is heavily restricted by railway underbridge 1579a and is limited to 10 metres.C16 Prickwillow 1 level crossing has whistle boards installed as a mitigation measure for insufficient sighting.

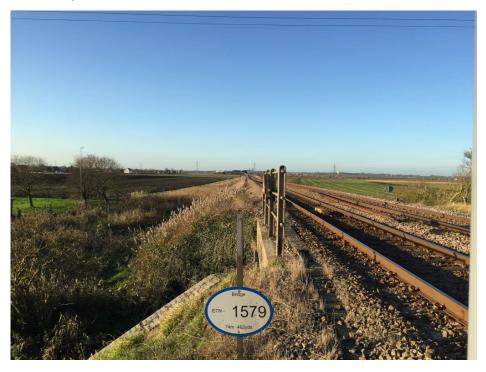
19.10 The photograph below is taken on the up side (South), at a train approaching in the down direction (from the West). The train usually approaches on the furthest (left hand side) set of lines.

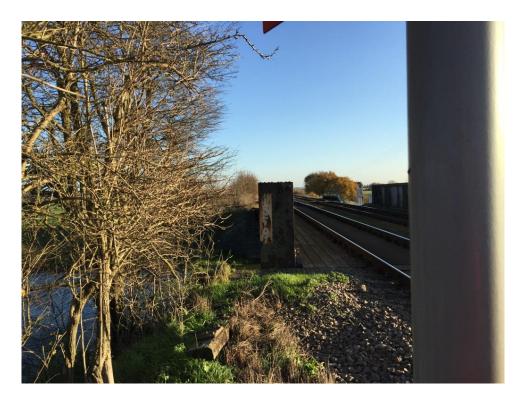
19.11 The photograph below is taken on the down side (North) at a train approaching in the up direction (from the East). The train usually approaches on the furthest (left hand side) set of lines.

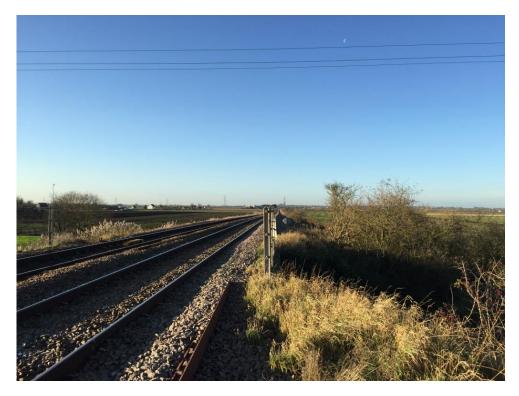
19.12 The photograph below is taken on the down side (North) at a train approaching in the down direction (from the West). The train usually approaches on the closest (right hand side) set of lines.

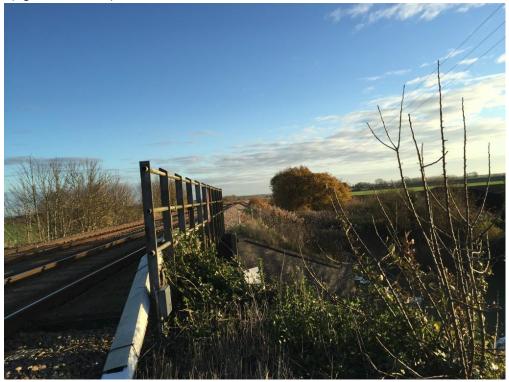
20.9 The photograph below is taken from the up side (South) at a train approaching in the up direction (from the East). The trains usually approach on the closest set of lines (right hand side).

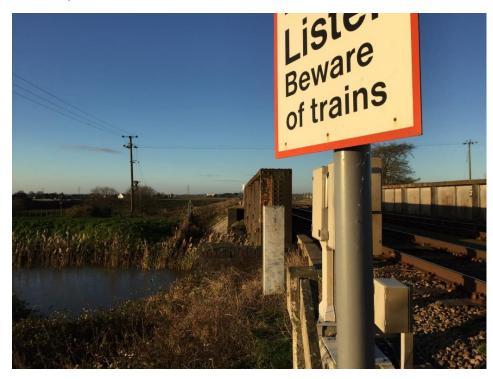
20.10 The photograph below is taken on the up side (South), at a train approaching in the down direction (from the West). The train usually approaches on the furthest (left hand side) set of lines.

20.13 As can been seen from the table above (20.8), C17 Prickwillow 2(Larks Bridge) level crossing does not have sufficient sighting to meet industry standards for up side looking toward down direction train approaching, down side looking toward up direction train approaching and down side looking toward down direction train approaching, sighting in these directions is heavily restricted by railway underbridges. C17 Prickwillow 2 (Larks Bridge) level crossing has whistle boards installed as a mitigation measure for insufficient sighting.

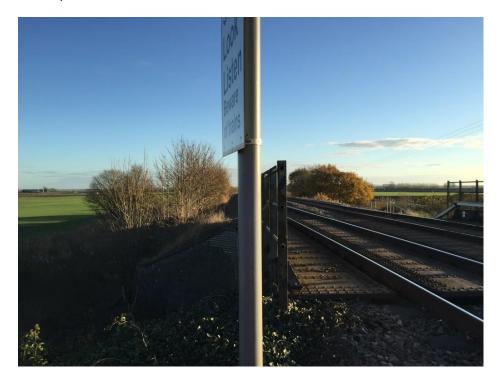
20.11 The photograph below is taken on the down side (North) at a train approaching in the Up direction (from the East). The train usually approaches on the furthest (left hand side) set of lines.

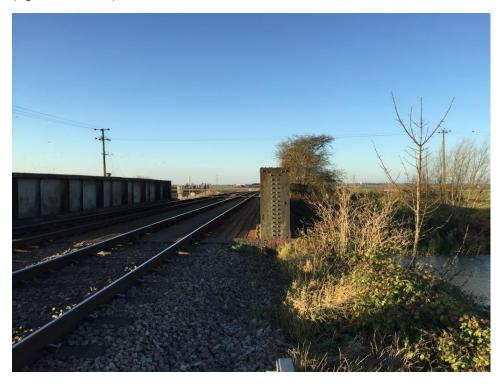
20.12 The photograph below is taken on the down side (North) at a train approaching in the down direction (from the West). The train usually approaches on the closest (right hand side) set of lines.

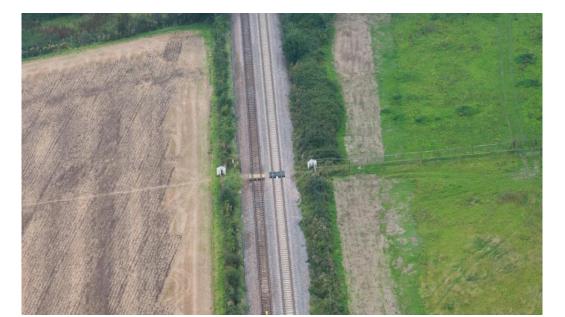
- 21.4 The track on the left on the first picture is the down line to Ely and the track on the right is the up line to Chippenham Junction. Trains would normally run down to Ely on the left hand line that is from the bottom of the picture to the top. Trains would normally run up to Chippenham Junction on the right hand side, which is from the top of the picture to the bottom.

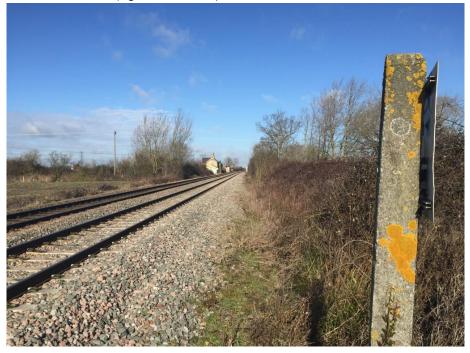
21.9 The photograph below is taken looking northward, from the up side (East) at a train approaching in the up direction (from the North). The trains usually approach on the closest set of lines (right hand side).

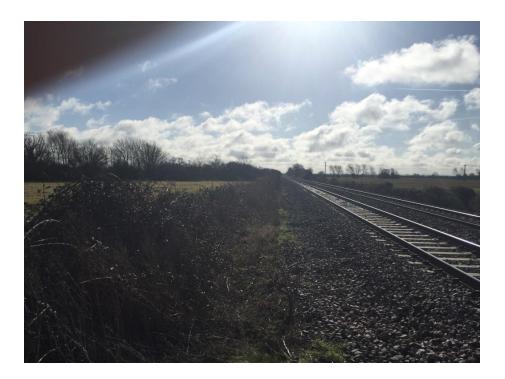
21.10 The photograph below is taken on the up side (east), looking south, the train usually approaches on the furthest (right hand side) set of lines.

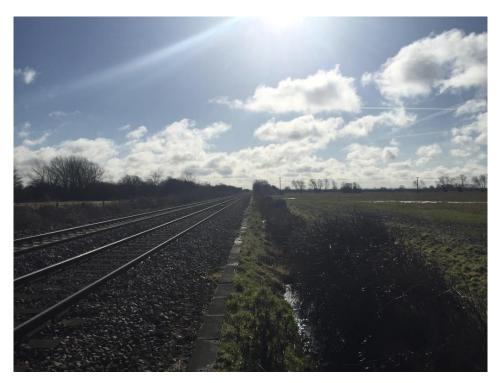
21.11 The photograph below is taken on the down side (west) looking south; the train usually approaches on the closest line (right hand side) set of lines.

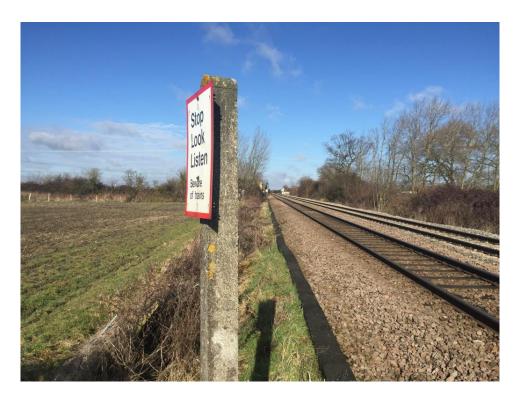
21.12 The photograph below is taken on the down side (west) looking north, the train usually approaches on the furthest line (right hand side) set of lines.

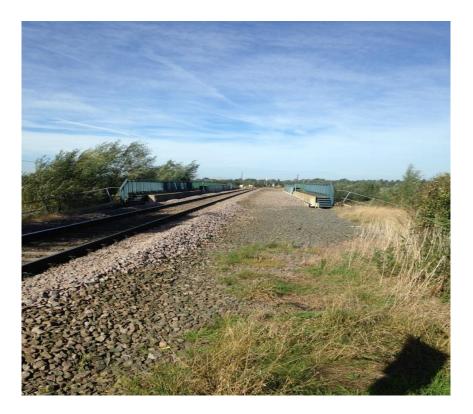
22.9 The photograph below is taken looking north-westward, from the up side (north) at a train approaching in the up direction (from the Northwest).

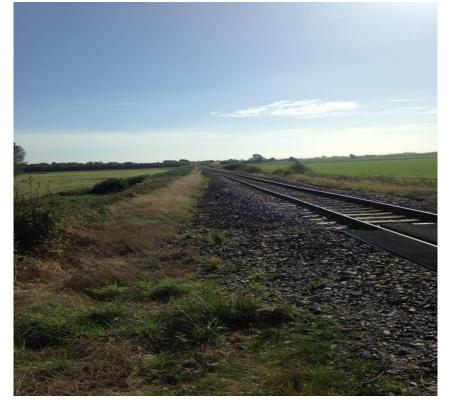
22.10 The photograph below is taken on the up side (north), looking southeast.

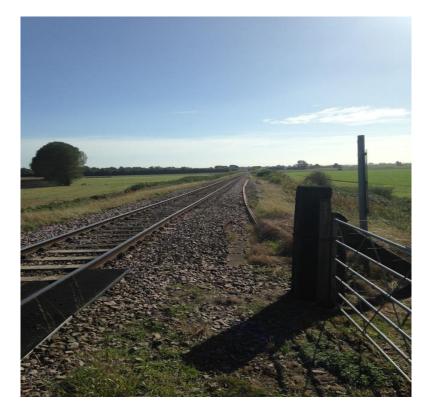
22.11 The photograph below is taken on the down side (south) looking southeast.

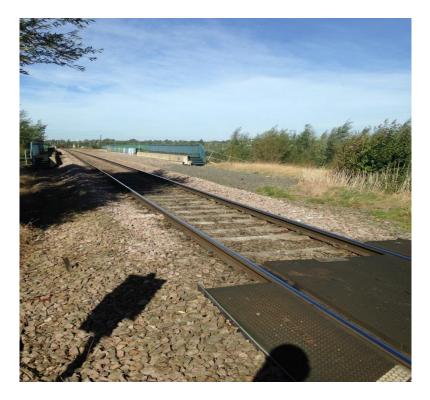
22.12 The photograph below is taken on the down side (south) looking northwest.

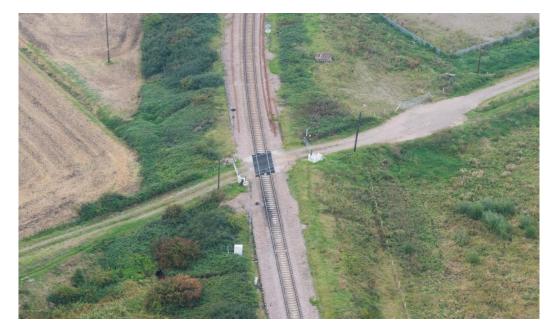
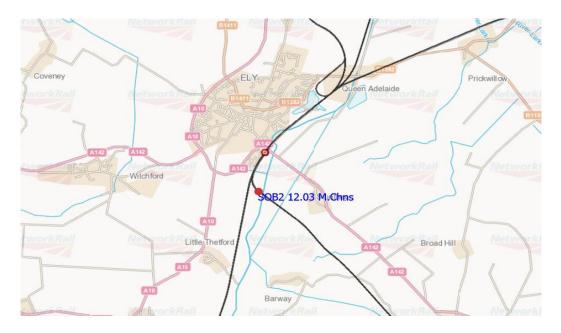
- 23.4 There is a single line at this location and trains are signalled to run in either direction at any time. From the bottom to the top of the picture is the down direction towards Ely and the top to the bottom of the picture is the up direction towards Chippenham Junction.

- 23.5 C22 Wells Engine level crossing is a passive crossing, meaning that there is no direct method of warning people who use the crossing of approaching trains. It is not controlled, or equipped with lights, or any automatic audible warning systems. The location and geography of the crossing means that it is therefore necessarily reliant upon users to `stop look and listen' to check for approaching trains, ensuring they have sufficient time to cross to protect their personal safety whilst traversing the line.

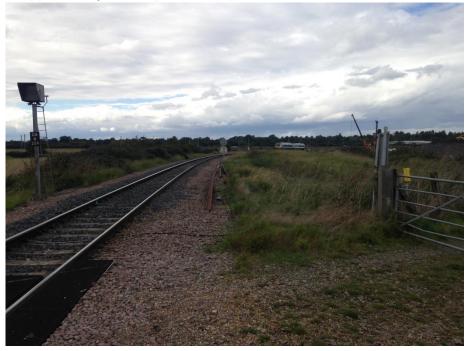
23.9 The photograph below is taken looking north-westward, from the up side (north) at a train approaching in the up direction (from the Northwest).

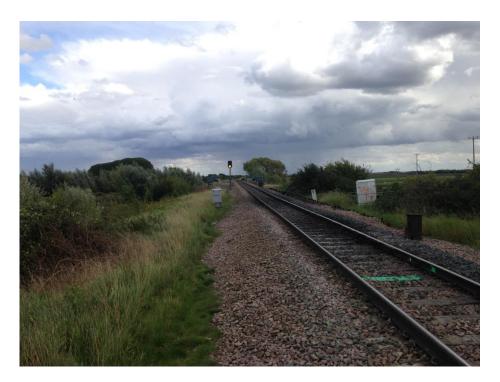
23.10 The photograph below is taken on the up side (north), looking southeast.

- 23.13 As can been from the table above (23.8), C22 Wells Engine crossing does have sufficient sighting to meet industry standards in all directions. C22 Wells Engine crossing is at the end of a long straight section of the railway and a long sweeping curve with minimal vegetation as shown in the photographs above. This means the sighting for a user to see an approaching train is very good when weather conditions are favourable. Sighting distances however, will be severely reduced when the weather is poor e.g. raining or foggy.
- 23.14 Following the risk assessment, an optioneering exercise was carried out to consider options for eliminating, reducing, mitigating or managing risk at this crossing. These options considered were:

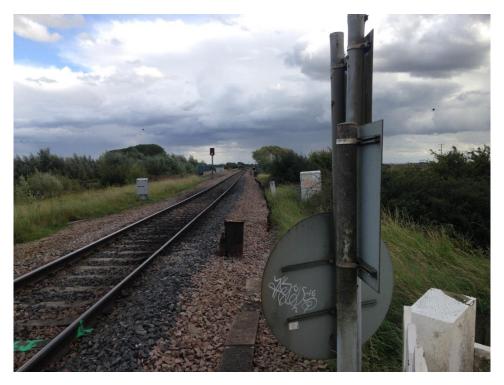
23.11 The photograph below is taken on the down side (south) looking southeast
