THE NETWORK RAIL

(CAMBRIDGE LEVEL CROSSING REDUCTION)

PROOF OF EVIDENCE

JOHN PREST

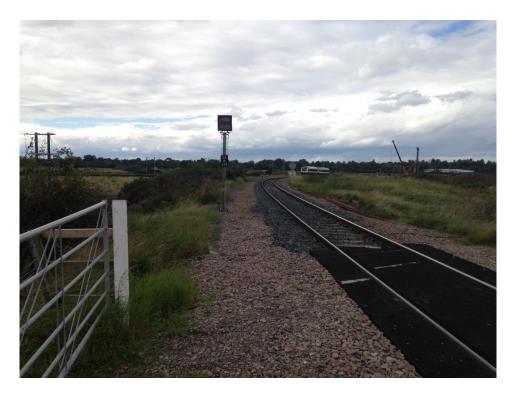
23.12 The photograph below is taken on the down side (south) looking northwest.

- 23.13 As can been from the table above (23.8), C22 Wells Engine crossing does have sufficient sighting to meet industry standards in all directions. C22 Wells Engine crossing is at the end of a long straight section of the railway and a long sweeping curve with minimal vegetation as shown in the photographs above. This means the sighting for a user to see an approaching train is very good when weather conditions are favourable. Sighting distances however, will be severely reduced when the weather is poor e.g. raining or foggy.
- 23.14 Following the risk assessment, an optioneering exercise was carried out to consider options for eliminating, reducing, mitigating or managing risk at this crossing. These options considered were:

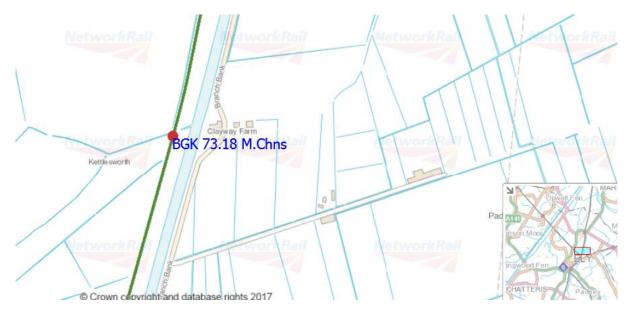
24.3 Aerial views of Cross keys footpath crossing can be seen below.

- 24.4 The left side of this track is the down line from London and the right side of this track is the up line to London. Trains would normally run from London that is from the bottom of the picture to the top. Trains would normally run to London, which is from the top of the picture to the bottom.

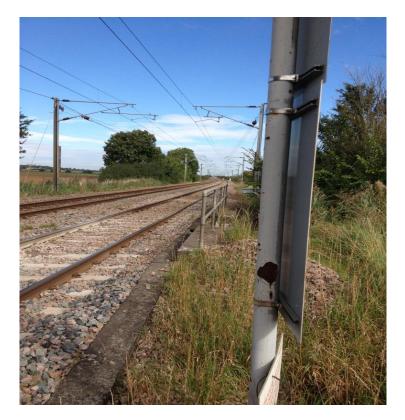
24.9 The photograph below is taken looking northward, from the up side (East) at a train approaching in the up direction (from the North). The trains usually approach on the closest set of lines (right hand side)

- 24.13 As can be seen from the table above (24.8), C24 Cross keys footpath crossing does have sufficient sighting to meet industry standards in all directions. C24 Cross Keys crossing is on a long straight section of the railway as shown in the photographs above. This means the sighting for a user to see an approaching train is very good when weather conditions are favourable. Sighting distances however, will be severely reduced when the weather is poor e.g. raining or foggy.
- 24.14 Following the risk assessment, an optioneering exercise was carried out to consider options for eliminating, reducing, mitigating or managing risk at this crossing. These options considered were:

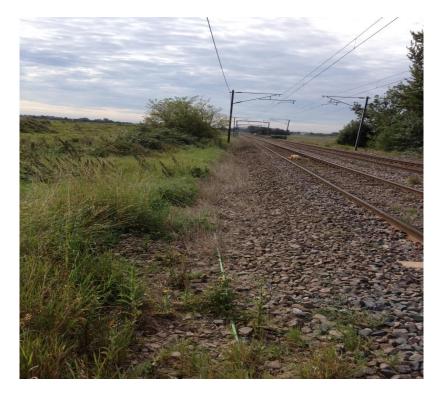
24.10 The photograph below is taken on the up side (east), looking south, the train usually approaches on the furthest (right hand side) set of lines

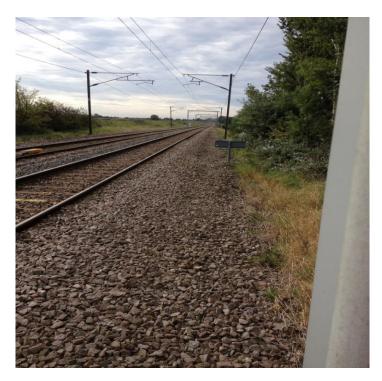
24.11 The photograph below is taken on the down side (west) looking south; the train usually approaches on the closest line (right hand side) set of lines

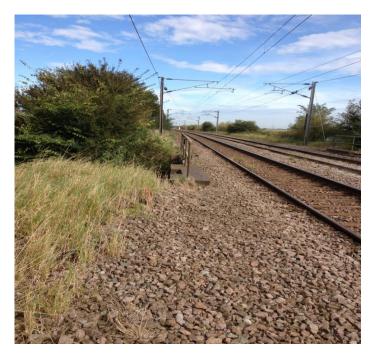
24.12 The photograph below is taken on the down side (west) looking north, the train usually approaches on the furthest line (right hand side) set of lines

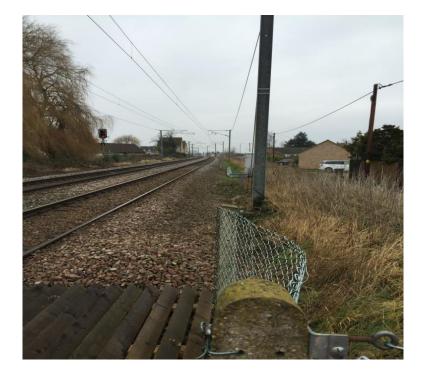
25.9 The photograph below is taken looking northward, from the up side (East) at a train approaching in the up direction (from the North). The trains usually approach on the closest set of lines (right hand side)

- 25.13 As can be seen from the table above (25.8), C25 Clayway FPS does not have sufficient sighting to meet industry standards in all directions but the crossing has whistle boards installed as a mitigation measure. C25 Clayway FPS is sighted to the centre of a curve section of the railway as shown in the photographs above. This means the sighting for a user to see an approaching train is insufficient when weather conditions are favourable. Sighting distances can also be severely reduced when the weather is poor e.g. raining or foggy.

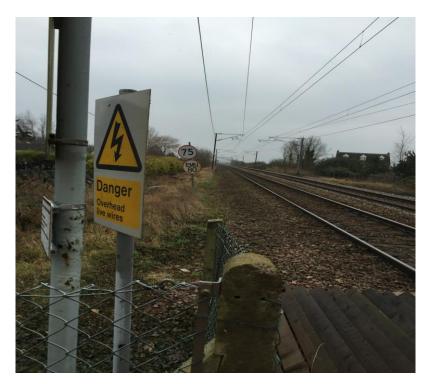
25.10 The photograph below is taken on the up side (east), looking south, the train usually approaches on the furthest (right hand side) set of lines

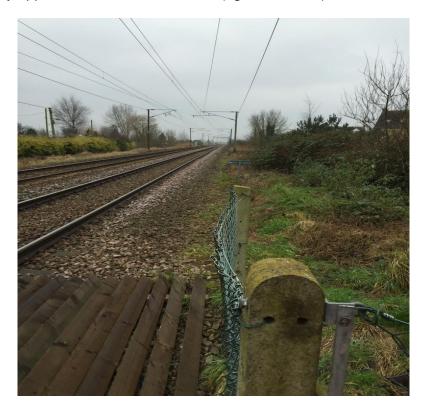
25.11 The photograph below is taken on the down side (west) looking south; the train usually approaches on the closest line (right hand side) set of lines

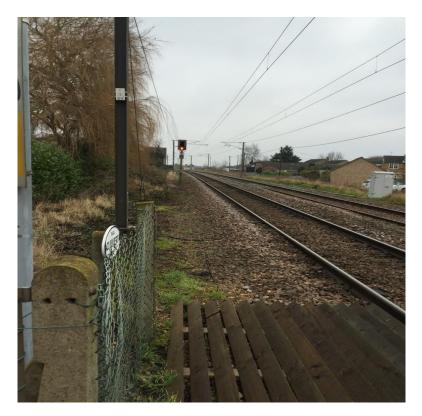
25.12 The photograph below is taken on the down side (west) looking north, the train usually approaches on the furthest line (right hand side) set of lines

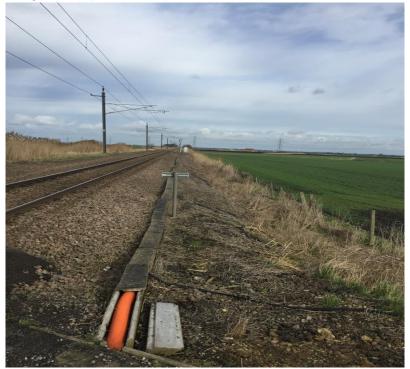
26.9 The photograph below is taken looking northward, from the up side (East) at a train approaching in the up direction (from the North).

- 26.13 As can been from the table above (26.8), C26 Poplar Drove crossing does not have sufficient sighting to meet industry standards in all directions. Whilst C26 Poplar Drove crossing is located on a long straight section of the railway as shown in the photographs above, there are numerous sighting restrictions which limit the sightlines e.g. OHL. This means the sighting for a user to see an approaching train is limited and will be severely reduced when the weather is poor e.g. raining or foggy.
- 26.14 Following the risk assessment, an optioneering exercise was carried out to consider options for eliminating, reducing, mitigating or managing risk at this crossing. These options considered were

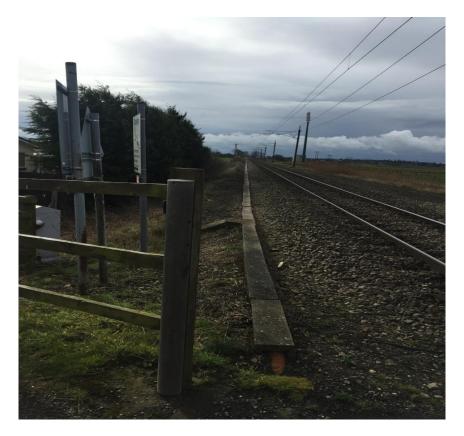
26.10 The photograph below is taken on the up side (east), looking south, the train usually approaches in the down direction

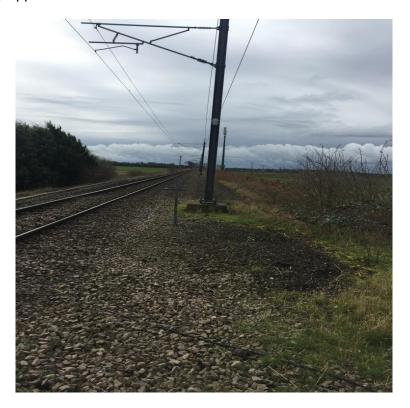
26.11 The photograph below is taken on the down side (west) looking south; the train usually approaches in the Down direction

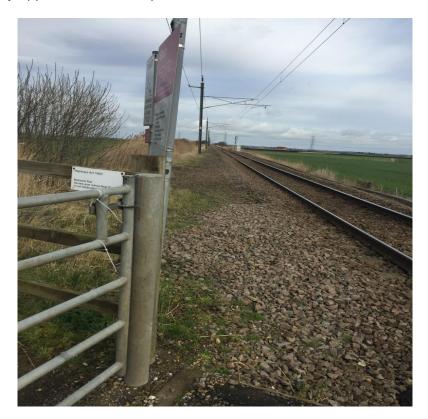
26.12 The photograph below is taken on the down side (west) looking south; the train usually approaches in the Up direction

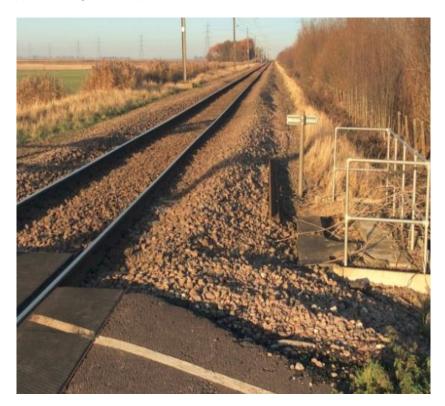
27.9 The photograph below is taken looking eastward, from the up side at a train approaching in the up direction.

- 27.13 As can been from the table above (27.8), C27 Willow Row crossing does have sufficient sighting to meet industry standards in all directions. C27 Willow Row crossing is on a long straight section of the railway as shown in the photographs above. This means the sighting for a user to see an approaching train is very good when weather conditions are favourable. Sighting distances however, will be severely reduced when the weather is poor e.g. raining or foggy
- 27.14 Following the risk assessment, an optioneering exercise was carried out to consider options for eliminating, reducing, mitigating or managing risk at this crossing. These options considered were:

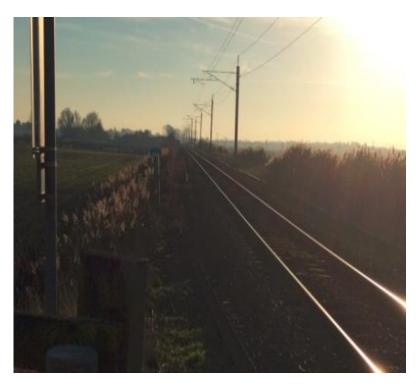
27.10 The photograph below is taken looking Westward, from the up side at a train approaching in the down direction

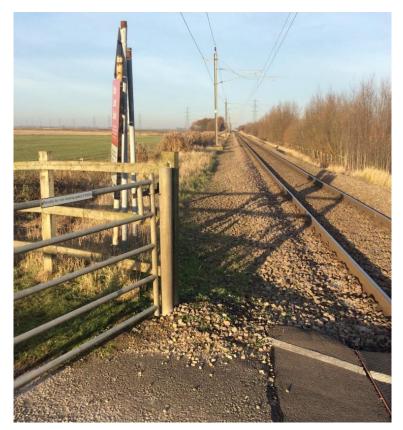
27.11 The photograph below is taken on the down side looking west, which is an approaching train on the Up Direction.

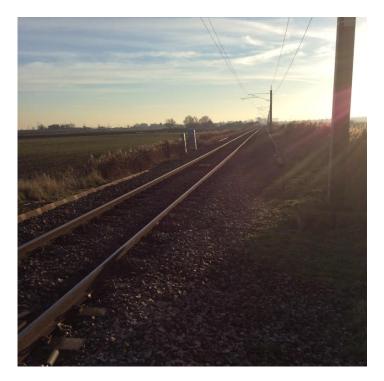
27.12 The photograph below is taken on the down side looking east which is an approaching train on the Down Direction.

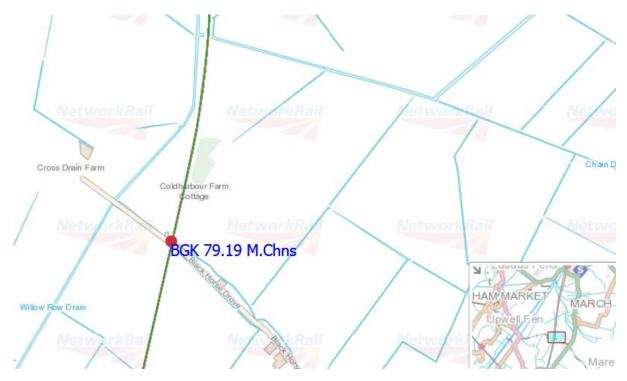
28.3 Aerial views of C28 Black Horse Drove can be seen below.

- 28.4 The left side of this single track is the down line from London and the right side of this single track is the up line to London. Trains would normally run down from London that is from the bottom of the picture to the top. Trains would normally run up to London, which is from the top of the picture to the bottom.

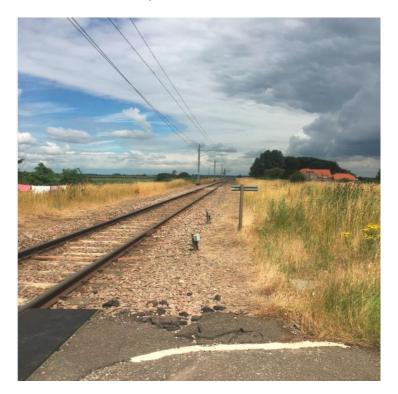
28.9 The photograph below is taken looking eastward, from the up side at a train approaching in the up direction.

- 28.13 As can be seen from the table above (28.8), C28 BLACK HORSE DROVE CROSSING WITH TELEPHONES & MWL has insufficient sighting aspects in all directions to meet industry standards and so MWL and telephones are installed as the mitigation.
- 28.14 Following the risk assessment, an optioneering exercise was carried out to consider options for eliminating, reducing, mitigating or managing risk at this crossing. These options considered were:

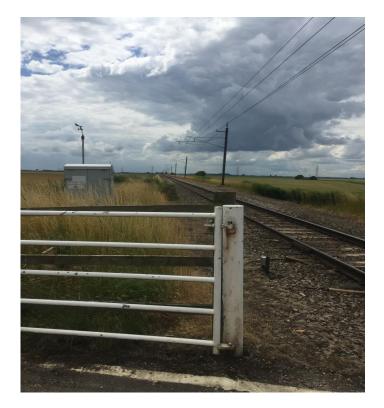
28.10 The photograph below is taken looking westward, from the up side, which is an approaching train in the down direction.

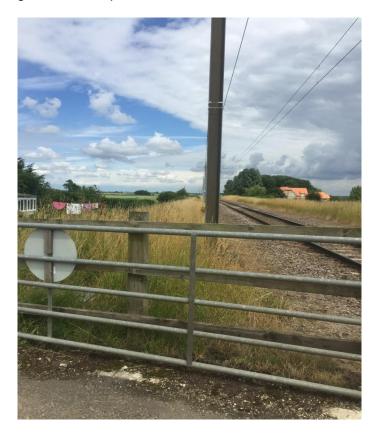
28.11 The photograph below is taken looking westward, from the down side, which is an approaching train in the up direction.

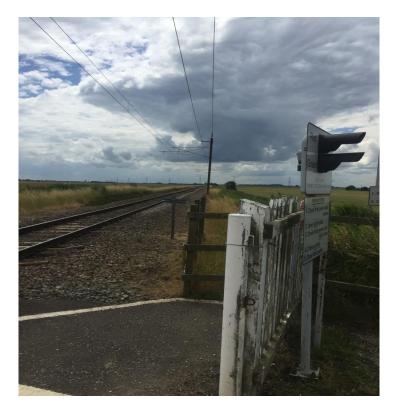
28.12 The photograph below is taken looking westward, from the down side, which is an approaching train in the down direction.

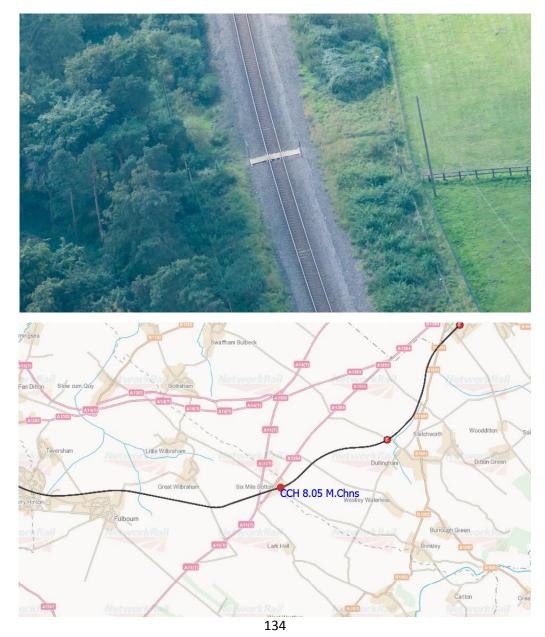
- 29.1 C29 Cassells footpath crossing has an ALCRM score of D8 with an FWI of 0.0000255064. It is located in Brinkley Parish on the CCH line (Coldham Lane Junction to Haughley Junction) which has a line speed of 60mph in both up and down directions on a single line. It is between Cambridge and Newmarket at 8 miles and 05 chains from Coldham Lane Junction, Cambridge.
- 29.2 There are 34 trains per day that run for 17 hours per day over this level crossing. Additionally, there are empty stock trains that pass over the crossing. There can also be various on-track machinery and plant that pass over the crossing at any point.
- 29.3 Aerial views of C29 Cassells Footpath crossing can be seen below.

- 29.4 There is a single line at this location and trains are signalled to run in either direction at any time. From the bottom to the top of the picture is the up direction towards Cambridge and the top to the bottom of the picture is the down direction towards Newmarket.

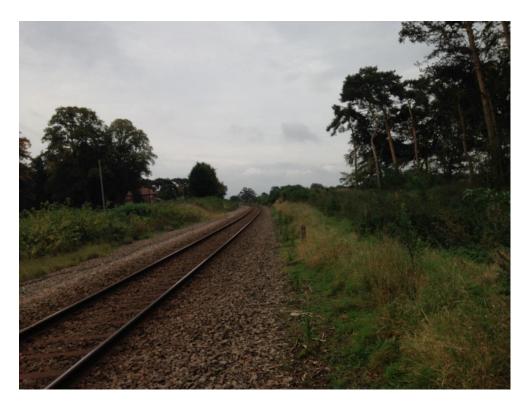
29.9 The photograph below is taken looking eastward, from the up side (south) at a train approaching in the up direction (from the east).

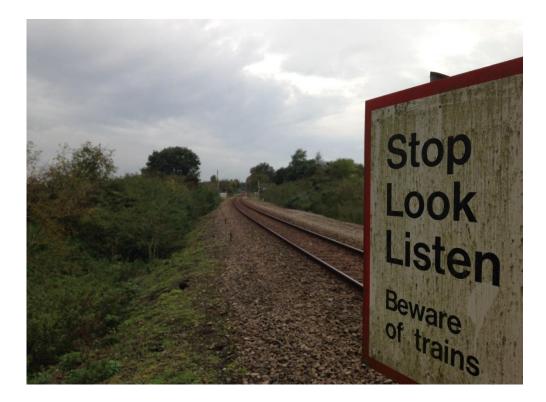
29.10 The photograph below is taken on the up side (south), looking west.

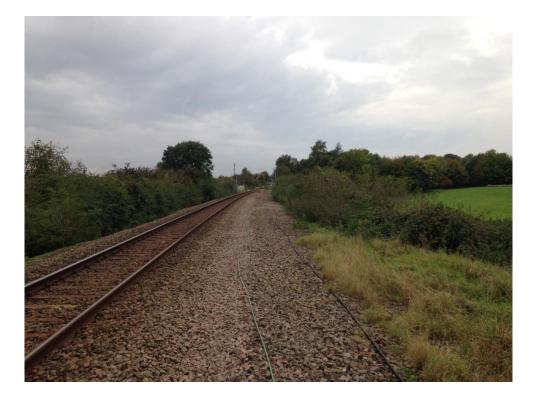
29.11 The photograph below is taken on the down side (North) looking west.

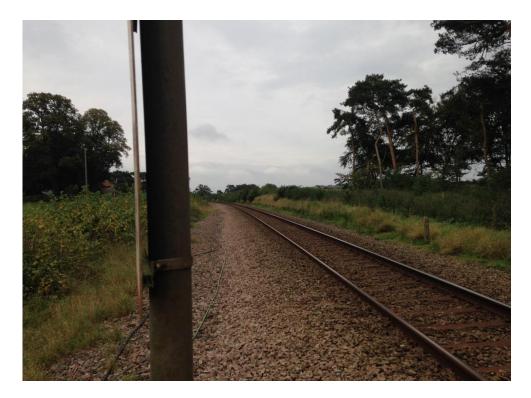
29.12 The photograph below is taken on the down side (North) looking east.

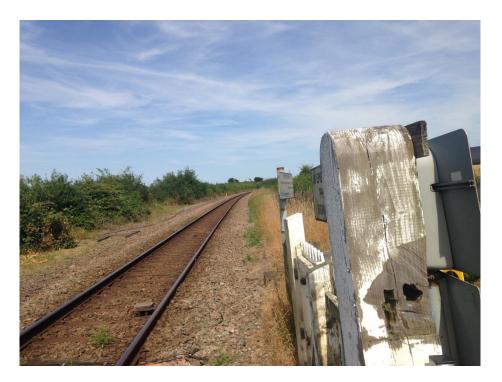
30.9 The photograph below is taken looking eastward, from the up side (south) at a train approaching in the up direction (from the east).

- 30.13 As can been from the table above (30.8), C30 Westley Road crossing does not have sufficient sighting to meet industry standards in all directions. C30 Westley Road crossing is on a reverse curved section of the railway as shown in the photographs above. This means the sighting for a user to see an approaching train is very poor even when weather conditions are favourable. Sighting distances however, will be severely reduced when the weather is poor e.g. raining or foggy.
- 30.14 Following the risk assessment, an optioneering exercise was carried out to consider options for eliminating, reducing, mitigating or managing risk at this crossing. These options considered were:

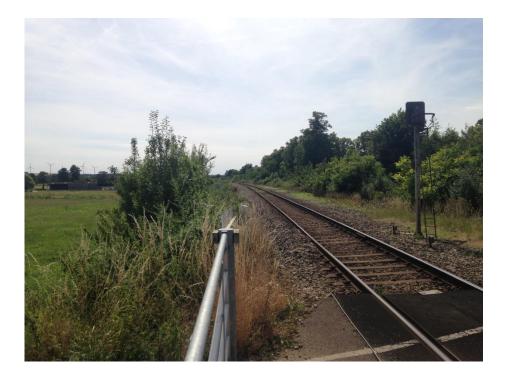
30.10 The photograph below is taken on the up side (south), looking west.

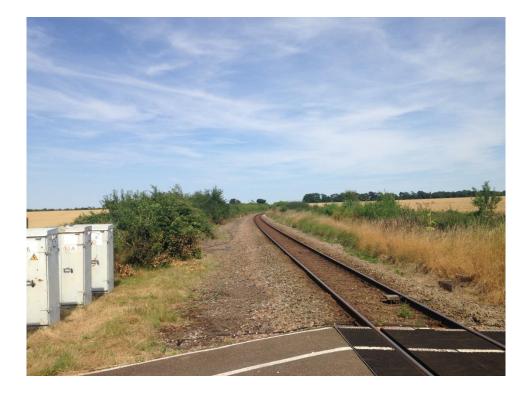
30.11 The photograph below is taken on the down side (north) looking east.

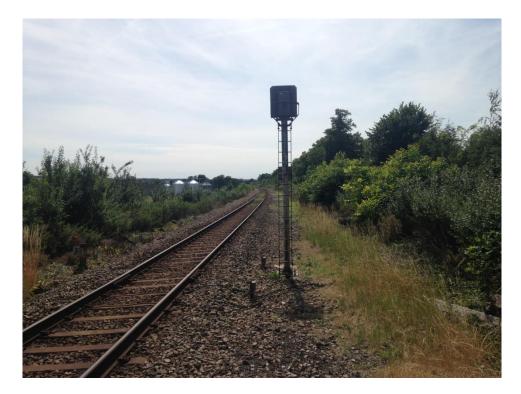
30.12 The photograph below is taken on the down side (north) looking west.

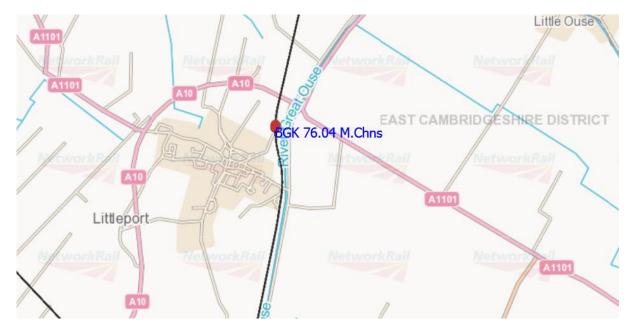
31.3 Aerial views of C31 Littleport station barrow crossing can be seen below.

- 31.4 The left side of this track is the down line from London and the right side of this track is the up line to London. Trains would normally run down from London that is from the bottom of the picture to the top. Trains would normally run up to London, which is from the top of the picture to the bottom.

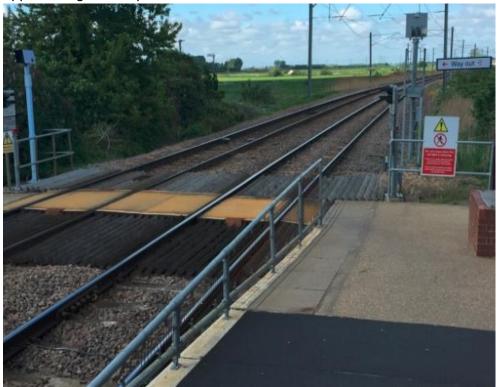
31.9 The photograph below is taken looking eastward, from the up side at a train approaching in the up direction.

- 31.13 As can be seen from the table above (31.8), C31 Littleport station barrow crossing does not have sufficient sighting to meet industry standards in all directions.
- 31.14 Following the risk assessment, an optioneering exercise was carried out to consider options for eliminating, reducing, mitigating or managing risk at this crossing. These options considered were:

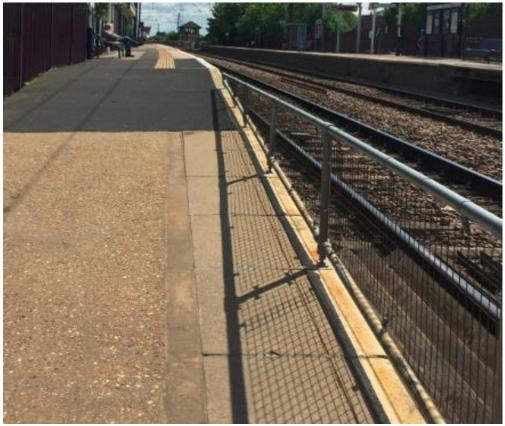
31.10 The photograph below is taken on the up side, looking west at a train approaching from the down direction.

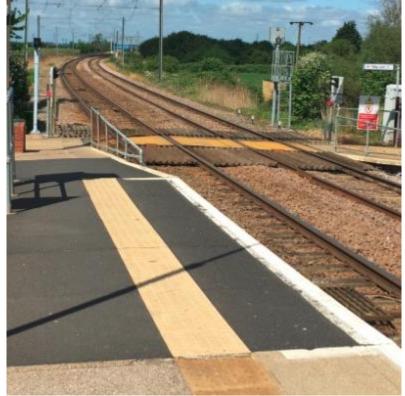
31.11 The photograph below is taken on the down side looking west, which is an approaching train traveling in the up direction.

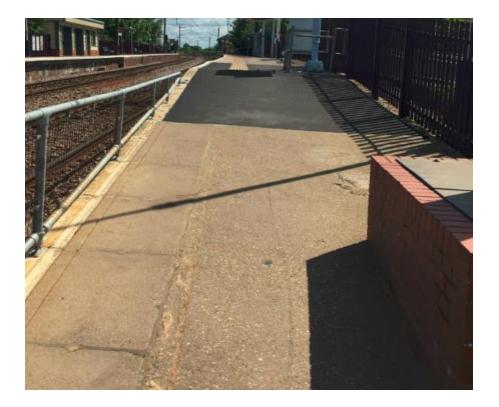
31.12 The photograph below is taken on the down side looking east, at a train approaching from the down direction.

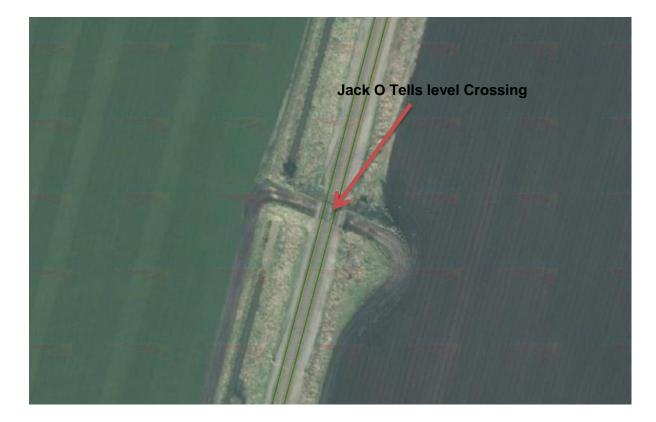
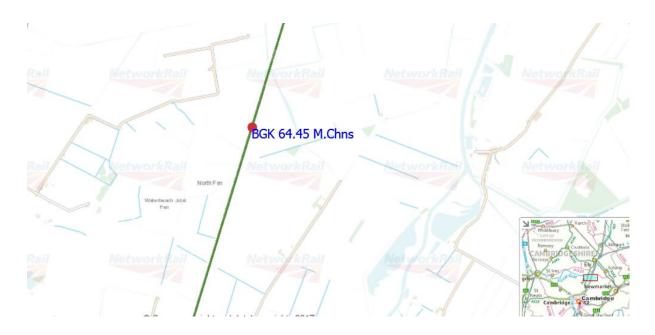
- 32.4 The track on the left is the down line from London and the track on the right is the up line to London. Trains would normally run down from London on the left hand line that is from the bottom of the picture to the top. Trains would normally run up to London on the right hand side, which is from the top of the picture to the bottom.

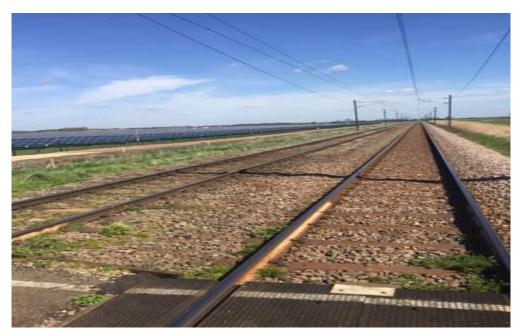
32.9 The photograph below is taken looking eastward, from the up side at a train approaching in the up direction. The trains usually approach on the closest set of lines (right hand side).

- 32.13 As you can see from the table above (32.8), C33 Jack O'Tells crossing does have sufficient sighting to meet industry standards in all directions. C33 Jack O' Tells crossing is on a long straight section of the railway as shown in the photographs above. This means the sighting for a user to see an approaching train is very good when weather conditions are favourable. Sighting distances however, will be severely reduced when the weather is poor e.g. raining or foggy.
- 32.14 Following the risk assessment, an optioneering exercise was carried out to consider options for eliminating, reducing, mitigating or managing risk at this crossing. The options considered were:

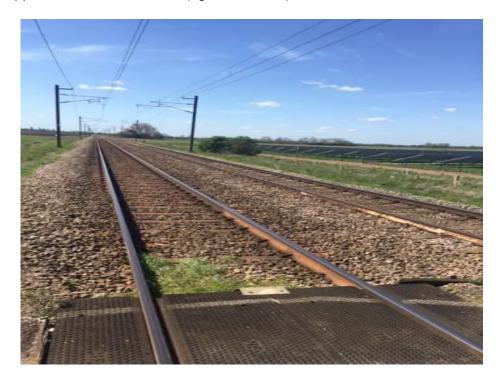
32.10 The photograph below is taken on the up side, looking west, the train usually approaches on the furthest (right hand side) set of lines.

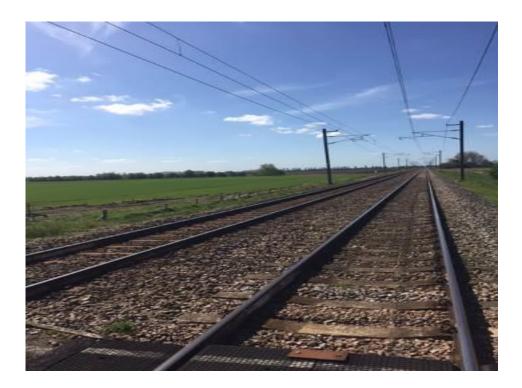
32.11 The photograph below is taken on the down side looking west, the train usually approaches on the closest line (right hand side) set of lines.

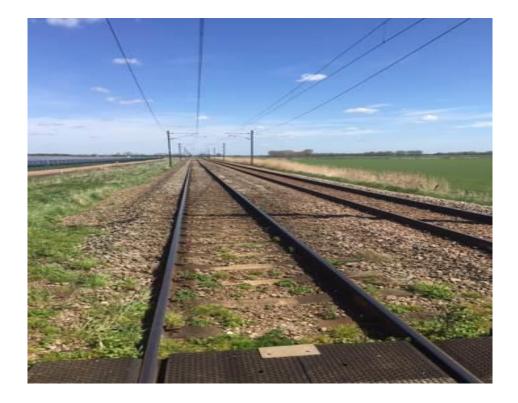
32.12 The photograph below is taken on the down side looking east, the train usually approaches on the furthest line (right hand side) set of lines.

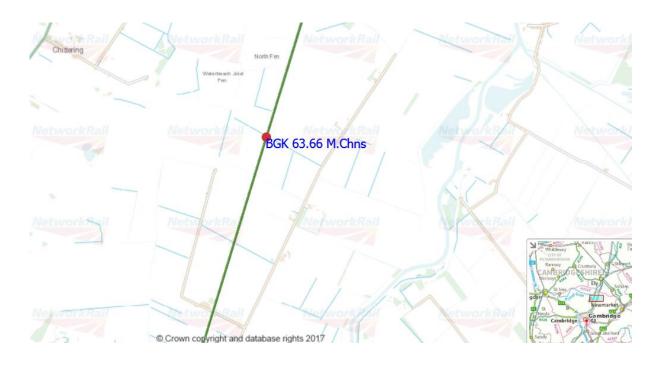
33.3 Aerial views of C34 Fysons Level crossing can be seen below.

- 33.4 The track on the left is the down line from London and the track on the right is the up line to London. Trains would normally run down from London on the left hand line that is from the bottom of the picture to the top. Trains would normally run up to London on the right hand side, which is from the top of the picture to the bottom.

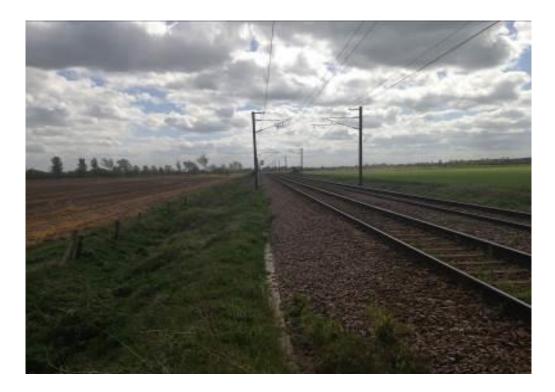
33.10 The photograph below is taken on the up side, looking west, the train usually approaches on the furthest (right hand side) set of lines.

- 33.13 As you can see from the table above (33.8), C34 Fysons level crossing does have sufficient sighting to meet industry standards in all directions. C34 Fysons crossing is on a long straight section of the railway as shown in the photographs above. This means the sighting for a user to see an approaching train is very good when weather conditions are favourable. Sighting distances however, will be severely reduced when the weather is poor e.g. raining or foggy.
- 33.14 Following the risk assessment, an optioneering exercise was carried out to consider options for eliminating, reducing, mitigating or managing risk at this crossing. These options considered were:

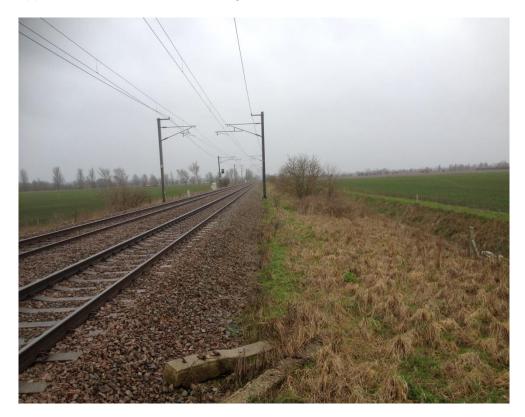
33.11 The photograph below is taken on the down side looking west, the train usually approaches on the closest line (right hand side) set of lines.

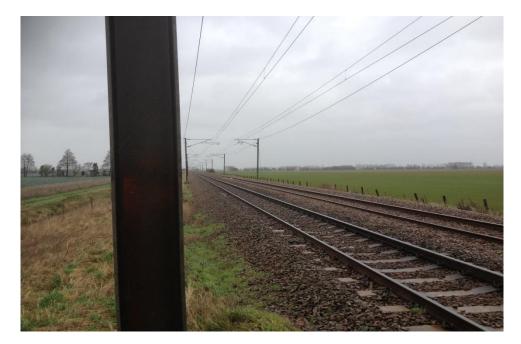
33.12 The photograph below is taken on the down side looking east, the train usually approaches on the furthest line (right hand side) set of lines.

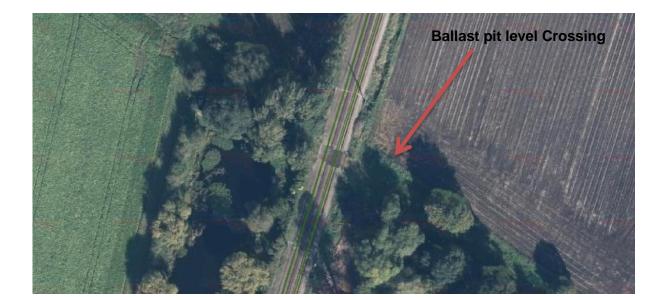
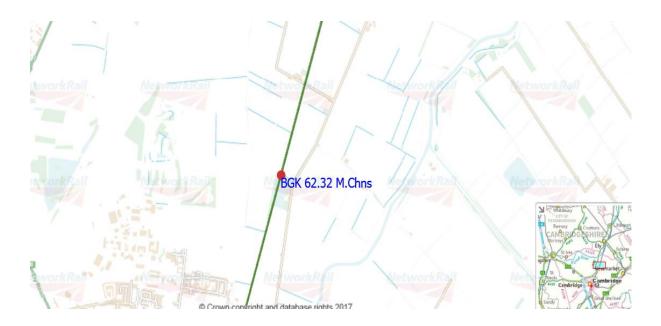
- 34.4 The track on the left is the down line from London and the track on the right is the up line to London. Trains would normally run down from London on the left hand line that is from the bottom of the picture to the top. Trains would normally run up to London on the right hand side, which is from the top of the picture to the bottom.

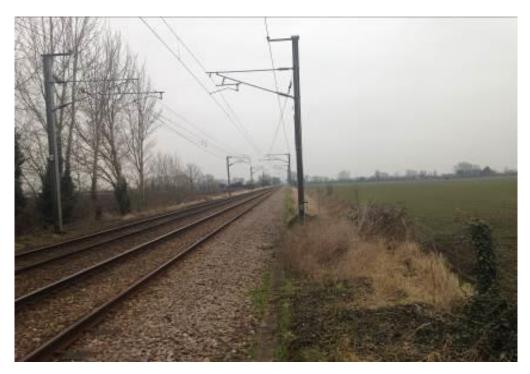
34.9 The photograph below is taken looking eastward, from the up side at a train approaching in the up direction. The trains usually approach on the closest set of lines (right hand side).

34.13 As you can see from the table above (34.8), C35 Ballast Pit level crossing does have sufficient sighting to meet industry standards in all directions. C35 Ballast Pit crossing is on a long straight section of the railway as shown in the photographs above. This means the sighting for a user to see an approaching train is very good

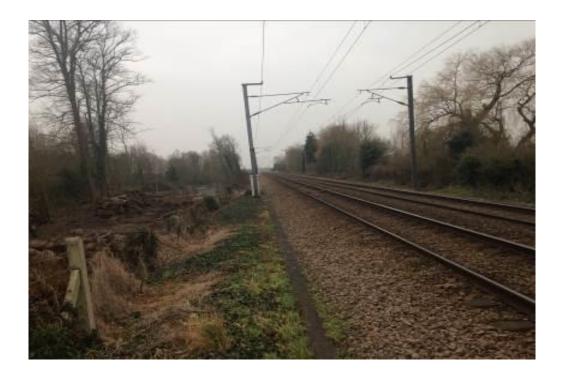
34.10 The photograph below is taken on the up side, looking west, the train usually approaches on the furthest (right hand side) set of lines.

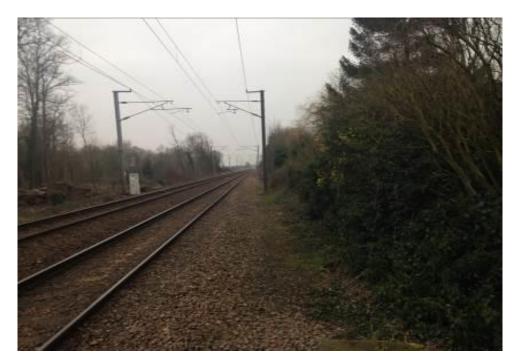
34.11 The photograph below is taken on the down side looking west, the train usually approaches on the closest line (right hand side) set of lines.

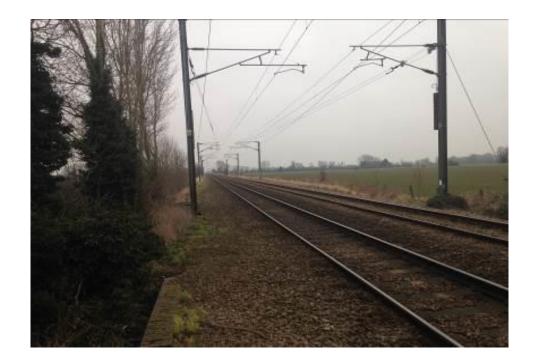
34.12 The photograph below is taken on the down side looking east, the train usually approaches on the furthest line (right hand side) set of lines.
