Explosive Ordnance Threat Assessment
in respect of
M4 Corridor around Newport

for
Hyder Consulting (UK) Limited

5750TA

21st November 2014

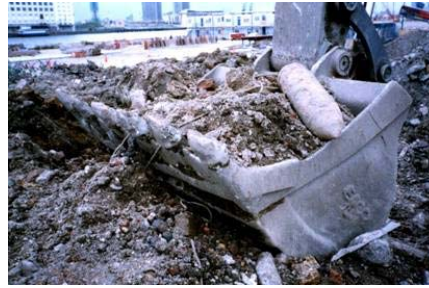
Bomb Weight: 40-54kg (110-119lb)
 Explosive Weight: c25kg (55lb)
 Fuze Type: Impact fuze/electro-mechanical time delay fuze
 Bomb Dimensions: 1,090 x 280mm (42.9 x 11.0in)
 Body Diameter: 200mm (7.87in)
 Use: Against lightly damageable materials, hangars, railway rolling stock, ammunition depots, light bridges and buildings up to three stories.
 Remarks: The smallest and most common conventional German bomb. Nearly 70% of bombs dropped on the UK were 50kg.

50kg bomb, London Docklands

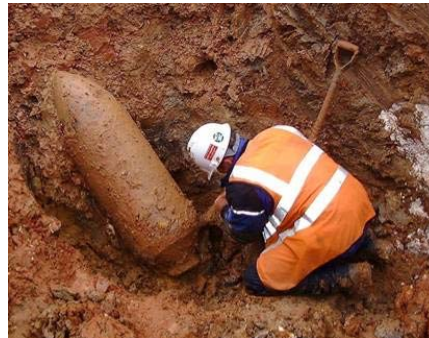
Bomb weight: 245-256kg (540-564lb)
 Explosive weight: 125-130kg (276-287lb)
 Fuze type: Electrical impact/mechanical time delay fuze.
 Bomb dimensions: 1640 x 512mm (64.57 x 20.16in)
 Body diameter: 368mm (14.5in)
 Use: Against railway installations, embankments, flyovers, underpasses, large buildings and below-ground installations.

250kg bomb, Hawkinge

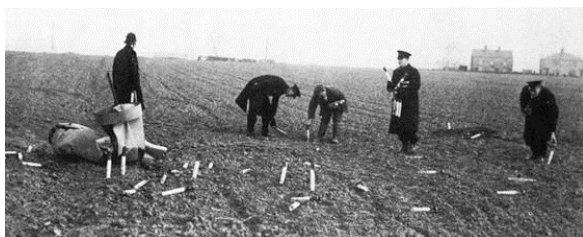
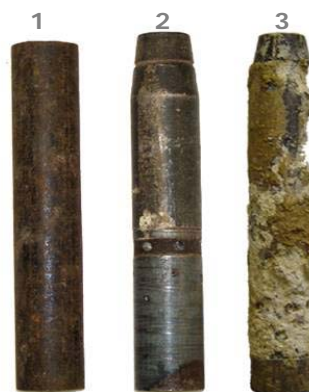
Bomb weight: 1.0 and 1.3kg (2.2 and 2.87lb)
 Filling: 680gm (1.3lb) Thermite
 Fuze type: Impact fuze
 Bomb dimensions: 350 x 50mm (13.8 x 1.97in)
 Body diameter: 50mm (1.97in)
 Use: As incendiary – dropped in clusters against towns and industrial complexes
 Remarks: Jettisoned from air-dropped containers. Magnesium alloy case. Sometimes fitted with high explosive charge

1. Scaffold pipe
2. Incendiary 1kg bomb
3. Incendiary bomb recently found on site in UK

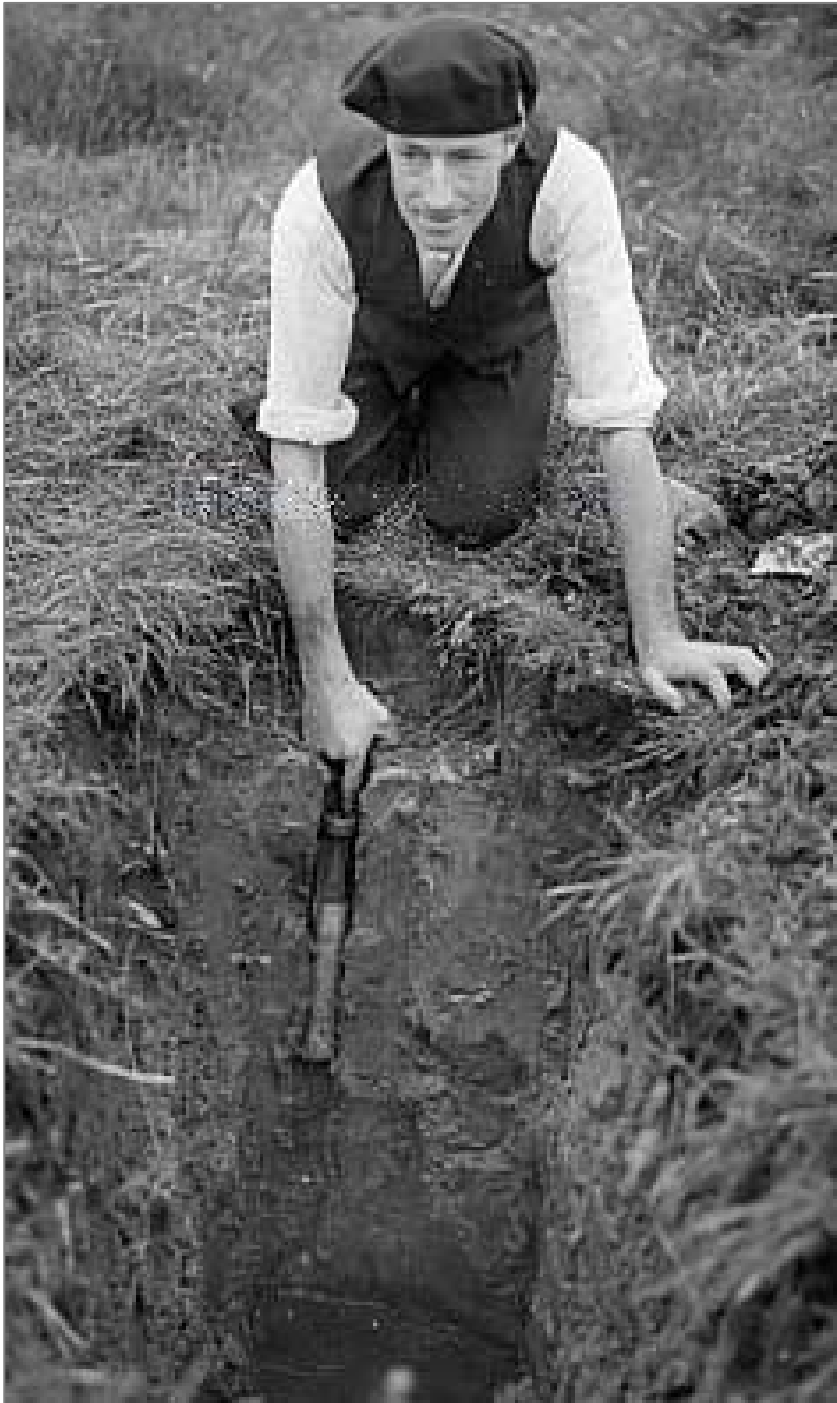
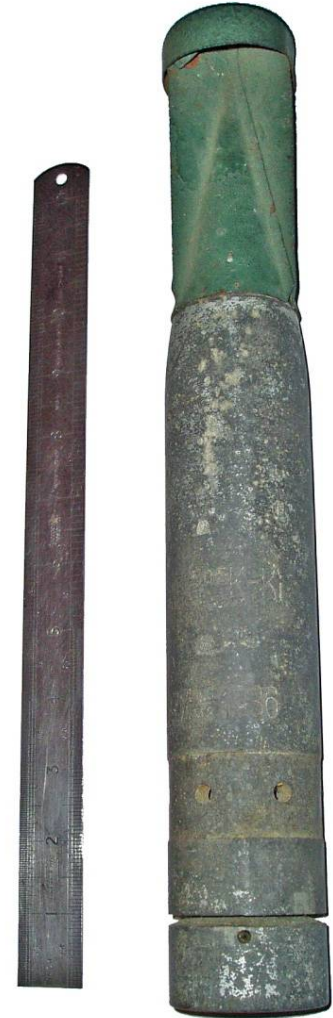
1kg German Incendiary
Bomb next to a 30cm ruler

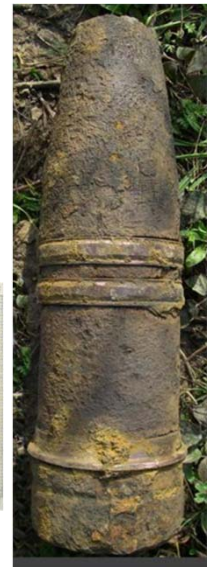
Weight: 12.7kg (28lb)
 Dimensions: 94 x 360mm (3.7 x 14.7in)
 Carriage: Mobile and Static Versions
 Rate of Fire: 10-20 rounds per minute
 Ceiling: 9-18,000m (29-59,000ft)
 Muzzle Velocity: 792m/s (2,598ft/s)
 Remarks: 4.5 inch projectiles were also commonly utilised

3.7 inch AA Projectile Minus Fuze

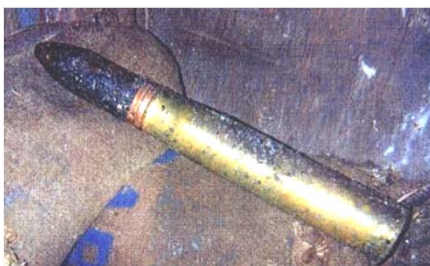
Weight: 0.86kg (1.96lb)
 Dimensions: 40mm x 310mm (1.6in x 12.2in)
 Rate of Fire: 120 rounds per minute
 Ceiling: 23,000ft (7000m)
 Muzzle Velocity: 2,890 ft/s (881m/s)
 Remarks: Mobile batteries – normally few records of where these guns were located

Unexploded 40mm Bofors projectile recovered from a marine environment

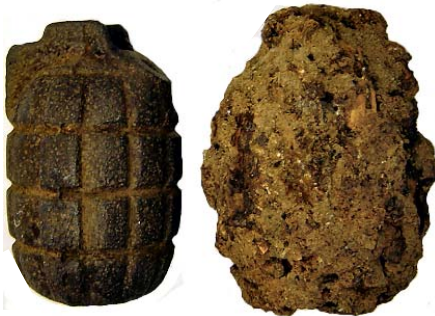
No. 36 'Mills' Grenade

Weight: 0.7kg filled (1lb 6oz)
Type: Hand or discharger, fragmentation
Dimensions: 95 x 61mm (3.7 x 2.4in)
Filling: Amatol, Amatol 2 or TNT
Remarks: 4 second hand-throwing fuse with approximate 30m range. First introduced May 1918.

Grenade, .303 inch rifle, No. 36M, Mark I.

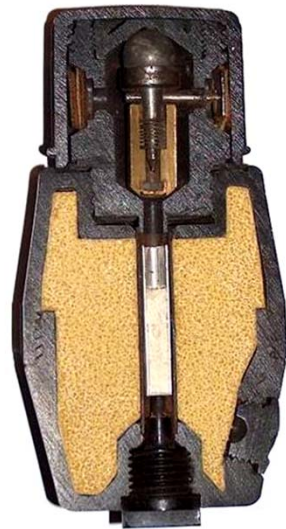
No. 69 Grenade

Weight: 0.38kg filled (0.8lb)
Type: Percussion/Blast
Date Introduced: December 1940
Remarks: Black Bakelite body. Blast rather than fragmentation type. After unscrewing the safety cap, a tape is held when throwing the grenade releasing the safety bolt in the throwing motion. Detection is problematic due to its very low metal content.

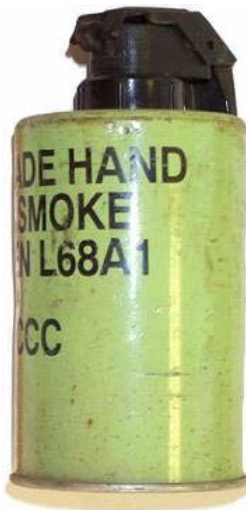
Typical Smoke Grenade

Dimensions: Approx. 65 x 115mm (2.5 x 4.5in)
Type: Smoke
Date Introduced: Current MoD issue
Remarks: Smoke grenades are used as ground-to-ground or ground-to-air signalling devices, target or landing zone marking devices, and screening devices for unit movement.

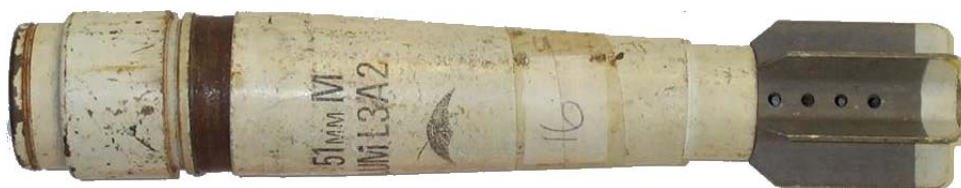
Typical 2 inch Illuminating Mortar

Type: Illum.
 Dimensions: 51 x 290mm
 Filling: Various
 Remarks: The expulsion charge ignites and ejects the candle assembly. A spring ejects the parachute from the tail cone. The parachute opens, slowing the descent of the burning candle which illuminates the target.

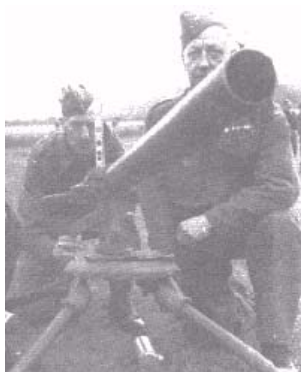
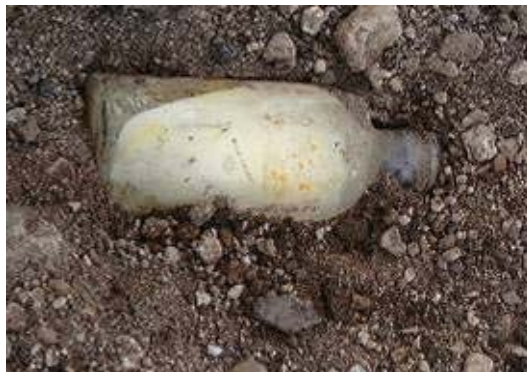
Self Igniting Phosphorous (SIP) Grenades

Filling: White Phosphorous and Benzene
Remarks: The grenade comprised a glass bottle with a total volume of approximately one pint. It was filled with White Phosphorus, benzene, a piece of rubber and water. Over time the rubber dissolved to create a sticky fluid which would self ignite when the bottle broke. Fired by hand or Northover Projector. Sometimes called the "A & W" (Albright & Wilson) grenade.

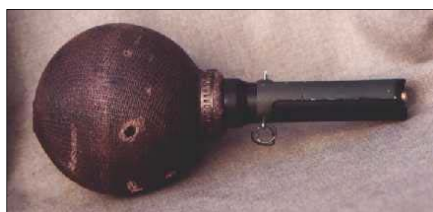
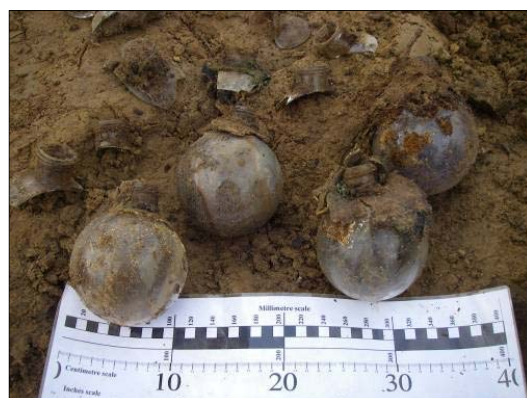
No 74 Grenade (Sticky Bomb)

Remarks: Designed as an anti-tank grenade and used by the Home Guard. The grenade consisted of a glass ball on the end of a Bakelite (plastic) handle. Inside the glass ball was an explosive filling whilst on the outside was a very sticky adhesive covering. Until used, this adhesive covering was encased in a metal outer casing.

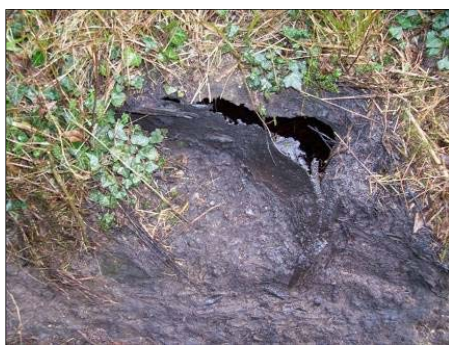
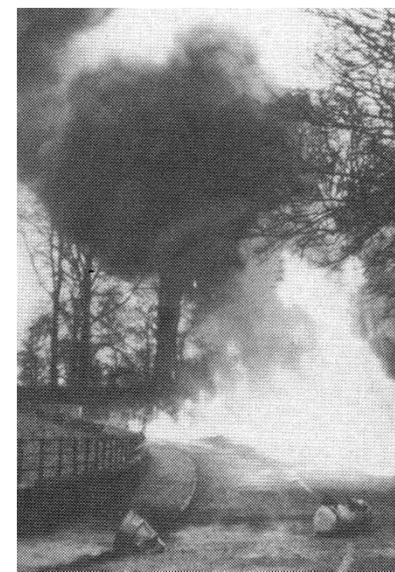
Flame Fougasse Bomb

Remarks: A Flame Fougasse was a weapon in which the projectile was a flammable liquid, typically a mixture of petrol and oil. It was usually constructed from a 40-gallon drum dug into the roadside and camouflaged. Ammonal provided the propellant charge which, when triggered, caused the weapon to shoot a flame 3m (10ft) wide and 27m (30 yards) long. Initially a mixture of 40% petrol and 60% gas oil was used, this was later replaced by an adhesive gel of tar, lime and petrol known as 5B.

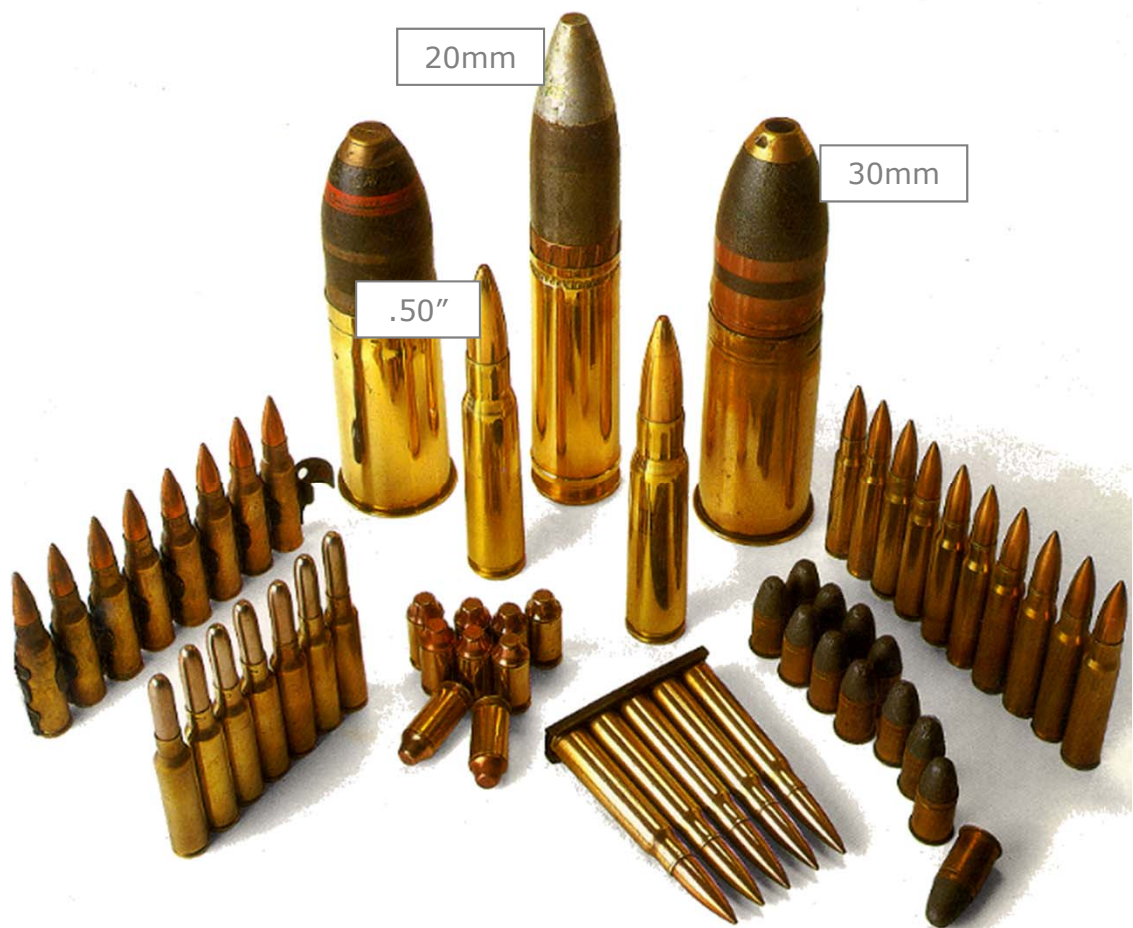
Small arms ammunition and cannon rounds up to 30mm
