Report for – Rother Valley Railway Limited Track Reinstatement between Northbridge Street and Junction Road Environmental Statement, Volume 4 – Supporting Figures Final

Track Reinstatement between Northbridge Street and Junction Road
Environmental Statement, Volume 4 – Supporting Figures
Final

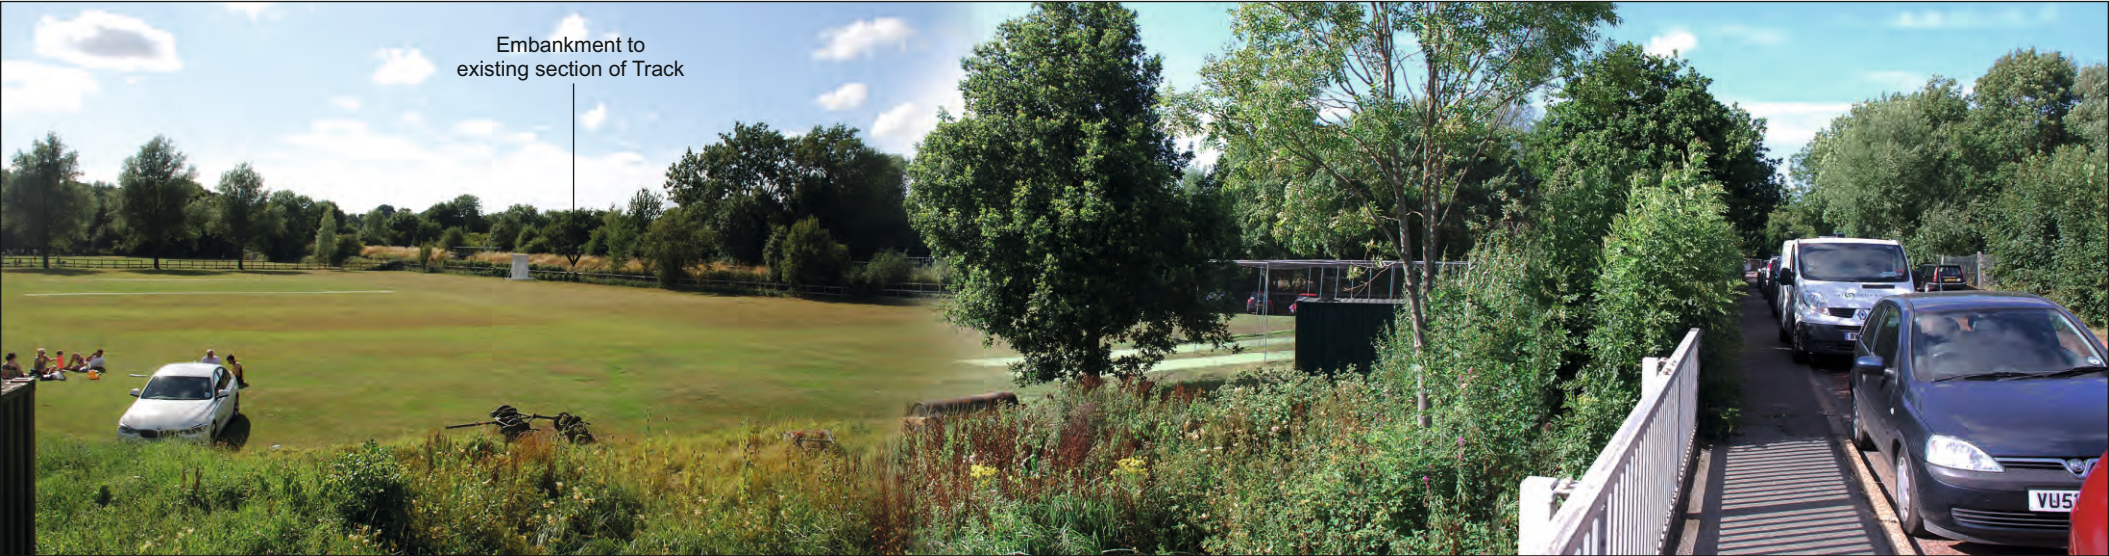
LVA Photograph 1: Looking north west from The Clappers towards existing section of Track

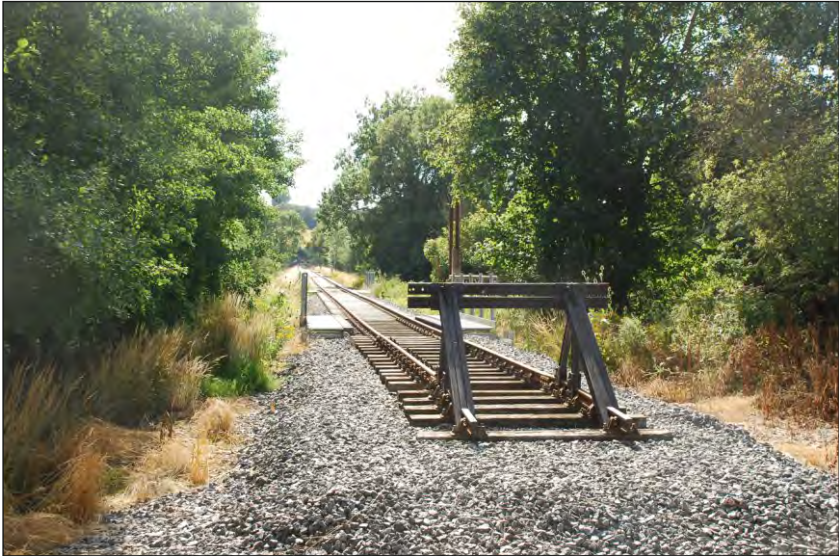
LVA Photograph 2: Showing existing section of Track

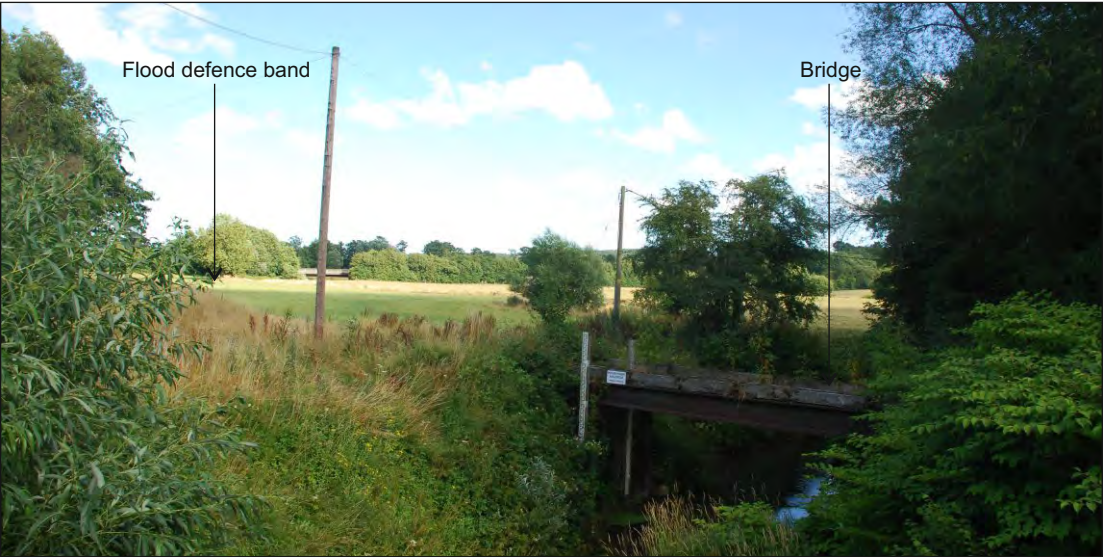
LVA Photograph 5: Showing remains of old Railway bridge over River Rother

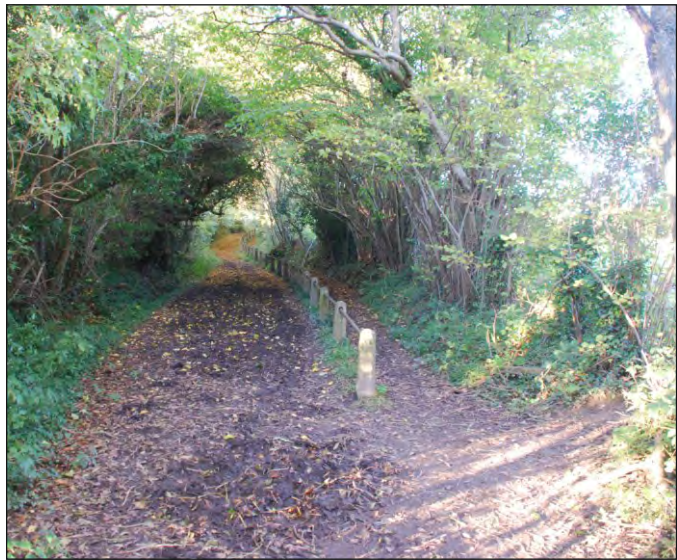
LVA Photograph 24: Showing Public Bridleway No.36c leading down to Salehurst Halt

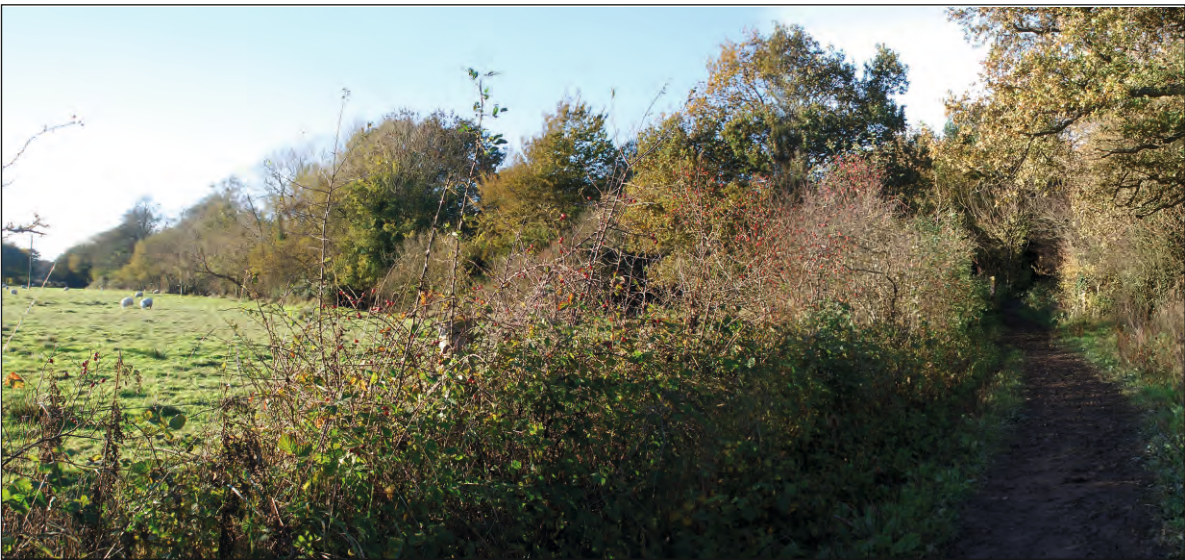
LVA Photograph 26: Looking north west towards Salehurst Halt from Public Bridleway No.36b

Following Mitigation (after 15 Years): Could result in benefits, subject to nature of tree works around Salehurst Halt and treatment of embankment to east of right of way. There would be well established replacement tree planting around the bridleway crossing and embankment, starting to provide some screening of lower level views. There is potential for linkage of the vegetation at Salehurst Halt to the wider habitat network.	NEGLIGIBLE / NEUTRAL	SLIGHT or NEUTRAL

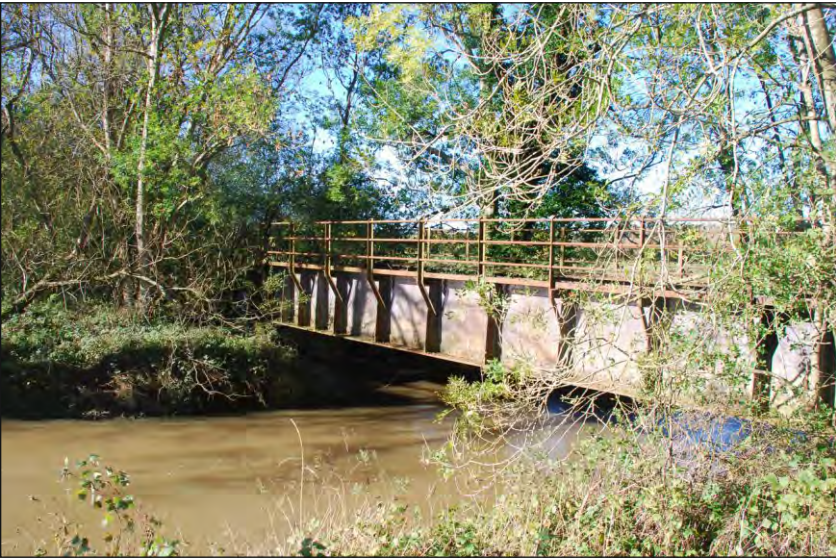
LVA Photograph 50: Showing existing bridge over River Rother

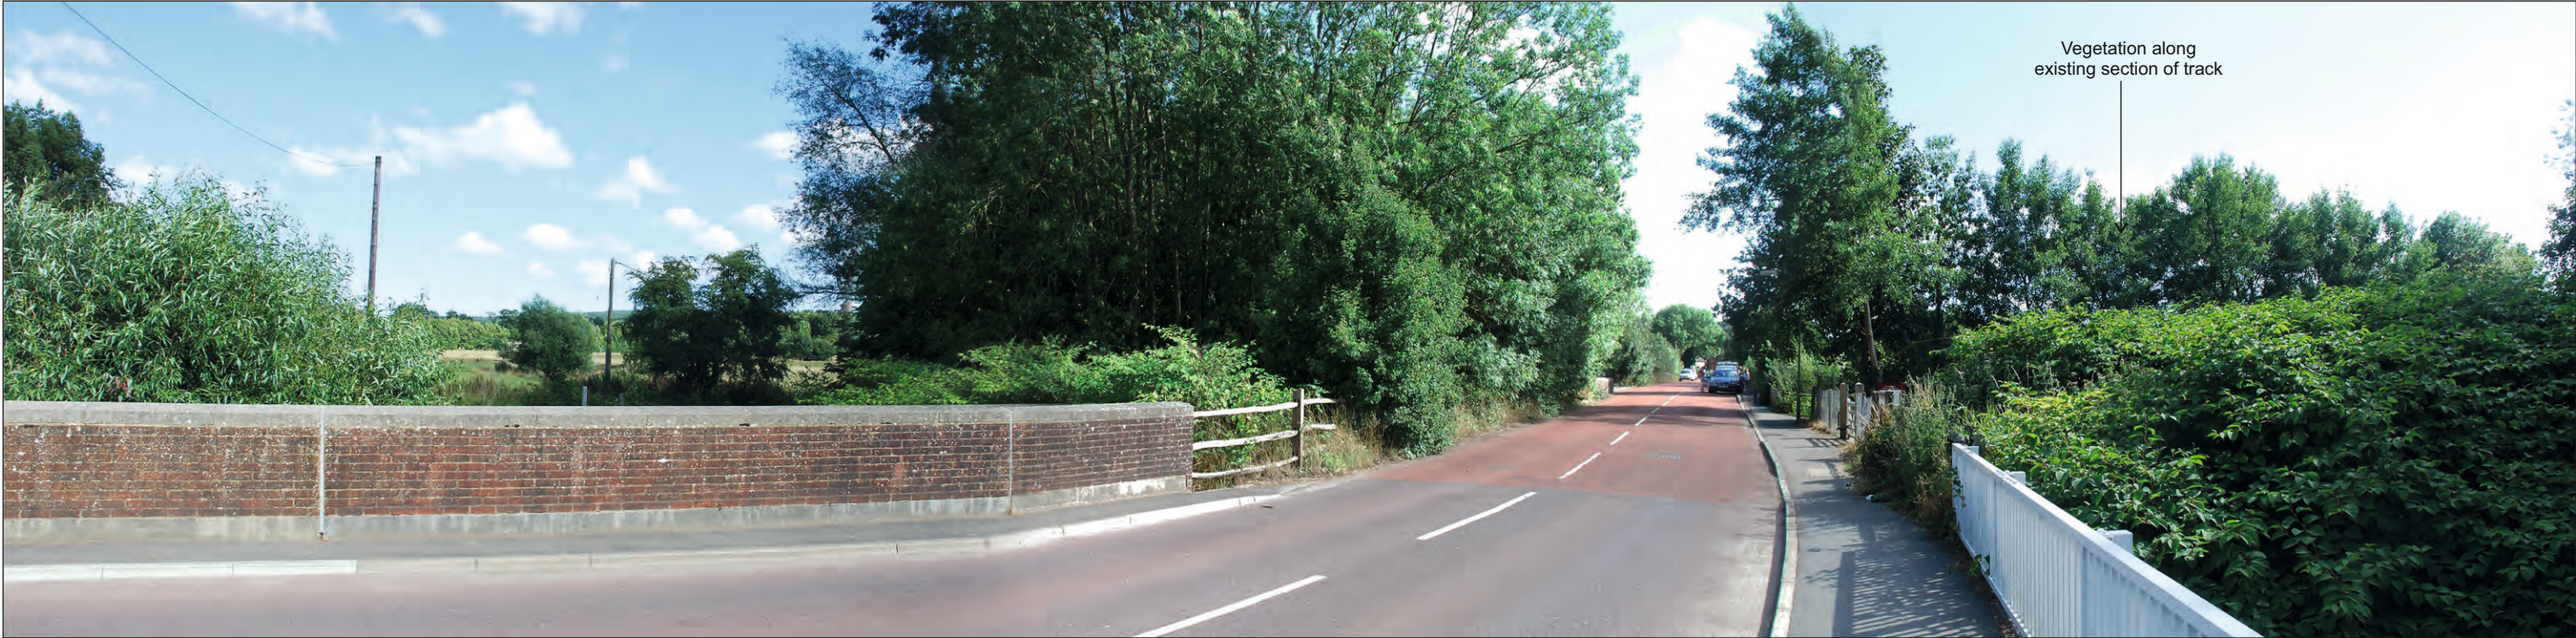
Looking south east from the bridge on Northbridge Street

Baseline Assessment	
Classification of Receptor	Description of Existing View
Location of Viewpoint: Northbridge Street bridge over River Rother at northern end of The Clappers	Foreground: The view shows the road approach and bridge parapet on Northbridge Street, at the western most end of the site. Middle Distance: The roadside which is well vegetated along much of its length is clearly visible, as is the vegetation along the existing section of track where it meets the site. There are small glimpses through the trees of the floodplain pastureland. Far Distance: Through gaps in the middle ground vegetation, there are glimpses of the well vegetated character of the surrounding landscape with distant, tall hedgerows forming a tree lined skyline.
Number / Type of Receptors: Moderately high number of passengers in cars/ pedestrians within built-up area	Existing Character: Northbridge Street forms the main vehicular and pedestrian connection between Robertsbridge to the south and properties along Northbridge Street to the north. Although close to the Conservation Area, this location already has the engineered features of the bridge and railings as part of its settlement edge character.

Assessment of Landscape and Visual Impacts		
Description of Impact	Magnitude of Impact	Significance of Impact
During Construction: Some loss of vegetation evident between Northbridge Street and River Rother. Re-construction of bridge visible (but bridge itself screened from this viewpoint by bridge parapet). Road subject to temporary closure for night-time construction of new crossing.	MODERATE	SLIGHT
Following Completion of Works: New level crossing clearly visible between existing and newly reinstated section of track. It is assumed that fencing along the railway corridor and signalling equipment on either side of the crossing would be required. Loss of foreground vegetation still apparent.	MODERATE	SLIGHT
Following Mitigation (after 15 Years): Reinstated track-bed with weather to become less apparent, and new crossing becomes accepted part of scene. There would be natural regeneration of vegetation in foreground, that would have helped to assimilate many of the new features and new tree planting, by this stage well established, would have offered further screening of the proposals.	MINOR	SLIGHT

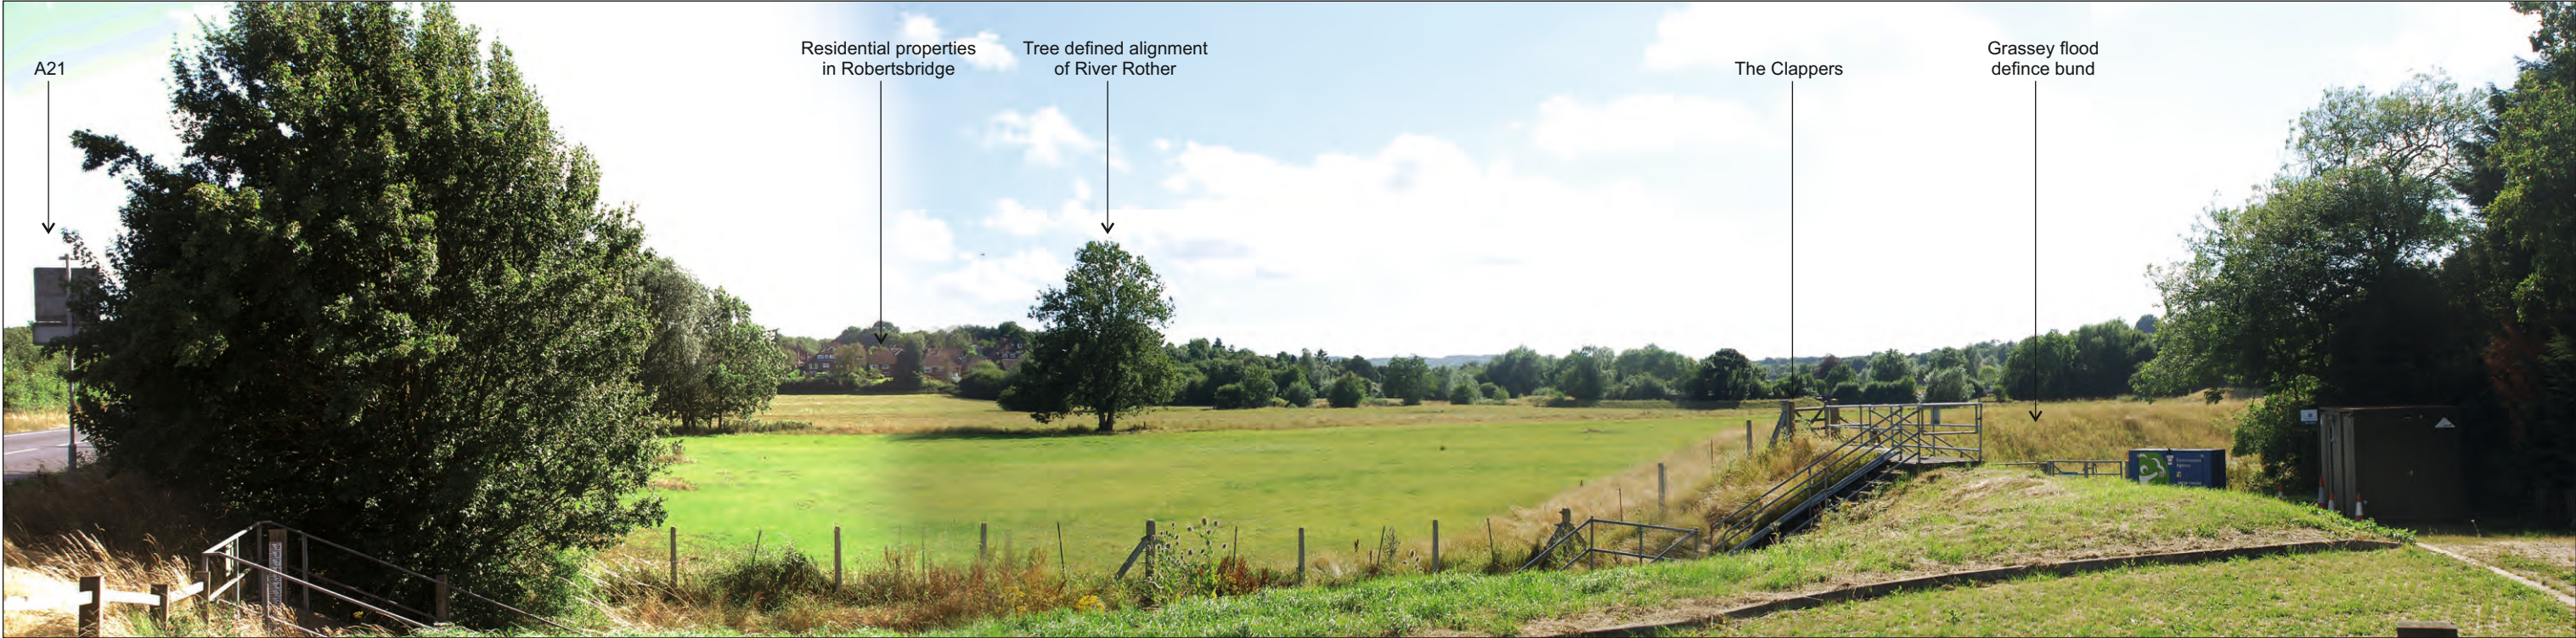
Looking south west towards Robertsbridge from edge of A21

Baseline Assessment	
Classification of Receptor	Description of Existing View
Location of Viewpoint: A21 close to junction with Northbridge Street Number / Type of Receptors: Glimpse views for large number of vehicle passengers, plus a few static views for local walkers Direction of View: South West Distance from Scheme: 100m Approximate Elevation: 10m AOD	Foreground: The view shows vegetation along the edge of the A21 road, a glimpse of the road itself and features of the flood defences including the grass flood defence embankments, reinforced grass surfacing, safety railings and equipment housing. There is very little foreground vegetation so the view is very open. Middle Distance: The central tree lies along the route of the River Rother, which otherwise has very little vegetation on its banks along this stretch. Either side of the river are the flat and generally open floodplain pastureland. Far Distance: There are views of some residential properties on the edge of Robertsbridge and the heavily vegetated eastern edge of The Clappers road. There are glimpses of the well vegetated and wooded landscape beyond, which form the skyline of this view. Existing Character: The character of the floodplain is generally open. The reinstated railway embankment should simply be grass seeded so that its appearance is similar to the existing flood defence bunds and sense of openness is maintained.

Assessment of Landscape and Visual Impacts		
Description of Impact	Magnitude of Impact	Significance of Impact
During Construction: Reinstatement of railway embankment clearly visible across open floodplain area between River Rother and properties in Northbridge Street. Some loss of trees necessary to connect proposals to existing section of track to west. Level crossing to A21 seen along roadway. Bridge construction within the embankment corridor (Bridges 8 & 9) may be visible during the embankment construction phase.	MODERATE	SLIGHT
Following Completion of Works: New track-bed clearly apparent across open floodplain running along a low embankment at this point, with the bridges located within this embankment corridor. Fencing to the base of the embankment will be visible, as will signalling equipment around the level crossing on the A21.	MODERATE	SLIGHT
Following Mitigation (after 15 Years): The grassy sides of the embankments would be fully established and appear similar to the existing flood defence bunds in this area. Completed embankment is similar in size and appearance to existing flood defence bunds on edges of floodplain and the fencing would be compatible with features in the existing view. Signalling equipment and the bridges would be assimilated into the scene by this stage.	MINOR	SLIGHT

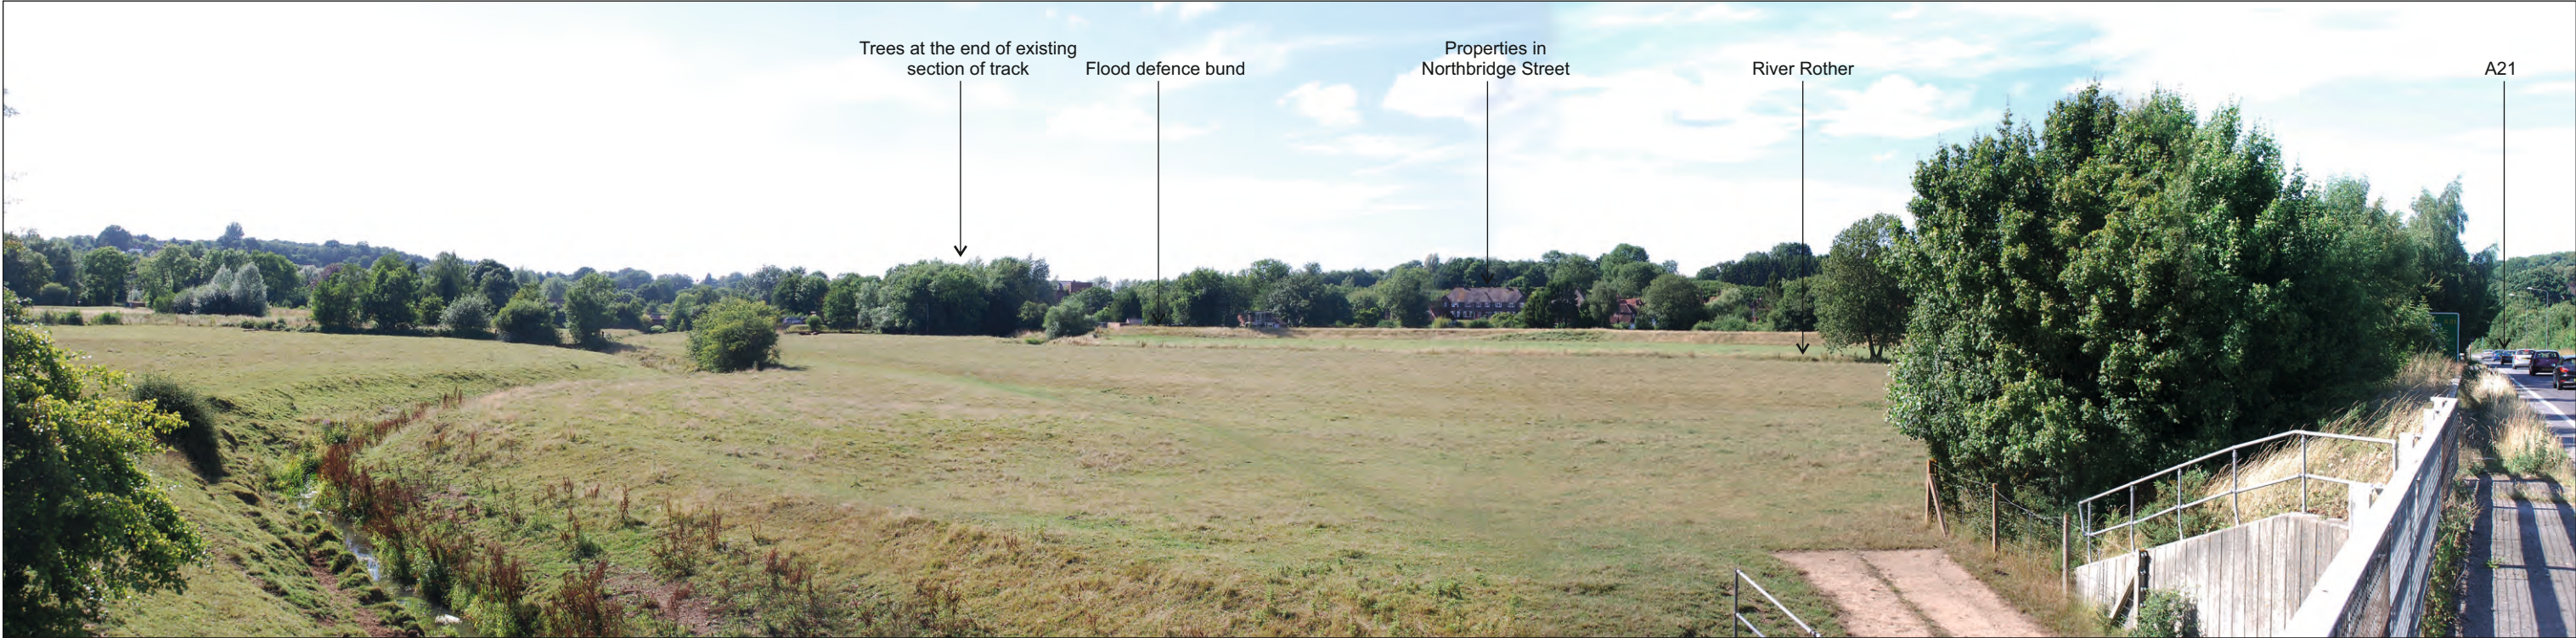
Looking north west across the River Rother floodplain from the A21

Baseline Assessment	
Classification of Receptor	Description of Existing View
Location of Viewpoint: A21 at eastern end of Public Footpath No. 30c	Foreground: The view comprises the A21 road, the bridge and vegetation along the western embankment, the drainage ditch and open floodplain pastureland. Middle Distance: The line of the River Rother is just visible running through the floodplain, although there is very little woody vegetation along this stretch of the river. There is some scattered vegetation along the drainage ditch. The grassy flood defence bund is visible along the edge of the floodplain. Far Distance: Some properties on the edge of Northbridge Street are apparent, as are the trees along the existing completed section of track towards the centre of the view. The well vegetated landscape beyond extends to the skyline. Existing Character: The character of the floodplain is generally open. The reinstated railway embankment should simply be grass seeded so that its appearance is similar to the existing flood defence bund and openness is maintained.

Assessment of Landscape and Visual Impacts		
Description of Impact	Magnitude of Impact	Significance of Impact
During Construction: Reinstatement of railway embankment clearly visible across open floodplain area between River Rother and properties in Northbridge Street. Some loss of trees necessary to connect proposals to existing section of track to west and to facilitate construction of crossing.	MINOR	SLIGHT
Following Completion of Works: New track-bed forms perceptible new feature across open floodplain on a low embankment with fencing along the base. Bridges 9 and 10 may be visible although these will be within the embankment corridor. Signalling equipment required for the A21 and The Clappers level crossings will be visible in this view.	MINOR	SLIGHT
Following Mitigation (after 15 Years): It is assumed that the sides of the embankments would be grass seeded, so the completed embankment will be similar in size and appearance to the existing flood defence bunds along the edges of the floodplain. Tree planting around the level crossing area will have become well established by this stage and signalling equipment would be well screened.	MINOR	NEUTRAL

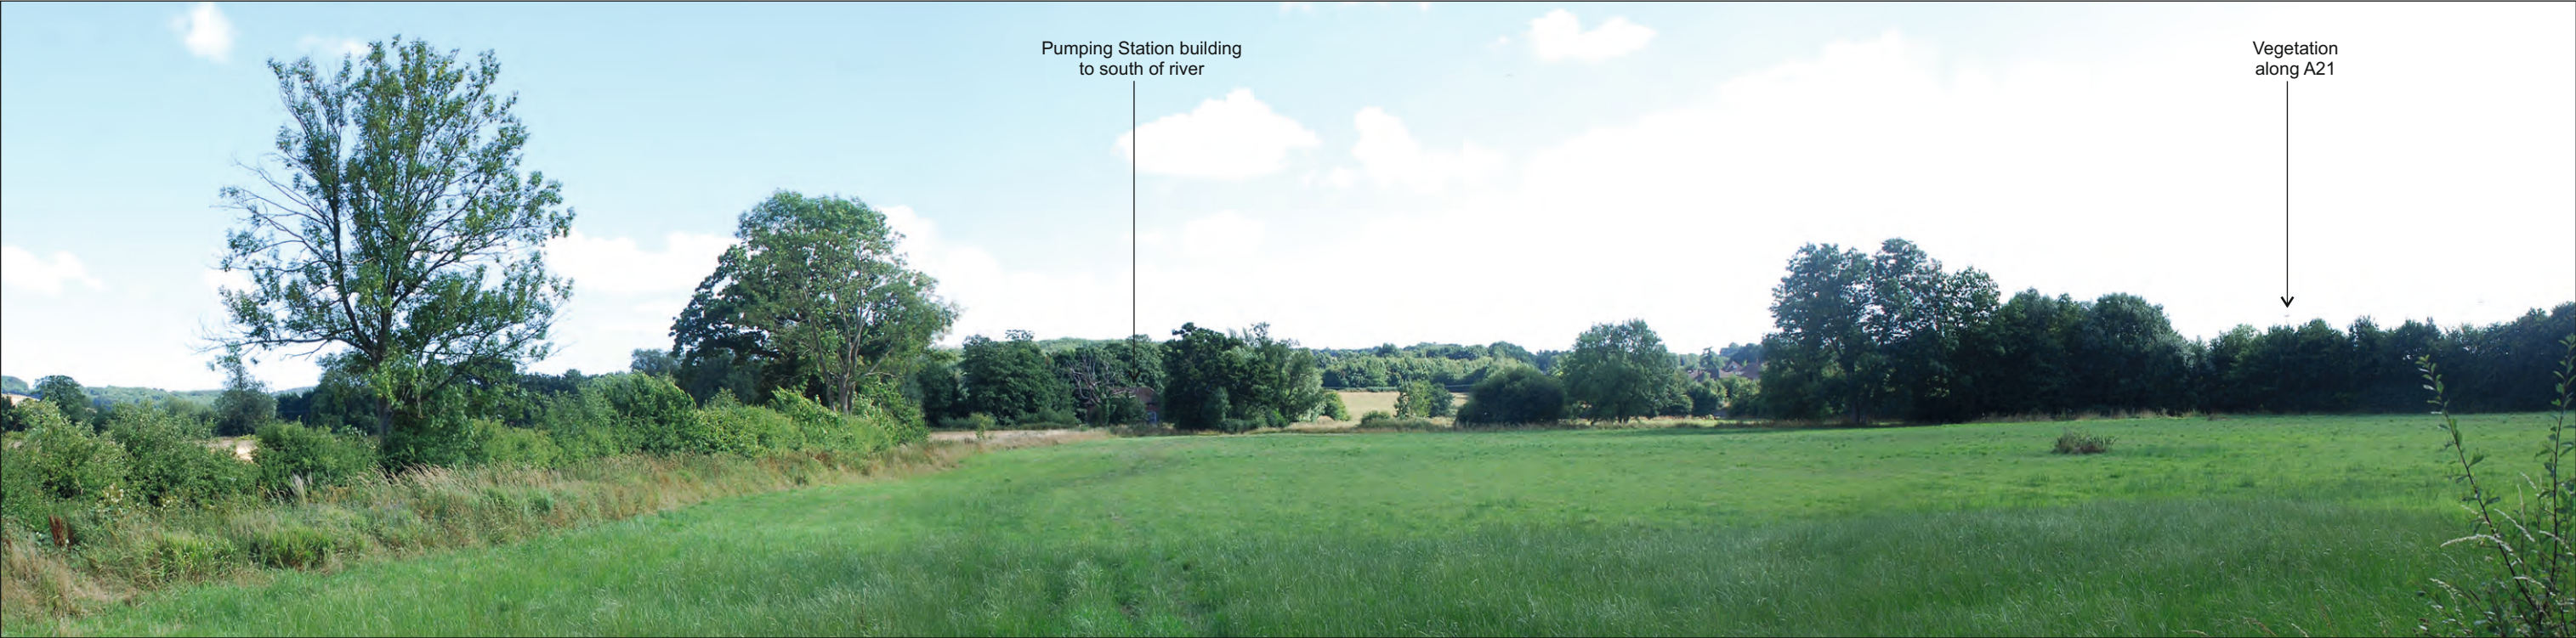
Looking south west from Church Lane

Baseline Assessment	
Classification of Receptor	Description of Existing View
Location of Viewpoint: Field gateway on Church Lane south of Andrews Close in Northbridge Street	Foreground: The open pasture landscape is viewed through this gateway on Church Lane.
Number / Type of Receptors: Glimpse views for limited number of car passengers and local resident pedestrians	Middle Distance: The hedgerows with mature trees to the left of this view are typical of this landscape. The heavily vegetated embankments alongside the A21 are clearly visible in this view, as is the pumping station with its well vegetated surroundings.
Direction of View: South West	Far Distance: The floodplain landscape with its well vegetated character and distant wooded hills.
Distance from Scheme: 175m	Existing Character: The view has a generally well-wooded character. Tree planting along existing hedgerows or field corners could help to integrate proposals into landscape setting and would reinforce local landscape character.

Following Mitigation (after 15 Years): New track-bed evident between viewpoint and vegetation along river. Mitigation planting is not possible within this area due to conflicts with flood defence requirement, though replacement tree planting would be well established by this stage and starting to screen views of signalling equipment and the pedestrian crossing. It is assumed that the sides of the embankment would be grass seeded to help it integrate into landscape.	MINOR	SLIGHT

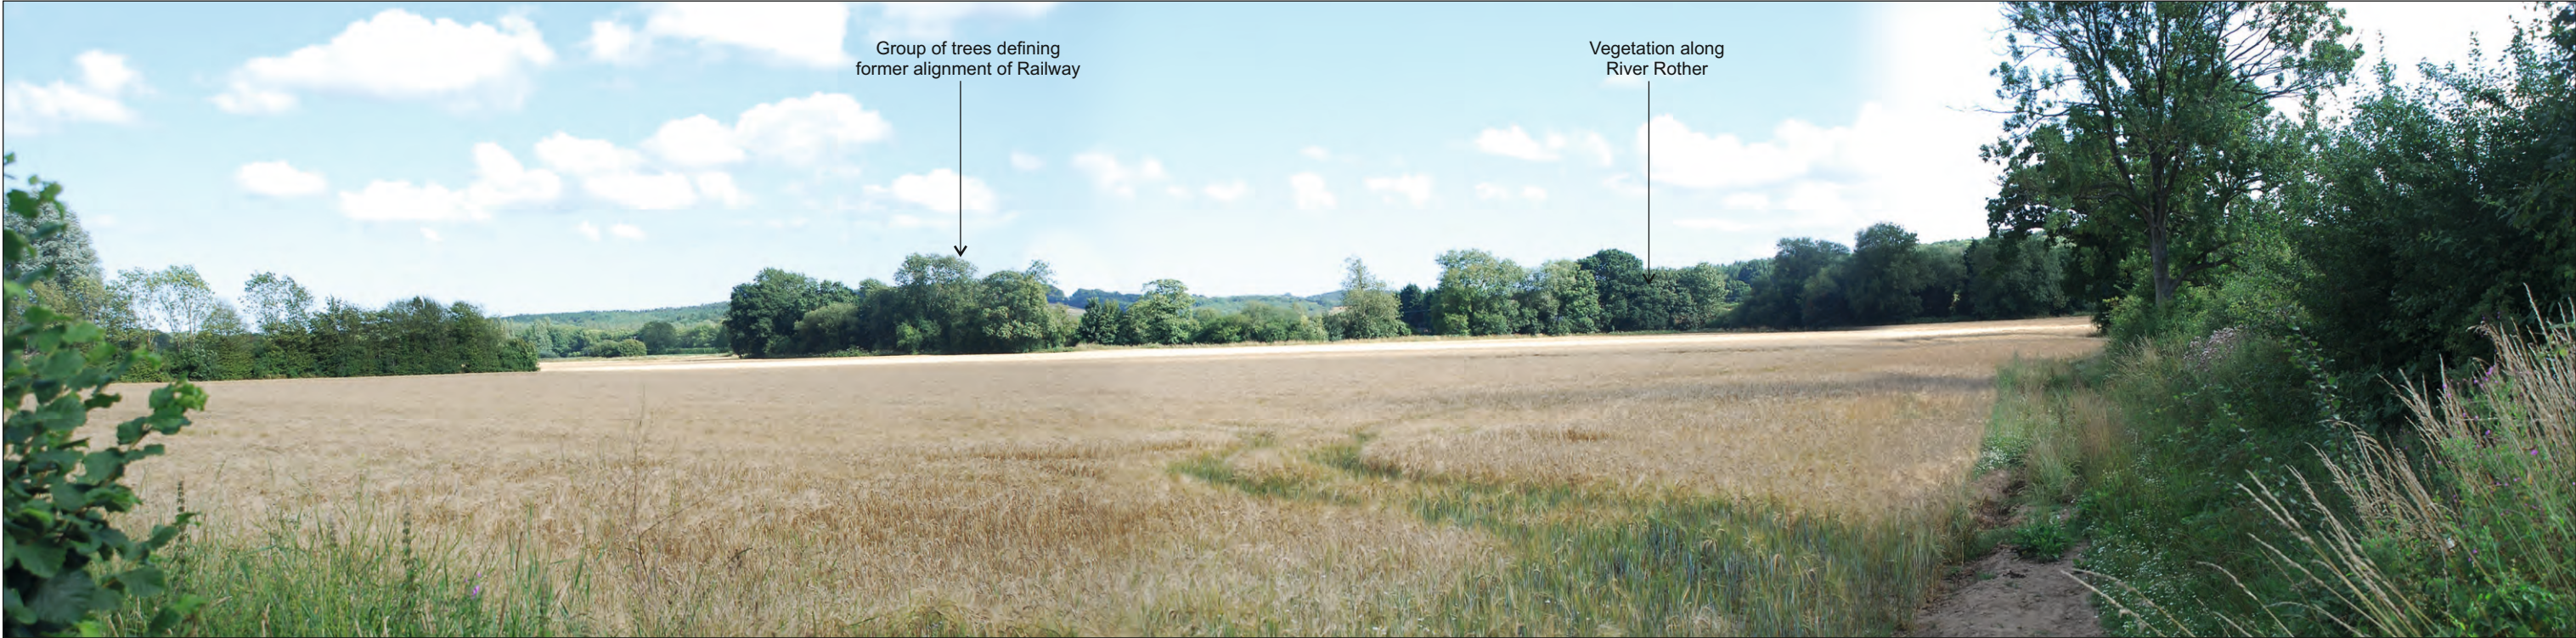
Looking south east from Church Lane

Baseline Assessment	
Classification of Receptor	Description of Existing View
Location of Viewpoint: Field gateway on Church Lane below Rother View on edge of Northbridge Street	Foreground: This view through a gateway on Church Lane shows the open arable landscape of this part of the floodplain.
Number / Type of Receptors: Some car passengers and local resident pedestrians on edge of Northbridge Street	Middle Distance: The disused railway passes very close to the river here, through the group of trees in the centre of this view. The banks of the River Rother are well vegetated along this stretch and the tall hedgerows that typify this landscape are visible to the left of the view.
Direction of View: South east	Far Distance: The well vegetated landscape to the south east is clearly demonstrated in this view and the wooded hill tops in the distance are visible on the skyline.
Distance from Scheme: 175m	Existing Character: The view is highly rural in character, with no buildings or engineering features readily apparent. The foreground is open in character, with open ditches. This is seen against the strongly vegetated river corridor beyond.

With hedgerow planting established along the base of the embankment, mitigation would be compatible with existing local character. This will help to integrate the new embankment into its landscape setting, reinforcing the landscape character of the AONB. Replacement trees to reinforce the reduced tree group will be well established by this stage and starting to further integrate the embankment into the scene.	MINOR / NEUTRAL	NEUTRAL

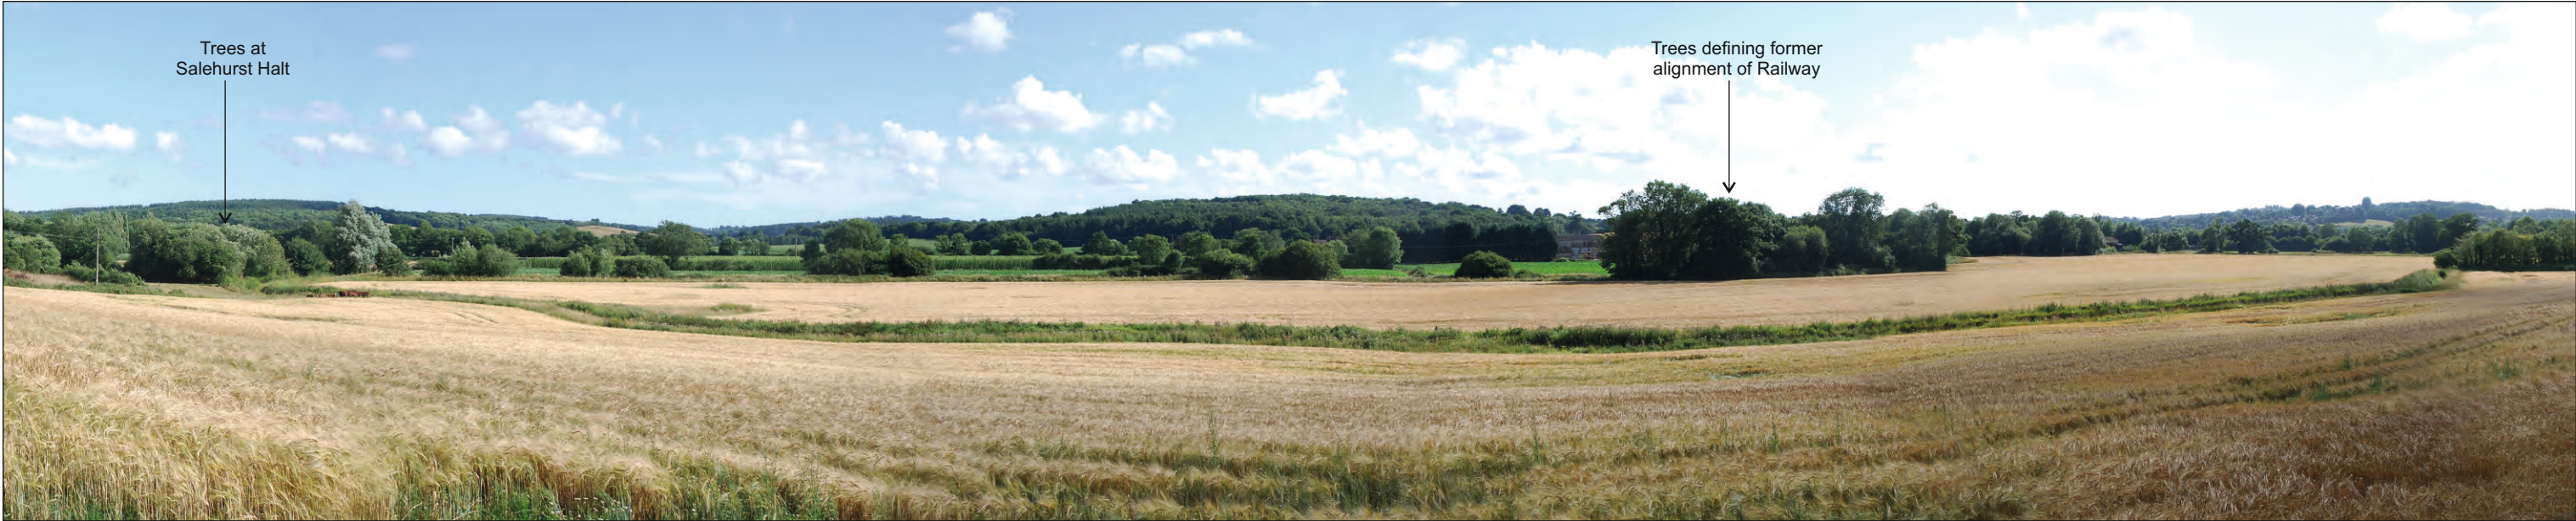
Looking south from field gateway on Church Lane, just west of Salehurst

Baseline Assessment	
Classification of Receptor	Description of Existing View
Location of Viewpoint: Field Gateway on Church Lane, just to west of Salehurst	Foreground: This view from a field gateway on Church Lane shows the open, arable landscape, there is no intervening vegetation in this part of the view. Middle Distance: Some properties are visible on the edge of Salehurst, though only the upper storeys can be seen. Within the well vegetated landscape beyond, mature trees around the old Salehurst Halt and in the centre of the view, along the edge of the former railway, are clearly visible. The former railway ran along the far edge of the wheat field. Far Distance: The wooded hilltops to the south form the skyline in this view. Existing Character: The view is highly rural in character, with no buildings or engineering features readily apparent. The foreground is predominantly open in character, with open ditches and low hedgerows. This area is seen against the strongly vegetated river corridor in the valley and the wooded skyline.

Assessment of Landscape and Visual Impacts		
Description of Impact	Magnitude of Impact	Significance of Impact
During Construction: Construction of reinstated section of railway embankment forms clearly noticeable part of the composition of view.	MODERATE	MODERATE
Following Completion of Works: Reinstated low embankment and track bed forms a somewhat alien, engineered feature in otherwise rural landscape with fencing running along the base of the embankment. There may be views of bridges 14, 16 and the farm access crossing with signalling equipment if required. Depending upon the detailed design for the halt, there may be views of tree clearance and of the Salehurst Halt construction and signalling equipment.	MINOR / MODERATE	SLIGHT to MODERATE
Following Mitigation (after 15 Years): The recommendation for hedgerow along this section would allow the best screening and integration of the embankment, however, to preserve hydraulic connectivity on either side of the embankment, it may be that the hedgerow option is not achievable. Without hedgerow planting, the impact will be dependent on height and treatment of the new railway embankment. With hedgerow planting, the mitigation would be compatible with existing local character. This will help to integrate the new embankment into its landscape setting, reinforcing the landscape character of the AONB. There is potential for linkage of vegetation around pond to the wider habitat network.	MINOR / MODERATE MINOR / NEUTRAL	SLIGHT to MODERATE SLIGHT to NEUTRAL

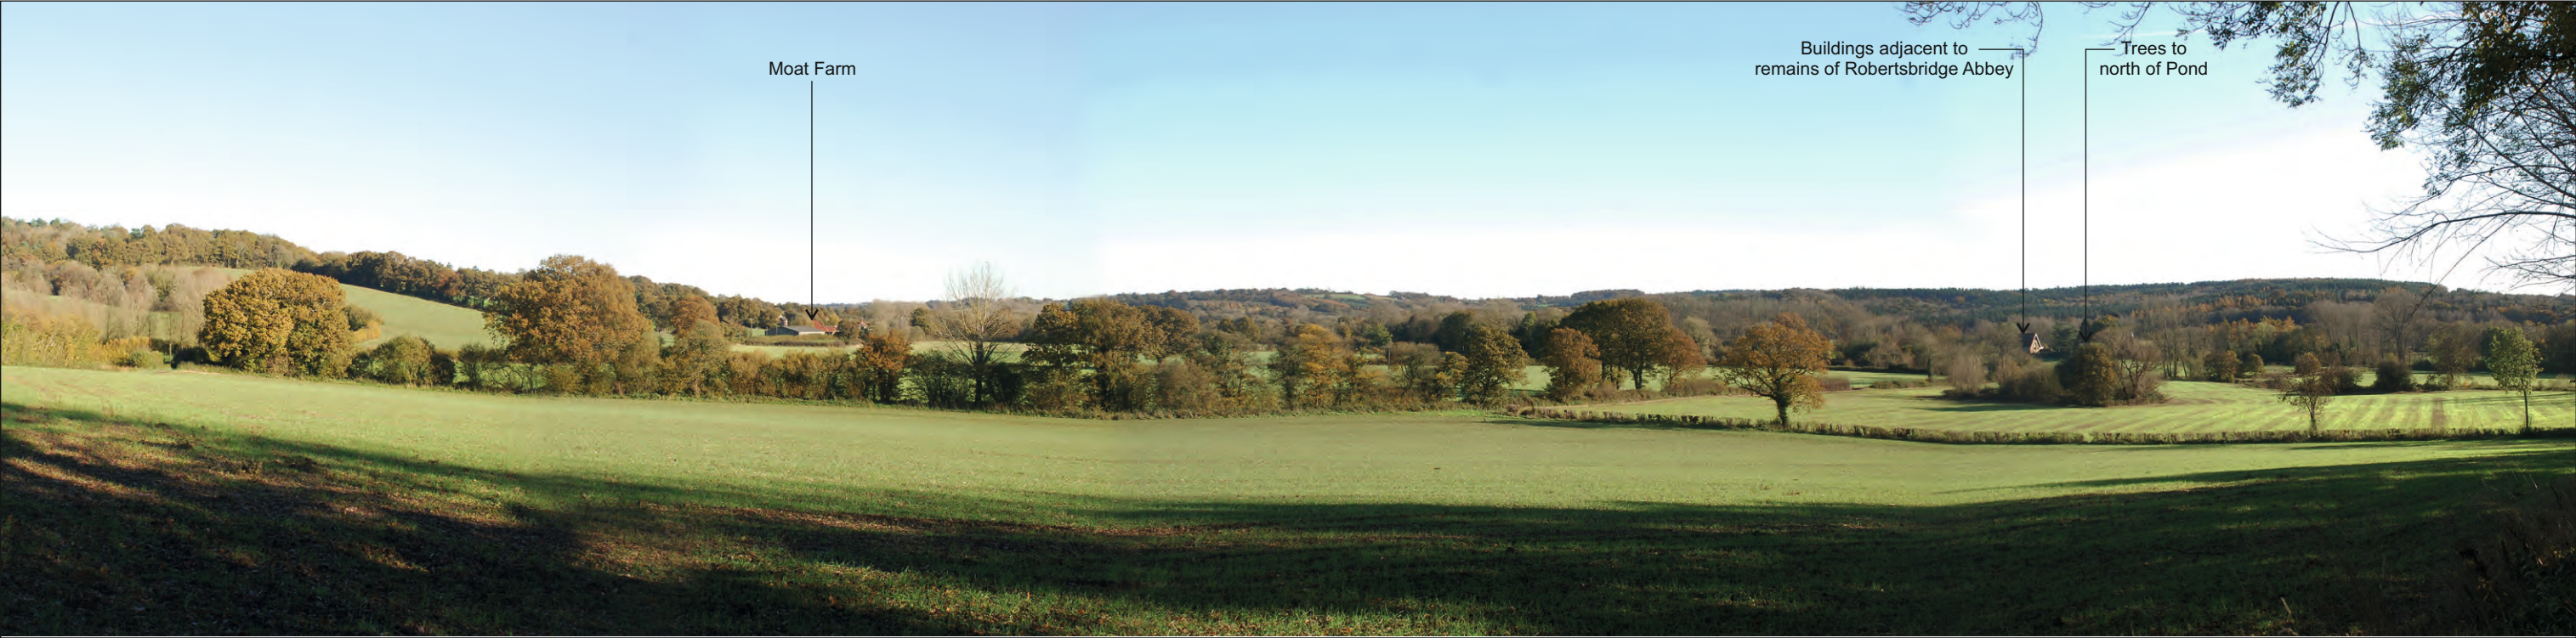
Looking south east from Public Footpath No.34c on eastern edge of Salehurst

Baseline Assessment	
Classification of Receptor	Description of Existing View
Location of Viewpoint: Slightly elevated location on Public Footpath No. 34c as it emerges from St Mary's churchyard on eastern side of Salehurst	Foreground: The open arable landscape of the foreground extends to the middle distance due to the slightly elevated position and uncharacteristically low hedgerow in the centre of the view. Middle Distance: To the left of the view, the taller hedgerows typical of the area are visible with glimpses through to the fields around Moat Farm beyond. The small clump of central vegetation surrounds the north side of a pond, where the line of the former railway passed through just to the north of the pond. Far Distance: The upper storeys of properties adjacent to Robertsbridge Abbey are just visible on the raised land to the south of the floodplain. Beyond, the wooded hills form the skyline to the view. Existing Character: This view is highly rural in character, with very few buildings or engineering features visible. The foreground is predominantly open in character, with low hedgerows and occasional hedgerow trees. Views are more contained where there are greater numbers of mature trees. This area is seen against the strongly vegetated river corridor in the valley and the wooded skyline.

Assessment of Landscape and Visual Impacts		
Description of Impact	Magnitude of Impact	Significance of Impact
During Construction: Construction of reinstated sectionsrailway embankment on either side of the trees around the small pond will be clearly noticeable throughout the construction period. There would be a loss of vegetation around the pond to facilitate embankment and bridge works.	MODERATE	LARGE
Following Completion of Works: The reinstated low embankment and track bed with fencing to the base forms a somewhat alien, engineered feature in otherwise rural landscape. The loss of the mature vegetation around the pond has opened views of the embankment further. Bridges 19, 20 and 21 within the embankment may be visible, if rather distantly from here.	MINOR	MODERATE
Following Mitigation (after 15 Years): The recommendation for hedgerow along this section would allow the best screening and integration of the embankment, however, to preserve hydraulic connectivity on either side of the embankment, it may be that the hedgerow option is not achievable. Without planting the impact would be dependent on height and treatment of the new railway embankment. With hedgerow planting mitigation is compatible with existing local character. This will help to integrate the new embankment into its landscape setting, reinforcing the landscape character of the AONB. There is potential for linkage of vegetation around pond to the wider habitat network.	MINOR NEGLECTIBLE / NEUTRAL	MODERATE SLIGHT to NEUTRAL

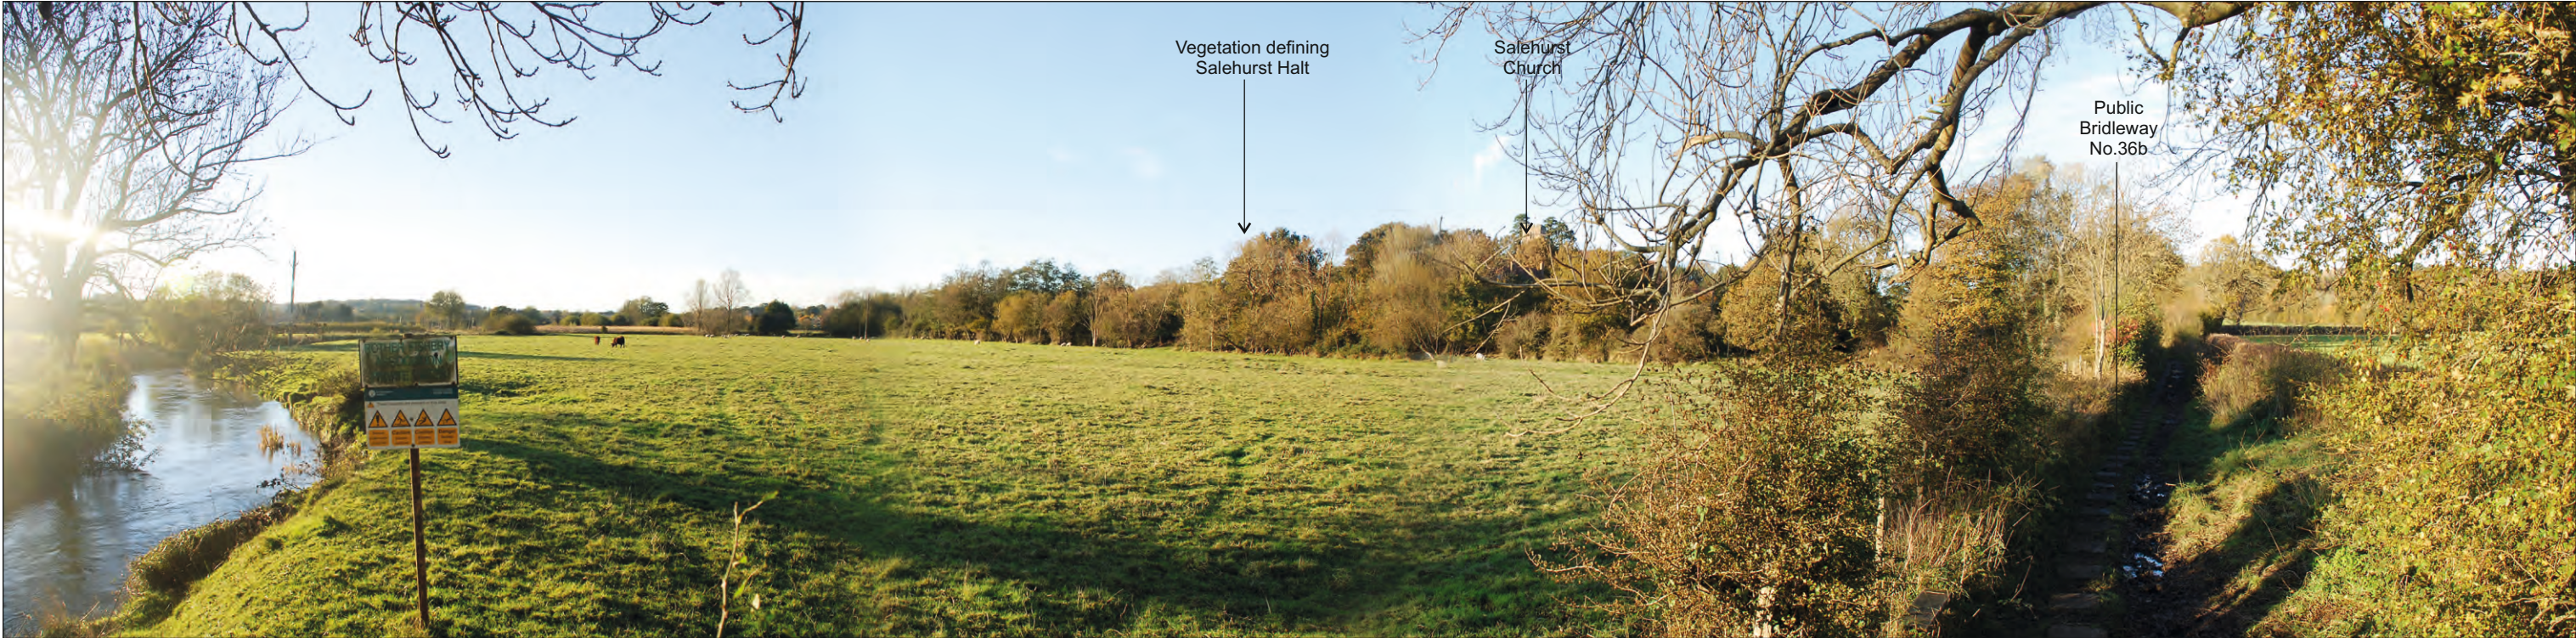
Looking north west from Public Bridleway No36b at Church Bridge

Baseline Assessment	
Classification of Receptor	Description of Existing View
Location of Viewpoint: Public Bridleway No. 36b on northern side of Church Bridge	Foreground: From Church Bridge the foreground view shows the well established vegetation along the sides of the bridleway, the River Rother and the open floodplain pasture. Middle Distance: Across the view, vegetation along the former railway line and particularly around Salehurst Halt is visible. Salehurst Church lies just beyond the trees. Far Distance: To the north west in the distance, the well vegetated floodplain can be seen with the wooded hills beyond. Existing Character: This view is highly rural in character, with very few buildings or engineering features visible. The open water meadows forming the floodplain along the river contrast with the more enclosed character on the side slopes of the valley. The existing trees around the former location of Salehurst Halt contribute positively to existing character.
