Report for – Rother Valley Railway Limited Track Reinstatement between Northbridge Street and Junction Road Environmental Statement, Volume 4 – Supporting Figures Final

Track Reinstatement between Northbridge Street and Junction Road
Environmental Statement, Volume 4 – Supporting Figures
Final

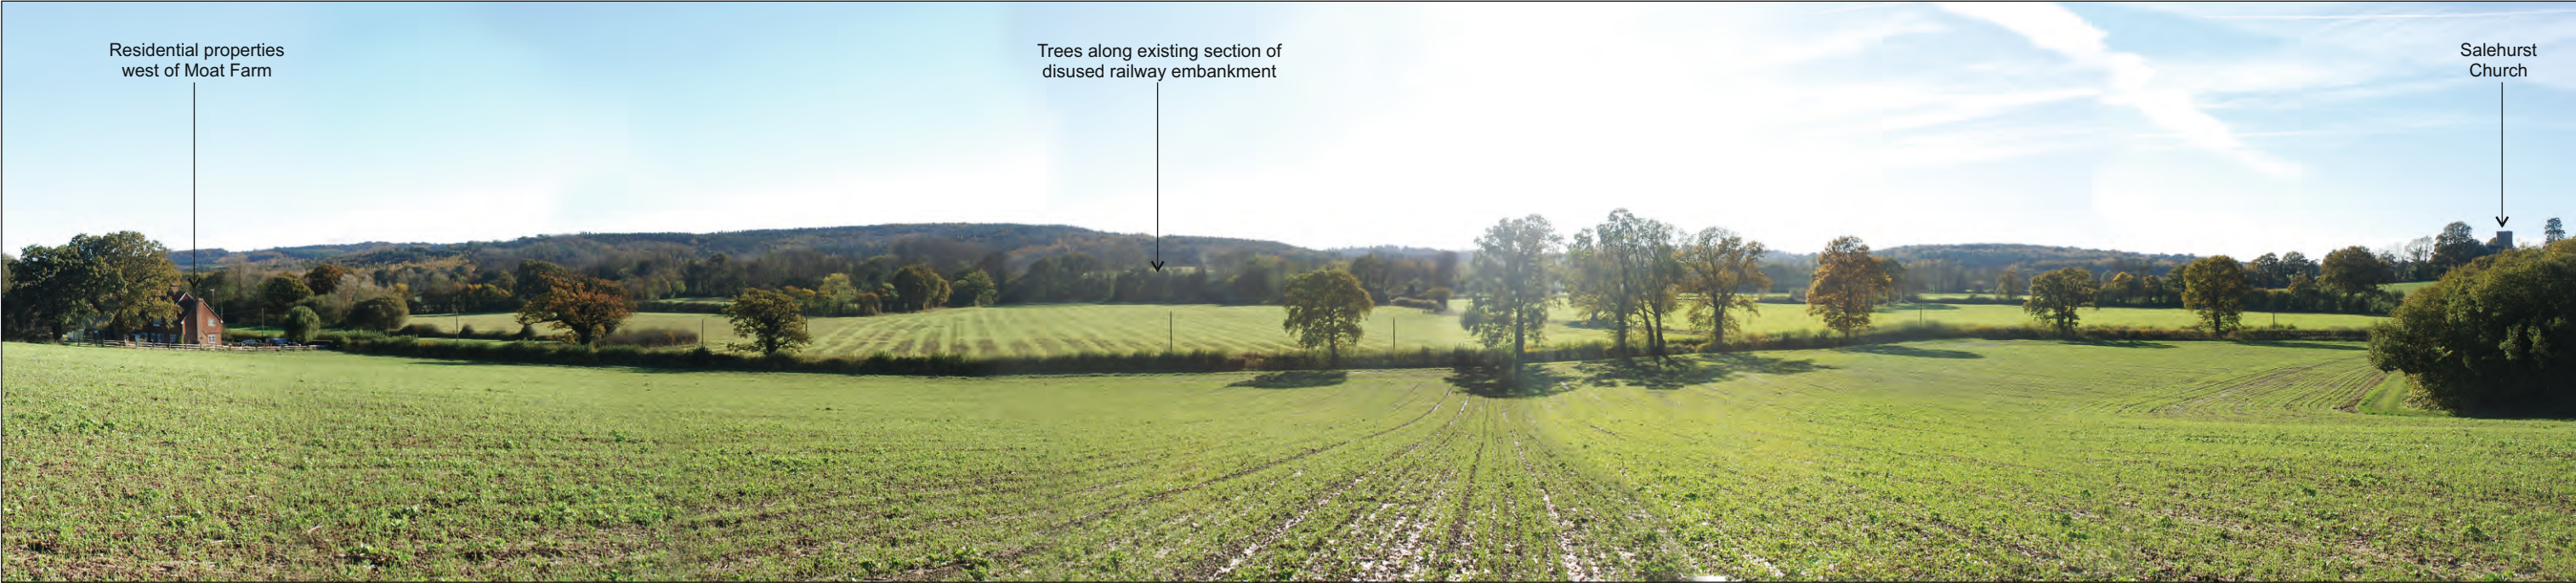
Looking south from Public Footpath No.34e east of Rocks Hill

Baseline Assessment	
Classification of Receptor	Description of Existing View
Location of Viewpoint: Slightly elevated location on Public Footpath No. 34c above Moat Farm Cottages	Foreground: The open arable landscape and residential property west of Moat Farm with its surrounding vegetation. Middle Distance: The arable landscape extends through the middle distance with a scattering of mature trees through the low hedgerows. Far Distance: The disused railway line lies behind the small, central line of trees and the skyline is composed of wooded hills. This view shows that trees screen many of the views further up the valley sides. Existing Character: This view is highly rural in character, with very few buildings or engineering features visible. The foreground is predominantly open in character, with low hedgerows and occasional hedgerow trees along the track to Moat Farm. Fields are moderately large in size. Low hedgerows with individual hedgerow trees characterise the area around the former railway embankment.

Following Mitigation (after 15 Years): The recommendation for hedgerow along this section would allow the best screening and integration of the embankment, however, to preserve hydraulic connectivity on either side of the embankment, it may be that the hedgerow option is not achievable. Without hedgerow the reinstated embankment would be just evident through trees, particularly in winter. Replacement trees required as a result of tree loss would be well established by this stage, providing lower level screening. Low hedgerow planting would further integrate the reinstated embankment into its landscape setting. This would be compatible with and would reinforce local landscape character.	MINOR / NEGLIGIBLE NEGLIGIBLE / NEUTRAL	SLIGHT NEUTRAL

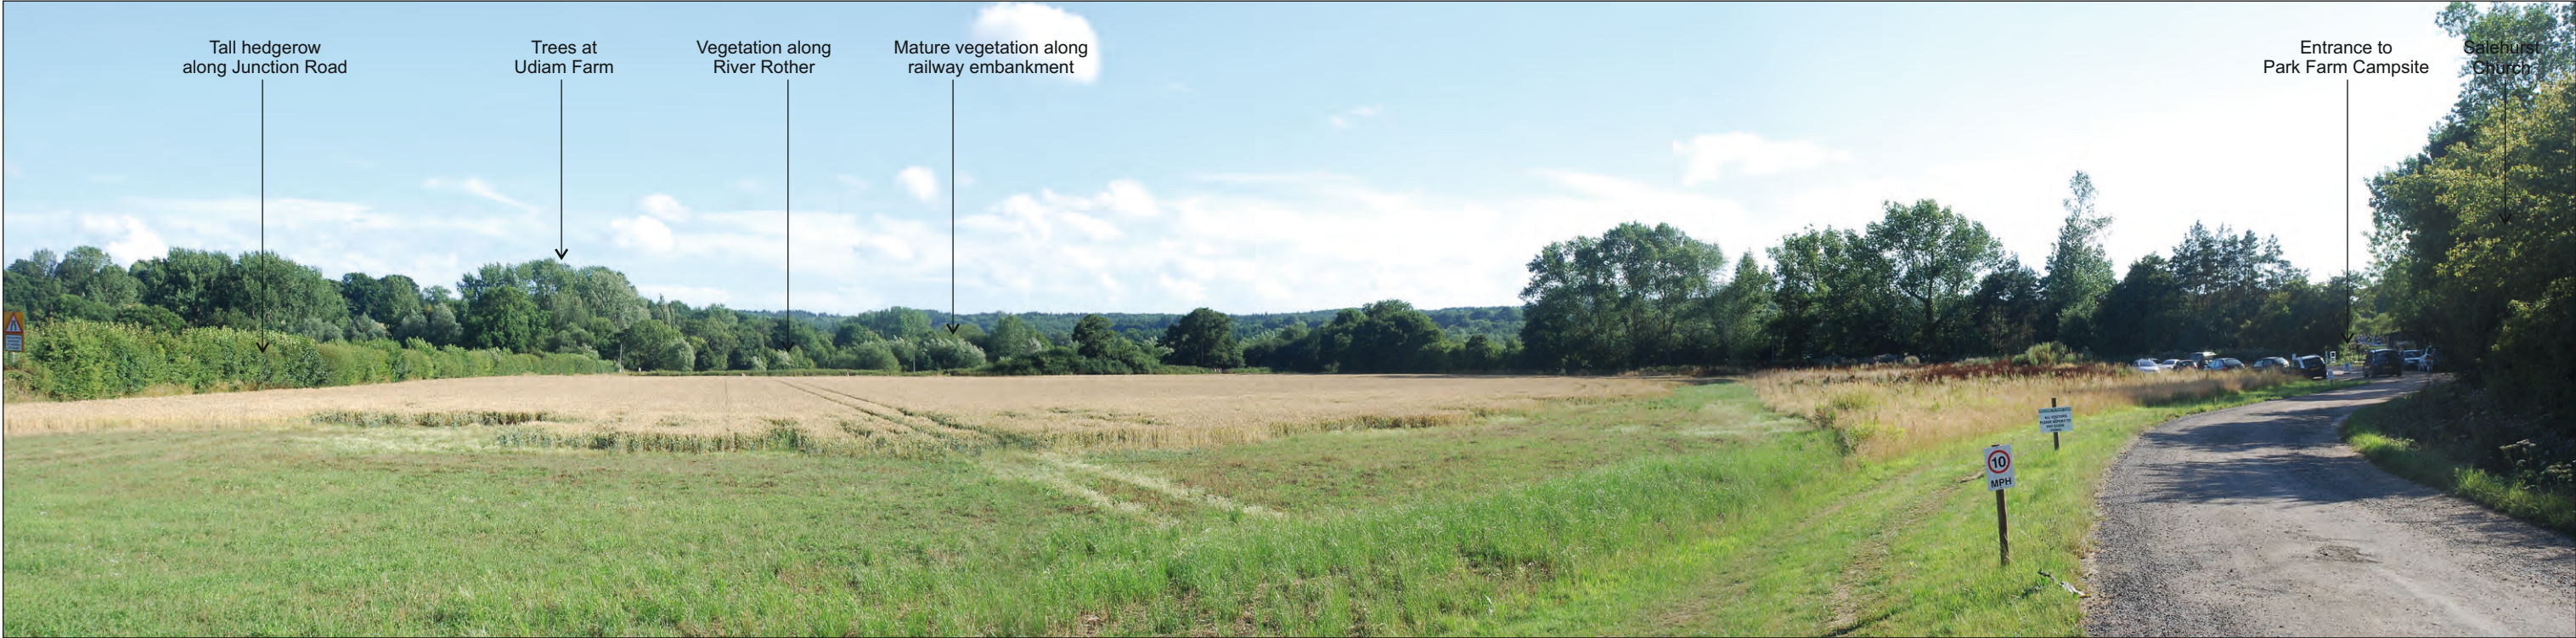
Looking south west from entrance to Park Farm Campsite

Baseline Assessment	
Classification of Receptor	Description of Existing View
Location of Viewpoint: Entrance to Park Farm campsite	Foreground: Views from here comprise the access track to the camp site and an arable field dropping gently towards river. Middle Distance: To the left of the view the vegetation along Junction Road forms a dense screen to the road. The larger trees mark where the road crosses the river. To the right the camp site car park and the mature trees that surround it are visible. Far Distance: Parts of the well treed valley floor are visible with the wooded hills beyond forming the skyline. Existing Character: The trees along the dismantled section of railway contribute positively to the strongly wooded character of the landscape adjacent to this part of the scheme. Proposals should seek to minimise any adverse impacts on the existing mature vegetation.
Number / Type of Receptors: Moderately high numbers of leisure visitors

Following Mitigation (after 15 Years): Any vegetation lost during the construction period will have been replaced where required or have naturally regenerated and will be established by this time. Any views of the signalling equipment will be further reduced. This location offers the benefit of views of the trains for visitors to the area.	NEGLIGIBLE or NO CHANGE	NEUTRAL

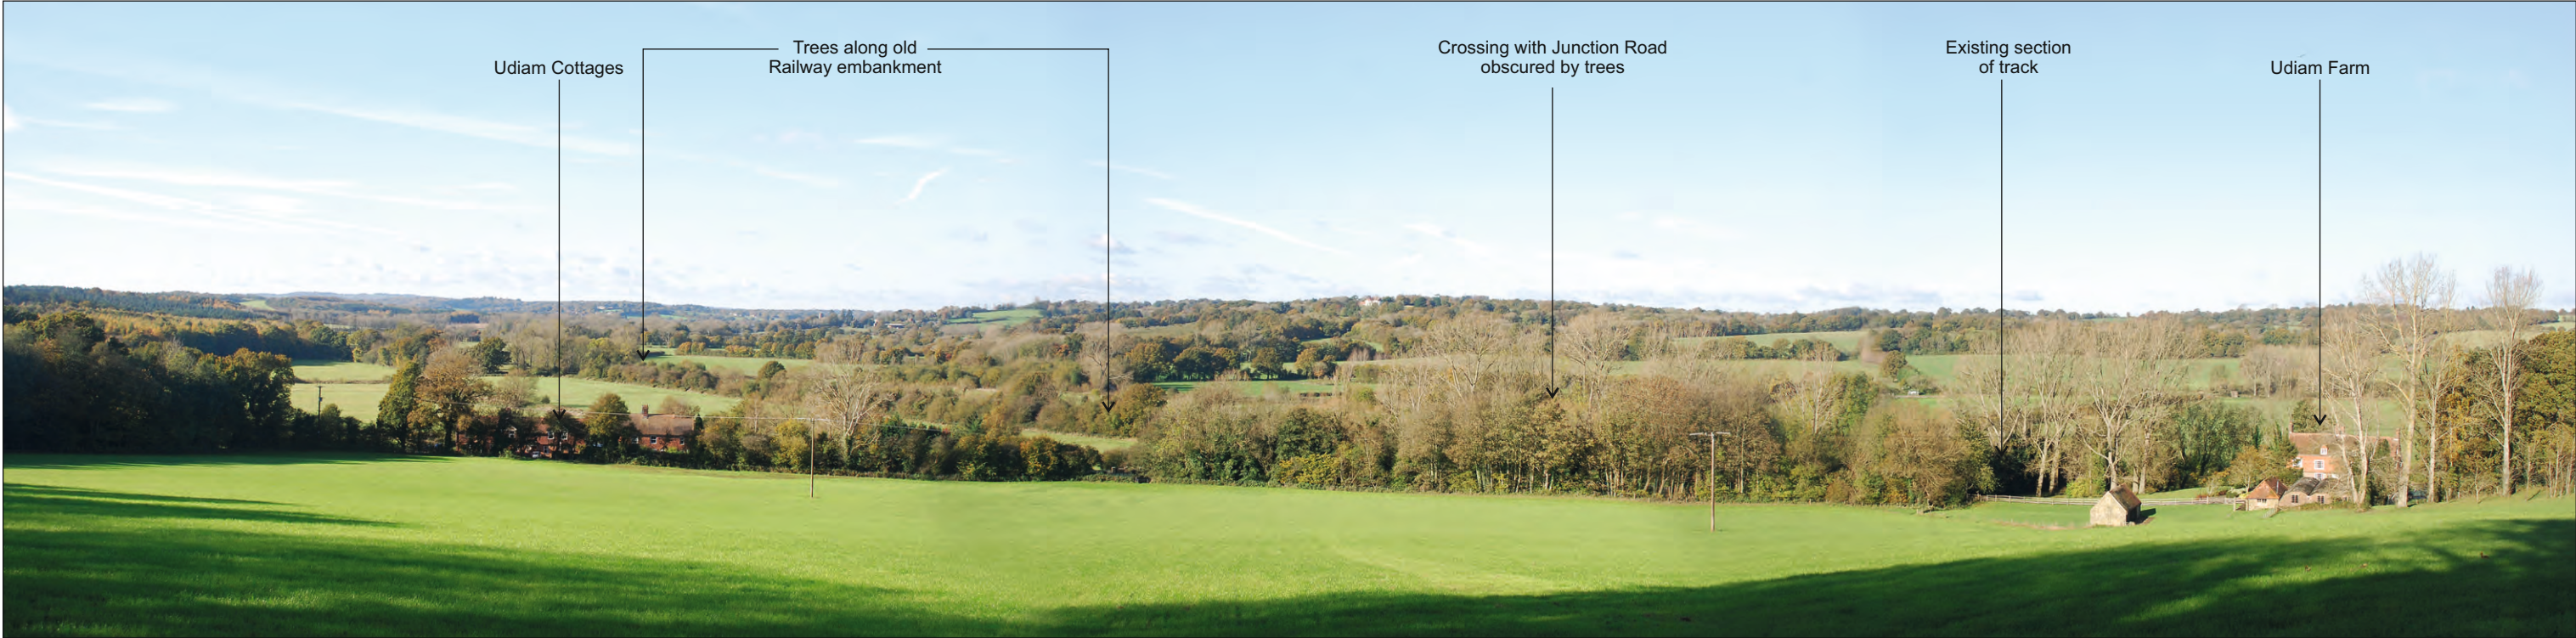
Looking west from Public Footpath No.9 above Udiam Cottages

Baseline Assessment	
Classification of Receptor	Description of Existing View
<p>Location of Viewpoint: Field gateway on Public Footpath No. 9 above Udiam Cottages</p> <p>Number / Type of Receptors: Small number of people using Public Rights of Way</p> <p>Direction of View: West</p> <p>Distance from Scheme: 300m</p> <p>Approximate Elevation: 30m AOD</p> <p>Sensitivity of Receptor: VERY HIGH</p>	<p>Foreground: The open pastureland stretches down towards Junction Road.</p> <p>Middle Distance: Udiam Farm lies to the right of the view and Udiam cottages to the left. There is consistent vegetation along Junction Road with a group of taller trees where the disused railway crosses the river and a mass of vegetation along the riverbank. Behind Udiam Cottages the line of semi-mature vegetation running east-west along the former railway embankment is evident.</p> <p>Far Distance: Well-wooded skyline and Higham House set in the woodland on the northern side of valley.</p> <p>Existing Character: The existing embankment forms part of the well-wooded landscape character of this part of the valley. Viewpoint provides a panoramic view of the cherished, positive characteristics of the AONB.</p>

Assessment of Landscape and Visual Impacts		
Description of Impact	Magnitude of Impact	Significance of Impact
<p>During Construction:</p> <p>Impacts will be dependent on degree of vegetation loss required to create 450m long Passing Loop. Views of construction activities along dismantled section of railway will be partially screened by the existing vegetation to be retained. Some limited disruption evident due to formation of level crossing over Junction Road. Views could be slightly more prominent in winter.</p> <p>There may be more extensive views due to vegetation loss to create Passing Loop, but the details of these elements are unclear at present.</p>		MODERATE to LARGE
<p>Following Completion of Works:</p> <p>Reinstated single track bed not likely to be clearly visible and fencing would appear distant where visible, but any necessary loss of trees will still be apparent. However, the strongly vegetated nature of the view will be maintained and the overall character of the view will not be affected.</p> <p>The additional track required to create the Passing Loop in this location, would result in some additional tree loss and therefore more possibility of open views of the track bed. Reinstatement of temporary construction compounds would be complete.</p> <p>This location offers the benefit of views of the trains for visitors to the area.</p>	MINOR to MODERATE	MODERATE to LARGE

<p>Following Mitigation (after 15 Years):</p> <p>The replanting of lost vegetation or natural regeneration of vegetation will be well established by this time and this could result in benefits to the well wooded character of the valley here.</p> <p>This location offers the benefit of views of the trains for visitors to the area.</p>	MINOR to MINOR BENEFIT	SLIGHT to MODERATE

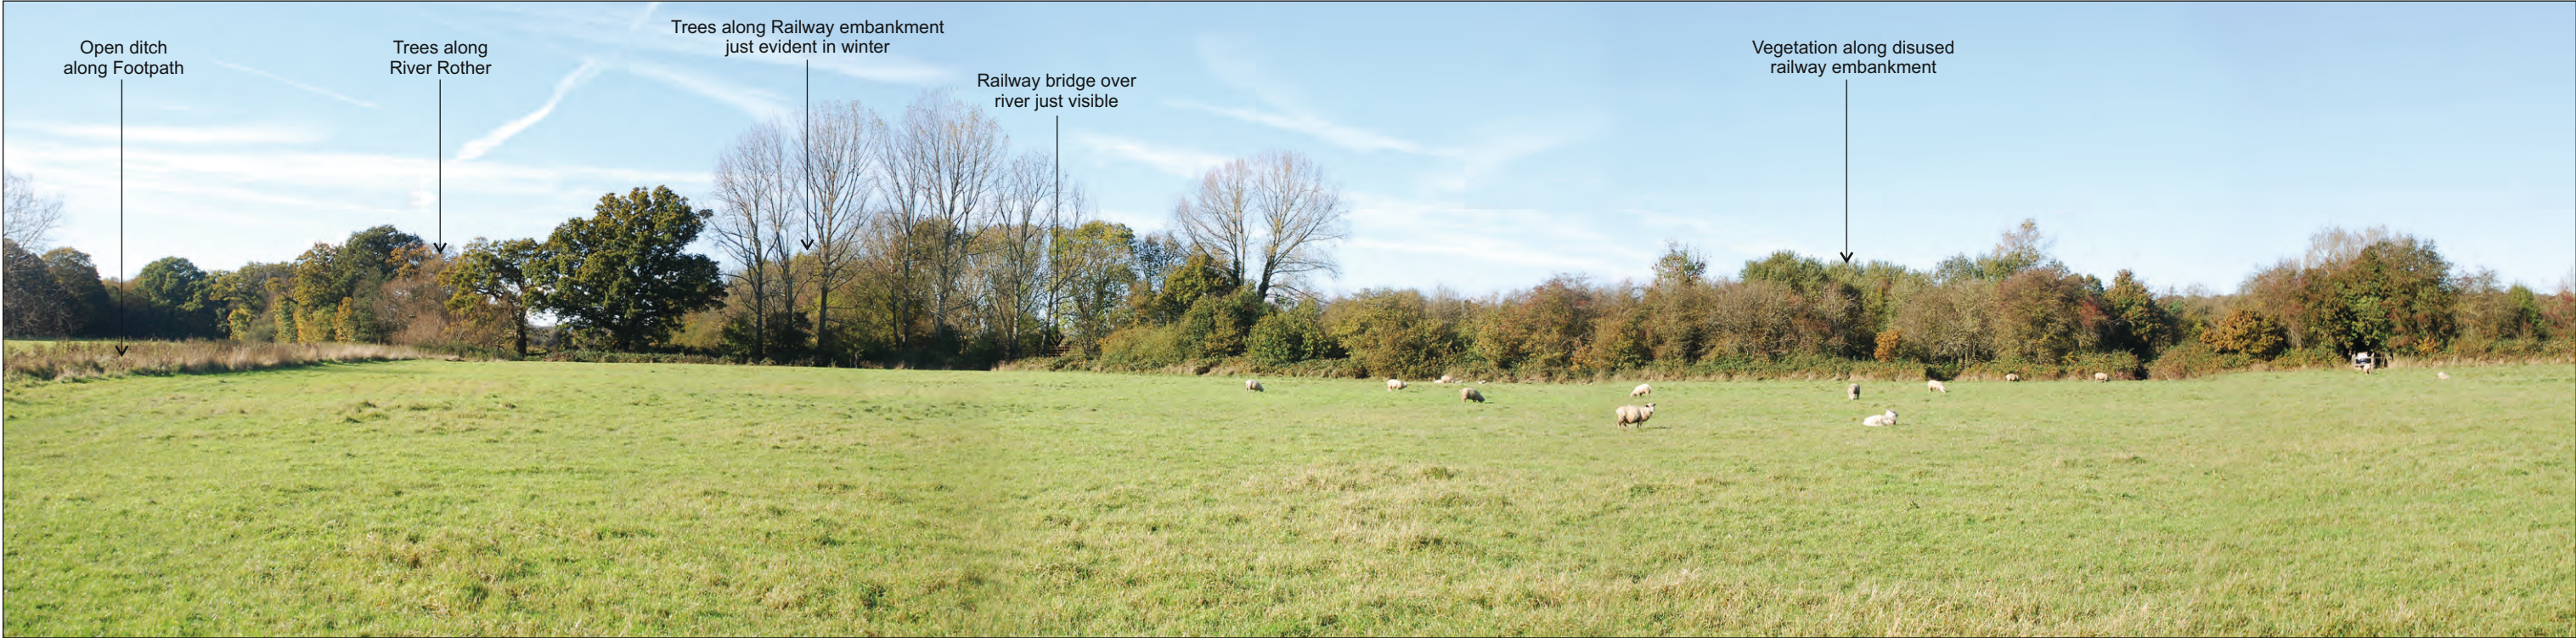
Looking west from footbridge on Public Footpath No.1

Baseline Assessment	
Classification of Receptor	Description of Existing View
Location of Viewpoint: From footbridge over open drainage ditch on Public Footpath No. 1 to west of Udiam Cottages	Foreground: Open floodplain pasture forms the foreground to this view. Middle Distance: The semi-mature vegetation along the former railway embankment and mature trees along the River Rother run across the view, with the large poplars at the river crossing particularly visible. The trees adjacent to the existing bridge over the river form a focal point to the view. Far Distance: There are glimpses of the well vegetated floodplain character, though relatively nearby trees form the skyline. Existing Character: The vegetation along the existing dismantled railway embankment forms the dominant features in the view, contributing to the well-wooded character of this part of the valley.
Number / Type of Receptors: Small number of people using Public Rights of Way

Assessment of Landscape and Visual Impacts		
Description of Impact	Magnitude of Impact	Significance of Impact
During Construction: The track-bed will be reinstated through the existing vegetation along the dismantled railway. Impacts will be dependent on level of vegetation loss required to reinstate track-bed and repair / construct new bridge over the river. The majority of the existing vegetation along the edge of the embankment should be undisturbed by the construction activities, but some machine running along the line will be evident in winter. Works to the bridge crossing over the river are likely to be clearly visible. A450m long Passing Loop will be created along this section of the former embankment. The degree of vegetation loss will be dependent on the precise position of the track-bed, but this could result in more extensive changes to the composition of the view, potentially impacting on views from Udiam Cottages.	MINOR to MODERATE	SLIGHT to MODERATE

MODERATE	MODERATE
Following Completion of Works: Impacts will be dependent on level of vegetation loss required to reinstate track-bed, repair / construct new bridge over the river and create Passing Loop. Any reinstatement works would be visible at this stage, along with views of bridge 26 which have been opened up by tree loss. It is possible that there may be more extensive views due to vegetation loss as a result of the creation of the 450m long Passing Loop. This could result in clearly noticeable impacts on the composition of the view.	NEGLECTIBLE to MODERATE	SLIGHT to MODERATE
	MODERATE	MODERATE
Following Mitigation (after 15 Years): Replanting of lost vegetation as required and natural regeneration of vegetation will have become well established by this time and provide good screening and tree cover in this area. Could result in minor benefits, subject to nature of tree works along existing embankment to north of Right of Way.	NEGLECTIBLE to MINOR	NEUTRAL to SLIGHT

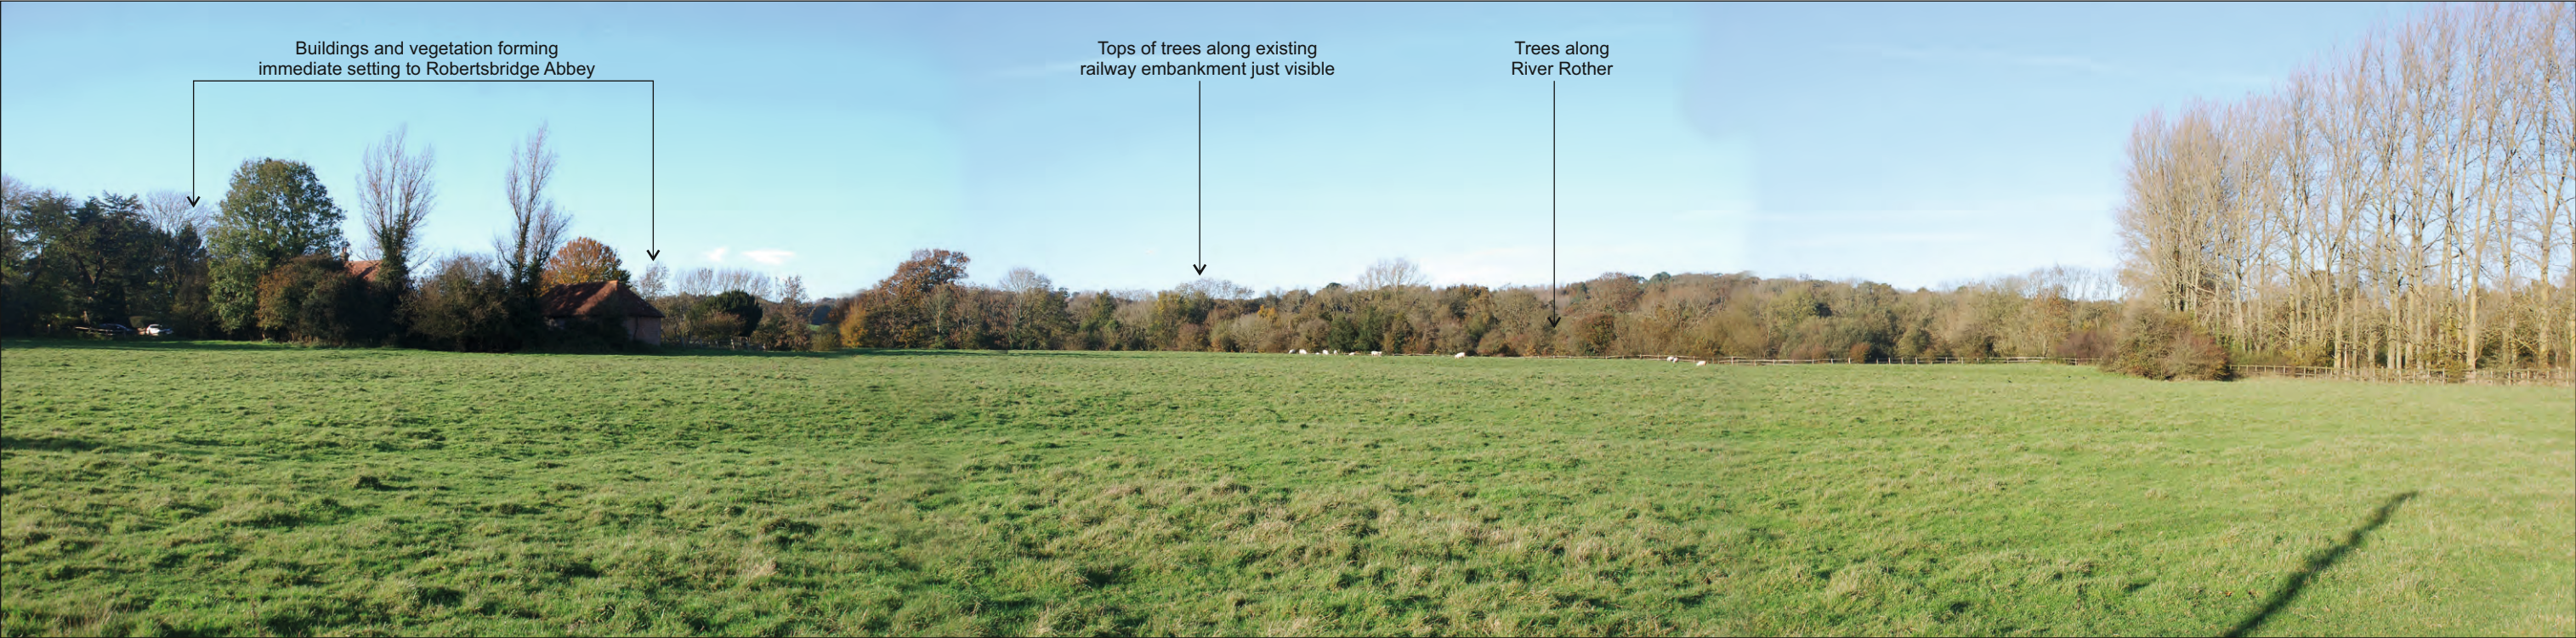
Looking north from Public Bridleway 39c east of Robertsbridge Abbey

Baseline Assessment	
Classification of Receptor	Description of Existing View
Location of Viewpoint: Public Bridleway No. 39c to east of remains of Robertsbridge Abbey	Foreground: Open, gently sloping pasture provides the foreground to this view. Middle Distance: Trees and the upper storeys of buildings around the remains of Robertsbridge Abbey are visible to the left of the view. To the right and centre of the view, the dense vegetation running along this stretch of the River Rother forms the edge of the pasture. Far Distance: The tops of trees along the existing railway embankment are just visible against the skyline. Existing Character: This viewpoint is within the setting of the remains of Robertsbridge Abbey. Impacts on the setting to Robertsbridge Abbey are considered by the Archaeology and Cultural Heritage Chapter.
Number / Type of Receptors: Local residents / Small number of people using Public Rights of Way

Direction of View: North	
Distance from Scheme: 300m	
Approximate Elevation: 20m AOD	
Sensitivity of Receptor: HIGH

Assessment of Landscape and Visual Impacts		
Description of Impact	Magnitude of Impact	Significance of Impact
During Construction: Views towards existing embankment predominantly screened by intervening vegetation. Some construction activities may be just evident in winter, along with some minor tree loss. However, it has been assumed that it will not be necessary to remove significant numbers of the mature trees from the sides of the embankment to reinstate the track-bed.	NEGLIGIBLE to MINOR	SLIGHT
Following Completion of Works: Reinstated track bed will not be visible, but any necessary loss of trees may still be apparent. However, the strongly vegetated nature of the view will be maintained and the overall character of the view will not be affected.	NEGLIGIBLE	SLIGHT
Following Mitigation (after 15 Years): Lost vegetation will be replaced by replanting where required and natural regeneration and should be well established by this time, reinforcing the well wooded character of this area. Could result in minor benefits to the condition of the vegetation along the embankment, subject to nature of tree works required.	NEGLIGIBLE	NEUTRAL to SLIGHT

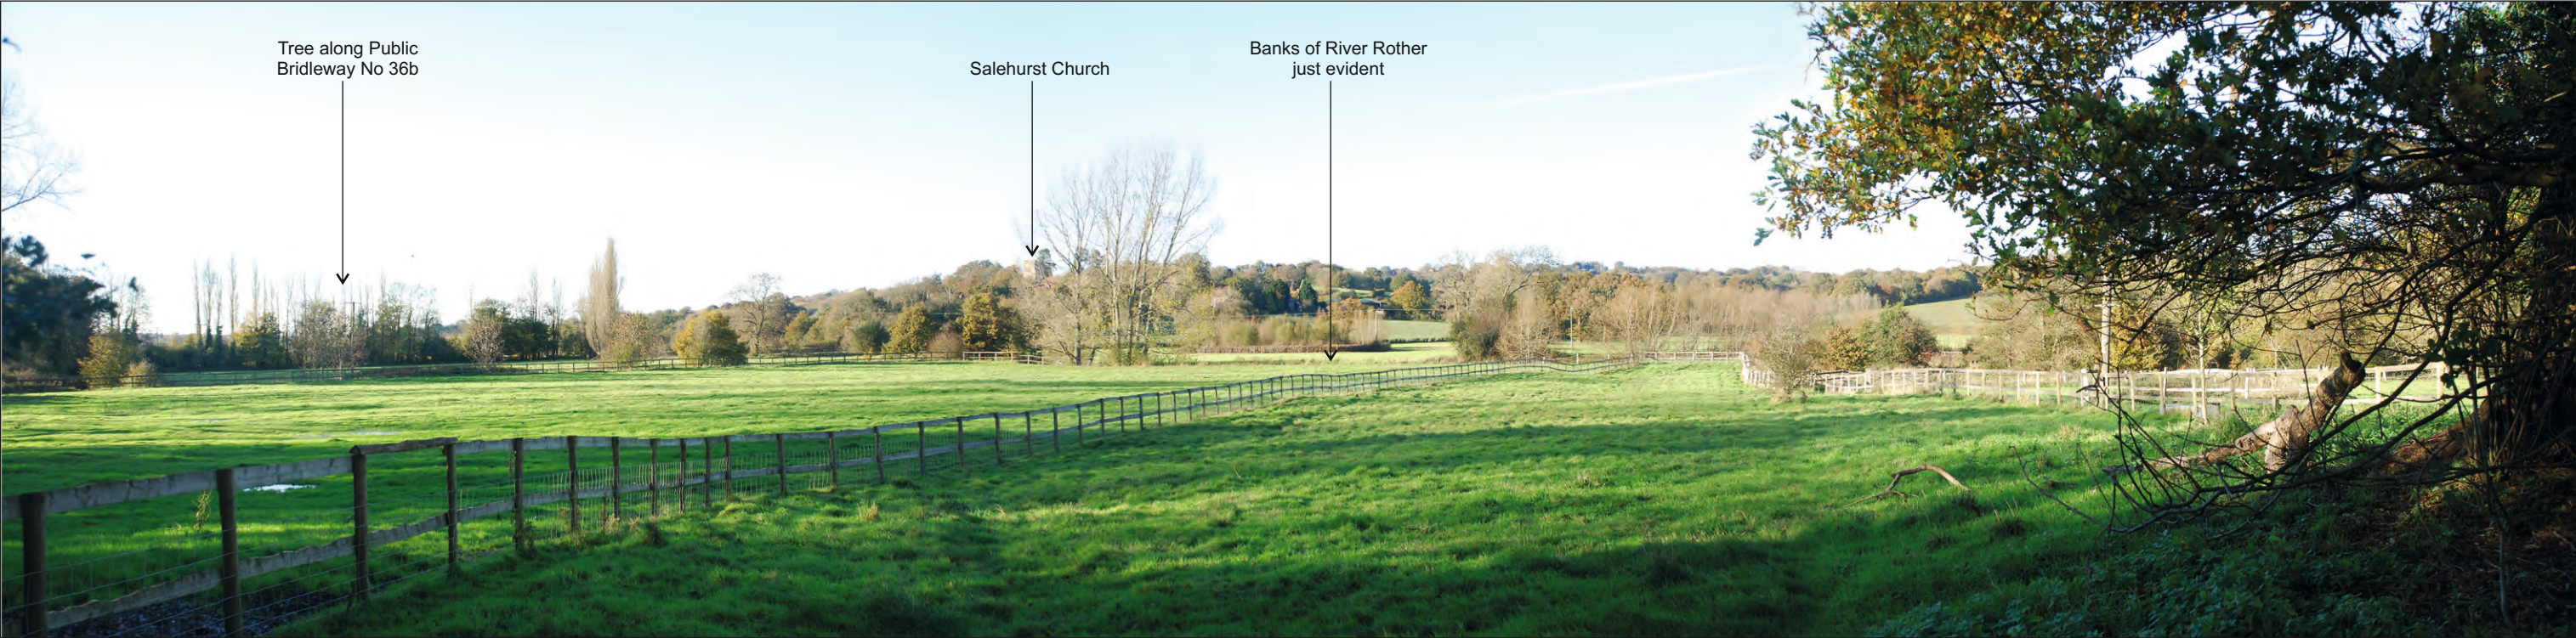
Looking north west from Public Bridleway west of Robertsbridge Abbey

Baseline Assessment	
Classification of Receptor	Description of Existing View
Location of Viewpoint: Public Bridleway to the west of Robertsbridge Abbey (as there is no public access to the Abbey this is the closest public viewpoint)	Foreground: The sloping pastureland towards the floodplain and fencing demarcating the edge of the Scheduled Ancient Monument forms the foreground of this view. Middle Distance: In the centre of the view, the banks of the River Rother can be seen, quite sparsely vegetated along this stretch. Behind this, there are glimpses of the disused railway vegetation through the gap in the centre of the view. To the left Public Bridleway no 36b appears well vegetated along this section, with poplars appearing quite distinctly in the view. Far Distance: In the distance, Salehurst Church can be glimpsed behind the well vegetated edge of Salehurst, with the wooded hills to the north west beyond.

Number / Type of Receptors: Small number of people using the Public Right of Way, local residents at the Abbey	
Direction of View: North west	
Distance from Scheme: 250m	
Approximate Elevation: 20m AOD	
Sensitivity of Receptor: HIGH	Existing Character: This viewpoint is on the edge of the land forming the setting to the remains of Robertsbridge Abbey. The channel of the River Rother is relatively open in this view, so there is some limited inter-visibility with St Mary's Church in Salehurst.

Assessment of Landscape and Visual Impacts		
Description of Impact	Magnitude of Impact	Significance of Impact
During Construction: The construction of short section of the reinstated low embankment will just be visible beyond the open channel of the river between areas of intervening vegetation.	MINOR	SLIGHT
Following Completion of Works: Glimpse views of reinstated track-bed would be available, with fencing visible along the base of the embankment. However, as the proportion of view affected is very limited this will not have an adverse influence on the overall character of the view. Bridge 21, possibly some of 22 may be visible and a farm access crossing may be visible in glimpses, partially screened by vegetation.	NEGLIGIBLE to MINOR	SLIGHT
Following Mitigation (after 15 Years): Hedgerow planting along the base of the embankment should be well established by this stage and will integrate the restored track-bed into the landscape in a manner compatible with the existing nature of surrounding landscape, reinforcing the character of the AONB. Replacement trees as required should be well established by this stage and screening lower level views. Impacts on the setting to Robertsbridge Abbey are considered by the Archaeology and Cultural Heritage Chapter.	NEGLIGIBLE to MINOR	NEUTRAL

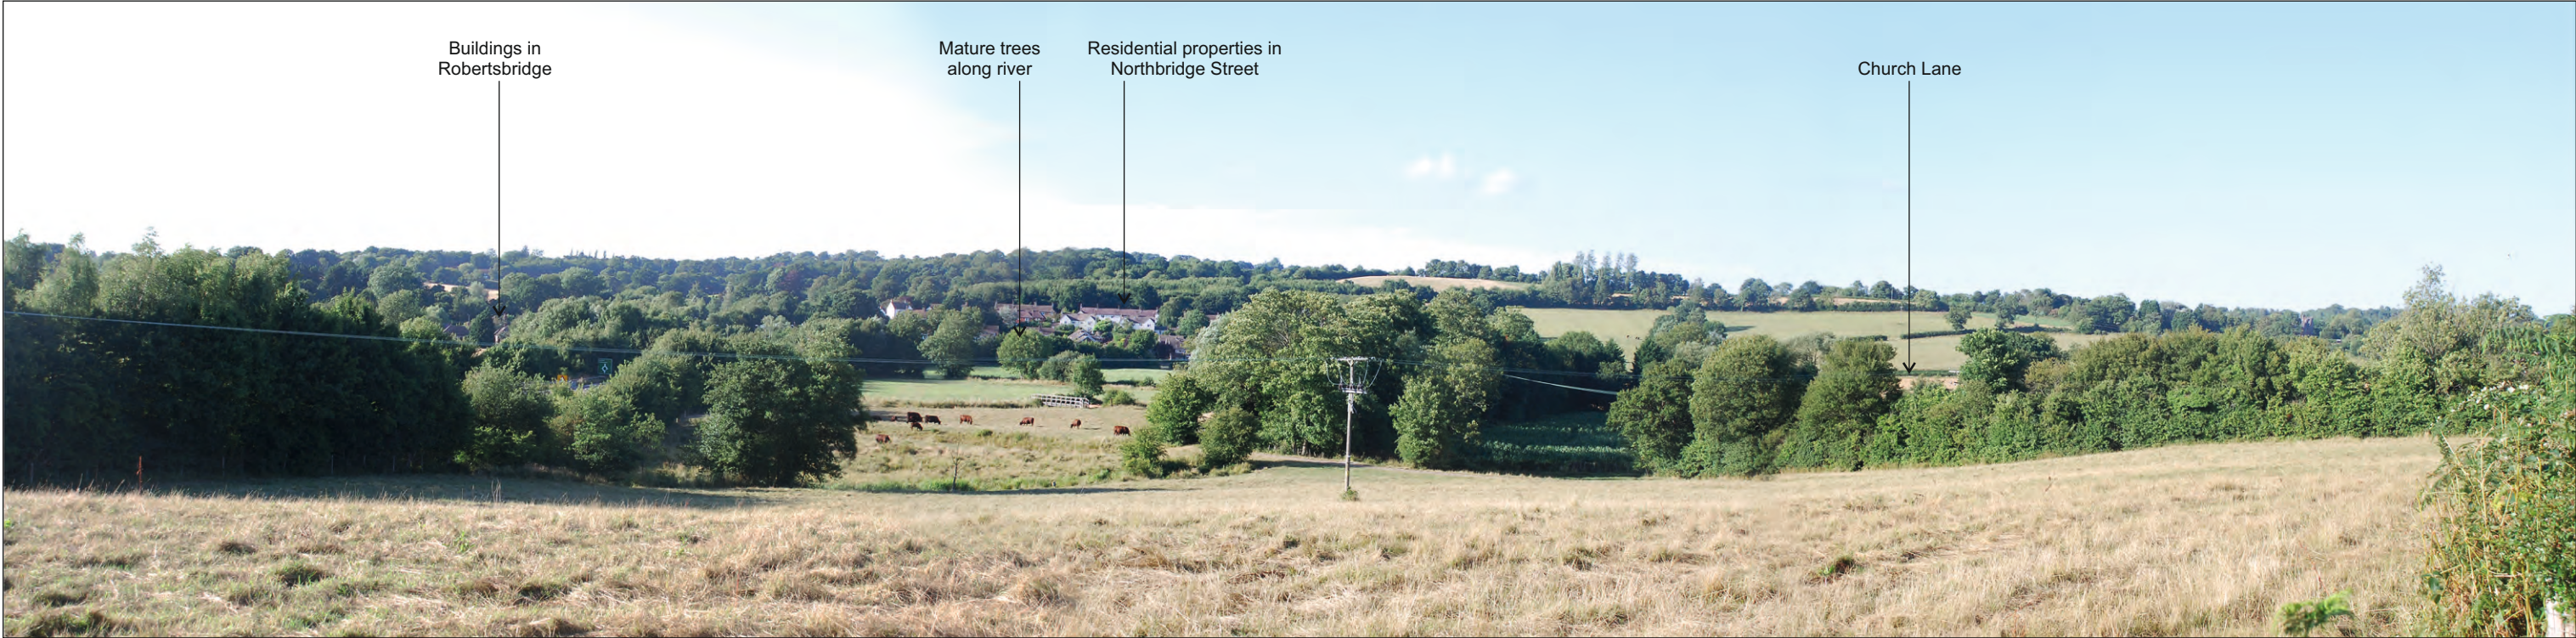
Looking north from Fair Lane west of Redlands

Baseline Assessment	
Classification of Receptor	Description of Existing View
Location of Viewpoint: Field gateway on Fair Lane west of Redlands	Foreground: The foreground shows the edge of the gateway hedge and rough pasture sloping towards the floodplain. Middle Distance: To the right of the view, Church Lane can be glimpsed through the layers of vegetation. There are upper storeys of residential properties in Northbridge Street in the centre of the view and some at Robertsbridge which are only just visible to the left. Mature trees along the river can be seen in front of the residential properties. The route of the former railway runs across the central, greener fields in the view, visible due to the topography from this location. Far Distance: On the skyline are the well wooded and tall hedgerows on hills to the north of the floodplain.
Number / Type of Receptors: Local residents in cars / Few walkers using minor road

Direction of View: North	
Distance from Scheme: 300m	
Approximate Elevation: 15m AOD	Existing Character: The well vegetated A21 corridor, mature trees along the river, hedgerows and woodland belts and the wooded skyline all contribute to the well wooded character of this landscape, allowing only glimpse views through to the valley floor.
Sensitivity of Receptor: MEDIUM

Assessment of Landscape and Visual Impacts		
Description of Impact	Magnitude of Impact	Significance of Impact
During Construction: Construction activities along short section of the reinstated embankment will be visible beyond the open channel of the river. Construction works would be seen in context of existing buildings in Northbridge Street. There may vegetation loss to create crossing and bridge, but this is unlikely to be clearly noticeable from this location.	MINOR	SLIGHT
Following Completion of Works: Reinstated low embankment with fencing along the base forms a perceptible change to the composition, partially screening lower level views beyond the river. Views towards the skyline beyond are not adversely affected. Bridge 12 and the farm access bridge would be just visible but in the context of the settlement edge beyond.	MINOR	SLIGHT
Following Mitigation (after 15 Years): Views of reinstated track-bed still available, but this will not have an adverse influence on the overall character of the view. Hedgerow planting and replacement tree planting would be well established by this time, further integrating the embankment into the pattern of this well wooded landscape.	MINOR	SLIGHT

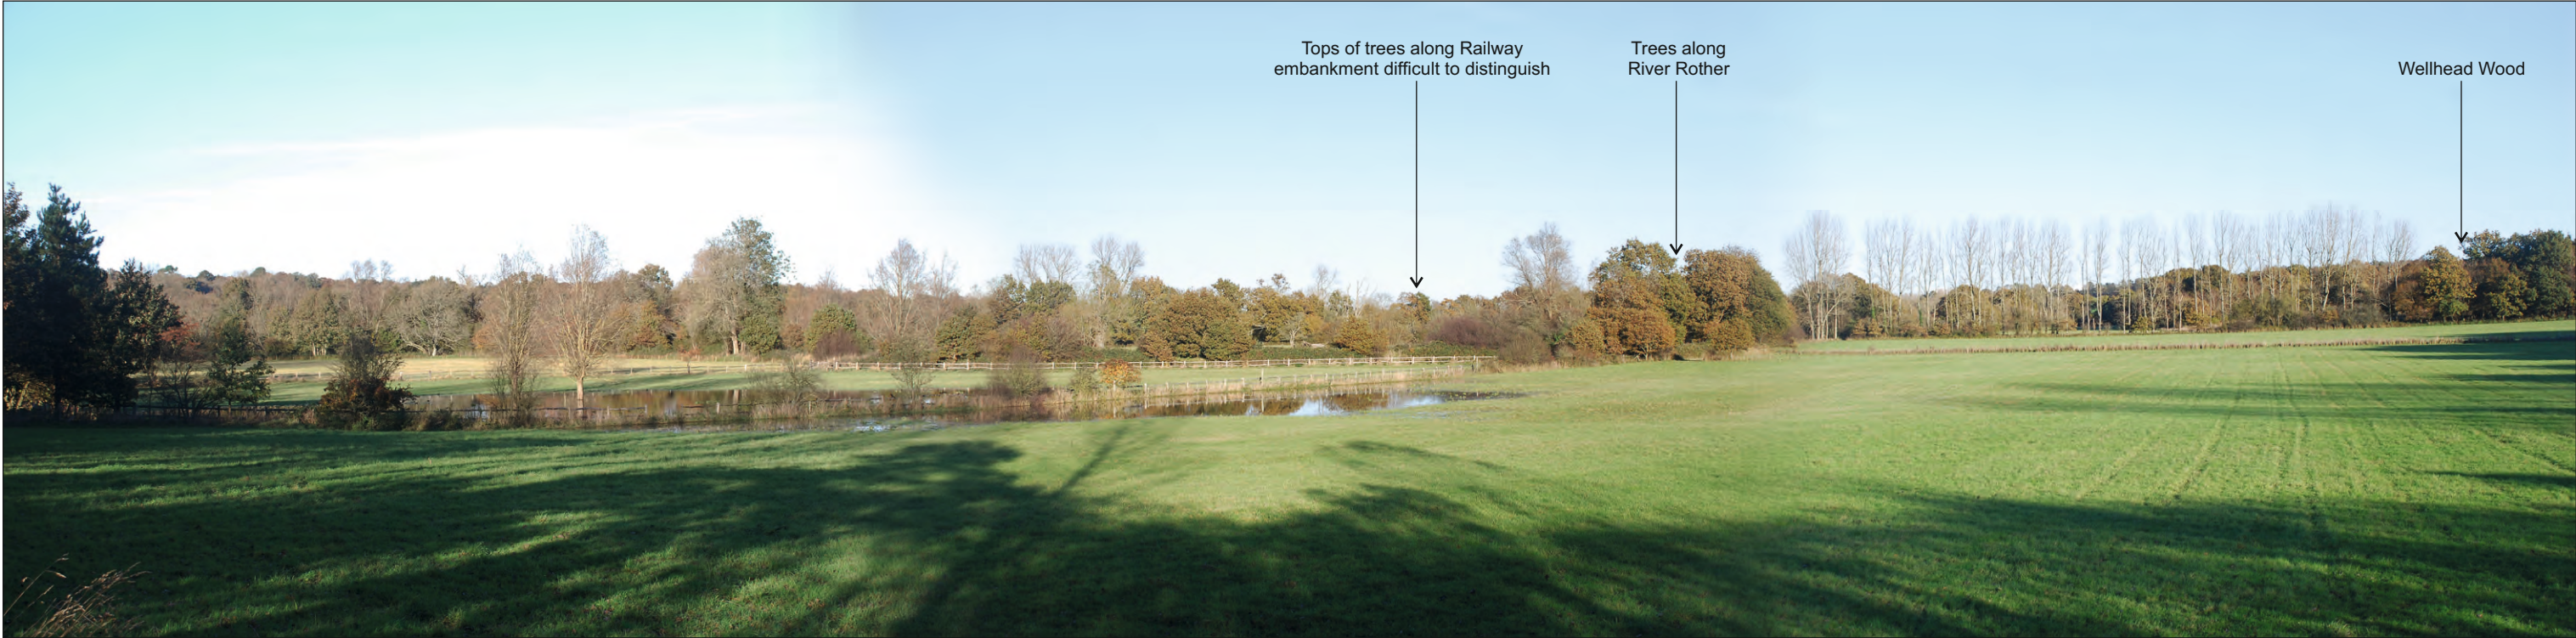
Looking north east from junction of Public Footpaths 4 and 5c

Baseline Assessment	
Classification of Receptor	Description of Existing View
Location of Viewpoint: Looking towards trees along River from Public Bridleway No.4 to north of Ivy Cottage	Foreground: Open views of arable and pasture form the foreground to this view. Middle Distance: In the centre, mature trees and vegetation can be seen along the River Rother and on the right of the view is Wellhead Wood. These groups of vegetation knit into the wider pattern of vegetation and contribute to the well wooded character of the landscape. Far Distance: The tops of trees along the former railway embankment are hard to distinguish against the generally wooded skyline. Existing Character: The well-vegetated nature of the river corridor contributes strongly to the character of the surrounding landscape, and screens almost all views towards the alignment of the railway.
Number / Type of Receptors: Few users of Public Bridleway

Direction of View: North East	
Distance from Scheme: 450m	
Approximate Elevation: 30m AOD	
Sensitivity of Receptor: HIGH

Assessment of Landscape and Visual Impacts		
Description of Impact	Magnitude of Impact	Significance of Impact
During Construction: Views towards existing embankment predominantly screened by vegetation along river, but some limited construction activity may just be visible in winter beyond the vegetation along the river. It has been assumed that it will not be necessary to remove the mature trees from the sides of the embankment to reinstate the track-bed.	NEGLECTIBLE to MINOR	SLIGHT
Following Completion of Works: Reinstated track bed will not be visible, but any necessary loss of vegetation from former alignment may still just be apparent. However, the strongly vegetated nature of the view will be maintained and the overall character of the view will not be affected.	NEGLECTIBLE	SLIGHT
Following Mitigation (after 15 Years): Any replanting of lost vegetation required or natural regeneration of vegetation will be well established by this stage and would contribute to the character of the surrounding landscape. Could result in minor benefits, subject to nature of tree works along the existing embankment.	NEGLECTIBLE	NEUTRAL
