**THE NETWORK RAIL
(SUFFOLK LEVEL CROSSING REDUCTION)
ORDER**

PROOF OF EVIDENCE

JOHN PREST

Document Reference	NR/31/1
--------------------	---------

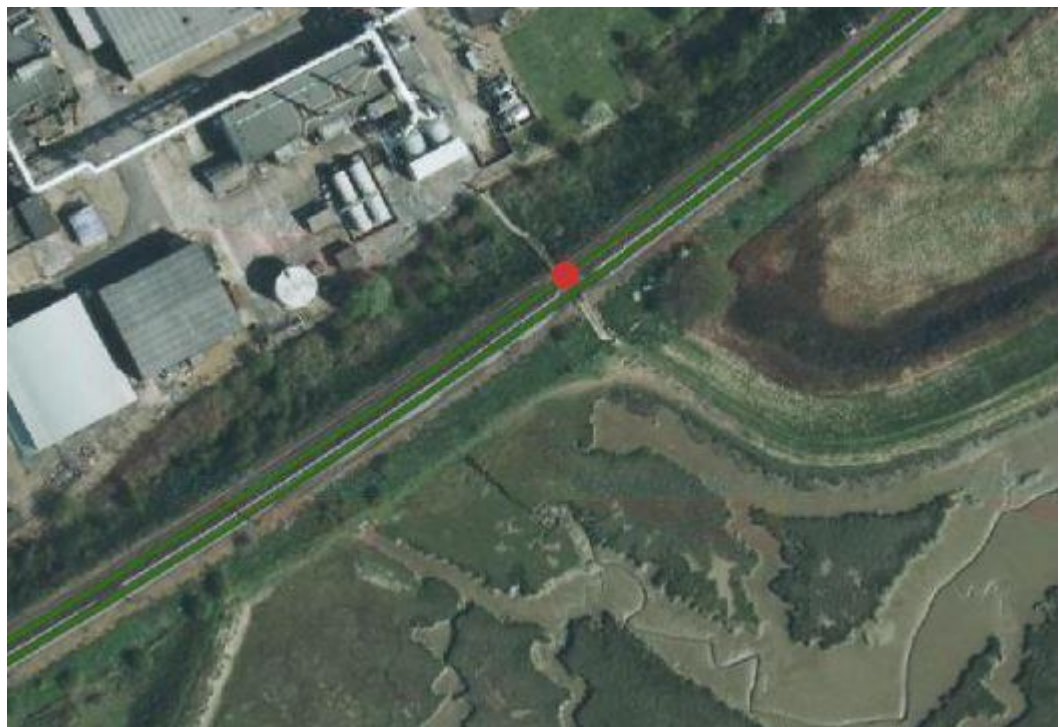
6. S01 – Sea Wall

- 6.4. The track on the left is the down line from London and the track on the right is the up line to London. Trains would normally run down from London on the left hand line that is from the bottom of the picture to the top. Trains would normally run up to London on the right hand line, which is from the top of the picture to the bottom.
- 6.5. Below photos shows the field to field approach to the crossing.

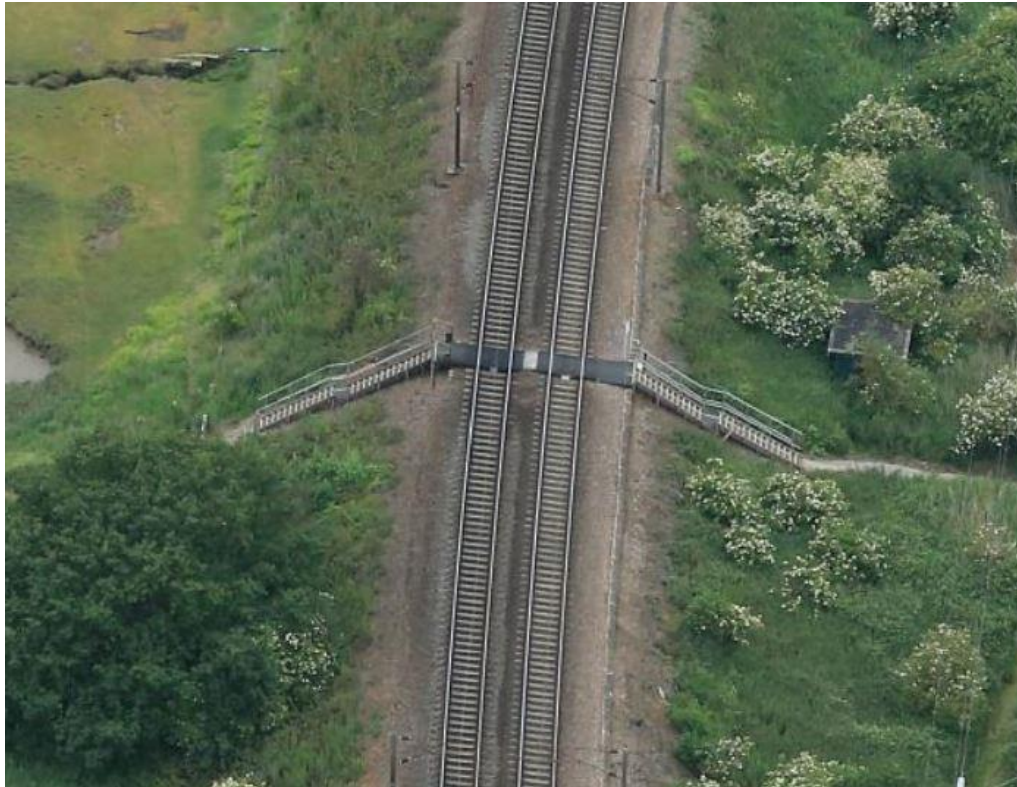
- 6.6. Sea Wall level footpath crossing is a 'Passive' crossing, meaning that there is no direct method of warning people who use the crossing of approaching trains. It is not controlled, or equipped with lights, or any automatic audible warning system other than whistle boards, which I discuss further below. The location and geography of the crossing means that it is therefore necessarily reliant upon users to 'stop look and listen' to check for approaching trains, ensuring they have sufficient time to cross and to protect their personal safety whilst traversing the line.

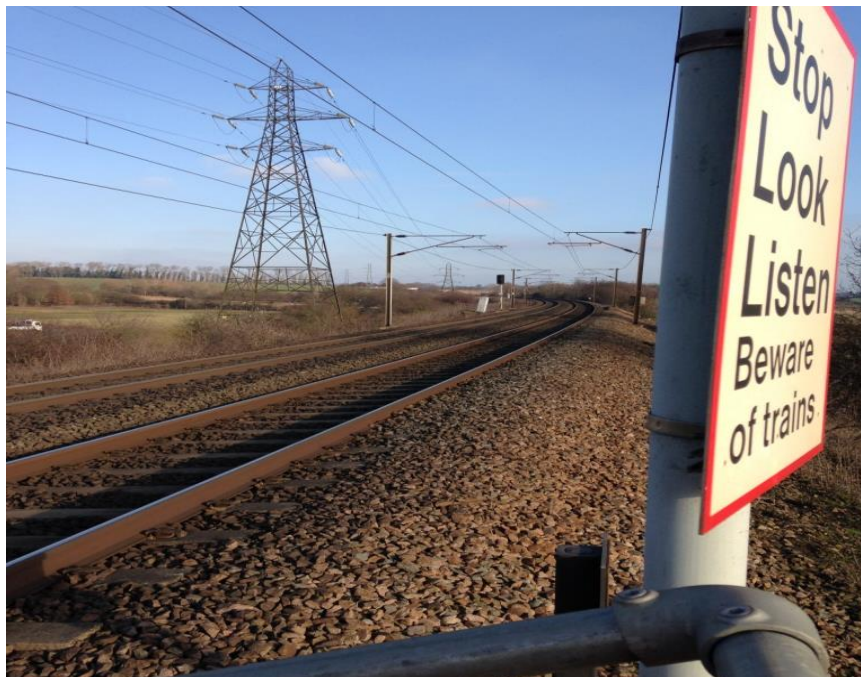
- 6.11. The photograph below is taken on the upside looking at train approaching in the down direction, looking south, the train usually approaches on the furthest (right hand side) set of lines.

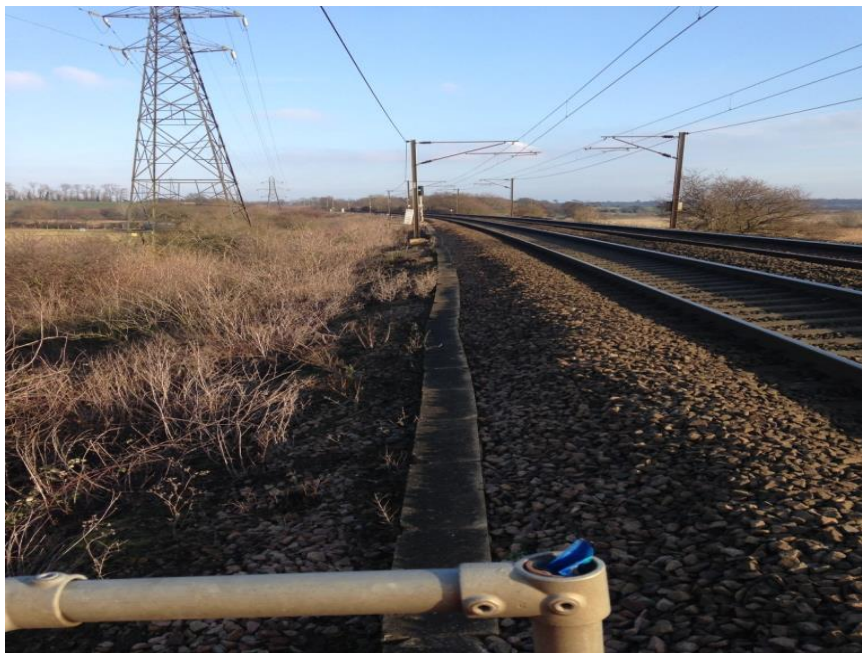
- 6.13. The photograph below is taken on the down side at a train approaching in the down direction looking south; the train usually approaches on the closest (right hand side) set of lines.

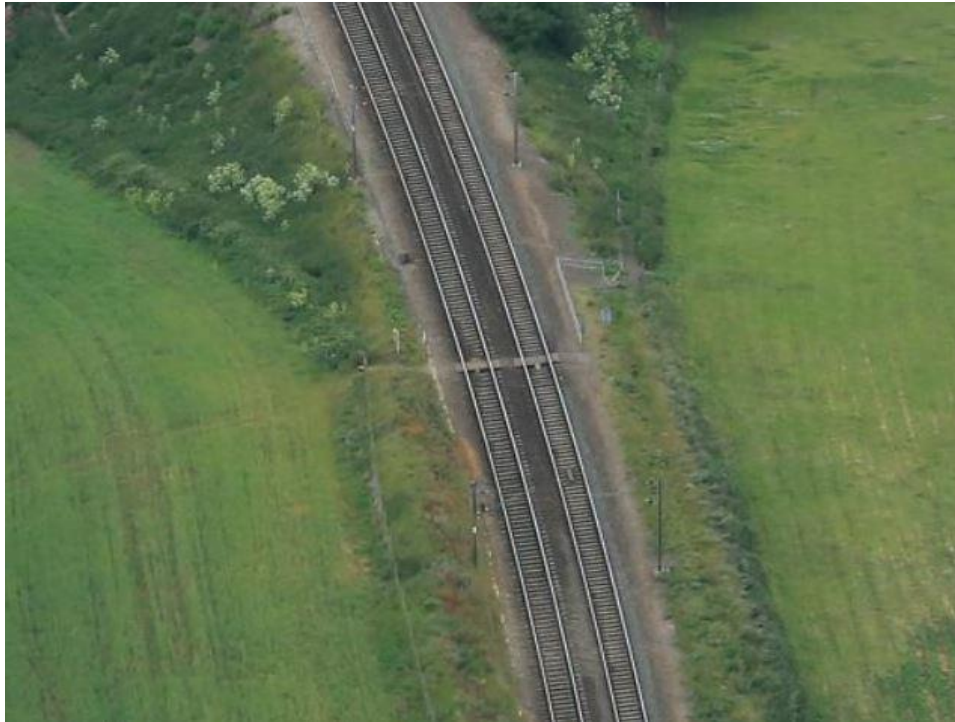
- 7.1. S02 Brantham High Bridge footpath crossing has an ALCRM score of M13, prior to the crossing being temporarily closed under TTRO in September 2016, the ALCRM score was C6 with a FWI of 0.000110097148. It is located in Brantham Parish on the LTN1 line (London Liverpool Street to Norwich) which has a line speed of 100 MPH; it is between Ipswich and Manningtree 61 miles and 74 chains from Liverpool street station London.
- 7.2. There are 204 trains per day that run for 24 hours per day over this level crossing. Additionally, there are empty stock trains that pass over the crossing. There can also be various on-track machinery and plant that pass over the crossing at any point.
- 7.3. An aerial view of S02 Brantham High Bridge crossing can be seen below.

- 7.4. The track on the left is the down line from London and the track on the right is the up line to London. Trains would normally run down from London on the left hand line that is from the bottom of the picture to the top. Trains would normally run up to London on the right hand line, which is from the top of the picture to the bottom.
- 7.5. Below photos shows the field to field approach to the crossing.

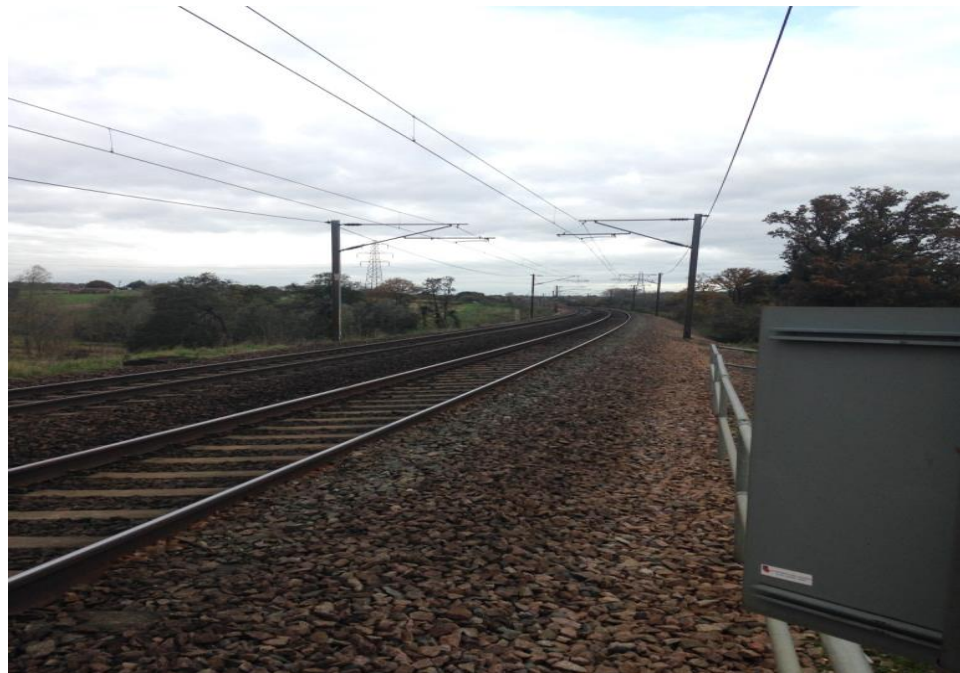
- 7.11. The photograph below is taken on the upside looking at train approaching in the down direction, looking south, the train usually approaches on the furthest (right hand side) set of lines.

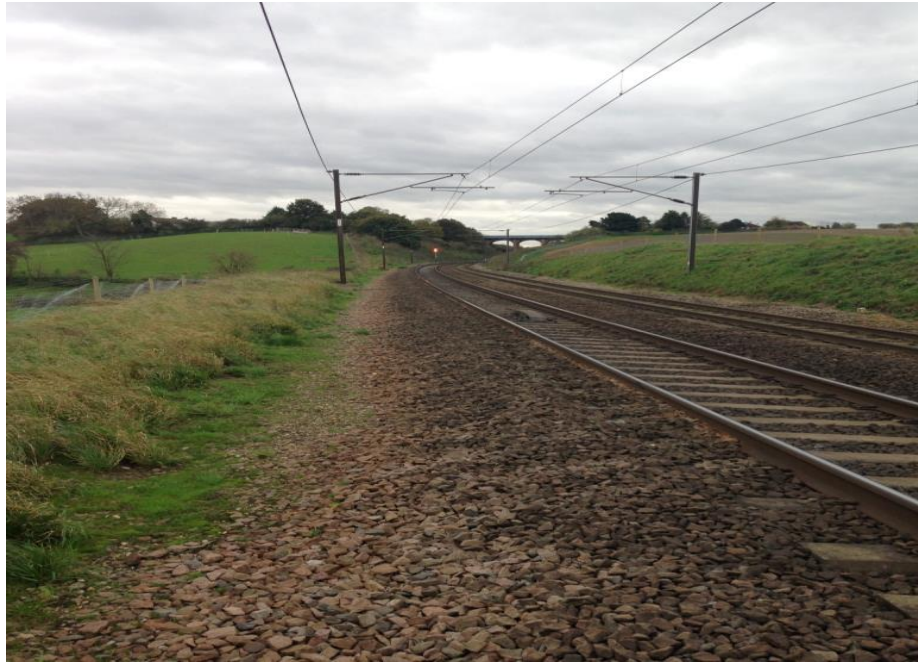
- 7.12. The photograph below is taken on the downside at a train approaching in the up direction looking north; the train usually approaches on the furthest line of the two running (central line) set of lines.

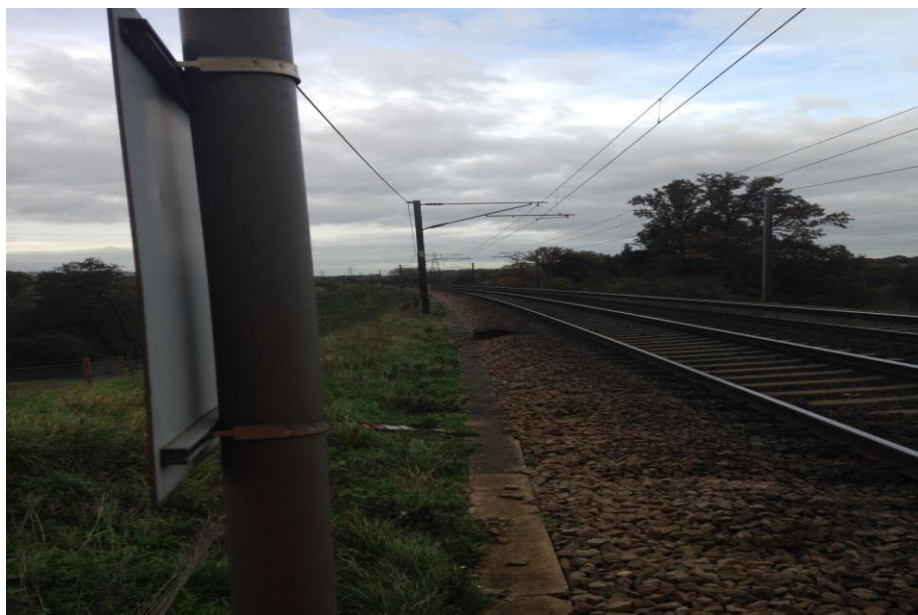
- 7.13. The photograph below is taken on the down side at a train approaching in the down direction looking south; the train usually approaches on the closest (right hand side) set of lines.

- 7.14 As can be seen from the table above (7.9), S02 Brantham High Bridge crossing does not have sufficient sighting to meet industry standards in all directions, Whistle boards are installed as mitigation. Trains regularly pass each other at this location. While on site the LCM has witnessed a train passing on the up line, while a train is approaching on the down line. The up line train completely blocks out the sound of the whistle board, when the whistle board warns a train is approaching on the down line. This is a prime example where whistle boards are not a reliable mitigation to insufficient sighting, it was for this reason it was decided this crossing had to be closed.

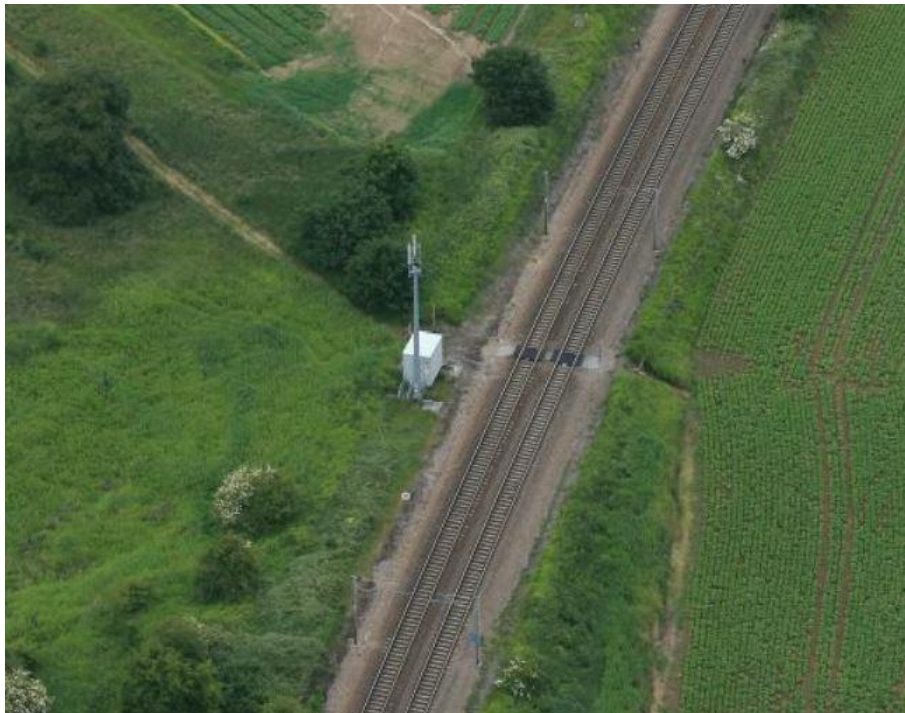
- 8.1. S03 Buxton Wood footpath crossing has an ALCRM score of C7 with an FWI of 0.000091322: it is located in Bentley Parish on the LTN1 line (London Liverpool Street to Norwich) which has a line speed of 100 MPH; it is between Ipswich and Manningtree 63 miles and 24 chains from Liverpool street station London.
- 8.2. There are 204 trains per day that run for 24 hours per day over this level crossing. Additionally, there are empty stock trains that pass over the crossing. There can also be various on-track machinery and plant that pass over the crossing at any point.
- 8.3. An aerial view of S03 Buxton Wood crossing can be seen below.

- 8.4. The track on the left is the down line from London and the track on the right is the up line to London. Trains would normally run down from London on the left hand line that is from the bottom of the picture to the top. Trains would normally run up to London on the right hand line, which is from the top of the picture to the bottom.
- 8.5. Below photos shows the field to field approach to the crossing.

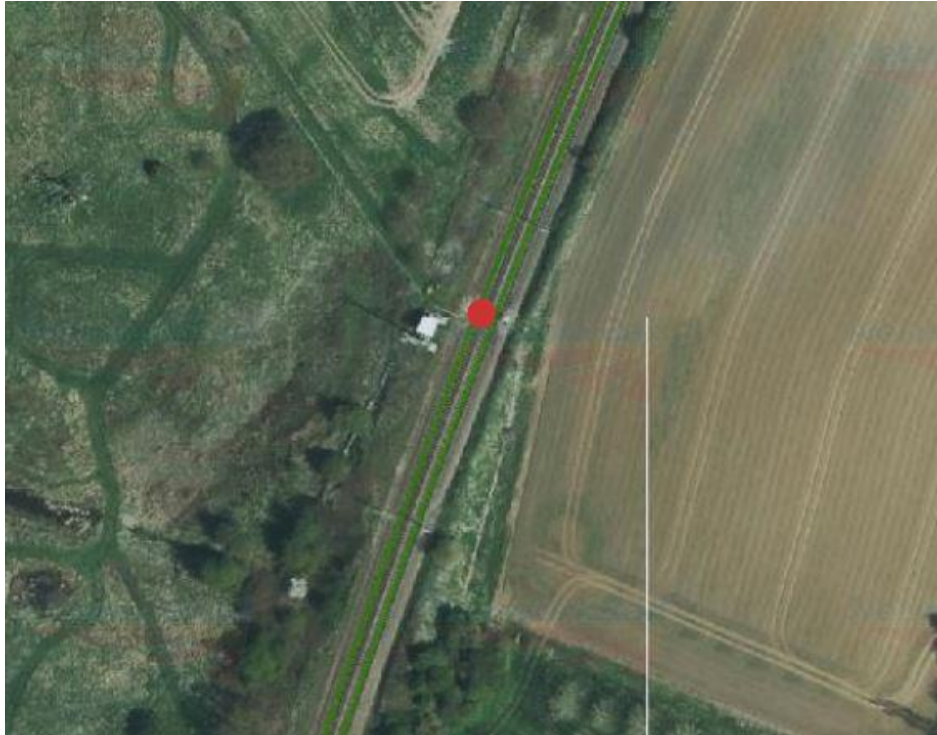
- 8.6. S03 Buxton Wood level crossing is a 'Passive' crossing, meaning that there is no direct method of warning people who use the crossing of approaching trains. It is not controlled, or equipped with lights, or any automatic audible warning systems. The location and geography of the crossing means that it is therefore necessarily reliant upon users to 'stop look and listen' to check for approaching trains, ensuring they have sufficient time to cross and to protect their personal safety whilst traversing the line.

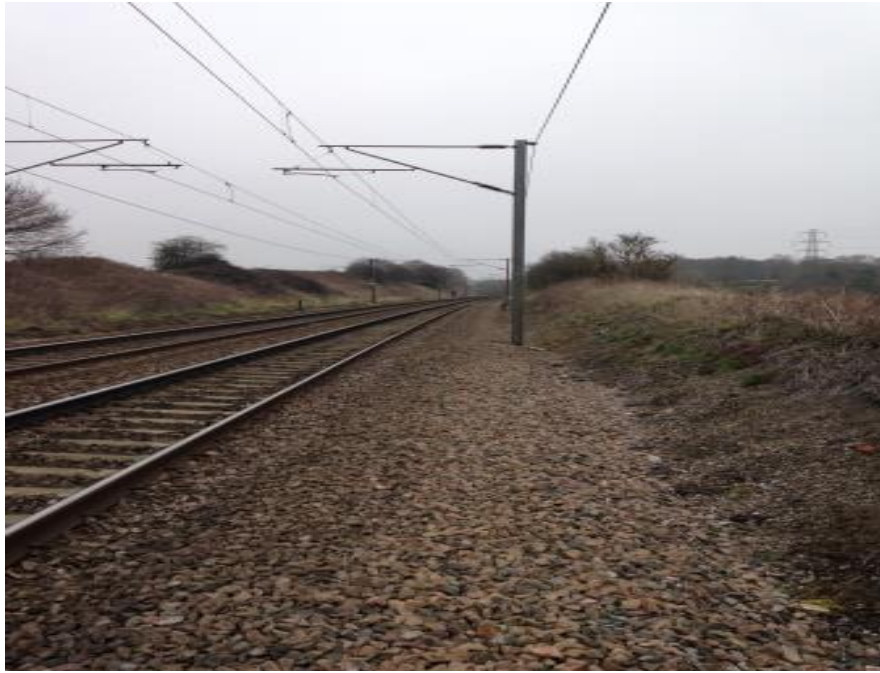
- 8.11. The photograph below is taken on the upside looking at train approaching in the down direction, looking south, the train usually approaches on the furthest (right hand side) set of lines.

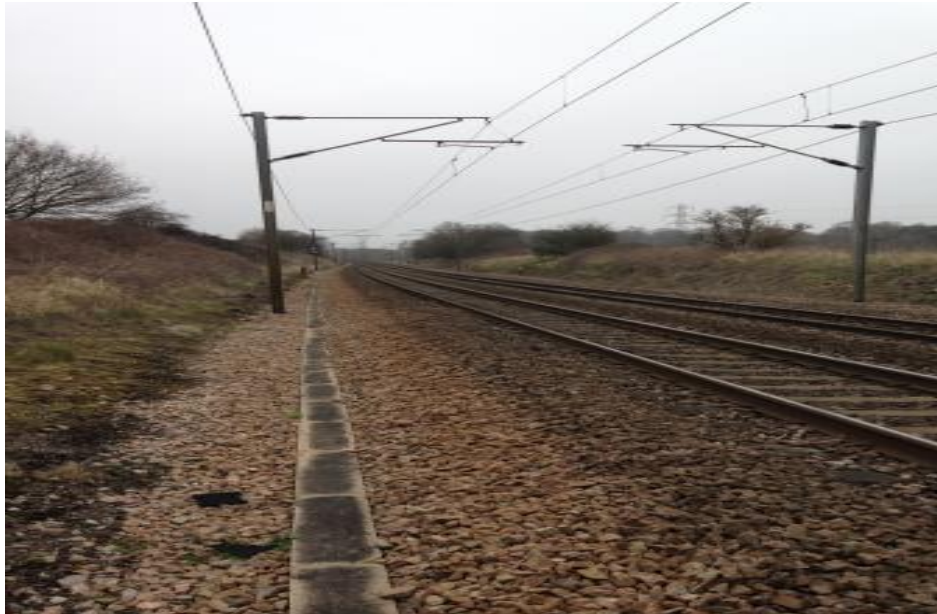
- 8.13. The photograph below is taken on the down side at a train approaching in the down direction looking south; the train usually approaches on the closest (right hand side) set of lines.

- 8.14. As can be seen from the table above, S03 Buxton wood crossing does have sufficient sighting to meet industry standards in all directions, if vulnerable users were to be identified the crossing would have insufficient sighting and a temporary speed restriction would be required. The OHL (overhead line cables) stations and the track curvature can make seeing a train approaching more difficult than a usual crossing.

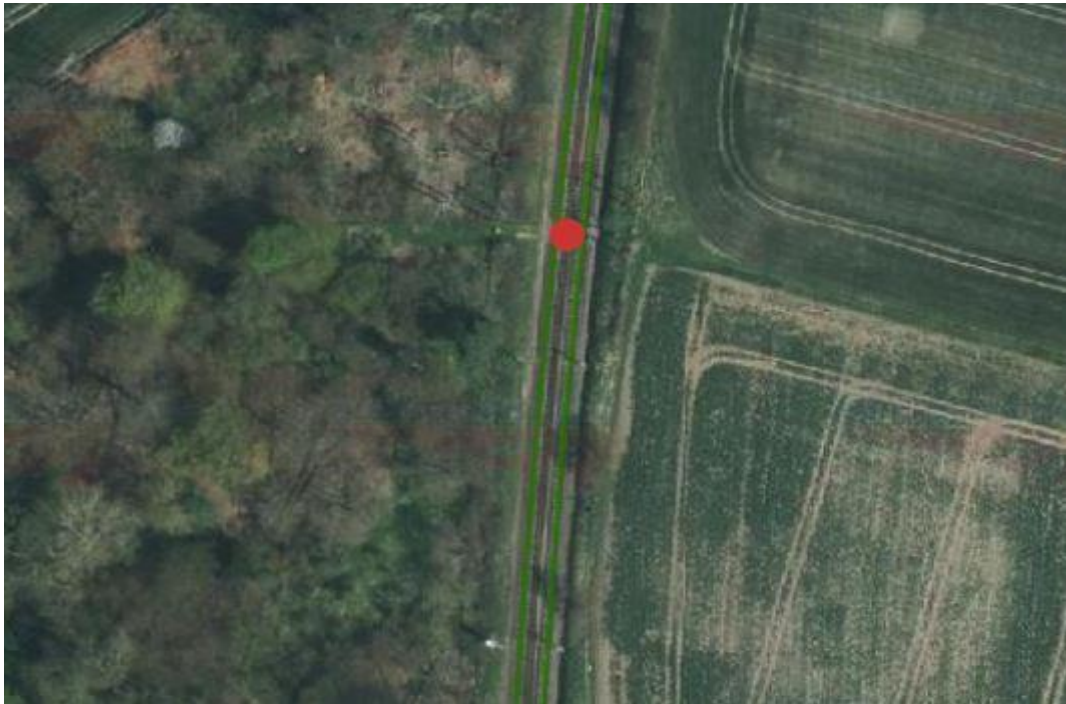
- 9.1. S04 Island footpath crossing has an ALCRM score of C6 with an FWI of 0.000189461: it is located in Bentley Parish on the LTN1 line (London Liverpool Street to Norwich) which has a line speed of 100 MPH; it is between Ipswich and Manningtree 64 miles and 04 chains from Liverpool street station London.
- 9.2. There are 204 trains per day that run for 24 hours per day over this level crossing. Additionally, there are empty stock trains that pass over the crossing. There can also be various on-track machinery and plant that pass over the crossing at any point.
- 9.3. An aerial view of S04 Island crossing can be seen below.

- 9.4. The track on the left is the down line from London and the track on the right is the up line to London. Trains would normally run down from London on the left hand line that is from the bottom of the picture to the top. Trains would normally run up to London on the right hand line, which is from the top of the picture to the bottom.
- 9.5. Below photos shows the field to field approach to the crossing.

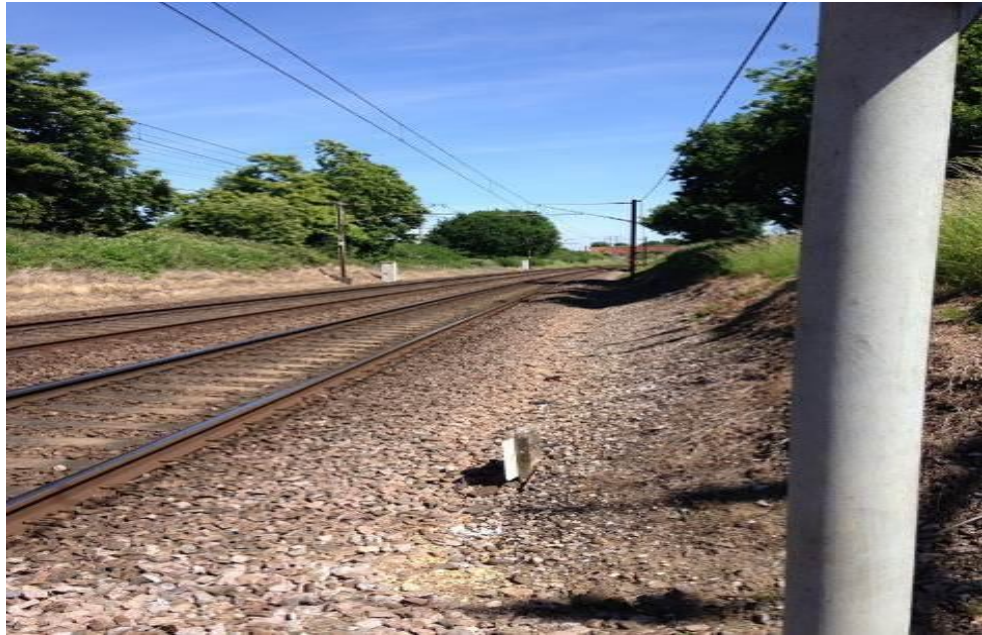
- 9.11. The photograph below is taken on the upside looking at train approaching in the down direction, looking south, the train usually approaches on the furthest (right hand side) set of lines.

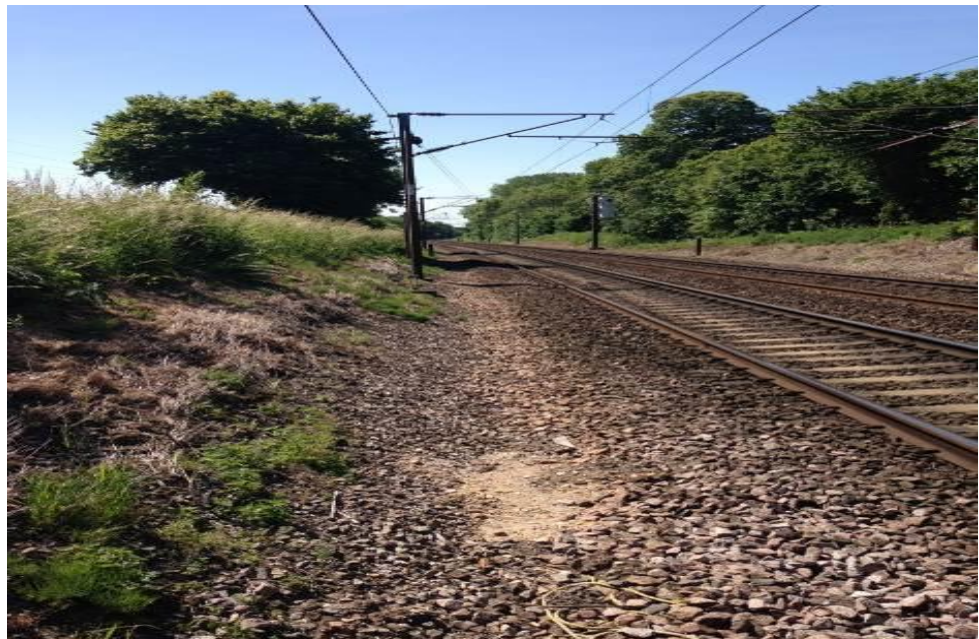
- 9.12. The photograph below is taken on the downside at a train approaching in the up direction looking north; the train usually approaches on the furthest line of the two running (central line) set of lines.

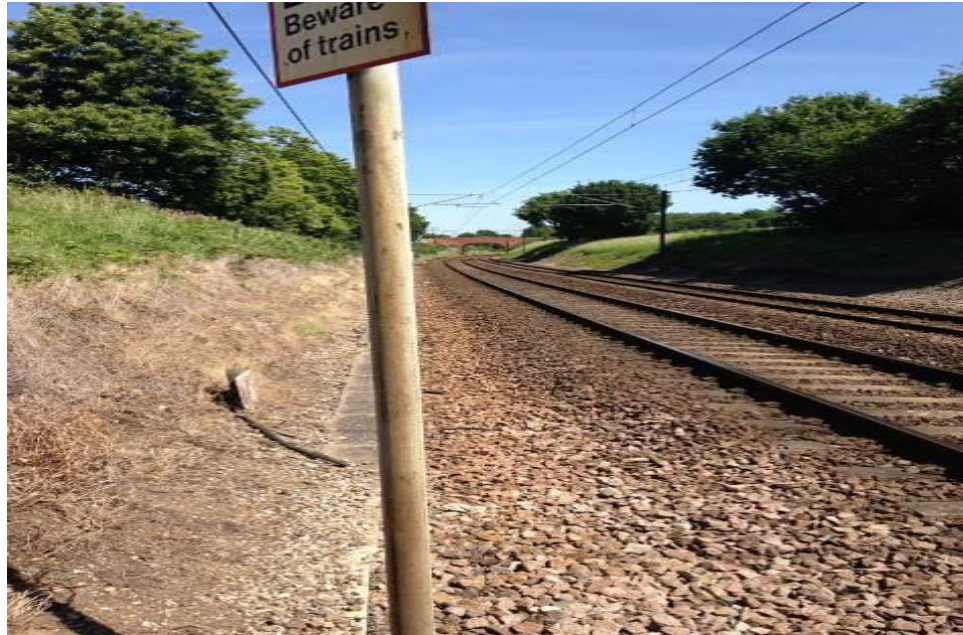
- 9.13. The photograph below is taken on the down side at a train approaching in the down direction looking south; the train usually approaches on the closest (right hand side) set of lines.

- 9.14. As can be seen from the table above (9.9), S04 Islands crossing does not have sufficient sighting to meet industry standards in all directions, Islands crossing has insufficient sighting on one out of the four approaches and the crossing is situated in a cutting, as you can see from the pictures the view of an approaching train is incredibly limited. Whistle boards are in place and COVTEC is also installed. The crossing is situated in the centre of a 'S' bend in an area where other crossings also

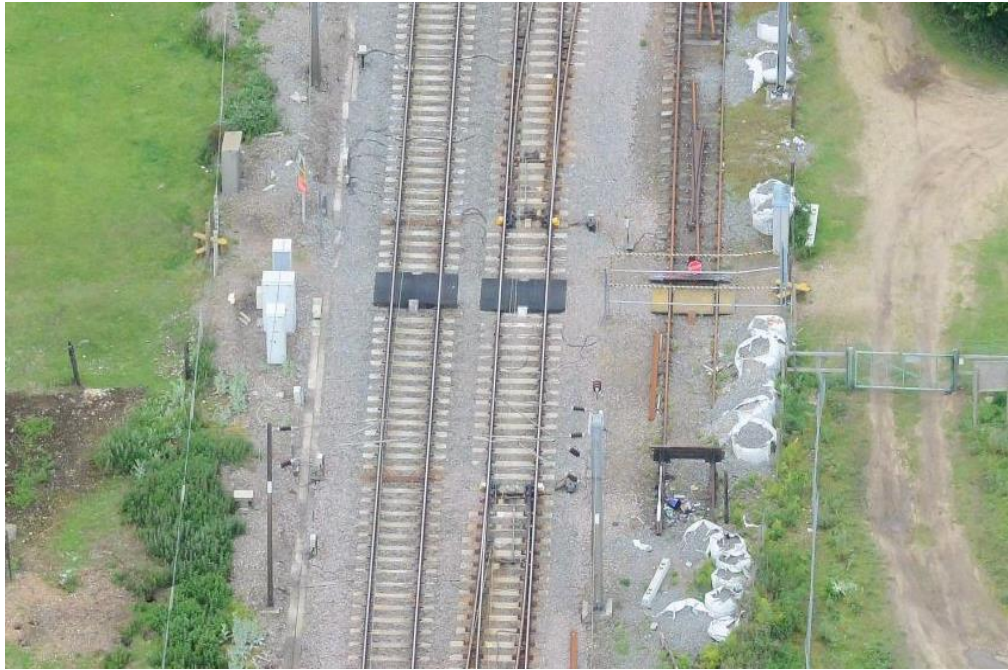
- 10.1. S07 Broomfield footpath crossing has an ALCRM score of C4 with an FWI of 0.001250089; it is located in Barham on the LTN1 line (London Liverpool Street to Norwich) which has a line speed of 100 MPH; it is between Ipswich and Stowmarket 74 miles and 14 chains from Liverpool street station London.
- 10.2. There are 207 trains per day that run for 24 hours per day over this level crossing. Additionally, there are empty stock trains that pass over the crossing. There can also be various on-track machinery and plant that pass over the crossing at any point.
- 10.3. An aerial view of S07 Broomfield footpath crossing can be seen below.

10.4. The track on the left is the down line from London and the track on the right is the up line to London. Trains would normally run down from London on the left hand line that is from the bottom of the picture to the top. Trains would normally run up to London on the right hand line, which is from the top of the picture to the bottom.

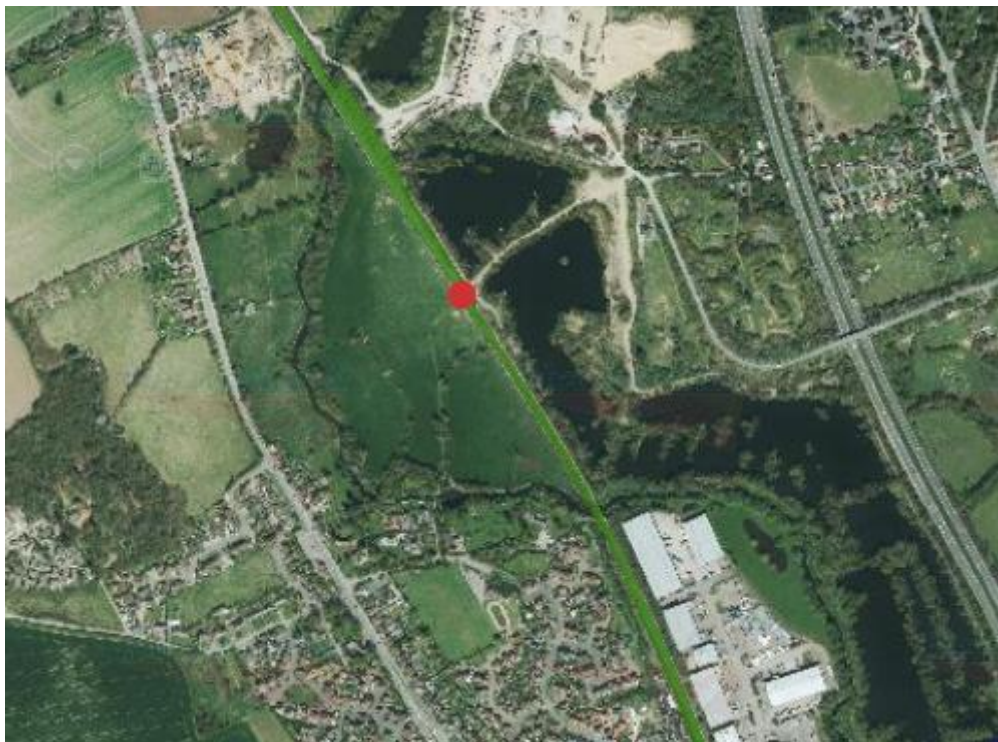
10.5. Below photos shows the field to field approach to the crossing.

- 10.6. S07 Broomfield footpath level crossing is a 'Passive' crossing, meaning that there is no direct method of warning people who use the crossing of approaching trains. It is not controlled, or equipped with lights, or any automatic audible warning systems. The location and geography of the crossing means that it is therefore necessarily reliant upon users to 'stop look and listen' to check for approaching trains, ensuring they have sufficient time to cross and to protect their personal safety whilst traversing the line.

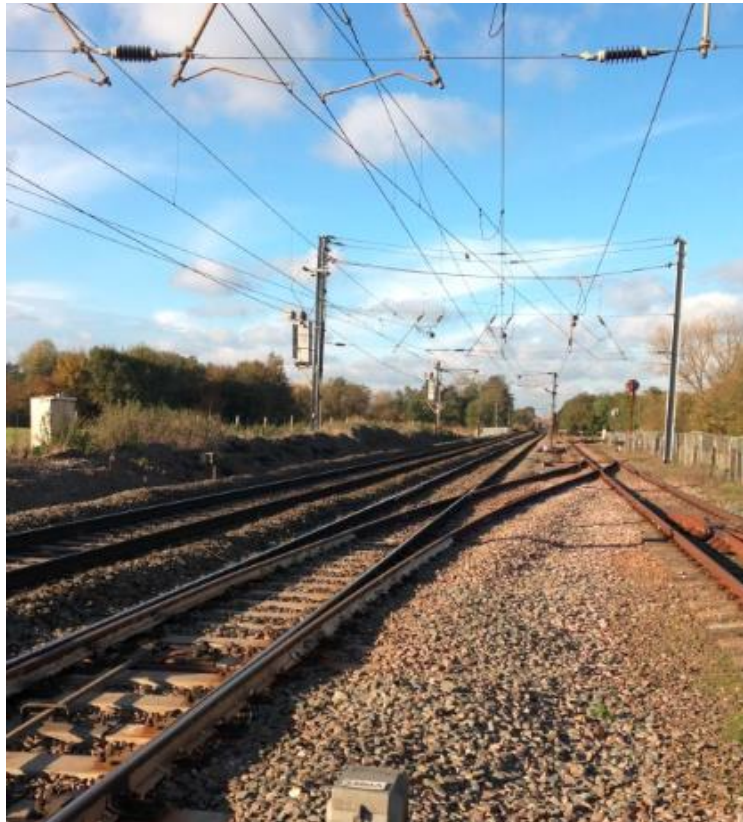
- 10.11. The photograph below is taken on the upside looking at train approaching in the down direction, looking south, the train usually approaches on the furthest (right hand side) set of lines.

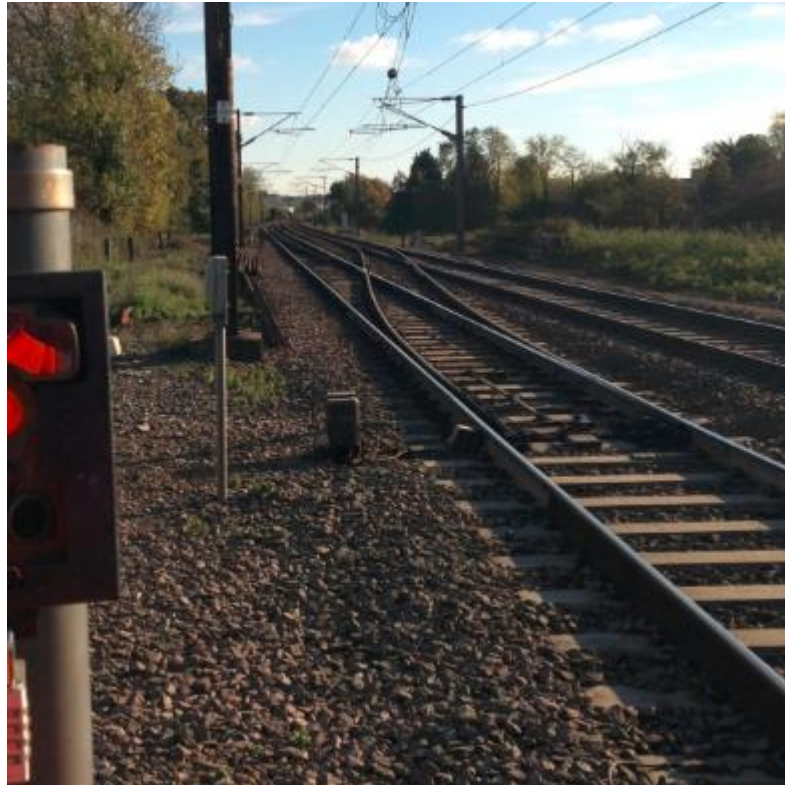
- 10.12. The photograph below is taken on the downside at a train approaching in the up direction looking north; the train usually approaches on the furthest line of the two running (central line) set of lines.

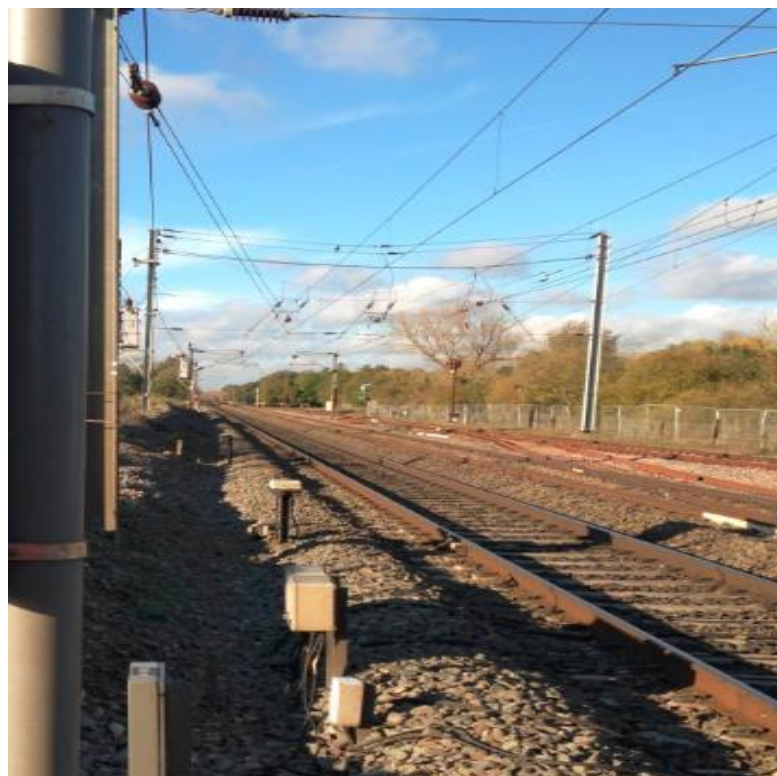
- 10.13. The photograph below is taken on the down side at a train approaching in the down direction looking south; the train usually approaches on the closest (right hand side) set of lines.

- 10.14. As can be seen from the table above (10.9), S07 Broomfield crossing does have sufficient sighting to meet industry standards in all directions

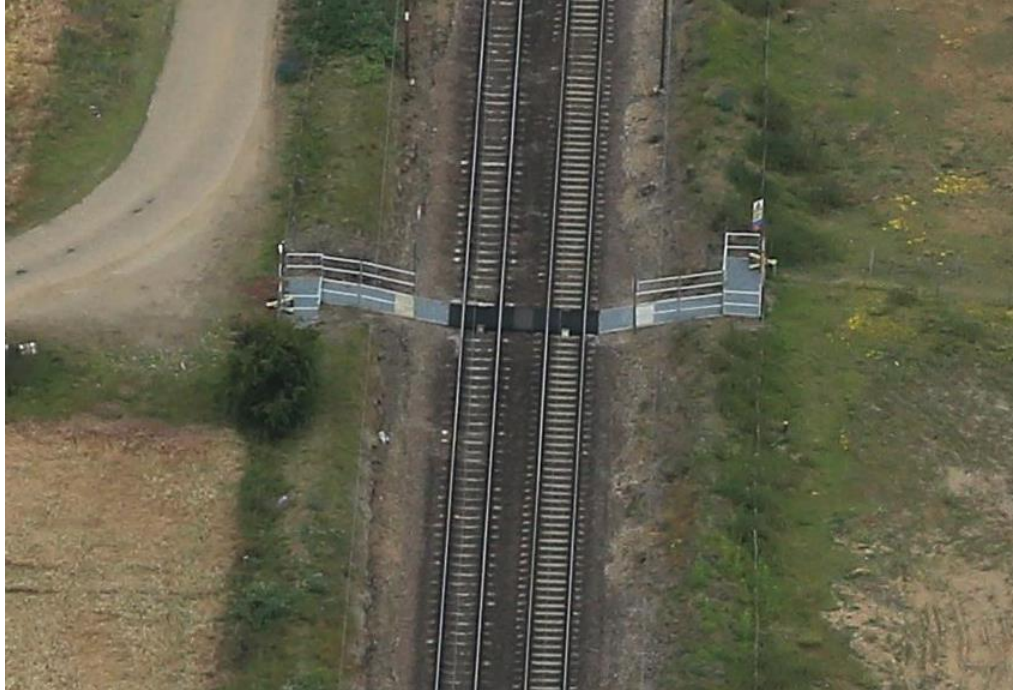
- 11.5. Below photos shows the field to field approach to the crossing.

- 11.6. S08 – Stacpools footpath level crossing is a 'Passive' crossing, meaning that there is no direct method of warning people who use the crossing of approaching trains. It is not controlled, or equipped with lights, or any automatic audible warning systems. The location and geography of the crossing means that it is therefore necessarily reliant upon users to 'stop look and listen' to check for approaching trains, ensuring they have sufficient time to cross and to protect their personal safety whilst traversing the line.

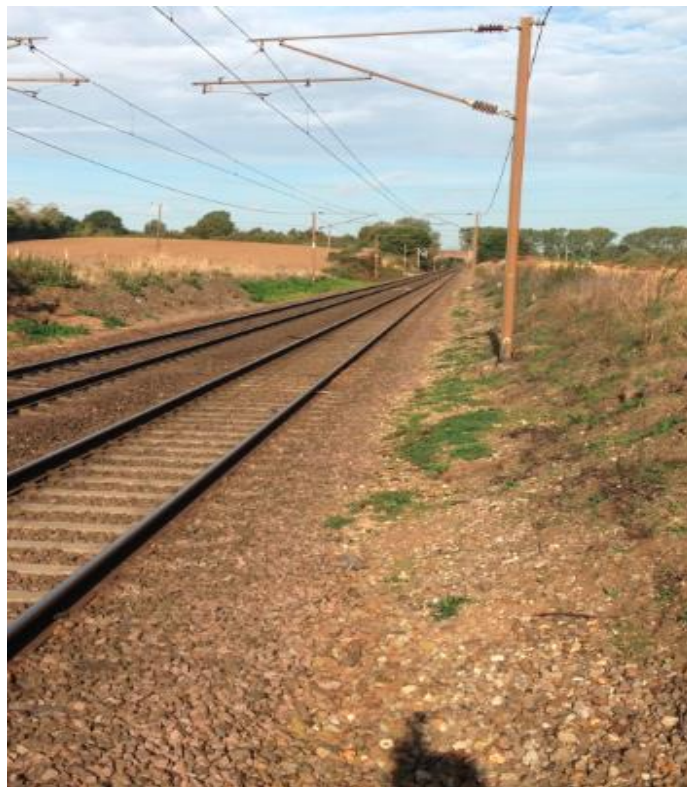
- 11.10. The photograph below is taken looking northward, from the up side at a train approaching in the up direction. The trains usually approach on the closest set of lines (right hand side).

- 11.14. As can be seen from the table above (11.9), S08 Stacpools crossing does have sufficient sighting to meet industry standards in all directions
- 11.15. As set out at section 3.31 above, following the risk assessment, an optioneering exercise was carried out to consider options for eliminating, reducing, mitigating or managing risk at this crossing. These options considered were:

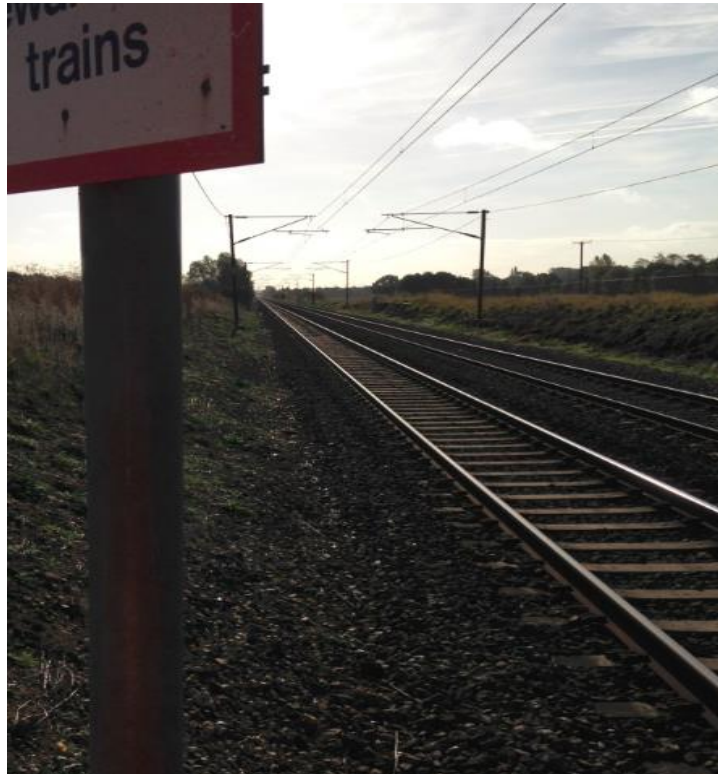
- 11.12. The photograph below is taken on the downside at a train approaching in the up direction looking north; the train usually approaches on the furthest line (right hand side) set of lines.

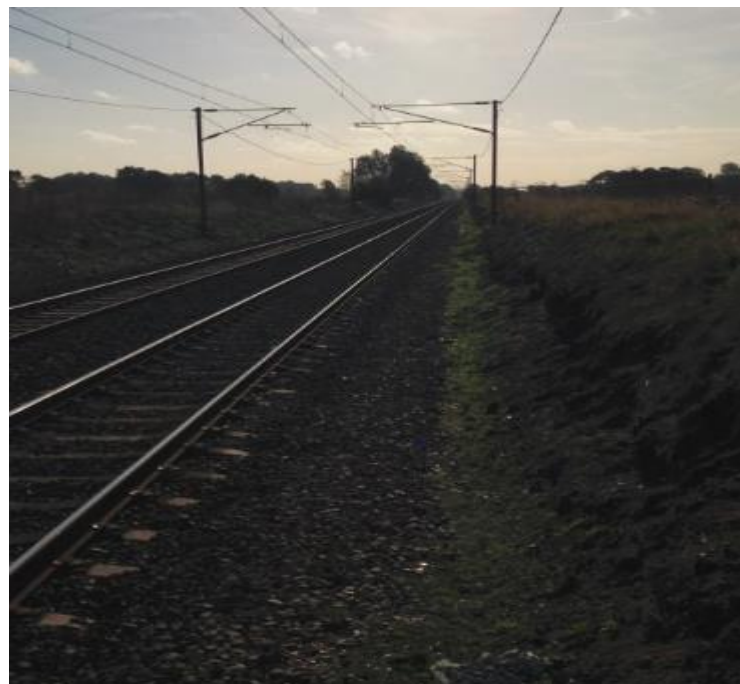
- 11.13. The photograph below is taken on the down side at a train approaching in the down direction looking south; the train usually approaches on the closest (right hand side) set of lines.

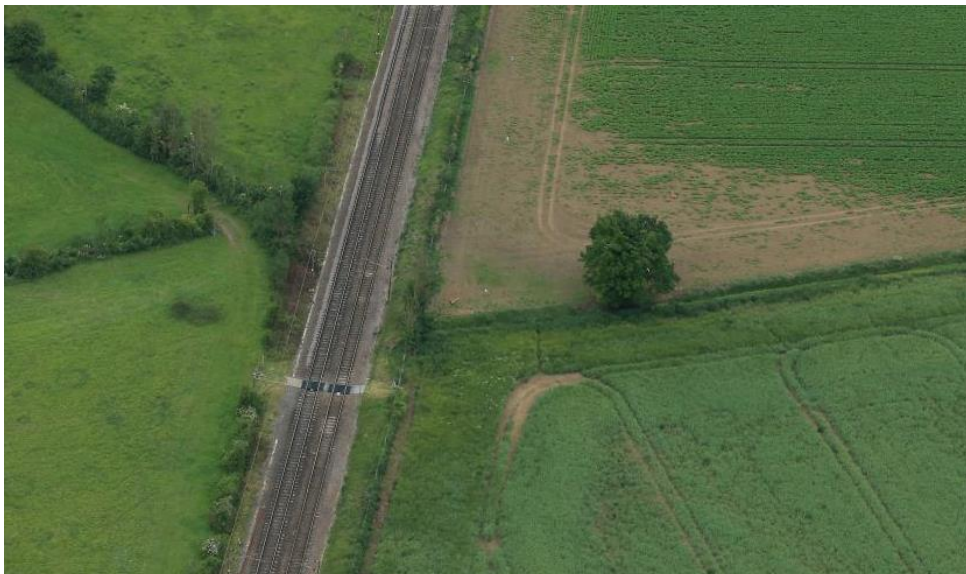
12.5. Below photos shows the field to field approach to the crossing.

12.6. S11 Leggetts level crossing is a 'Passive' crossing, meaning that there is no direct method of warning people who use the crossing of approaching trains. It is not controlled, or equipped with lights, or any automatic audible warning systems. The location and geography of the crossing means that it is therefore necessarily reliant upon users to 'stop look and listen' to check for approaching trains, ensuring they have sufficient time to cross and to protect their personal safety whilst traversing the line.

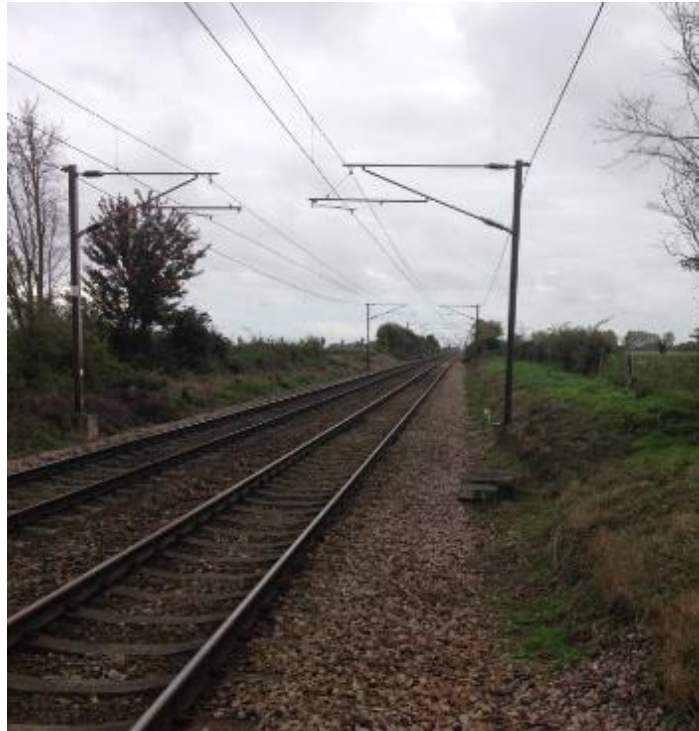
- 12.10. The photograph below is taken looking northward, from the up side at a train approaching in the up direction. The trains usually approach on the closest set of lines (right hand side).

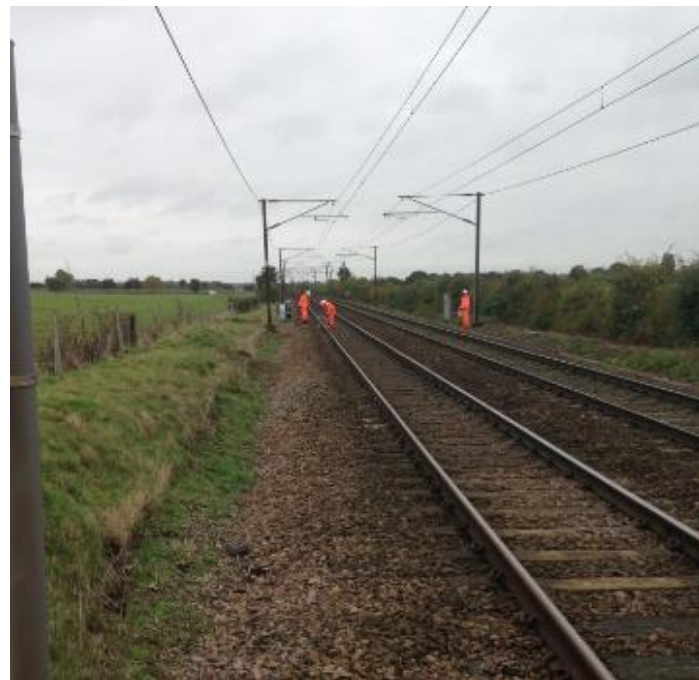
12.11. The photograph below is taken on the upside, looking south, the train usually approaches on the furthest (right hand side) set of lines.

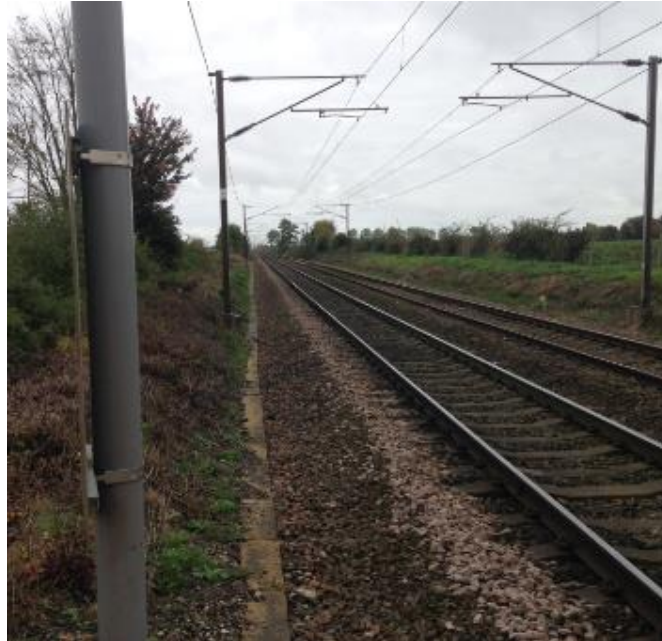
- 12.12. The photograph below is taken on the downside looking north; the train usually approaches on the closest line (right hand side) set of lines.

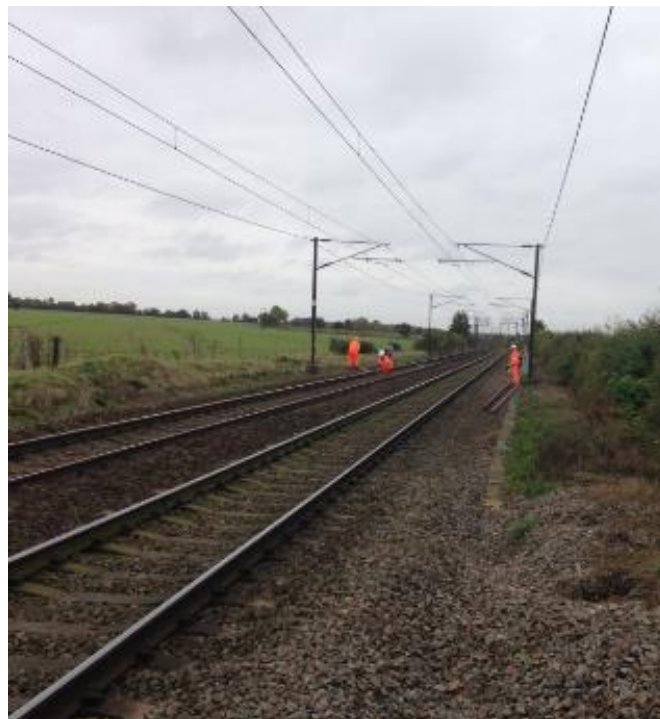
- 12.13. The photograph below is taken on the downside looking south; the train usually approaches on the furthest line (right hand side) set of lines.

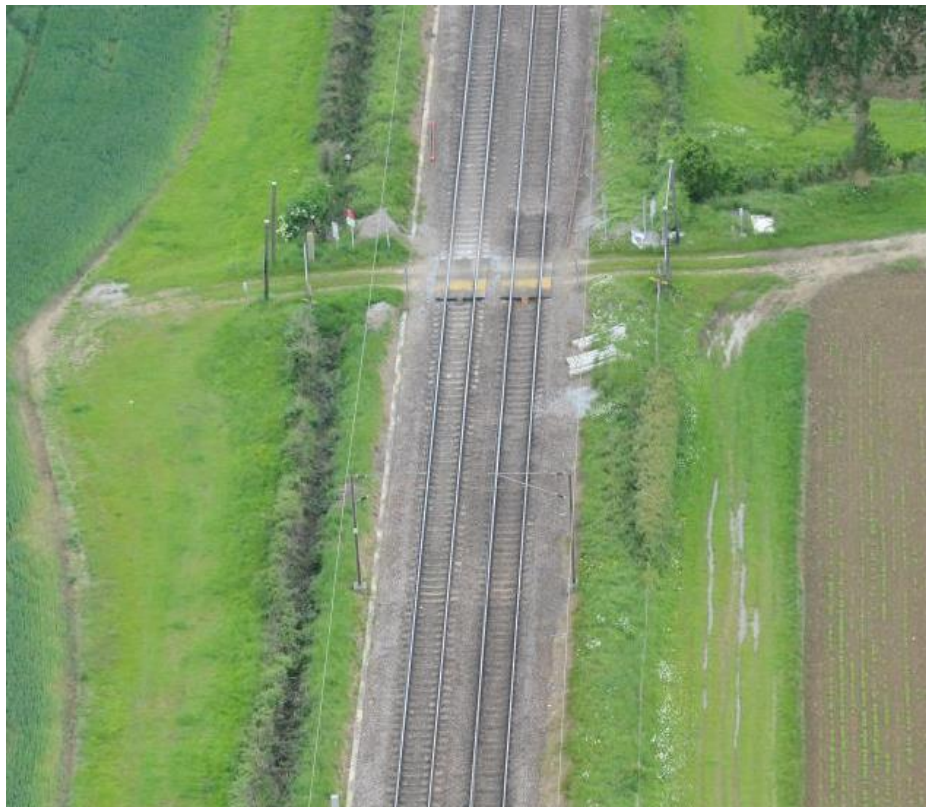
13.5. Below photo shows the field to field approach to the crossing.
