**THE NETWORK RAIL
(SUFFOLK LEVEL CROSSING REDUCTION)
ORDER**

PROOF OF EVIDENCE

JOHN PREST

Document Reference	NR/31/1
--------------------	---------

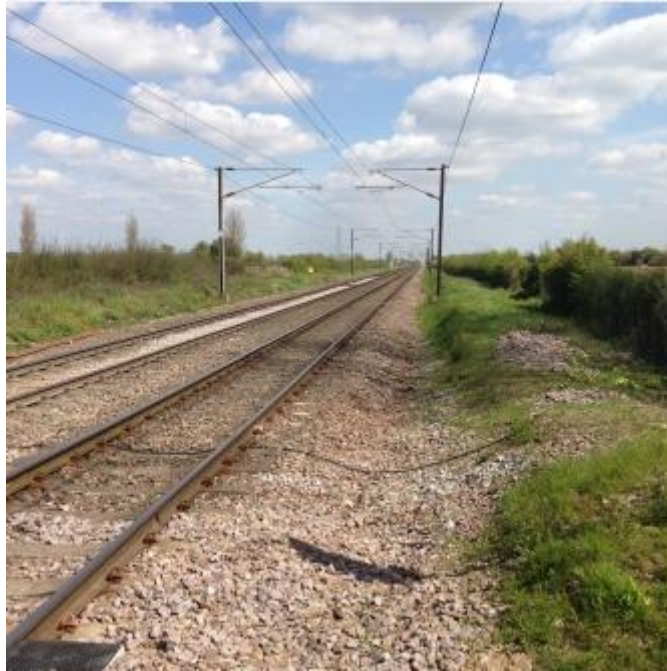
- 13.10. The photograph below is taken looking northward, from the up side at a train approaching in the up direction. The trains usually approach on the closest set of lines (right hand side).

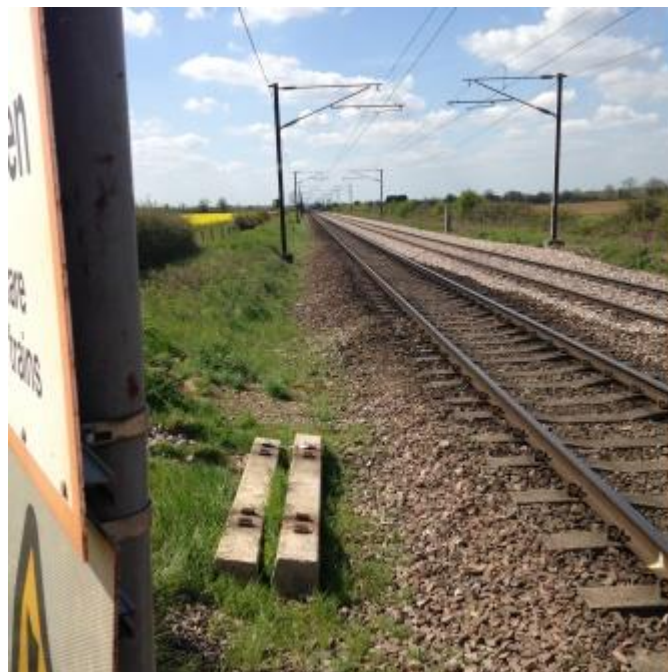
- 13.11. The photograph below is taken on the upside, looking south, the train usually approaches on the furthest (right hand side) set of lines.

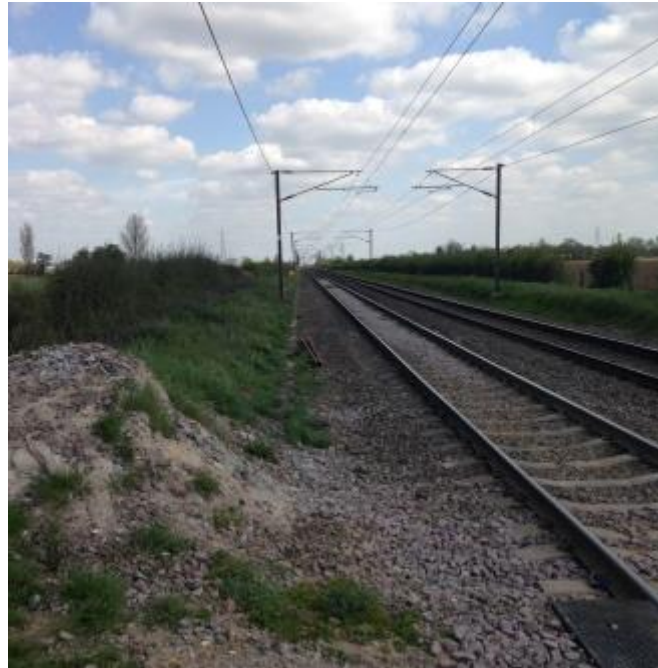
- 13.12. The photograph below is taken on the downside looking north; the train usually approaches on the closest line (right hand side) set of lines.

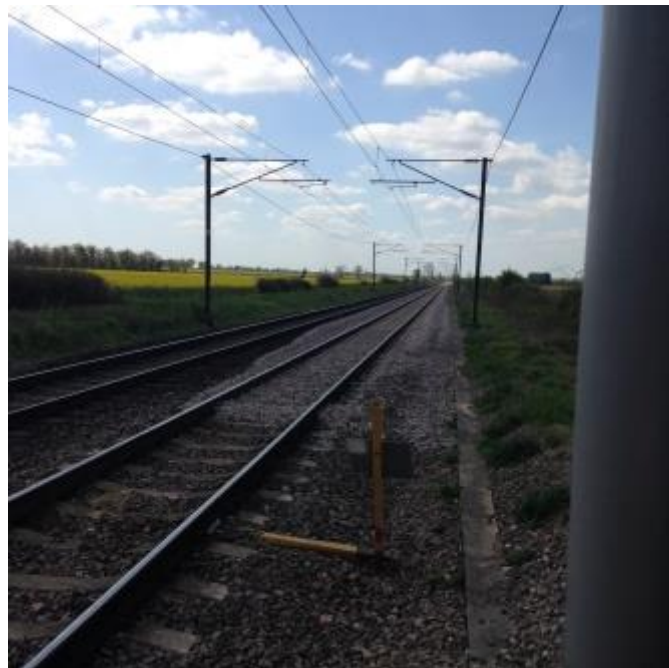
- 13.13. The photograph below is taken on the downside looking south; the train usually approaches on the furthest line (right hand side) set of lines.

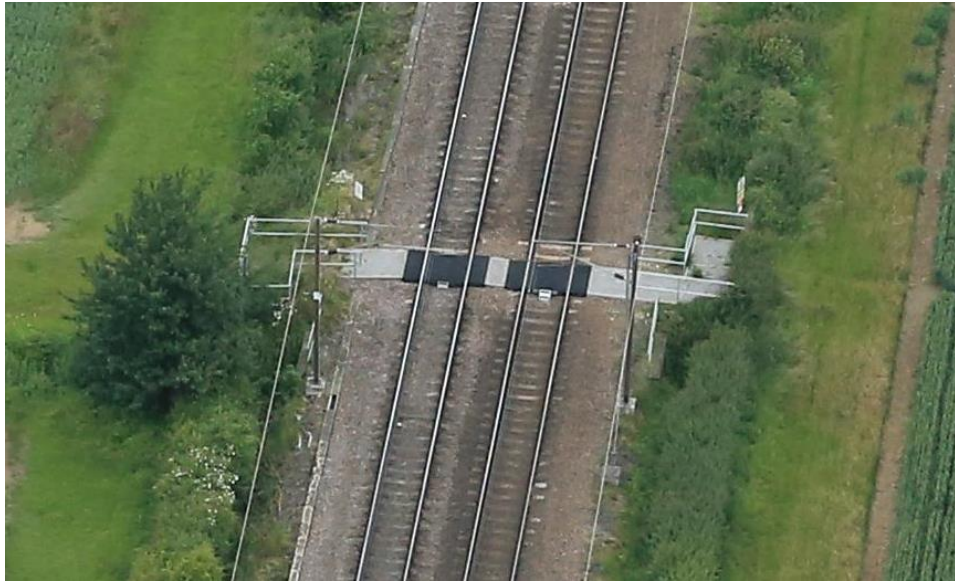
14.4. The track on the left is the down line from London and the track on the right is the up line to London. Trains would normally run down from London on the left hand line that is from the bottom of the picture to the top. Trains would normally run up to London on the right hand side, which is from the top of the picture to the bottom.

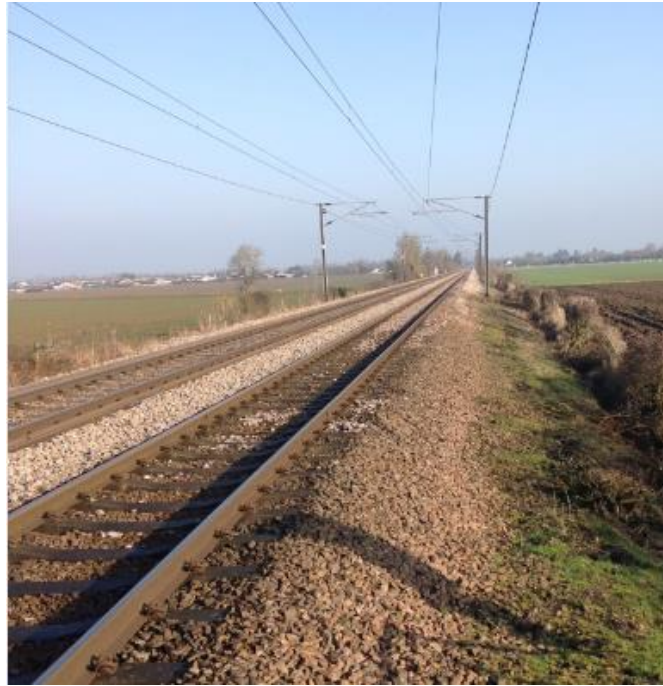
- 14.10. The photograph below is taken looking northward, from the up side at a train approaching in the up direction. The trains usually approach on the closest set of lines (right hand side).

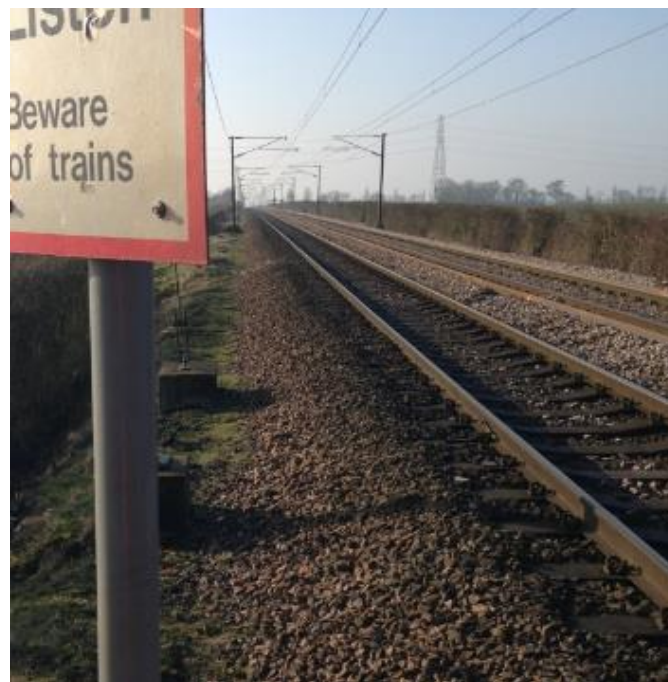
- 14.11. The photograph below is taken on the upside, looking south, the train usually approaches on the furthest (right hand side) set of lines.

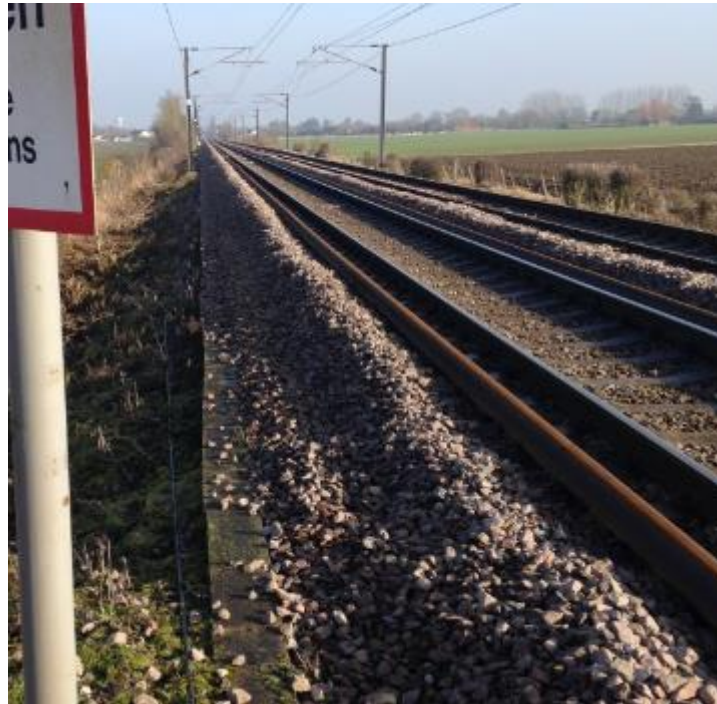
- 14.12. The photograph below is taken on the downside looking north; the train usually approaches on the closest line (right hand side) set of lines.

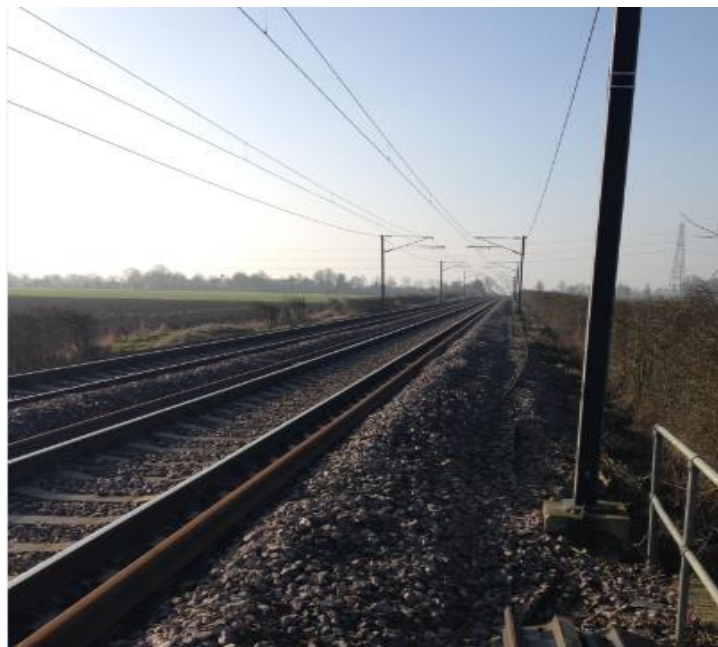
- 14.13. The photograph below is taken on the downside looking south; the train usually approaches on the furthest line (right hand side) set of lines.

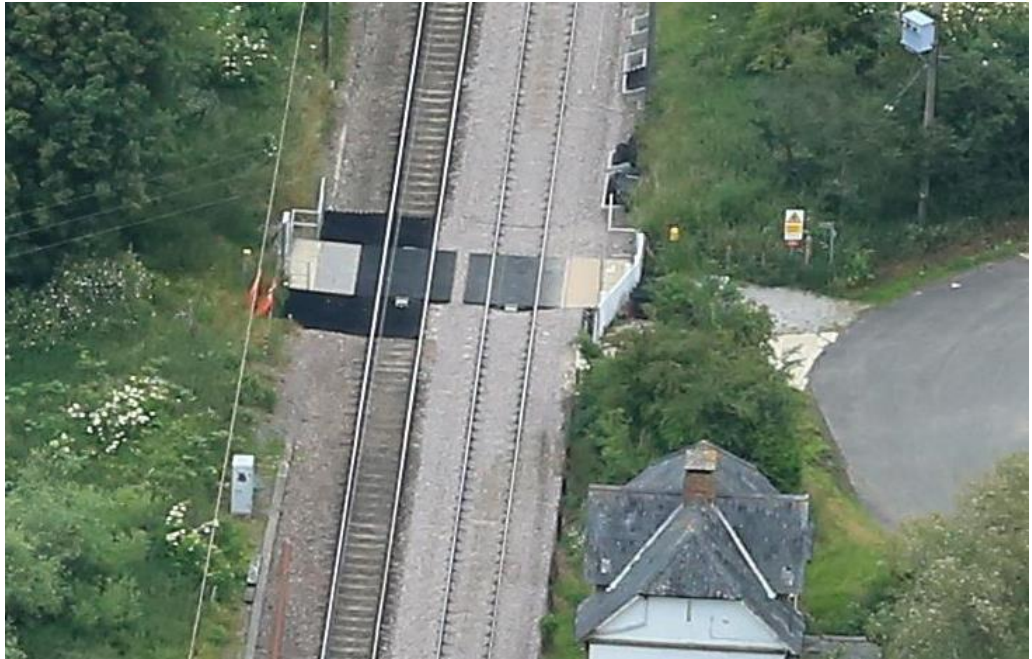
- 15.4. The track on the left is the down line from London and the track on the right is the up line to London. Trains would normally run down from London on the left hand line that is from the bottom of the picture to the top. Trains would normally run up to London on the right hand side, which is from the top of the picture to the bottom.
- 15.5. The picture below shows the crossing.

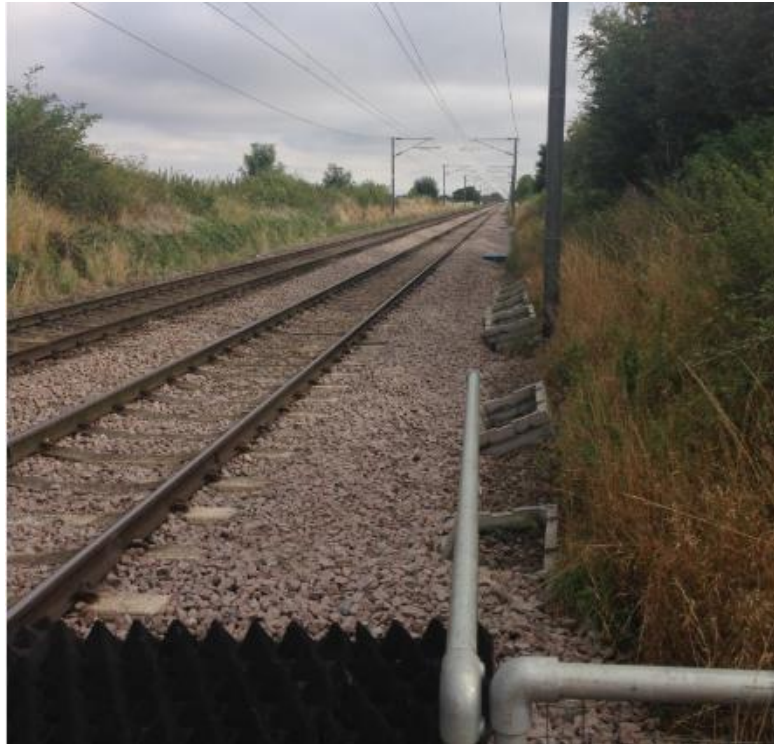
- 15.11. The photograph below is taken on the upside, looking south, the train usually approaches on the furthest (right hand side) set of lines.

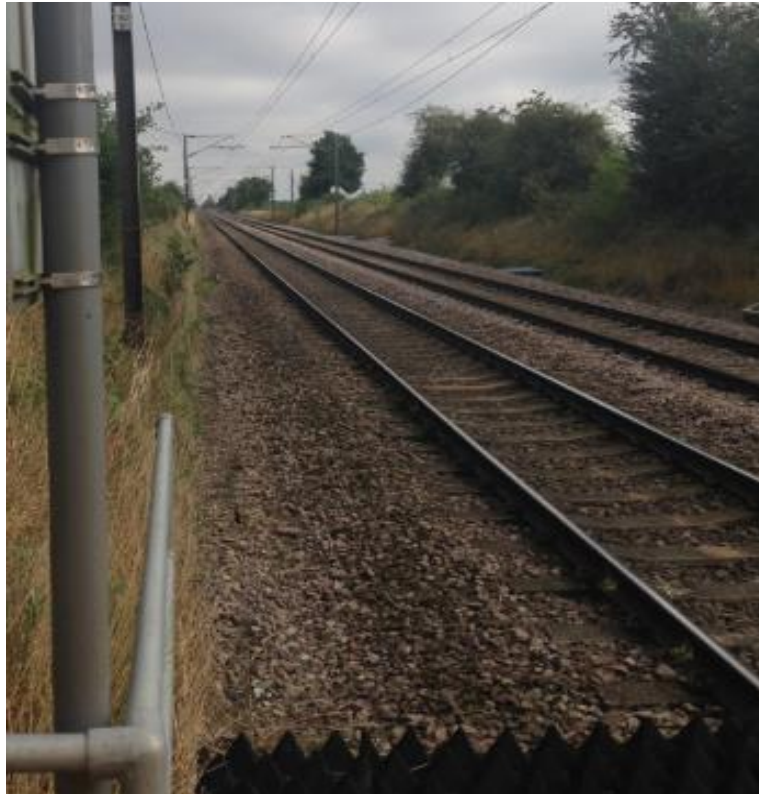
- 15.13. The photograph below is taken on the downside looking south; the train usually approaches on the furthest line (right hand side) set of lines.

- 15.14. As can be seen from the table above (15.9), S16 Gislingham crossing does have sufficient sighting to meet industry standards in all directions for pedestrians.

Telephones have been installed to mitigate sighting deficiency for horse riders. The decision point for equestrian users is 3 meters away from the nearest line, instead of 2 meters for pedestrian users. The OHL stantions obscure sighting from the 3 meter decision point.

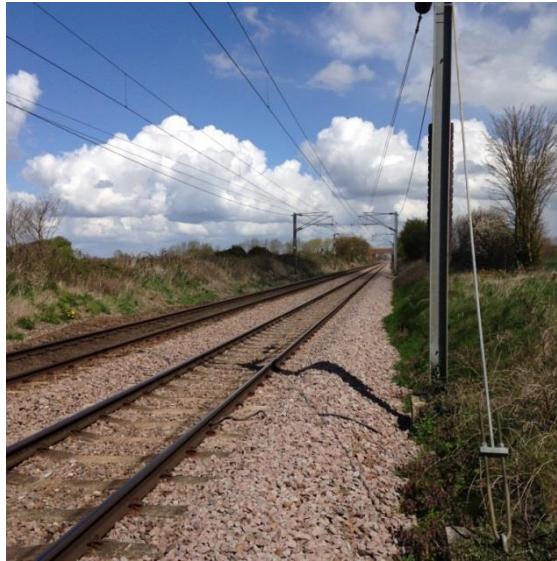
- 16.10. The photograph below is taken looking north, from the up side at a train approaching in the up direction. The trains usually approach on the closest set of lines (right hand side).

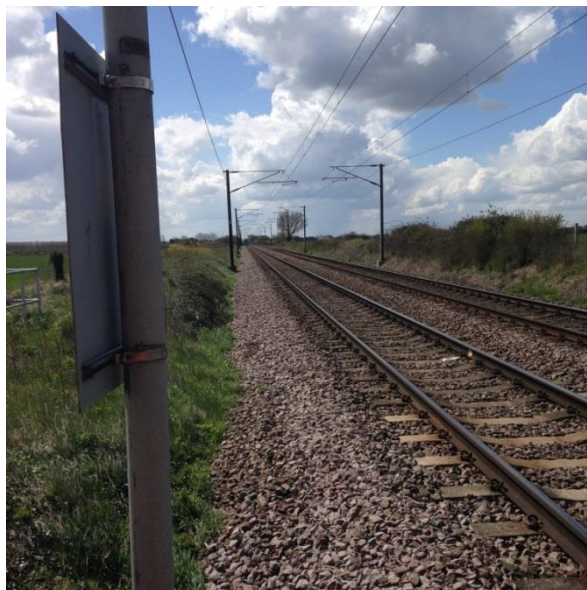
- 16.11. The photograph below is taken on the upside, looking South, the train usually approaches on the furthest (right hand side) set of lines.

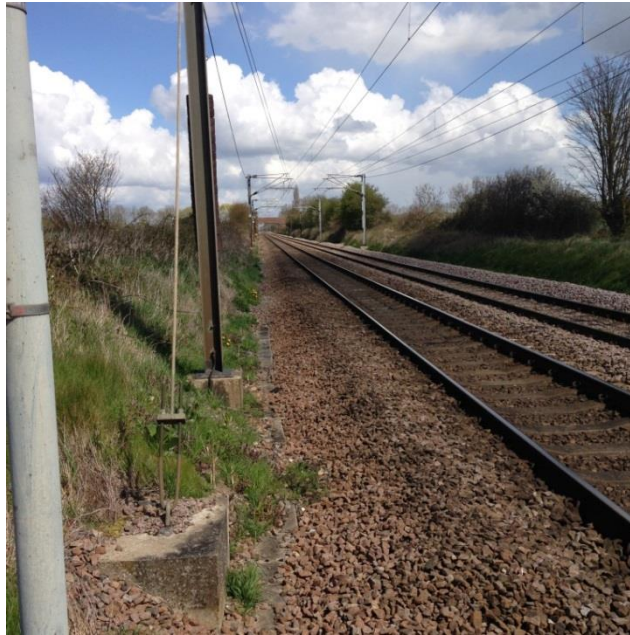
- 16.12. The photograph below is taken on the downside looking north; the train usually approaches on the closest line (right hand side) set of lines.

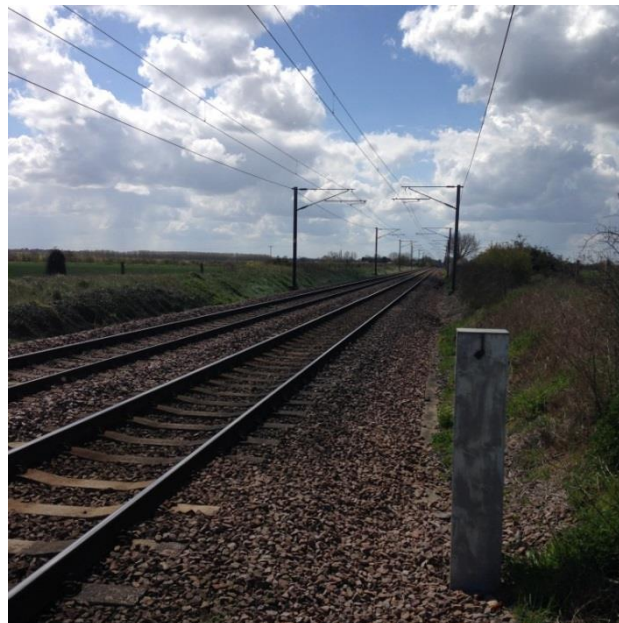
- 16.13. The photograph below is taken on the downside looking south; the train usually approaches on the furthest line (right hand side) set of lines.

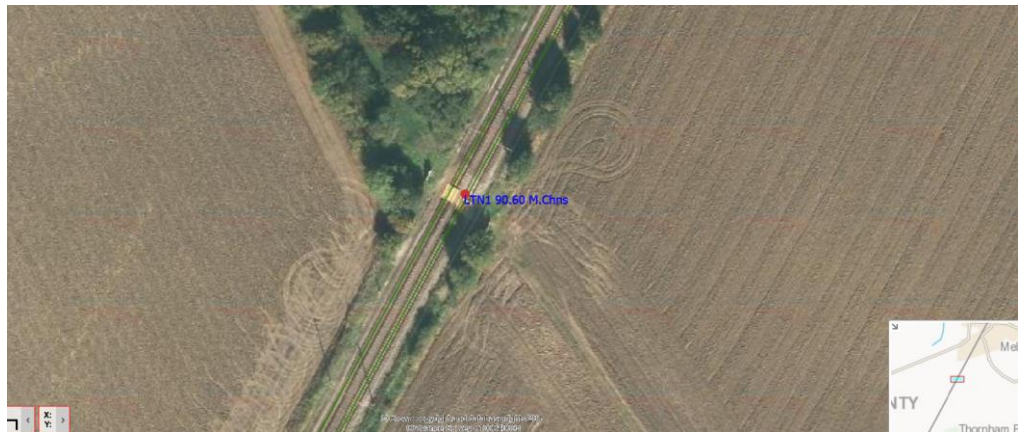
- 17.4. The track on the left is the down line from London and the track on the right is the up line to London. Trains would normally run down from London on the left hand line that is from the bottom of the picture to the top. Trains would normally run up to London on the right hand side, which is from the top of the picture to the bottom.
- 17.5. An second aerial picture below is showing Cow Pastures Lane crossing.

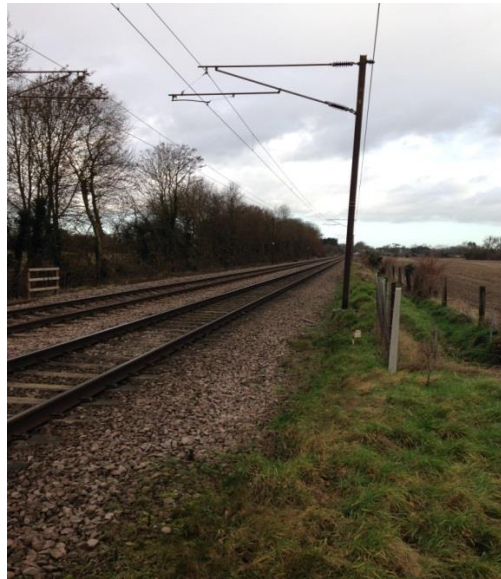
- 17.10. The photograph below is taken looking north, from the up side at a train approaching in the up direction. The trains usually approach on the closest set of lines (right hand side).

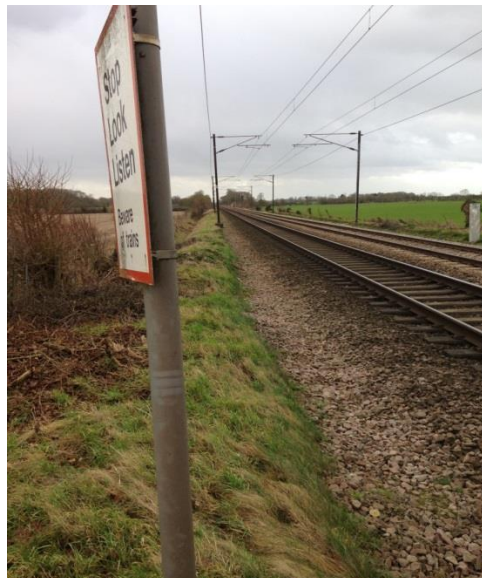
- 17.11. The photograph below is taken on the upside, looking South, the train usually approaches on the furthest (right hand side) set of lines.

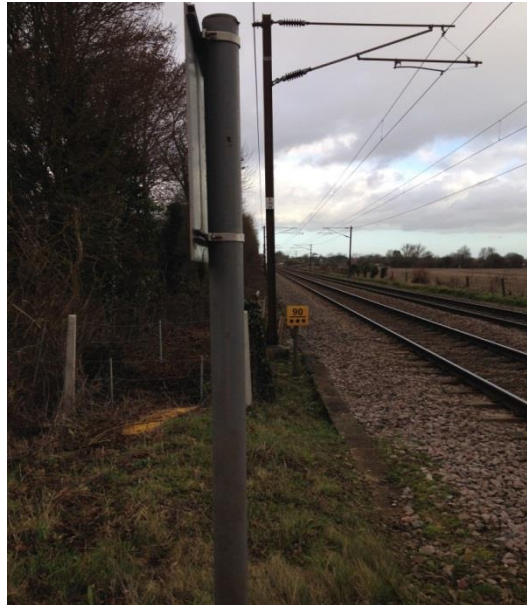
- 17.12. The photograph below is taken on the downside looking north; the train usually approaches on the closest line (right hand side) set of lines.

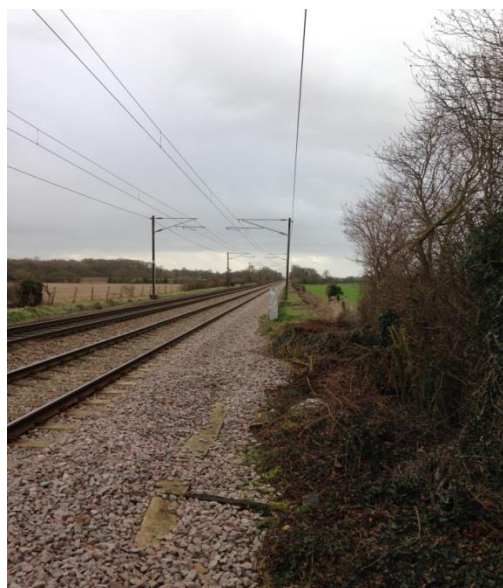
- 17.13. The photograph below is taken on the downside looking south; the train usually approaches on the furthest line (right hand side) set of lines.

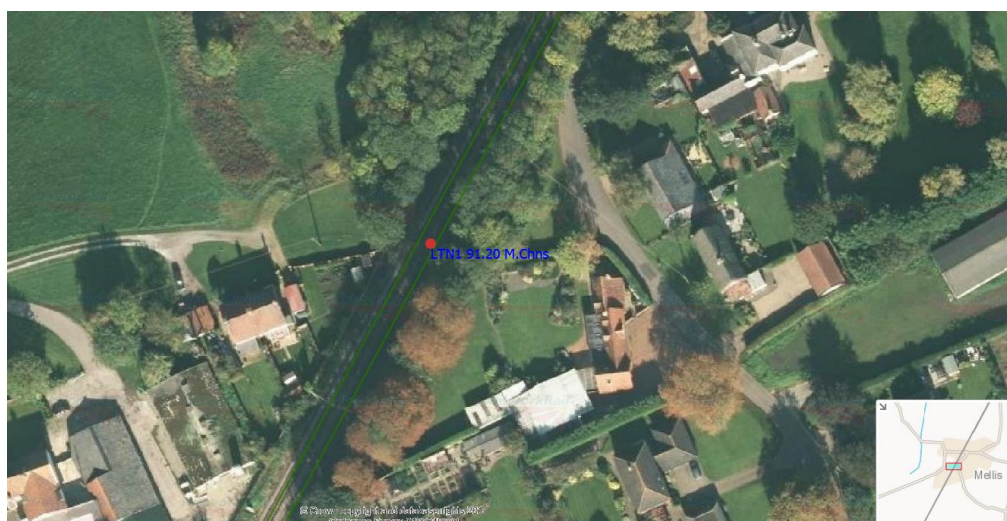
18.3. An aerial view of S21 Abbotts crossing can be seen below.

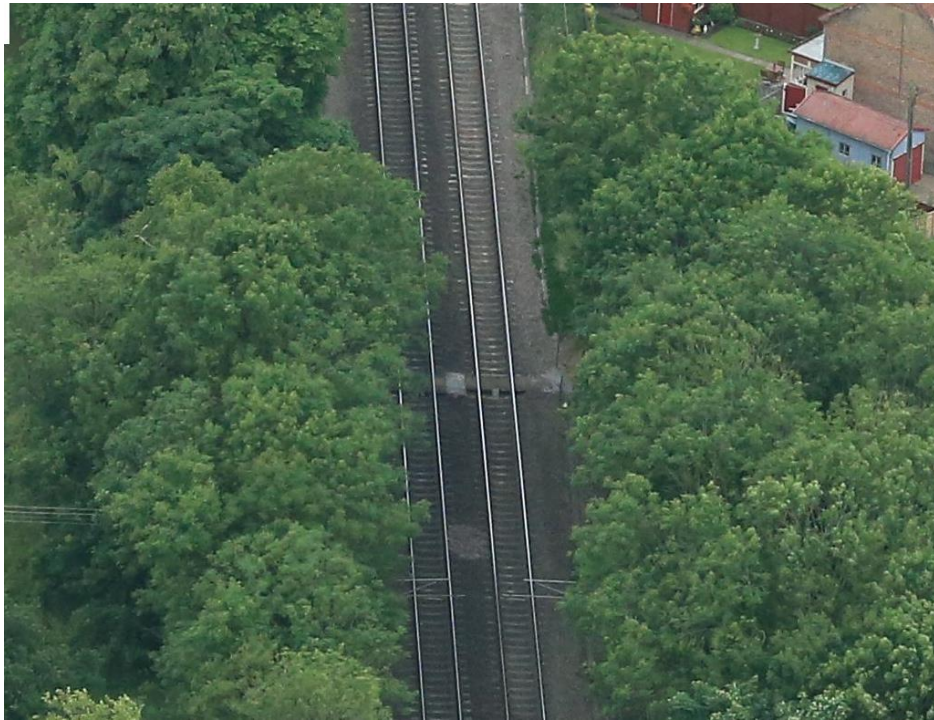
- 18.4. The track on the left is the down line from London and the track on the right is the up line to London. Trains would normally run down from London on the left hand line that is from the bottom of the picture to the top. Trains would normally run up to London on the right hand side, which is from the top of the picture to the bottom.
- 18.5. An second aerial picture below is showing Abbotts crossing from the Routeview helicopter.

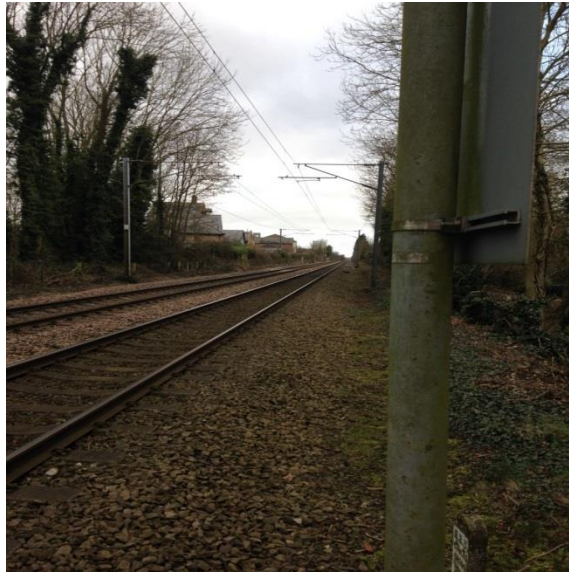
18.10. The photograph below is taken looking north, from the up side at a train approaching in the up direction. The trains usually approach on the closest set of lines (right hand side).

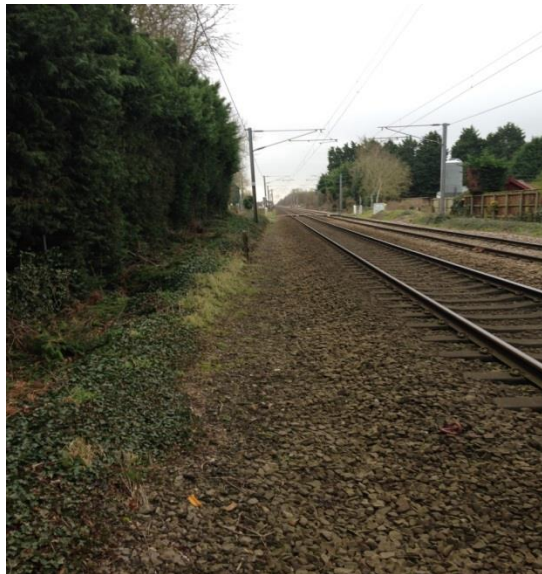
- 18.11. The photograph below is taken on the upside, looking South, the train usually approaches on the furthest (right hand side) set of lines.

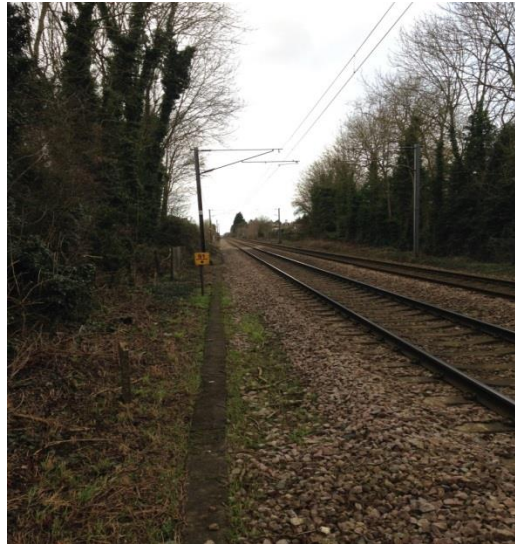
- 18.12. The photograph below is taken on the downside looking north; the train usually approaches on the closest line (right hand side) set of lines.

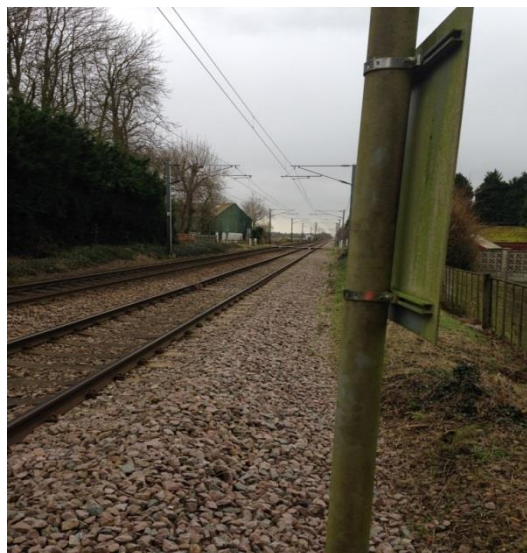
18.13. The photograph below is taken on the downside looking south; the train usually approaches on the furthest line (right hand side) set of lines.

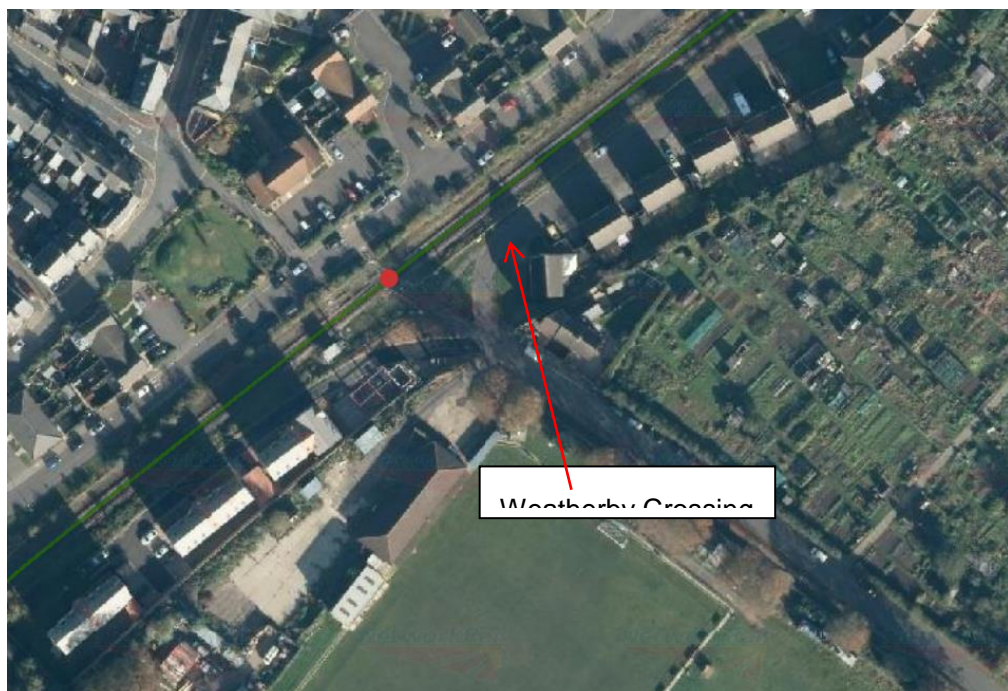
19.3. Aerial view of S22 Weatherby footpath crossing can be seen below.

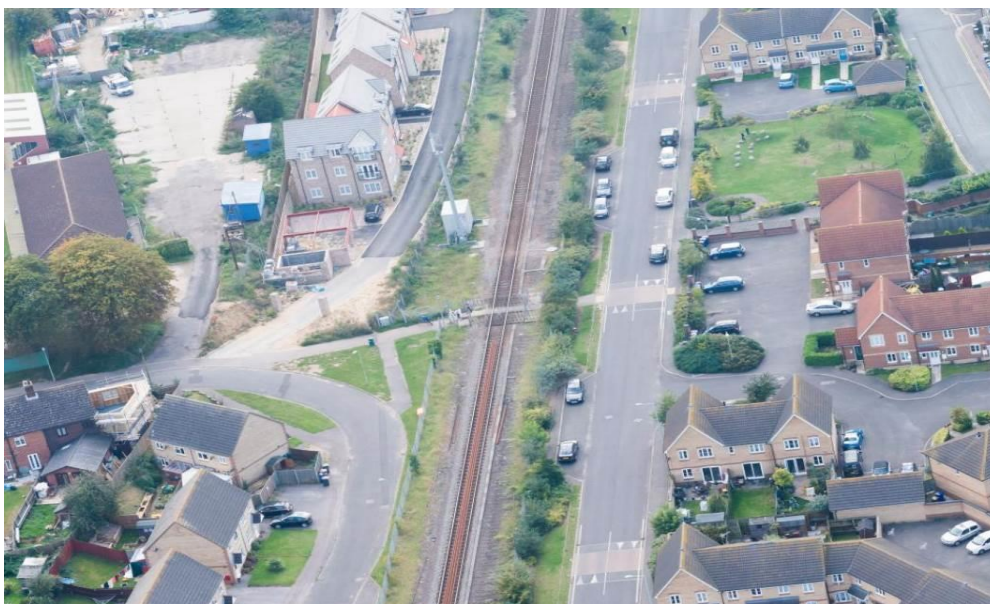
- 19.4. The crossing is situated on a single line and if a user is looking towards Newmarket Station from either side of the crossing then they would be looking in the up direction. If a user is looking away from Newmarket station from either side of the crossing, then they would be looking in the down direction.
- 19.5. A second aerial picture below is showing S22 Weatherby footpath crossing and its approaches.

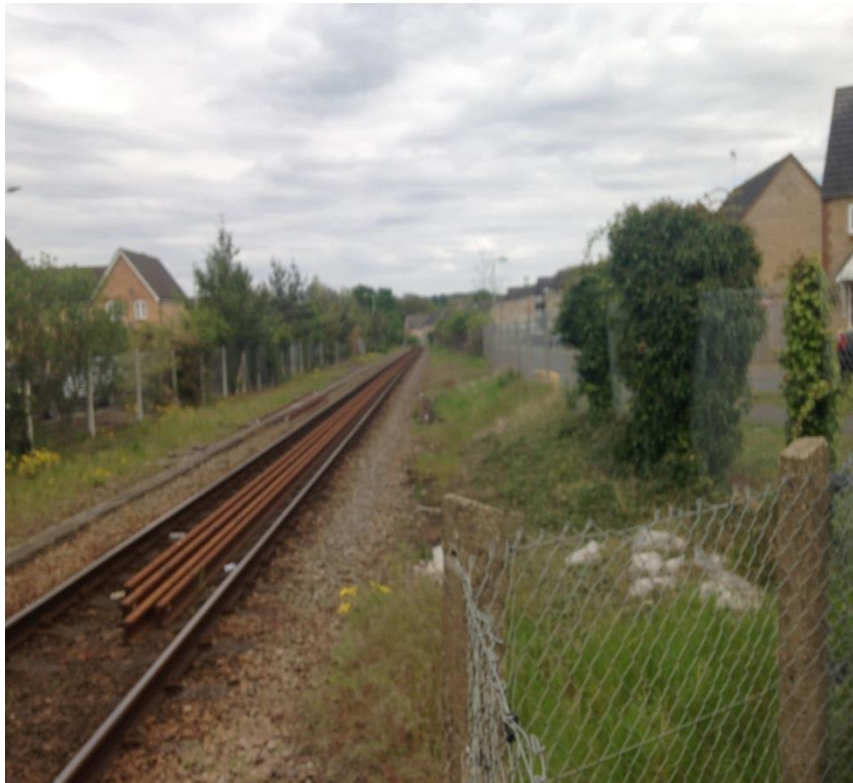
19.10. The photograph below is showing sighting for up direction up trains approaching

- 19.14. As can be seen from the table above (19.9), S22 Weatherby footpath crossing does have sufficient sighting to meet industry standards in all directions. This means the sighting for a user to see an approaching train is good when weather conditions are favourable. Sighting distances however, will be severely reduced when the weather is poor e.g. raining or foggy.

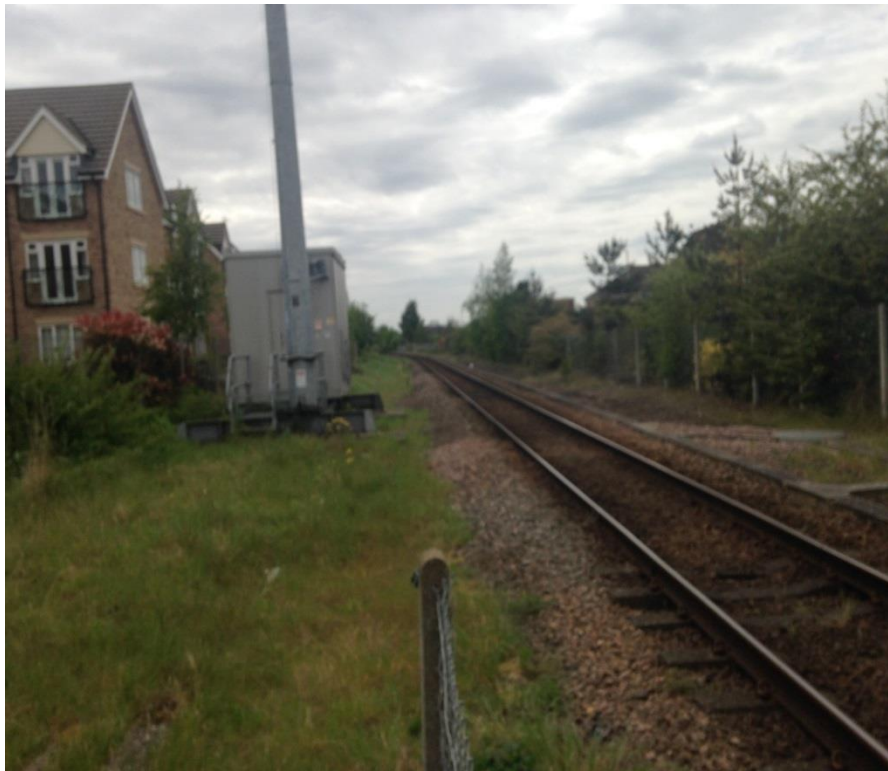
19.12. The photograph below is showing sighting for down direction up trains approaching

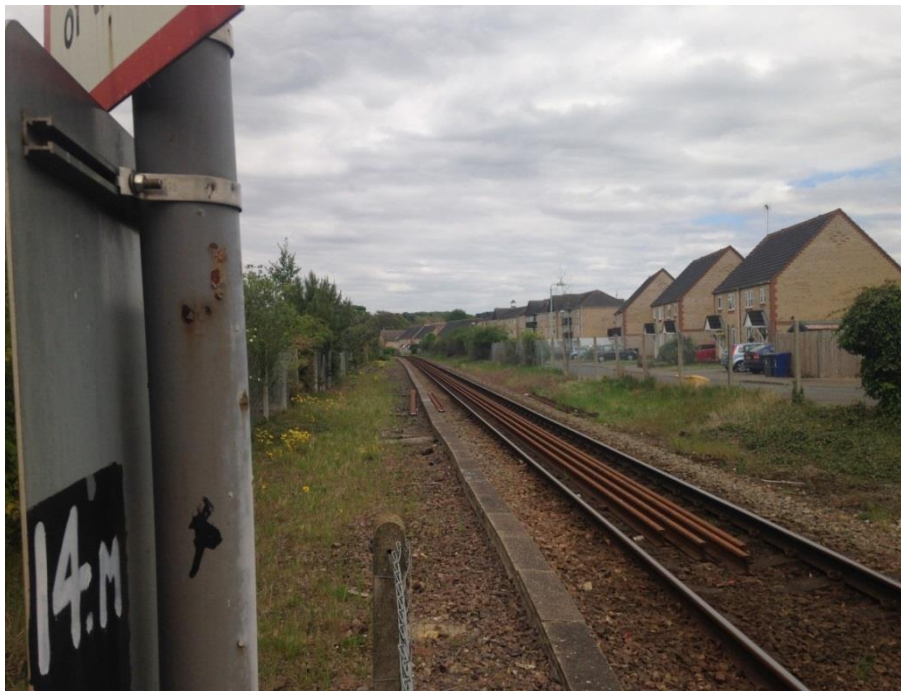
19.13. The photograph below is showing sighting for down direction down trains approaching

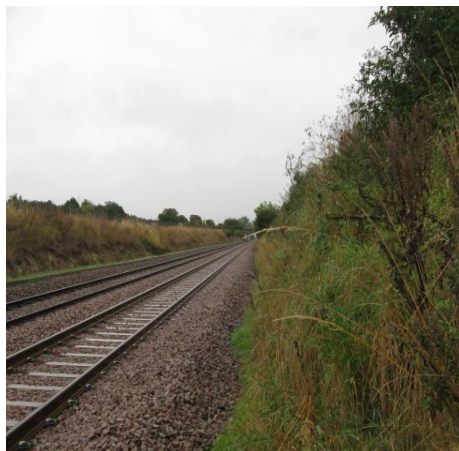
- 20.9. The photograph below is showing sighting for up side up direction trains approaching

- 20.13. As can be seen from the table above (20.8), S23 Higham crossing does have sufficient sighting to meet industry standards in all directions. This means the sighting for a user to see an approaching train is adequate when weather conditions are favourable, but can be affected by vegetation growth and the user's visibility when approaching from down a steep embankment. Sighting distances will also be severely reduced when the weather is poor e.g. raining or foggy. If vulnerable users were identified the sighting would be insufficient.

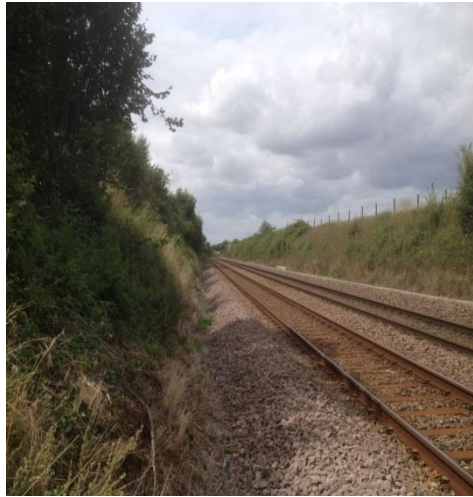
- 20.10. The photograph below is showing sighting for up side down direction trains approaching

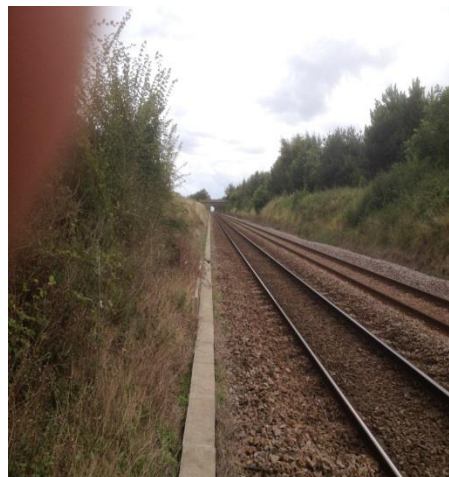
20.11. The photograph below is showing sighting for down side up direction trains approaching

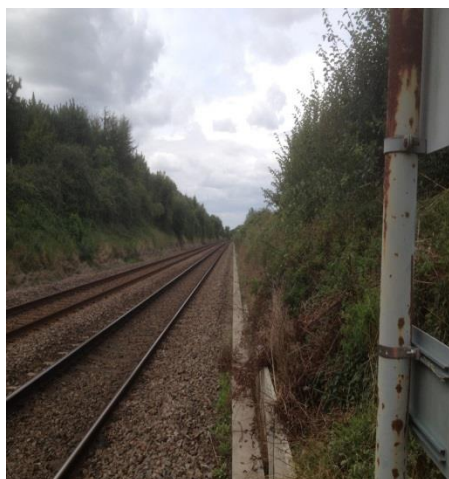
20.12. The photograph below is showing sighting for down side down direction trains approaching

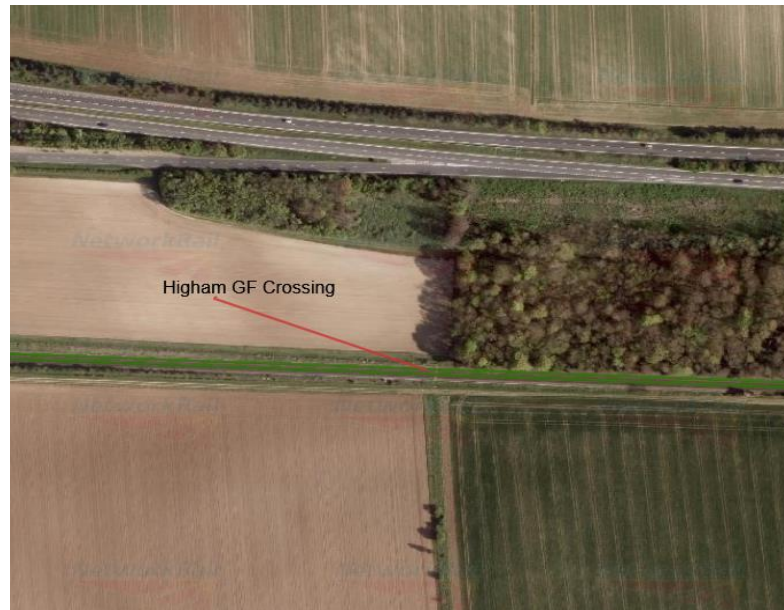
- 21.2. There are 124 trains per day that run for 24 hours per day over this level crossing. Additionally, there are empty stock trains that pass over the crossing. There can also be various on-track machinery and plant that pass over the crossing at any point.
- 21.3. Aerial views of S24 Higham ground Frame Footpath crossing can be seen below.

- 21.4. The track on the top is the down line from Kennett and the track on the bottom is the up line from Bury St Edmunds. Trains would normally run down from Kennett on the top line that is from the left of the picture to the right. Trains would normally run up from Bury St Edmunds on the bottom line, which is from the right of the picture to the left.
- 21.5. A second aerial view is shown below.

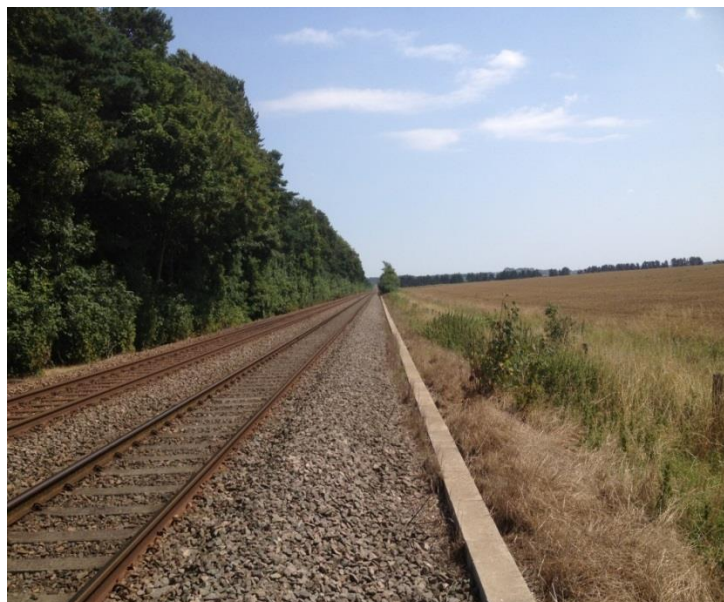
21.10. The photograph below is showing sighting for up side up direction trains approaching on the nearest running line

- 21.14. As can be seen from the table above (21.9), S24 Higham Ground Frame crossing does have sufficient sighting to meet industry standards in all directions. This means the sighting for a user to see an approaching train is good when weather conditions are favourable. Sighting distances however, will be severely reduced when the weather is poor e.g. raining or foggy.

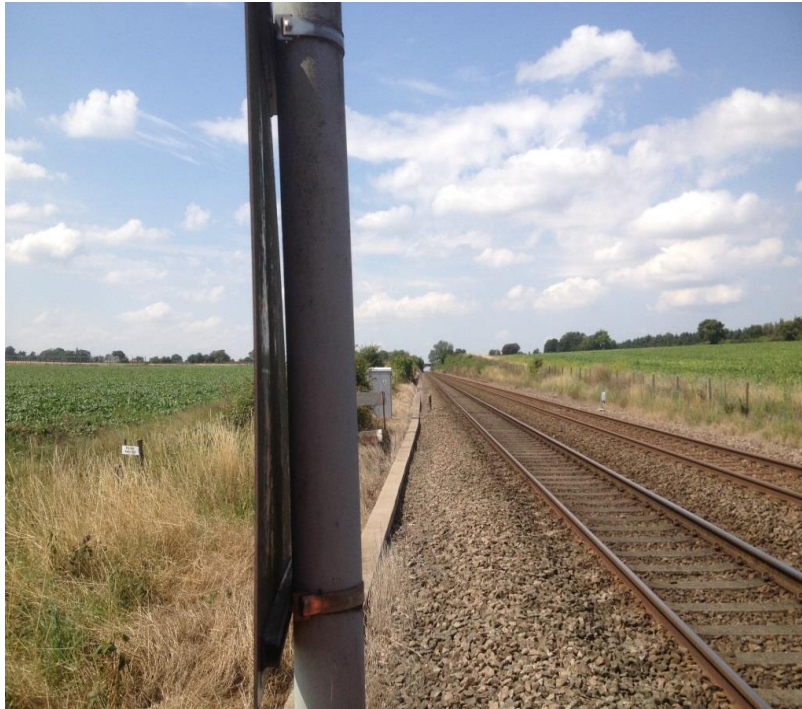
21.12. The photograph below is showing sighting for down side up direction trains approaching on the nearest running line

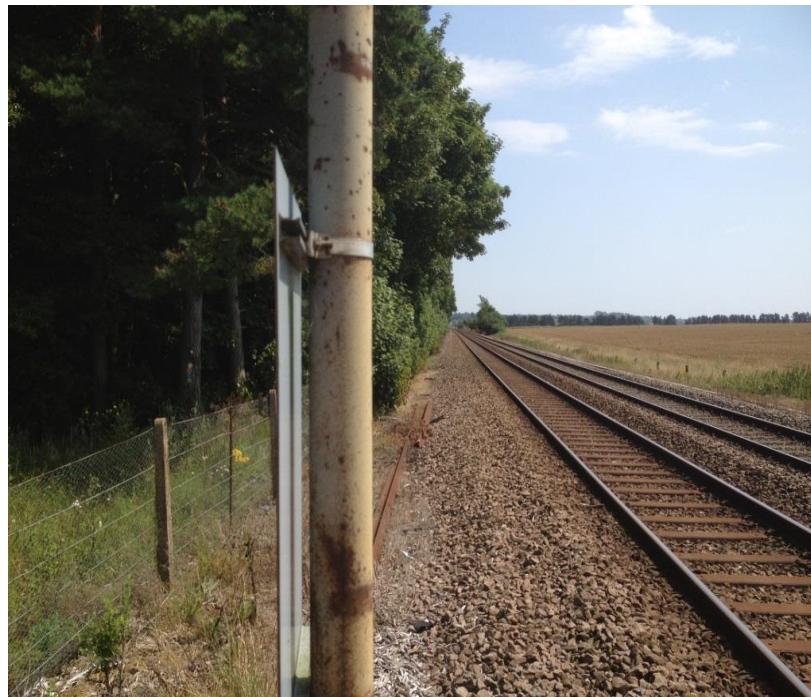
21.13. The photograph below is showing sighting for down side down direction trains approaching on the nearest running line

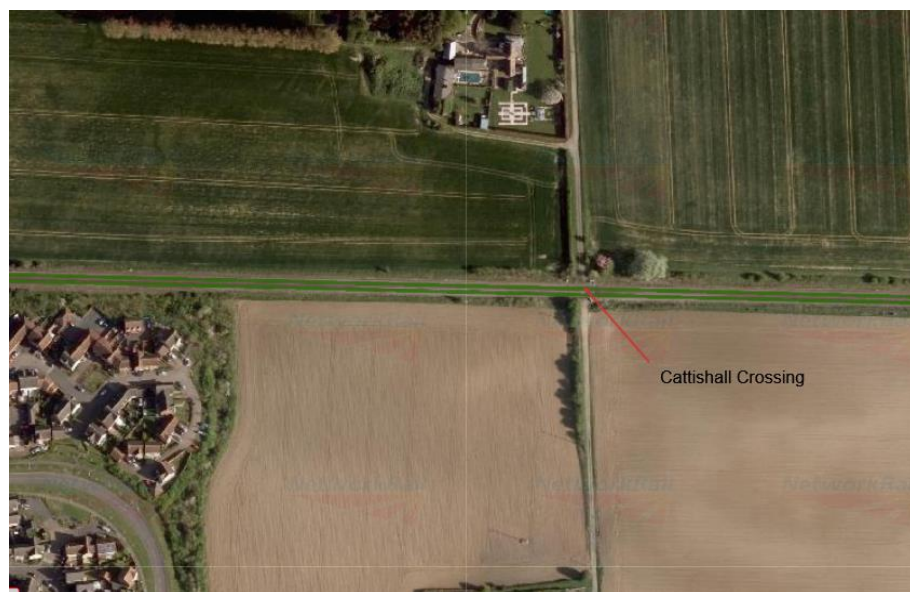
- 22.1. S25 Cattishall footpath crossing has an ALCRM score of C6 with an FWI of 0.00042802. It is located in Great Barton Parish on the CCH line (Coldham Lane Junction to Haughley Junction) which has a line speed of 75mph on the Up Side and also 75mph on the Down Side. It is between Thurston and Bury St Edmunds at 30 miles and 49 chains.
- 22.2. There are 110 trains per day that run for 24 hours per day over this level crossing. Additionally, there are empty stock trains that pass over the crossing. There can also be various on-track machinery and plant that pass over the crossing at any point.
- 22.3. Aerial views of S25 Cattishall Footpath crossing can be seen below.

- 22.4. The track on the bottom is the up line from Thurston and the track on the top is the down line from Bury St Edmunds. Trains would normally run up from Thurston on the bottom line that is from the right of the picture to the left. Trains would normally run down from Bury St Edmunds on the top line, which is from the left of the picture to the right.
- 22.5. A second aerial view can be seen below.

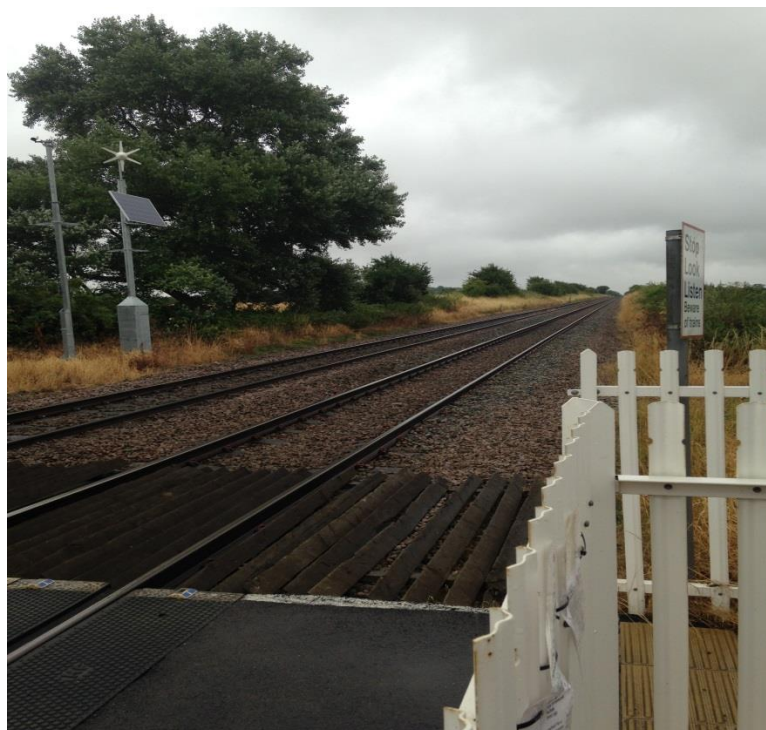
22.10. The photograph below is showing sighting for up side up direction trains approaching on the nearest running line

- 22.14. As can be seen from the table above (22.9), S25 Cattishall crossing does have sufficient sighting to meet industry standards in all directions. This means the sighting for a user to see an approaching train is good when weather conditions are favourable. Sighting distances however, will be severely reduced when the weather is poor e.g. raining or foggy.

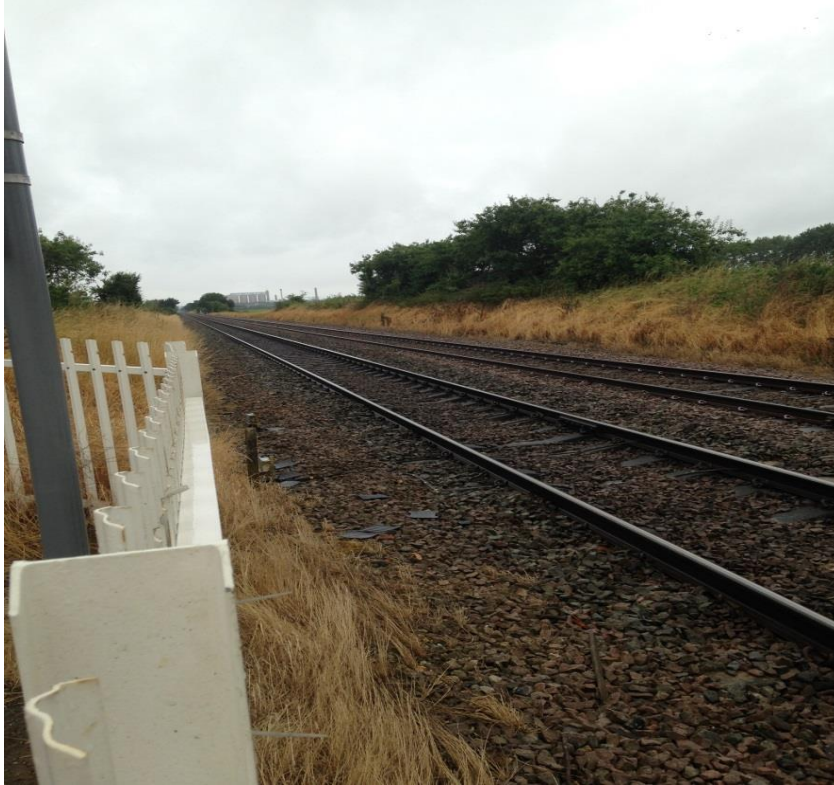
- 22.12. The photograph below is showing sighting for down side up direction trains approaching on the nearest running line
