**THE NETWORK RAIL
(SUFFOLK LEVEL CROSSING REDUCTION)
ORDER**

PROOF OF EVIDENCE

JOHN PREST

Document Reference	NR/31/1
--------------------	---------

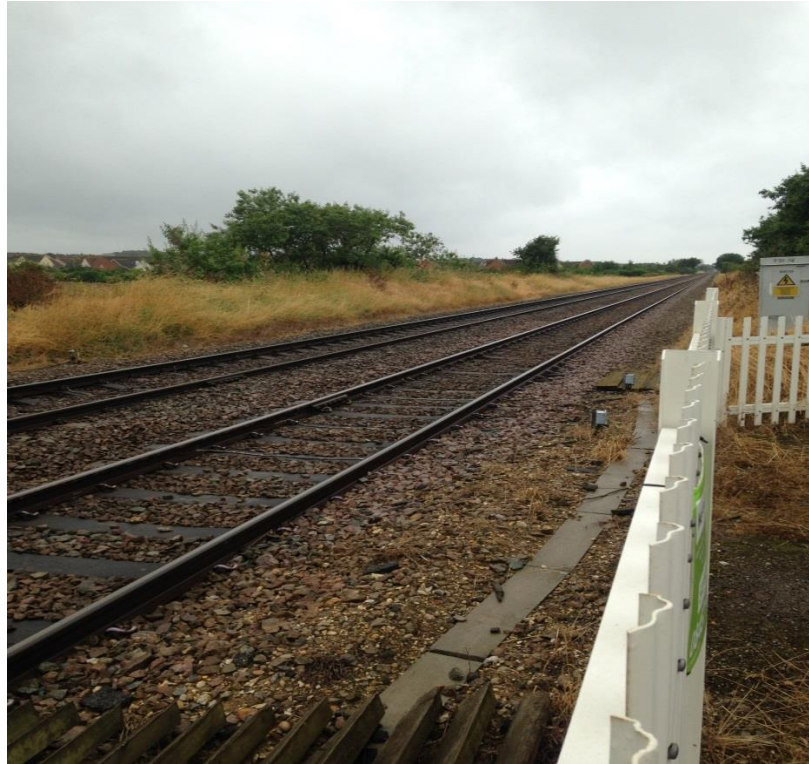
- 22.13. The photograph below is showing sighting for down side down direction trains approaching on the nearest running line

- 22.14. As can be seen from the table above (22.9), S25 Cattishall crossing does have sufficient sighting to meet industry standards in all directions. This means the sighting for a user to see an approaching train is good when weather conditions are favourable. Sighting distances however, will be severely reduced when the weather is poor e.g. raining or foggy.

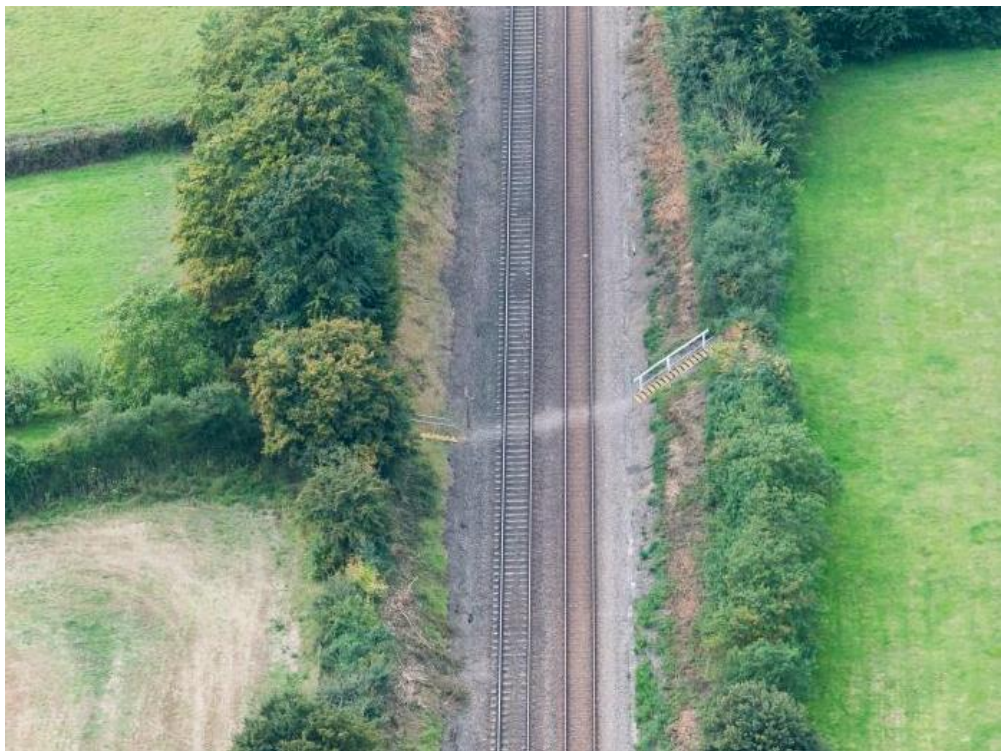
- 23.1. S27 Barrells footpath crossing has an ALCRM score of C6 with an FWI 0.000223206, it is located in Thurston on the CCH line (Coldham lane jcn. to Haughley) which has a line speed of 75 MPH; it is between Thurston and Elmswell at 33miles and 72 chains.
- 23.2. There are 124 trains per day that run for 24 hours per day over this level crossing. Additionally, there are empty stock trains that pass over the crossing. There can also be various on-track machinery and plant that pass over the crossing at any point.
- 23.3. An aerial view of S27 Barrells crossing can be seen below.

- 23.4. The track on the left is the up line to Cambridge and the track on the right is the down line to Haughley. Trains would normally run down from Cambridge on the right hand line that is from the top of the picture to the bottom. Trains would normally run up to Cambridge on the left hand side, which is from the bottom of the picture to the top.
- 23.5. An second aerial picture below is showing S27 Barrells crossing from the Routeview helicopter and clearly shows the footpath approaches to the crossing.

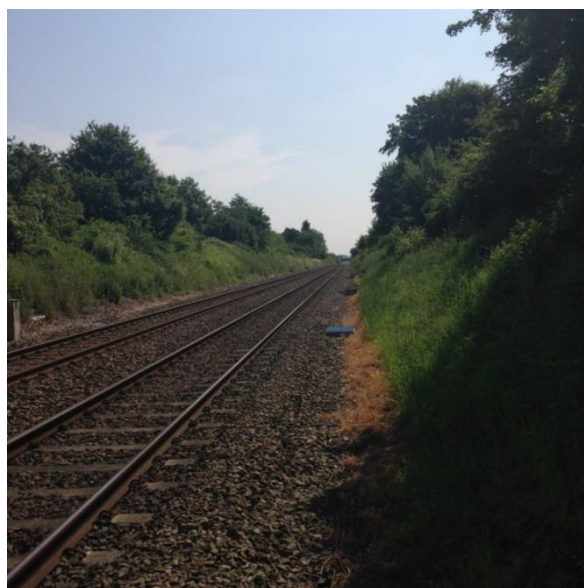
23.10. The photograph below is taken from the up side at a train approaching in the up direction. The trains usually approach on the closest set of lines (right hand side).

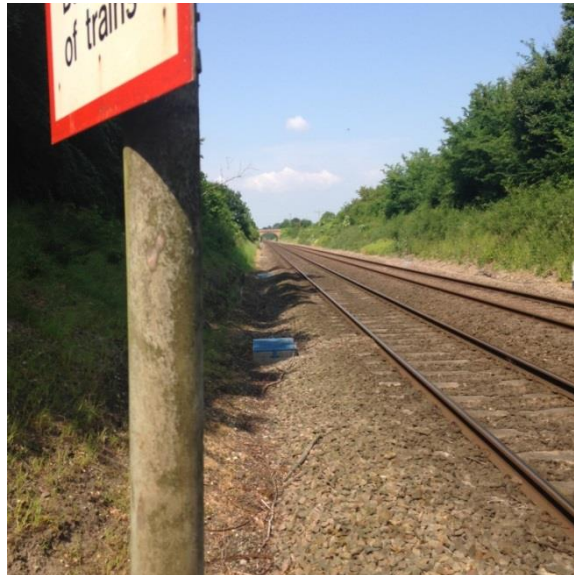
- 23.11. The photograph below is taken on the upside, the train usually approaches on the furthest (right hand side) set of lines.

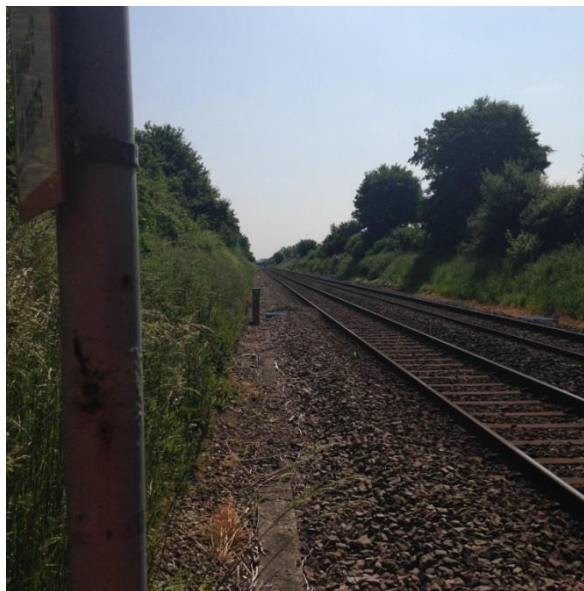
- 23.12. The photograph below is taken on the downside; the train usually approaches on the furthest line (right hand side) set of lines.

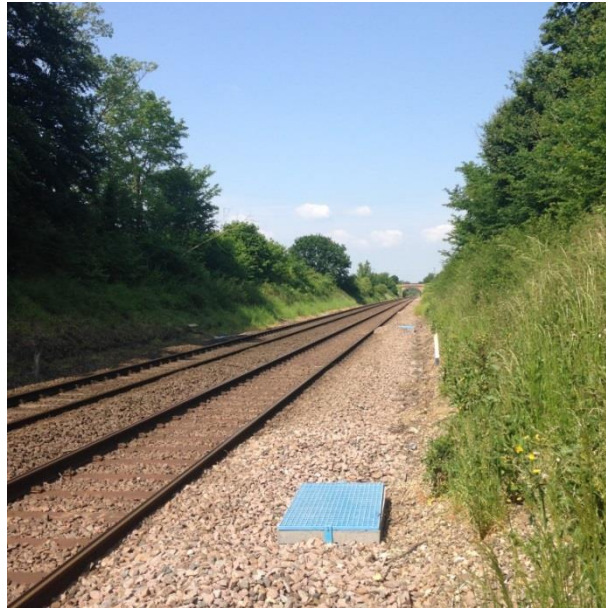
- 23.13. The photograph below is taken on the downside looking south; the train usually approaches on the closest line (right hand side) set of lines.

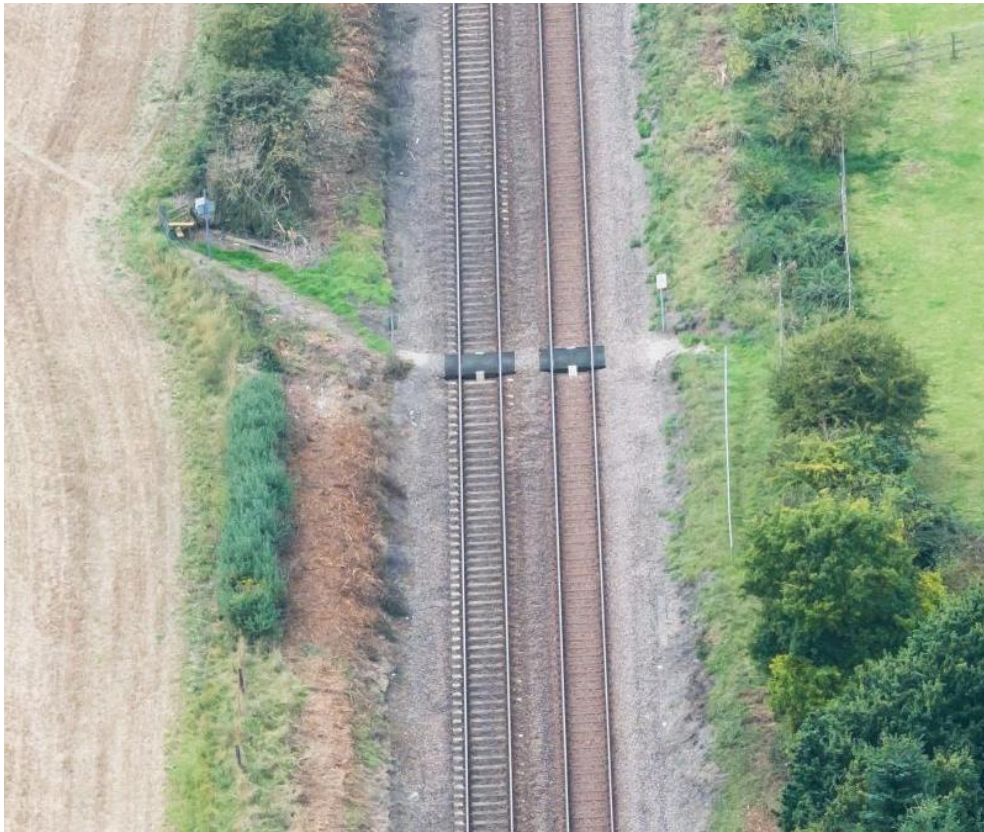
- 24.2. There are 124 trains per day that run for 24 hours per day over this level crossing. Additionally, there are empty stock trains that pass over the crossing. There can also be various on-track machinery and plant that pass over the crossing at any point.
- 24.3. An aerial view of S28 Grove Farm crossing can be seen below.

- 24.4. The track on the left is the up line to Cambridge and the track on the right is the down line from Cambridge. Trains would normally run down from Cambridge on the right hand line that is from the top of the picture to the bottom. Trains would normally run up to Cambridge on the left hand side, which is from the bottom of the picture to the top.
- 24.5. An second aerial picture below is showing S28 Grove Farm crossing from the Routeview helicopter and clearly shows the footpath approaches to the crossing.

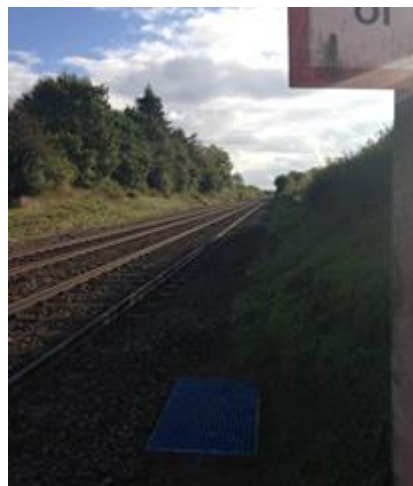
24.10. The photograph below is taken from the up side at a train approaching in the up direction. The trains usually approach on the closest set of lines (right hand side).

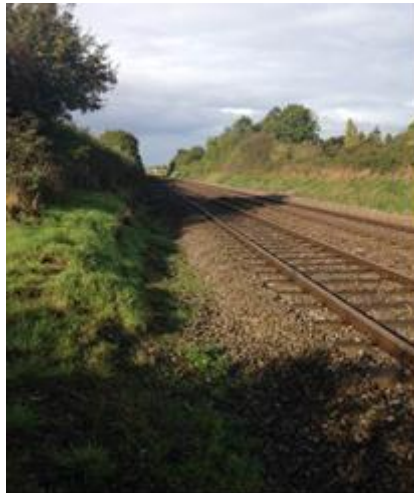
- 24.11. The photograph below is taken on the upside, the train usually approaches on the furthest (right hand side) set of lines.

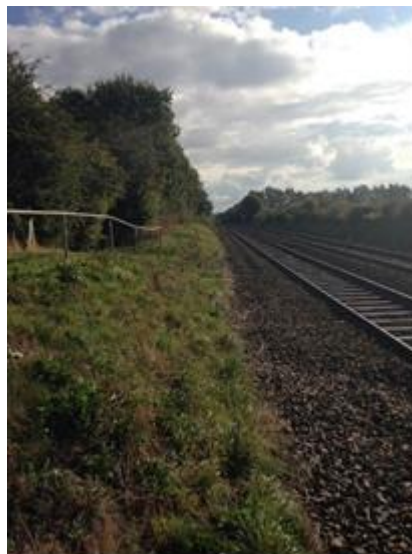
- 24.12. The photograph below is taken on the downside; the train usually approaches on the furthest line (right hand side) set of lines.

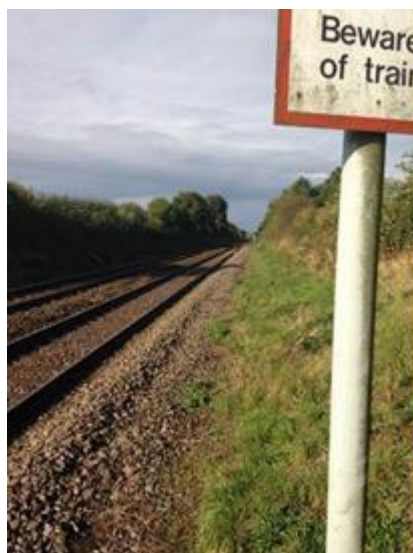
- 24.13. The photograph below is taken on the downside; the train usually approaches on the closest line (right hand side) set of lines.

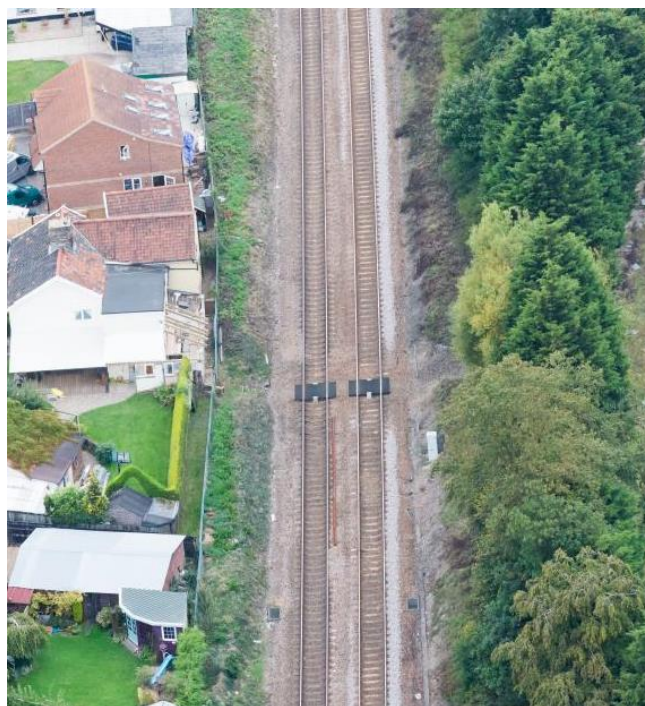
- 25.1. S29 Hawk End Lane Footpath crossing has an ALCRM score of C6 with an FWI of 0.000111603, it is located in Elmswell on the CCH line (Coldham lane jcn. to Haughley), which has a line speed of 75 MPH; it is between Thurston and Elmswell at 37miles and 0 chains. This crossing is currently closed and has been for at least 2 years, the crossing was closed by the developer who is building houses on the old disused factory on the northern side of the crossing.
- 25.2. There are 124 trains per day that run for 24 hours per day over this level crossing. Additionally, there are empty stock trains that pass over the crossing. There can also be various on-track machinery and plant that pass over the crossing at any point.
- 25.3. An aerial view of S29 Hawk End Lane crossing can be seen below.

- 25.4. The track on the left is the up line to Cambridge and the track on the right is the down line from Cambridge. Trains would normally run down from Cambridge on the right hand line that is from the top of the picture to the bottom. Trains would normally run up to Cambridge on the left hand side, which is from the bottom of the picture to the top.
- 25.5. An second aerial picture below is showing S29 Hawk End Lane crossing from the Routeview helicopter and clearly shows the footpath approaches to the crossing.

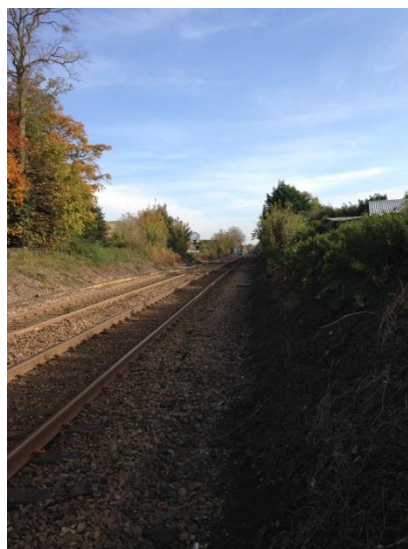
25.10. The photograph below is taken from the up side at a train approaching in the up direction. The trains usually approach on the closest set of lines (right hand side).

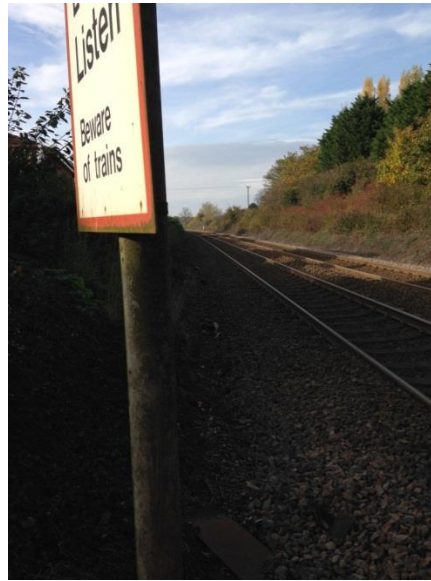
- 25.11. The photograph below is taken on the upside, the train usually approaches on the furthest (right hand side) set of lines.

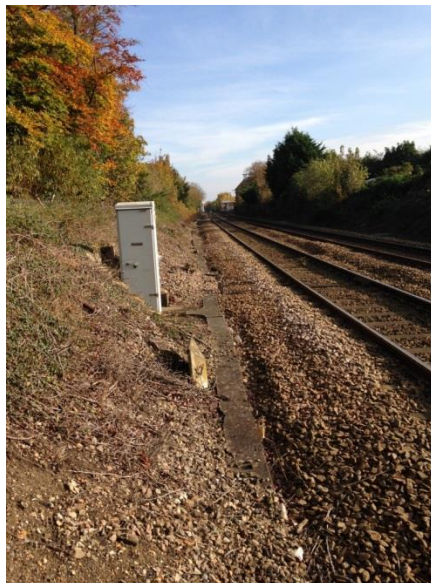
- 25.12. The photograph below is taken on the downside; the train usually approaches on the furthest line (right hand side) set of lines.

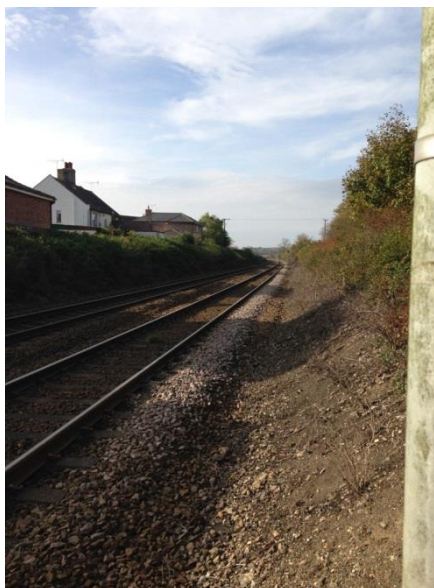
- 25.13. The photograph below is taken on the downside; the train usually approaches on the closest line (right hand side) set of lines.

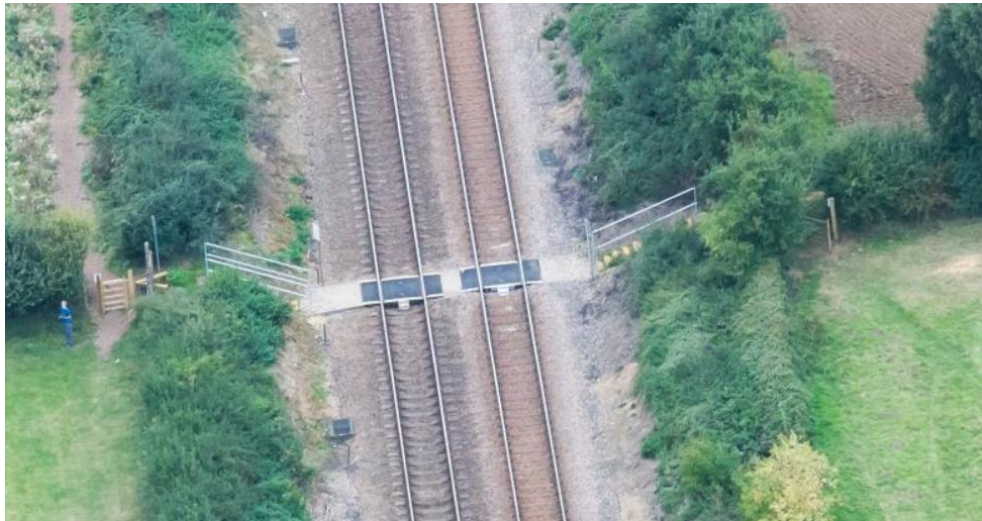
- 26.3. An aerial view of S30 Lords No.29 crossing can be seen below.

- 26.4. The track on the left of the above picture is the up line to Cambridge and the track on the right is the down line to Haughley. Trains would normally run down from Cambridge on the right hand line that is from the top side of the picture to the bottom. Trains would normally run up to Cambridge on the left hand line, which is from the bottom of the picture to the top.
- 26.5. A second aerial picture below is showing S30 Lords No.29 crossing from the Routeview helicopter and clearly shows the footpath approaches to the crossing.

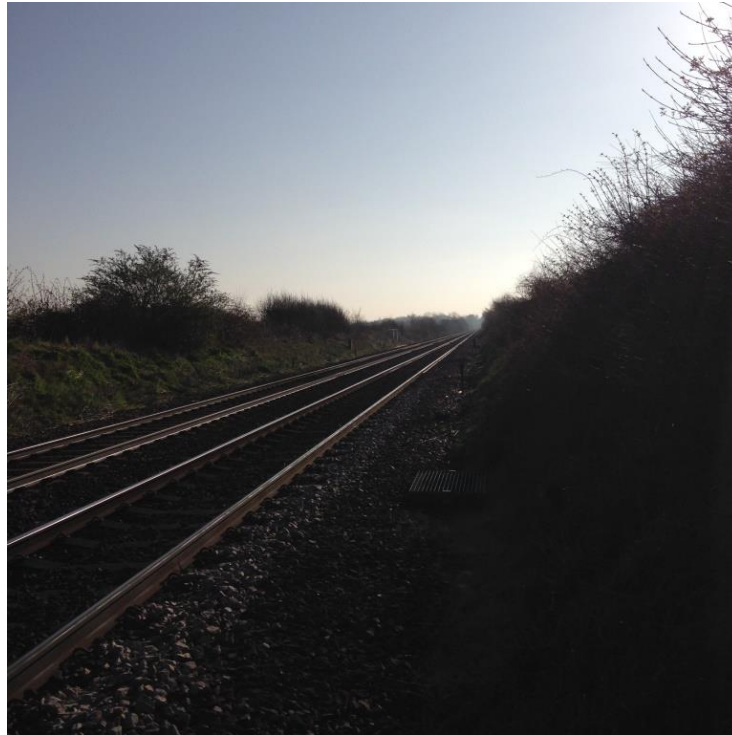
- 26.10. The photograph below is taken from the up side at a train approaching in the up direction. The trains usually approach on the closest set of lines (right hand side).

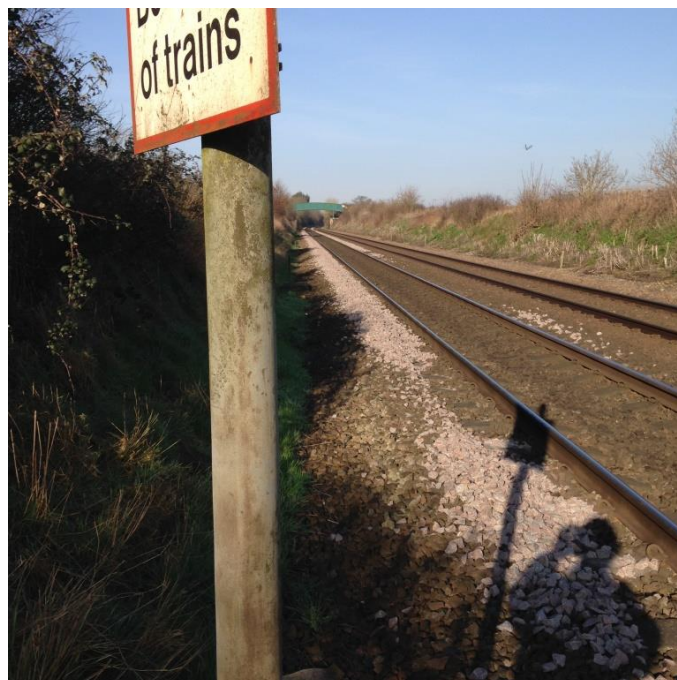
- 26.11. The photograph below is taken on the upside at a train approaching in the down direction. The train usually approaches on the furthest (right hand side) set of lines.

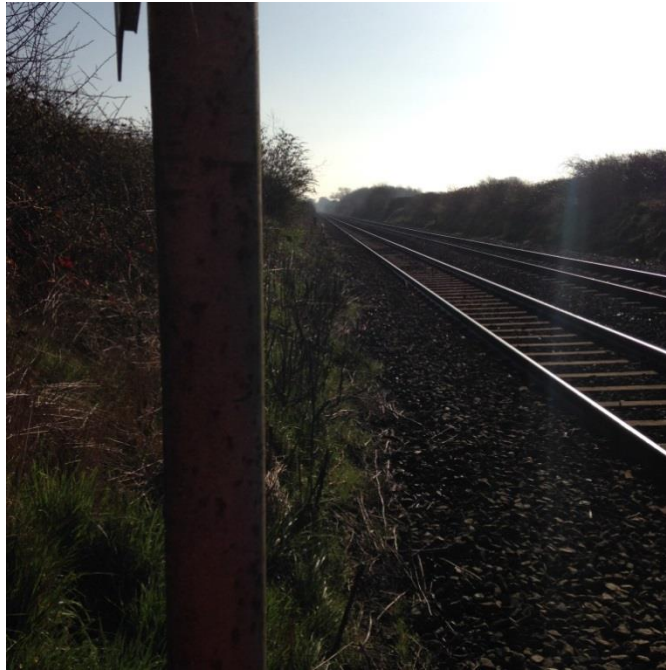
- 26.12. The photograph below is taken on the downside at a train approaching in the up direction. The train usually approaches on the furthest line (right hand side) set of lines.

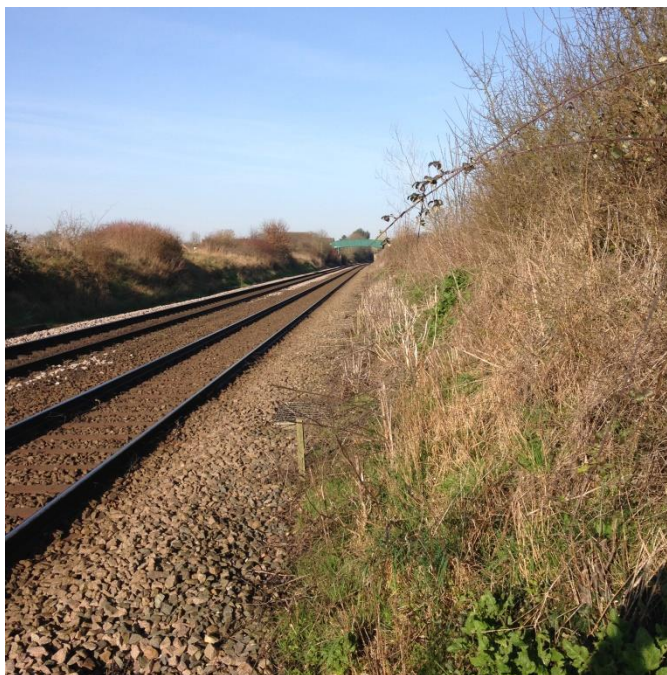
- 26.13. The photograph below is taken on the downside looking at a train approaching in the Down direction. The train usually approaches on the closest line (right hand side) set of lines.

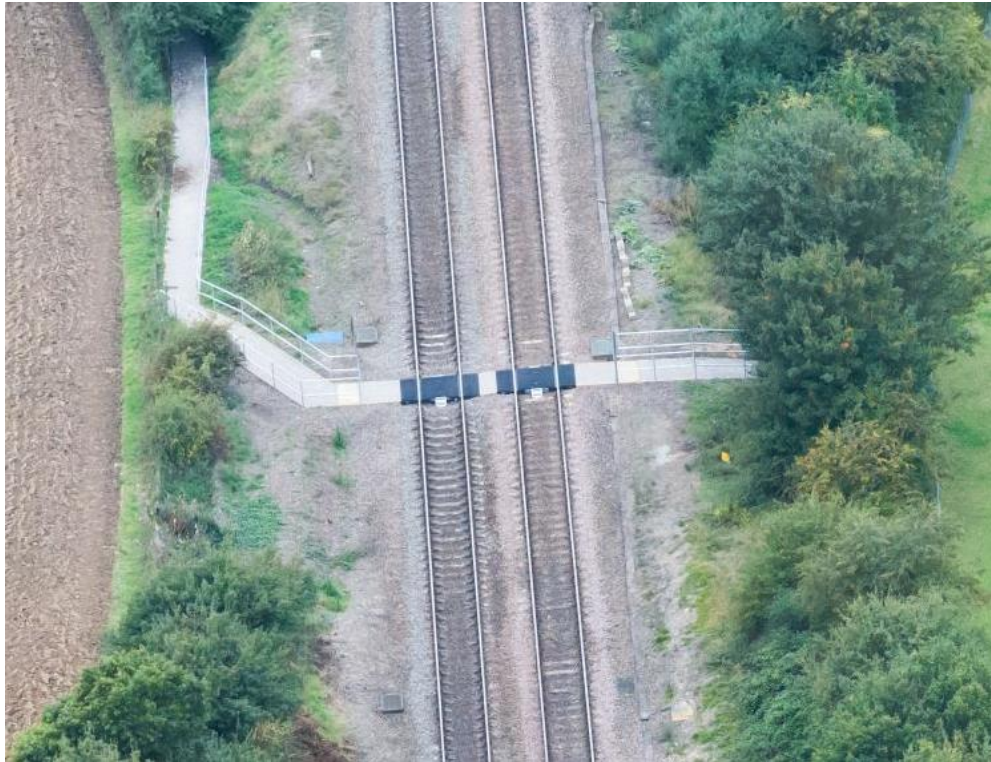
27.3. An aerial view of S31 Mutton Hall crossing can be seen below.

27.4. The track on the left hand side of the picture is the up line to Cambridge and the track on the right is the down line to Haughley. Trains would normally run down from Cambridge on the right hand line that is from the top of the picture to the bottom. Trains would normally run up to Cambridge on the left hand line, which is from the bottom of the picture to the top.

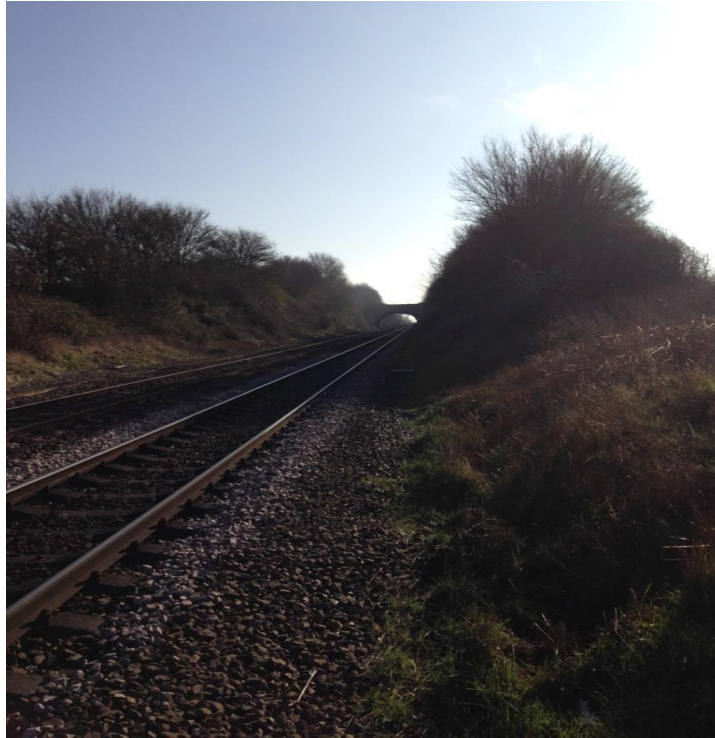
- 27.10. The photograph below is taken from the up side at a train approaching in the up direction. The trains usually approach on the closest set of lines (right hand side).

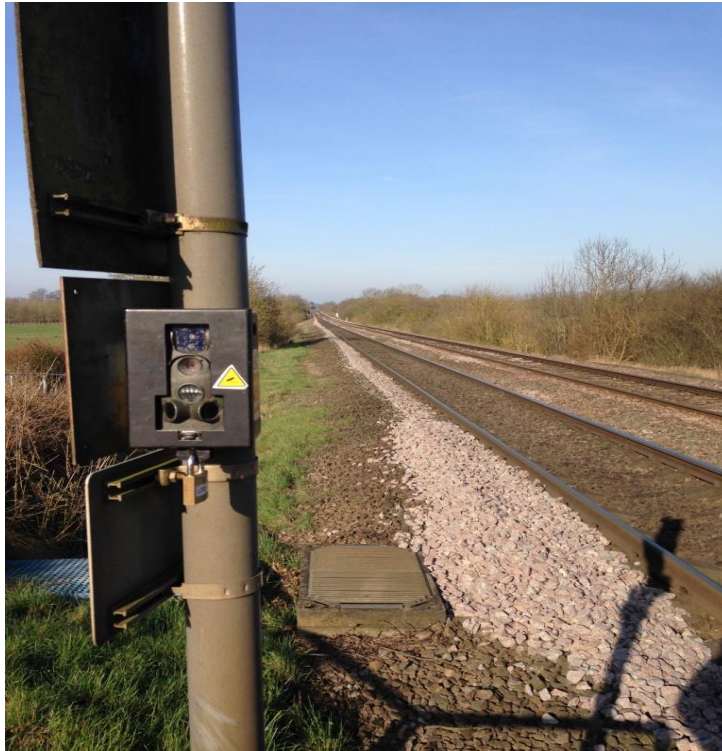
- 27.11. The photograph below is taken on the upside at a train approaching in the down direction. The train usually approaches on the furthest (right hand side) set of lines.

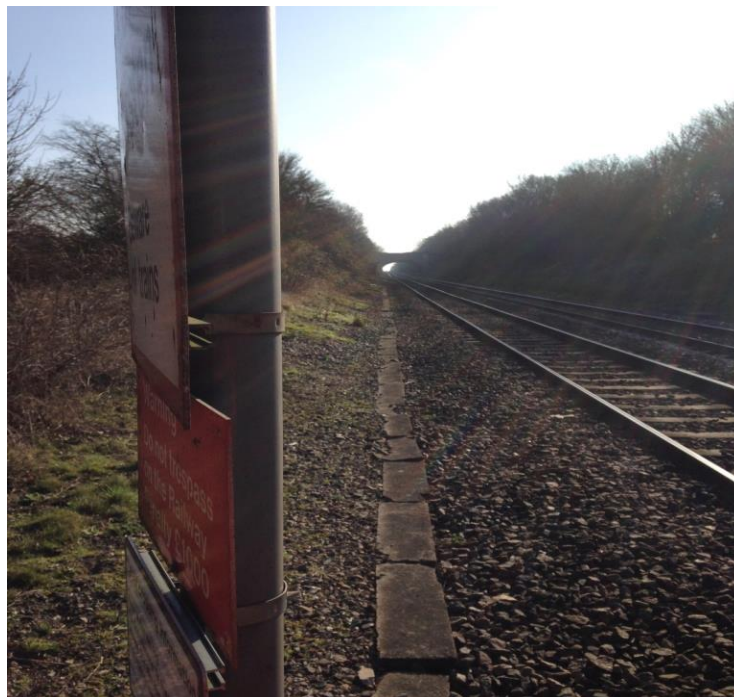
27.12. The photograph below is taken on the downside at a train approaching in the up direction. The train usually approaches on the furthest line (right hand side) set of lines.

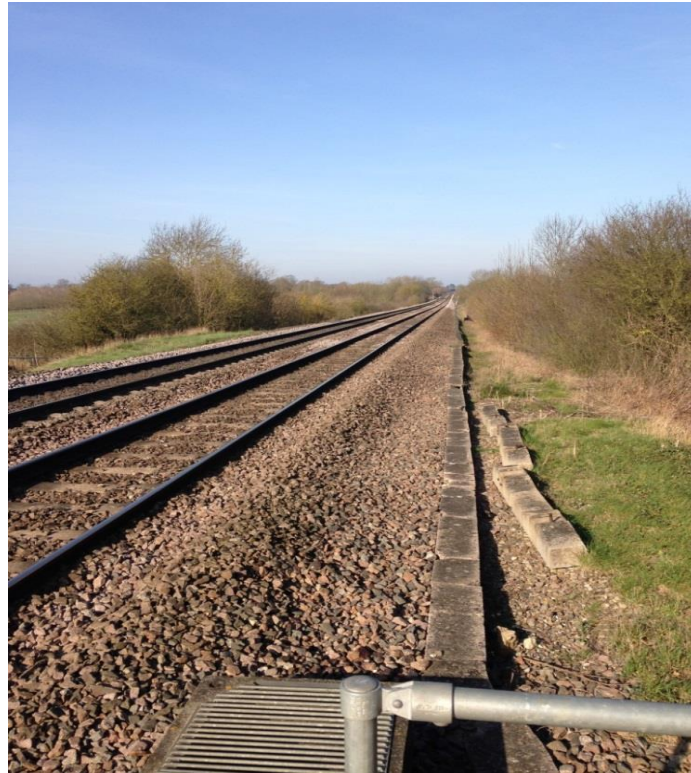
27.13. The photograph below is taken on the downside looking south at a train approaching in the Down direction. The train usually approaches on the closest line (right hand side) set of lines.

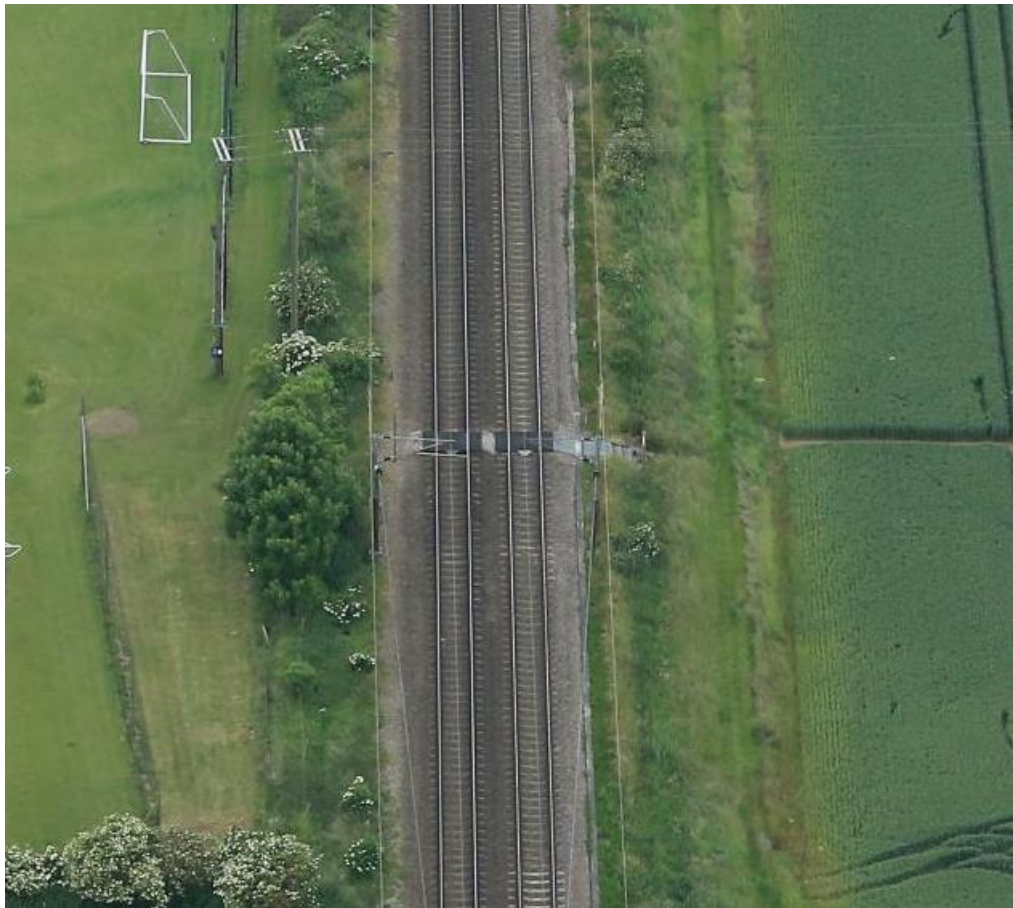
- 28.1. S69 Bacton footpath crossing has an ALCRM score of C8 with an FWI of 3.9875E-5; it is located in Bacton on the LTN1 line (London Liverpool Street to Norwich) which has a line speed of 100 MPH; it is between Diss and Stowmarket 86 miles and 06 chains from Liverpool street station London.
- 28.2. There are 92 trains per day that run for 20 hours per day over this level crossing. Additionally, there are empty stock trains that pass over the crossing. There can also be various on-track machinery and plant that pass over the crossing at any point.
- 28.3. An aerial view of S69 Bacton footpath crossing can be seen below.

- 28.4. The track on the right is the down line from London and the track on the left is the up line to London. Trains would normally run down from London on the right hand line that is from the top of the picture to the bottom. Trains would normally run up to London on the left hand side, which is from the bottom of the picture to the top.
- 28.5. A second aerial picture of Bacton foot crossing.

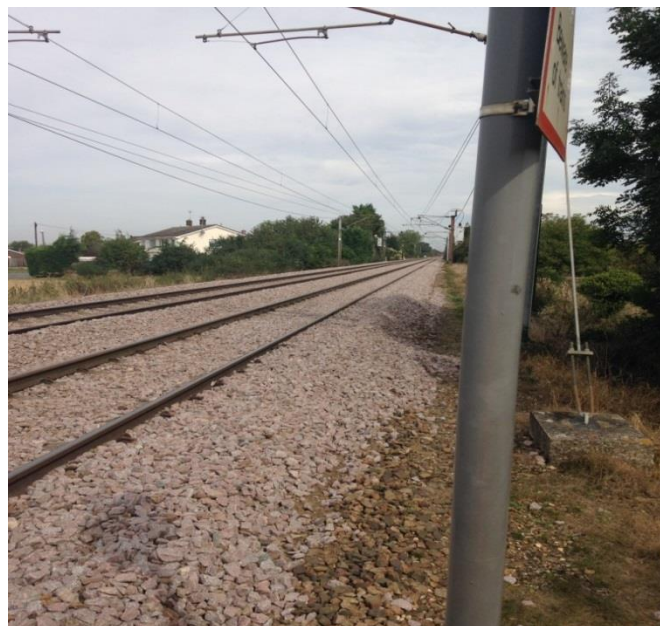
28.10. The photograph below is taken looking northward, from the up side at a train approaching in the up direction. The trains usually approach on the closest set of lines (right hand side).

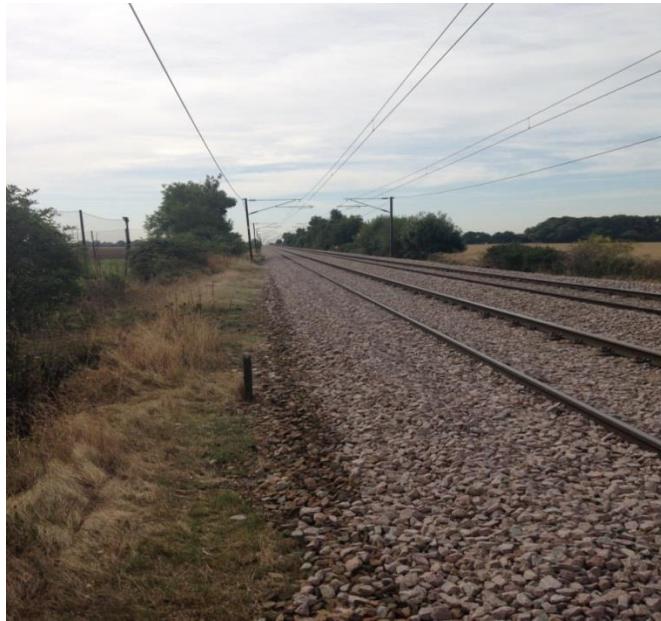
28.11. The photograph below is taken on the upside, looking south, the train usually approaches on the furthest (right hand side)

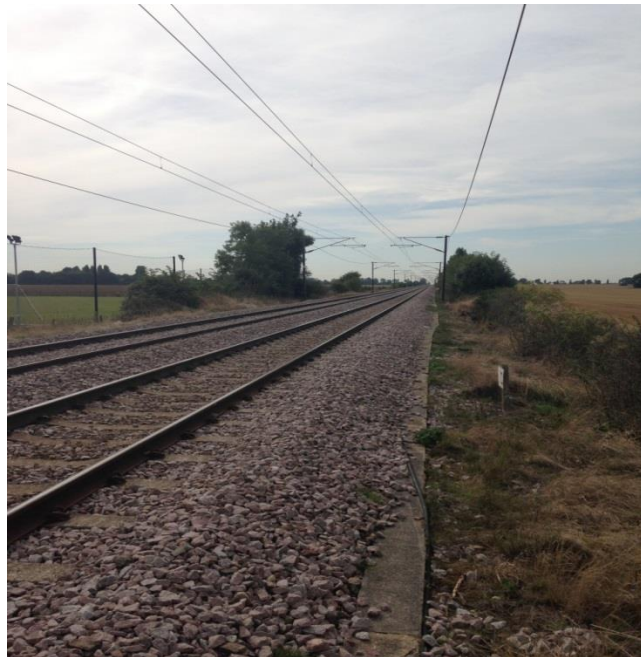
28.12. The photograph below is taken on the downside looking north; the train usually approaches on the closest line (right hand side) set of lines.

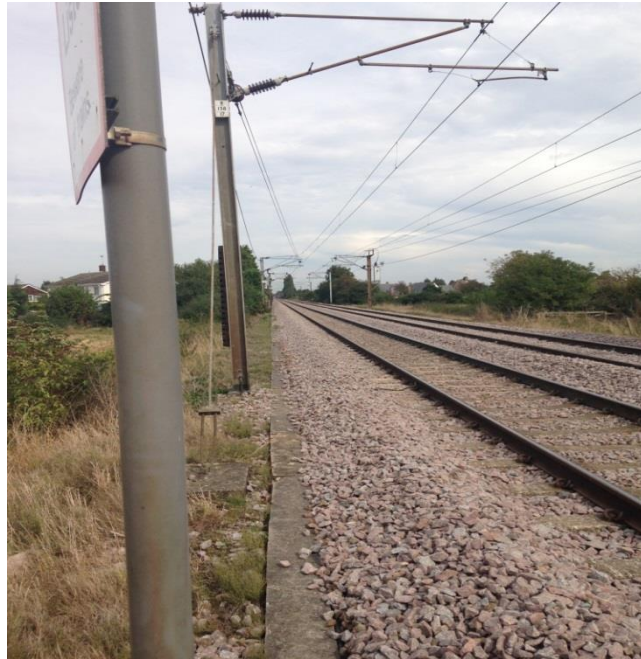
28.13. The photograph below is taken on the downside looking south; the train usually approaches on the furthest line (right hand side) set of lines.

28.14. As can be seen from the table above (28.9), S69 Bacton footpath crossing does have sufficient sighting to meet industry standards in all directions
