**Report By:** Amanda Mays, Suffolk Highways Asset Manager. (Footways, Street Furniture, and Drainage)

**Date:** 13<sup>th</sup> April 2018

**Prepared For:** The Inquiry, The Proposed Network Rail Suffolk Level Crossing Reduction Order

### **Pound Hill Bacton. Highway Flooding Issues, Summary Of Suffolk Highways Activity.**

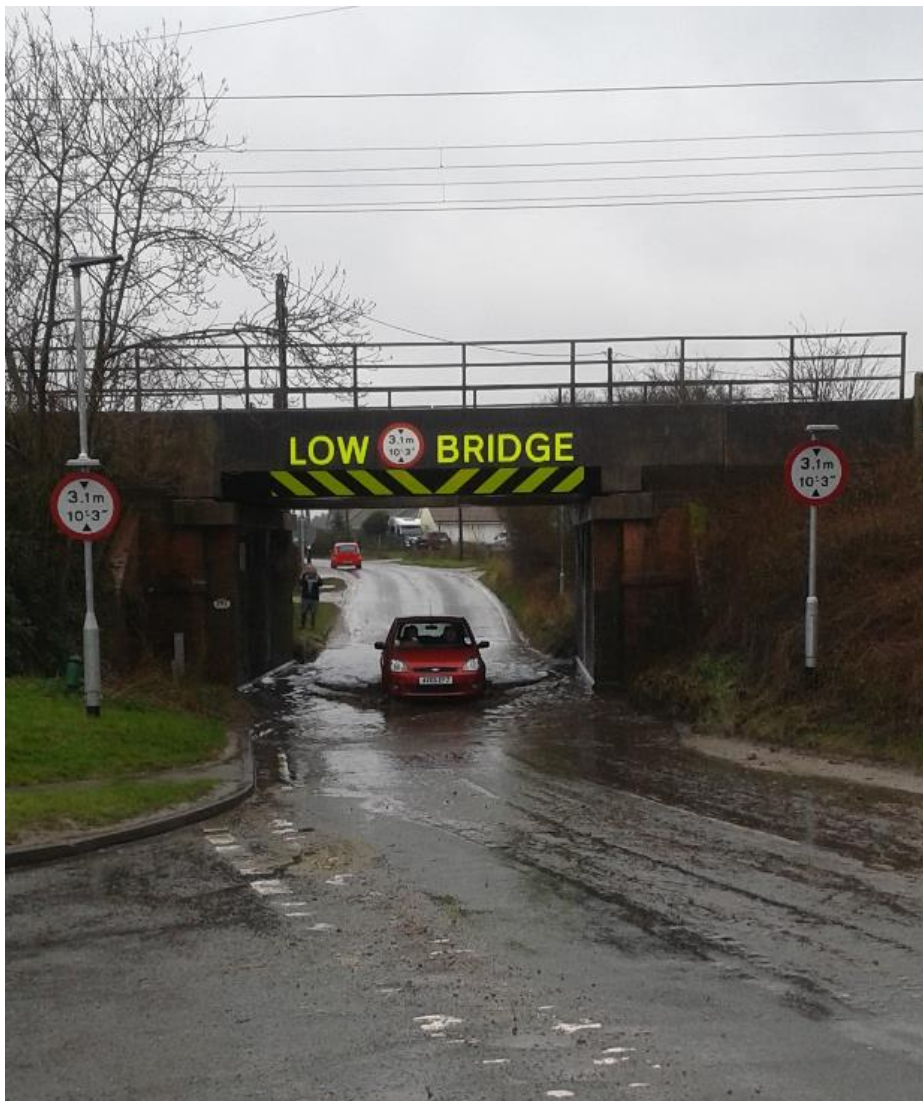
1. Periodic flooding of the highway has been reported under the rail bridge over the last few years.

The water can be a foot or more deep, and extends for around 30 feet. On several occasions, the emergency call out crews have had to put out flood warning signs to warn drivers in advance. The Council also has a series of customer reports to Suffolk Highways specifically about this issue, 2 in 2015, 9 in 2016 and 1 in 2017.

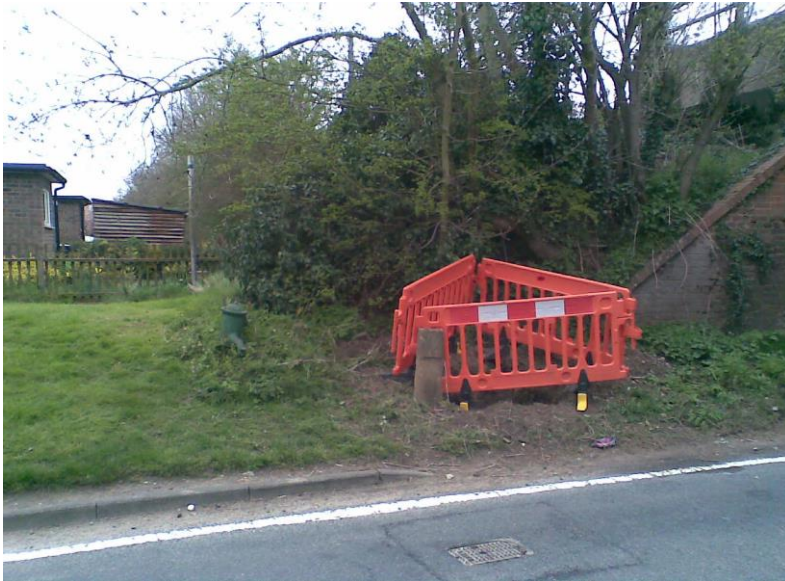
*Location of the underground chamber indicated by the orange barriers around it.*

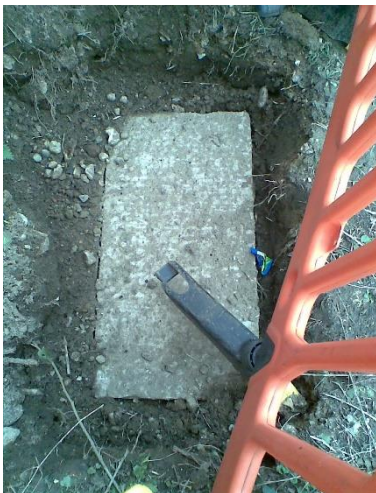
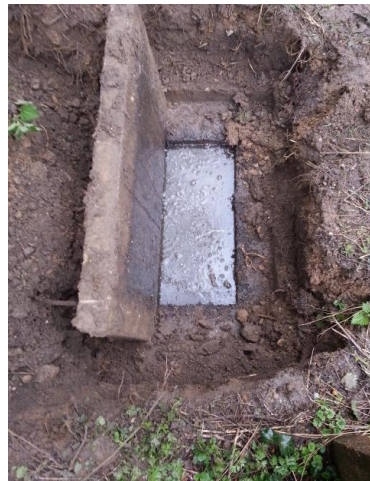
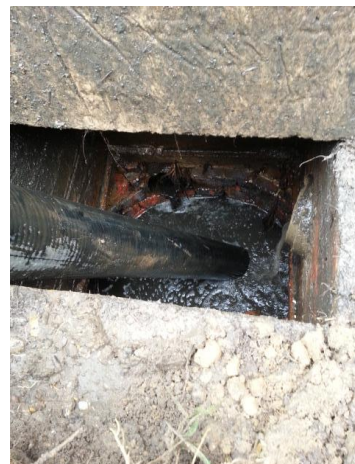
*Images below show the cover of the chamber, it being full of water when opened and the internal view when it was pumped out.*

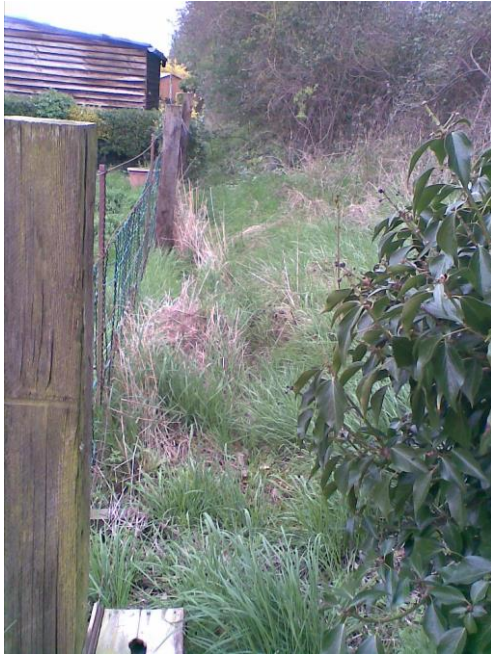
4. The problem was found to be within the Network Rail boundary. This was reported to NR in June 2016. The area along the toe of the rail embankment is overgrown appears to have previously had an open ditch which is now silted and overgrown with vegetation.

*The outfall from the chamber is to the drain at the toe of the embankment. View along the inside line of the Network Rail fence showing ditch silted up and overgrown with grass.*

5. The cleansing and jetting works by Suffolk Highways may have improved the situation, there have been fewer reports of flooding. However as far as we are aware the underlying issues remains. Suffolk Highways aren't aware of any works on this ditch having been carried out by Network Rail. Further jetting or works on the Suffolk highways section of the system will only be fully effective once the system downstream is clear and operating effectively.
