## ANGLIA LEVEL CROSSING REDUCTION STRATEGY S69: BACTON, SUFFOLK

### STAGE 1 ROAD SAFETY AUDIT

1.1 Document No: 1459/0001-RSA-01

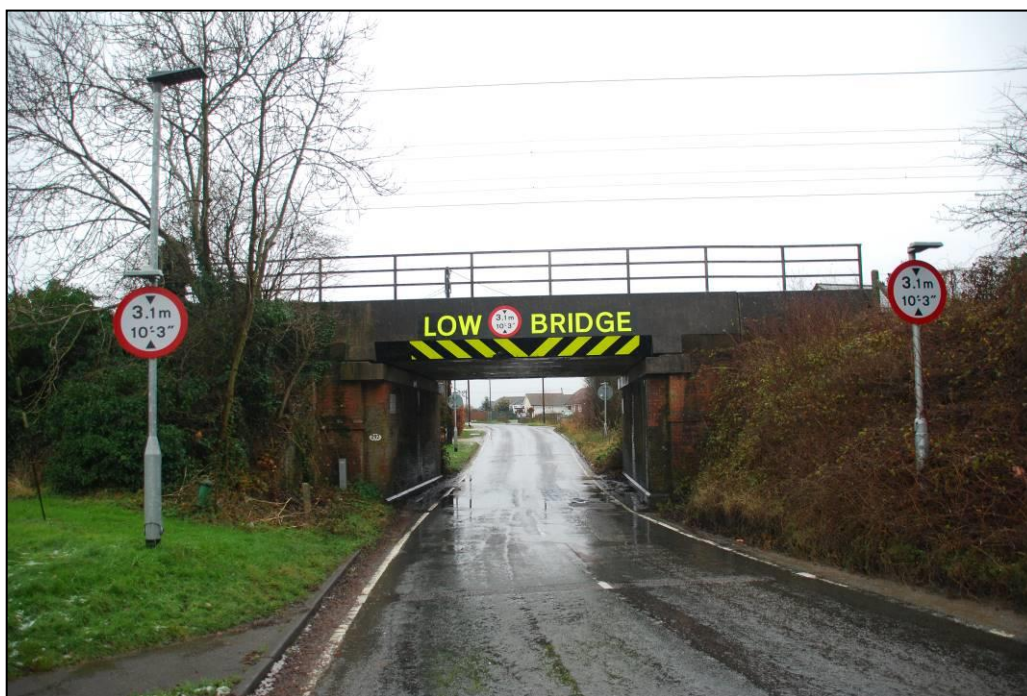
**Location:** A – Pound Hill railway bridge.

**Summary:** Risk to diverted walkers of being struck by vehicular traffic.

The section of footpath affected by the closure of level crossing S69 runs between Birch Avenue and Broad Road. It links a residential area to the west of the railway and a recreation ground to the east. At the time of the site visit there was clear evidence to suggest use of the level crossing by walkers going to/from Birch Avenue, although nothing obvious to suggest access being made from Broad Road directly via the signed route (walkers may, instead, be using the recreation ground access track). The shortest alternative route between Birch Avenue and the recreation ground will be via Pound Hill and Broad Road. Pedestrian facilities at the Pound Hill railway bridge are discontinuous; there are no footways beneath the arch, where the carriageway narrows, nor also for a short distance on either side. Walkers diverted by the closure of crossing S69 may, therefore, be exposed to new hazards at the Pound Hill bridge pinch point where they will need to walk in the carriageway. This may increase their risk of being struck by passing vehicular traffic, with poor visibility or dark conditions exacerbating the problem.

#### RECOMMENDATION

Pedestrian facilities in the vicinity of the Pound Hill railway bridge should be improved, within the constraints posed by the arch. The resulting overall

scheme (see also recommendation 4.1.2) should be subject to a robust risk assessment, comparing the use of it to the use of the level crossing.
