**APPLICATION FOR THE PROPOSED NETWORK RAIL
(SUFFOLK LEVEL CROSSING REDUCTION) ORDER**

ANGLIA LEVEL CROSSING REDUCTION STRATEGY S23: HIGHAM, SUFFOLK

STAGE 1 ROAD SAFETY AUDIT

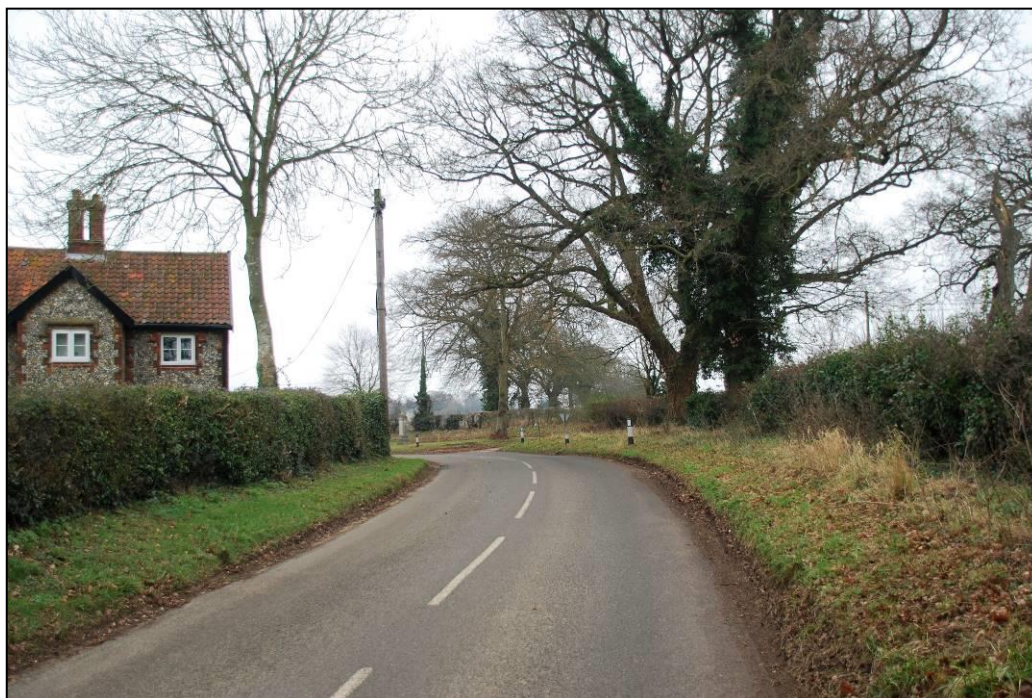
Location: A – Higham Road.

Summary: Risk to diverted walkers of being struck by passing vehicular traffic.

Following extinguishment of the footpath walkers will be diverted from the southern extinguishment point along Higham Road towards the A14. The section of Higham Road in question has a 60mph speed limit (national limit). There are no footways along Higham Road, plus some steep/high/narrow verges and restrictions in forward visibility due to the horizontal alignment (bend at the war memorial – see photo below) and vertical alignment (over the railway bridge). Walkers diverted by the closure of crossing S23 may, therefore, be exposed to passing vehicular traffic on Higham Road as they will sometimes need to walk in the carriageway. This may increase their risk of being struck by passing vehicular traffic, with poor visibility or dark conditions exacerbating the problem.

Pedestrian facilities along Higham Road should be improved (e.g. reprofiled verges, vegetation cut back), or an alternative footpath diversion route off the carriageway developed.

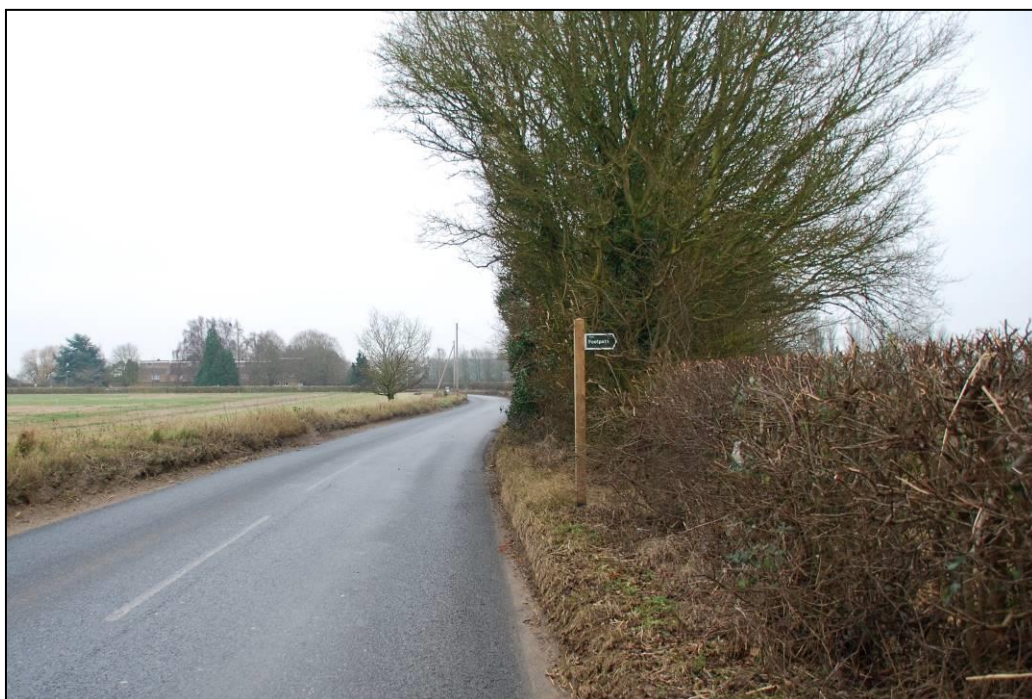
Location: B – Coalpit Lane.

Summary: Risk to diverted walkers of being struck crossing Coalpit Lane due to constrained visibility.

The S23-S24 footpath diversion route will require walkers to cross Coalpit Lane, a 60mph (national speed limit) route. At the location of the proposed crossing the horizontal carriageway alignment may constrain intervisibility at the western crossing point between northbound drivers and eastbound walkers wishing to cross. This may increase the risk of walkers being struck when crossing the carriageway, especially in poor visibility conditions.

Ensure that visibility as per LTN 2/95 Table 1 is available where the footpath crosses Coalpit Lane.

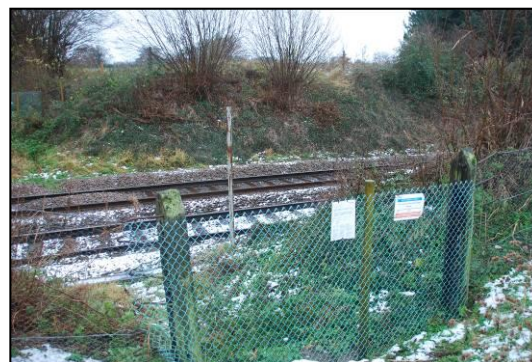
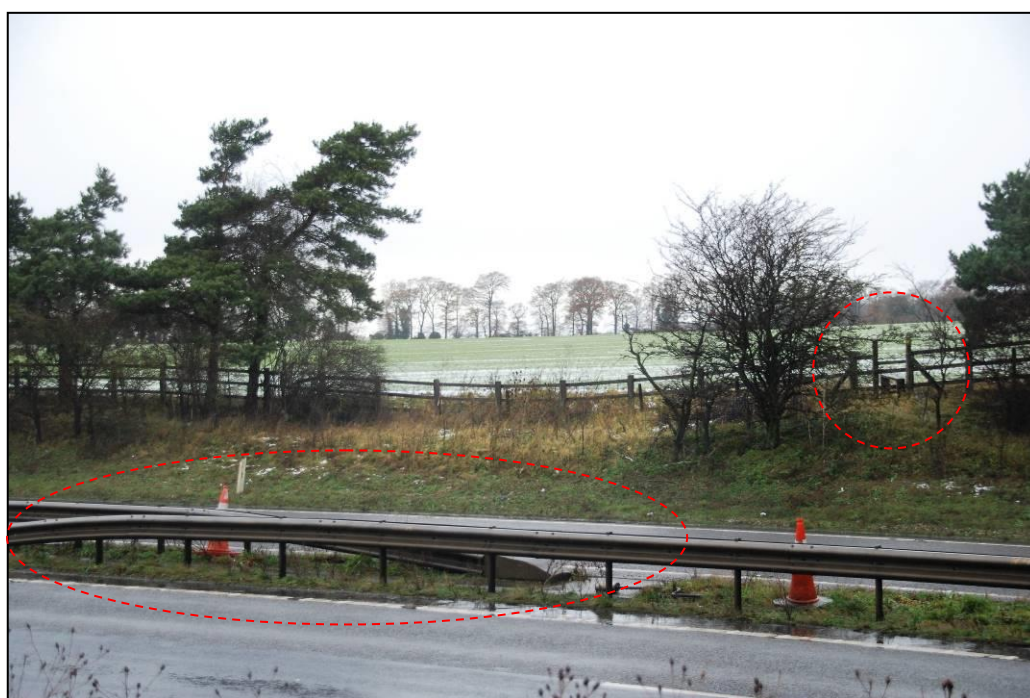
Location: C – A14.

Summary: Remnants of an extinguished footpath may increase the risk of walkers being struck crossing the A14 or on the A14 slip road.

The proposal to close level crossing S23 will see the footpath running from Higham Road to the A14 via the level crossing being extinguished, with an alternative route being proposed along Higham Road and the two-way section of the A14 westbound on-slip. In fact, the crossing has already been closed and northern section of footpath ploughed up.

The Audit Team understands that a footpath has already been extinguished to the immediate north of the length of footpath that is now proposed for extinguishment. There are, however, still clear remnants of the extinguished footpath on the A14 in the form of a gap in the barrier on the central reserve and stile with footpath plate on the northern highway boundary. This gives rise to concern that walkers may still approach the level crossing from the north as the extinguished footpath appears to remain. In doing so they will cross the A14, where the risk of being struck by fast moving traffic appears high. Then, finding the footpath south of the A14 extinguished, have to walk along the A14 slip road. Although traffic flows along the slip road are moderate, vehicles are

moving at high speed, particularly towards the western end. Walkers using the A14 slip road may be at increased risk of being struck by high speed traffic, especially in poor visibility or dark conditions.

Fully remove the remnants of the extinguished footpath (stile, sign and central reserve gap) from the northern side of the A14 and ensure that an appropriate route is implemented from north to south across A14 Junction 40.
