# **River Medway (Flood Relief) Act 1976**

**The Environment Agency's application to vary the Scheme for the operation of the Leigh Flood Storage Area**

## **Objection to the application**

**From Jenny & Kevin Storey**

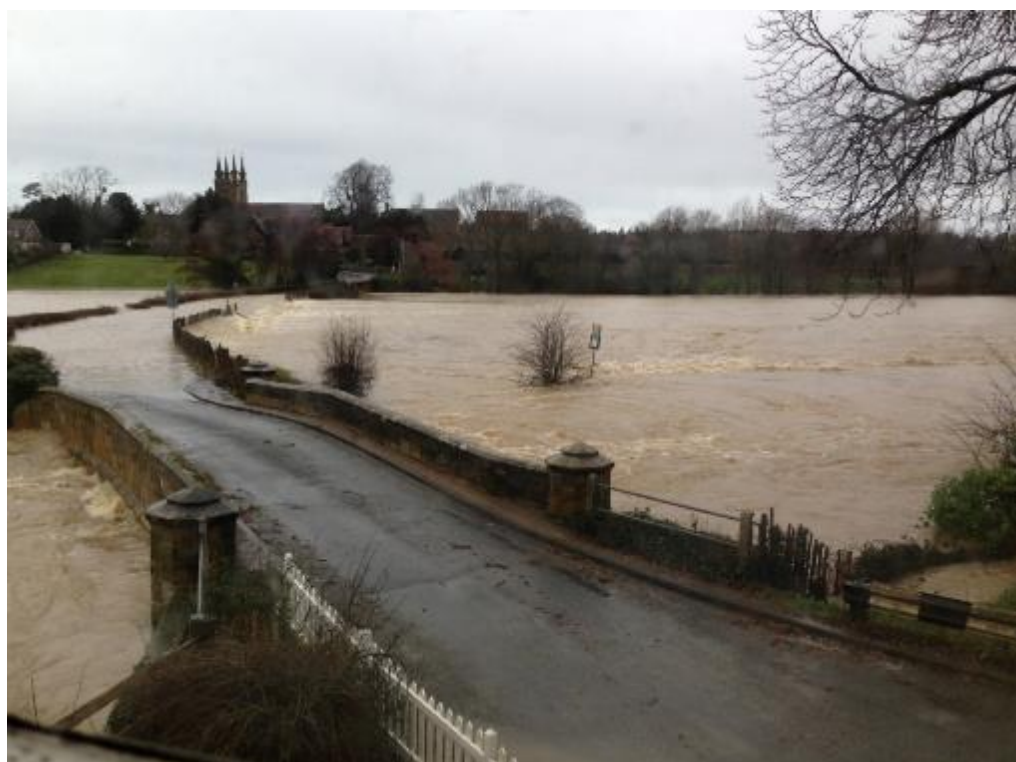
Photograph of December 2013 when [REDACTED] was flooded.

Taken after the Environment Agency operated the Leigh Barrier impounding the existing Flood Storage Area to its maximum depth of 28.05 metres AOD.

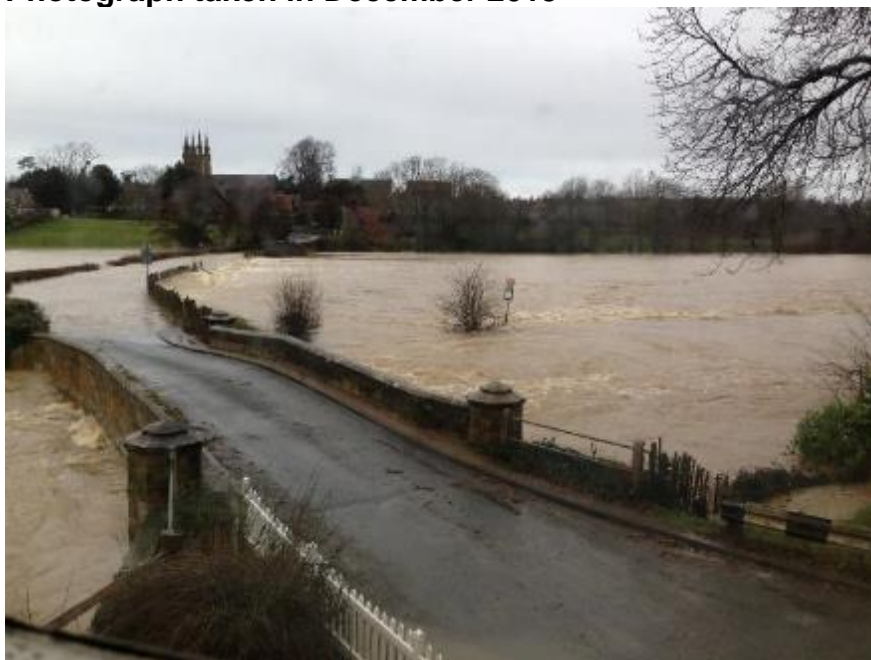
**Photograph taken in December 2013**

In December 2013 [REDACTED] flooded to 29.5 m AOD. This flooded property marked white on the deed. The Environment Agency paid compensation for this flooding.

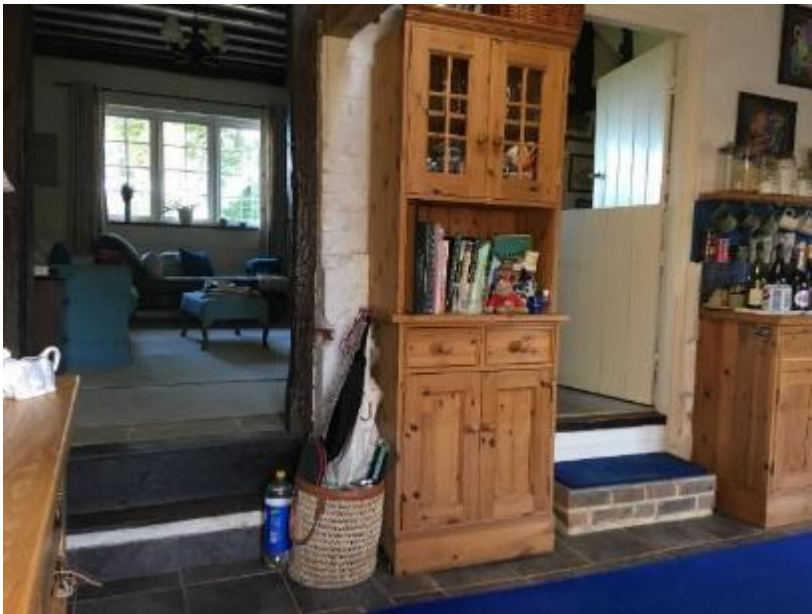
Flood water entered the Lounge from the two interconnecting doors between it and the Kitchen as well as coming in the front door.

The two interconnecting doors between Lounge and Kitchen where floodwater entered the Lounge

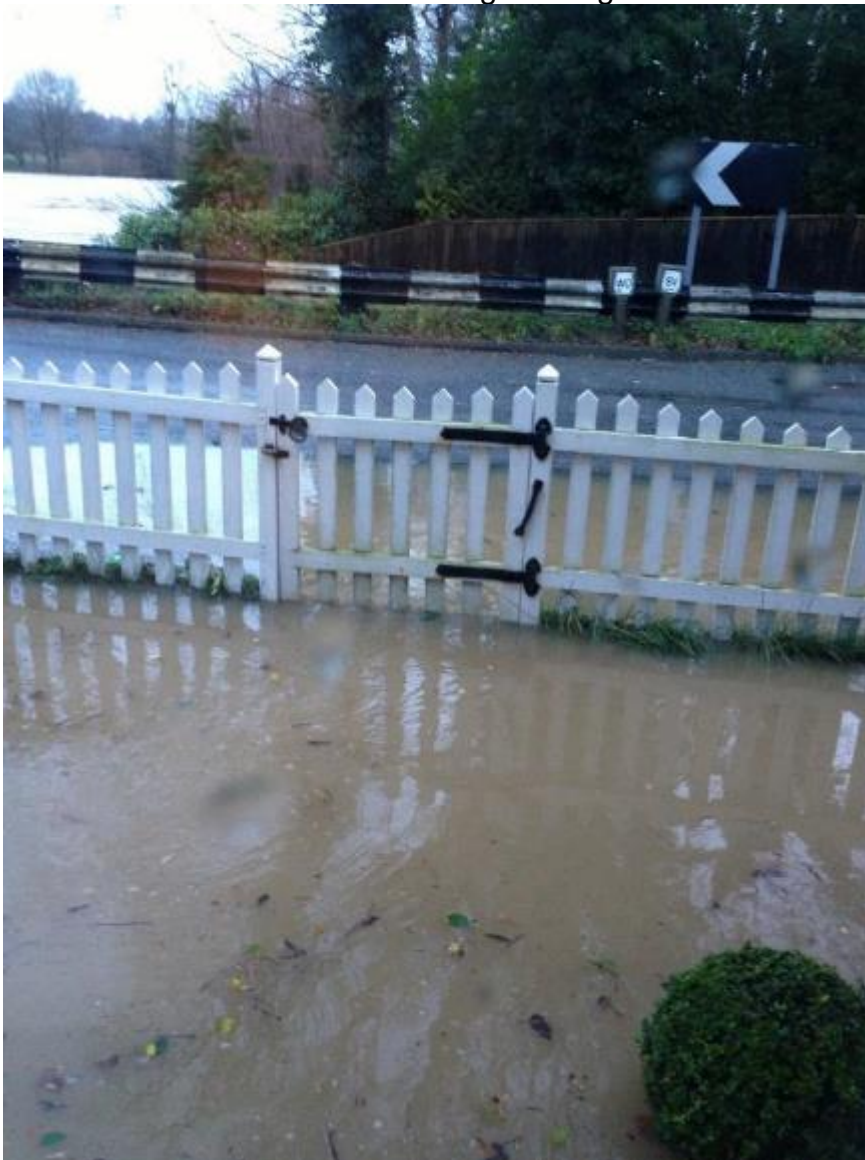
Floodwater also entered the Lounge through the front door

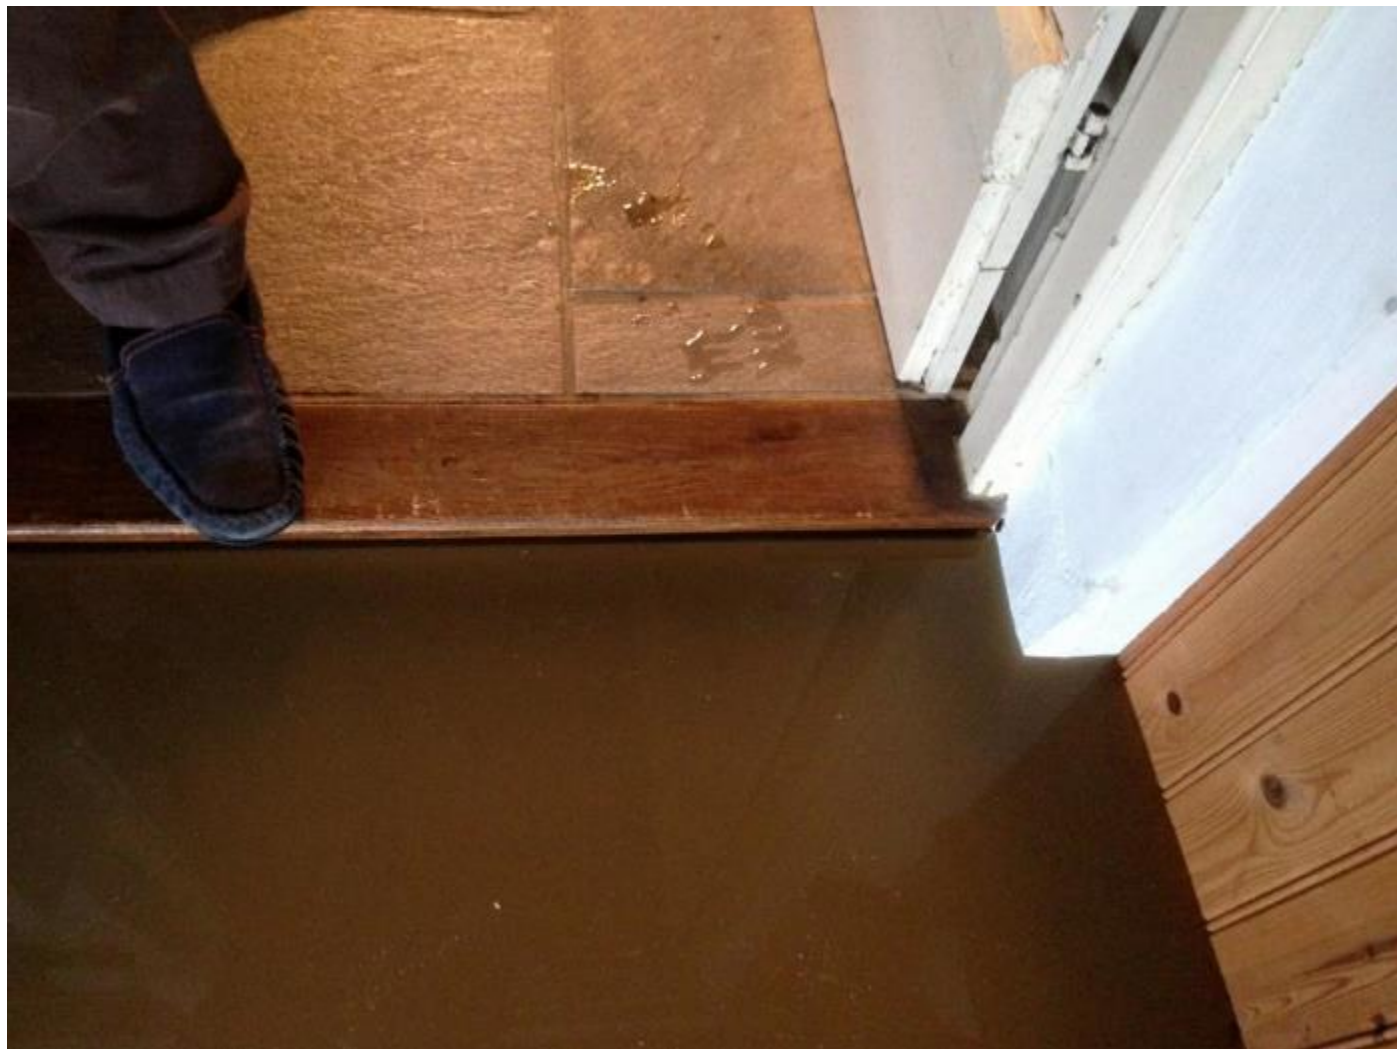
Photo #1958

**Christmas Eve. Peak flood water level in the Kitchen**

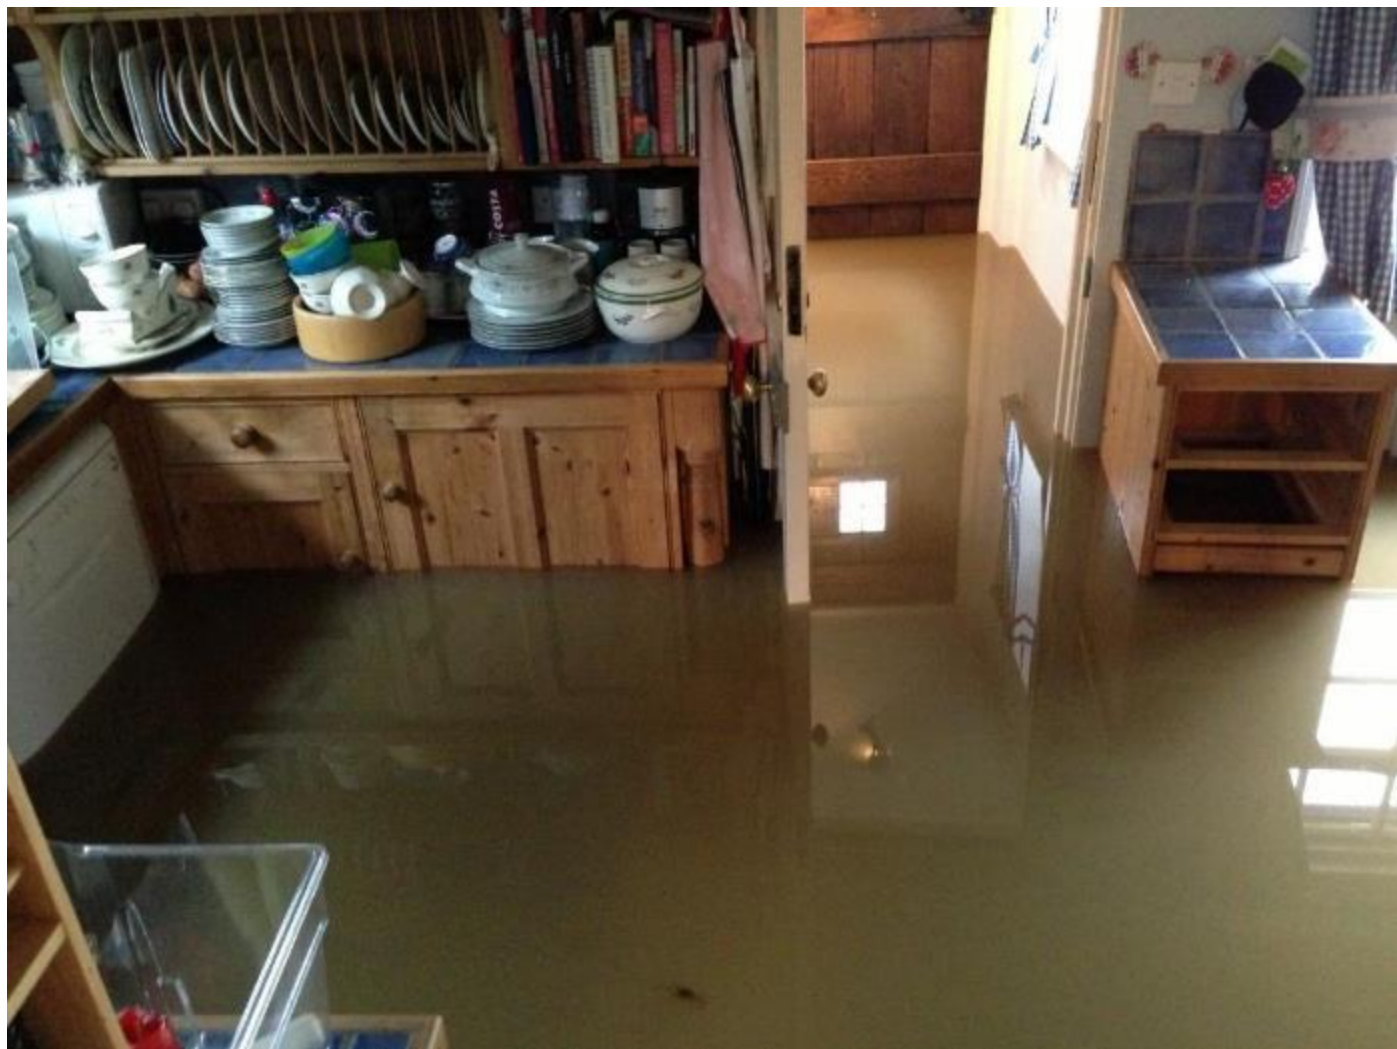
Photo #1961

**Christmas Eve. Peak flood water level in the Kitchen**

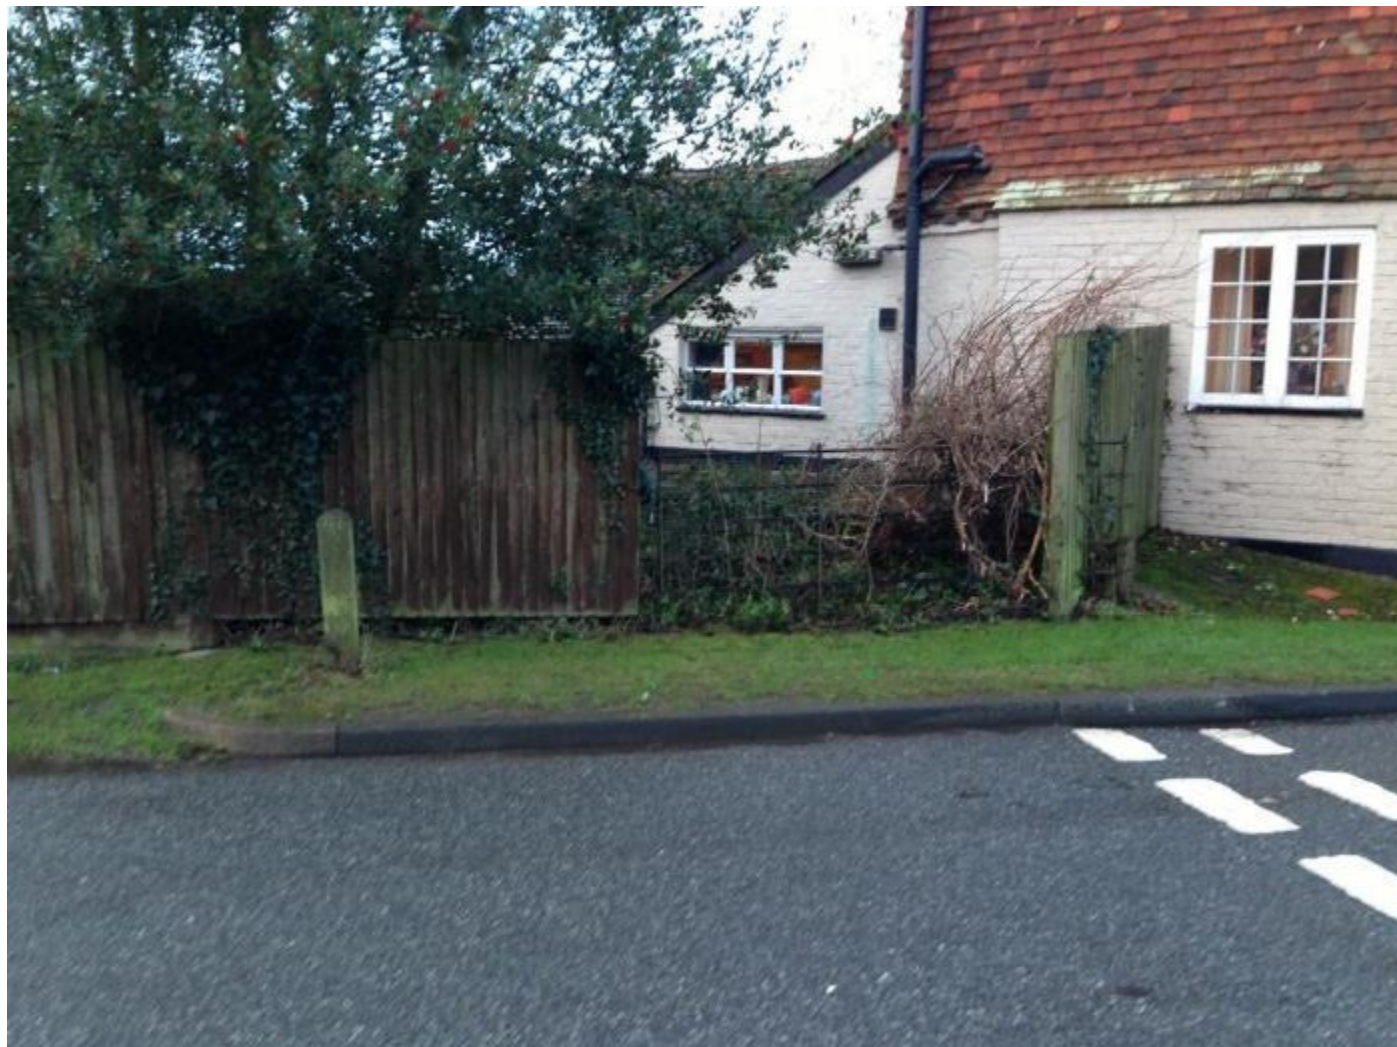
Photo #1962

A length of close boarded fencing and gravel boarding was displaced and damaged by the flood water

**Christmas Day. Loss of close boarded fence due to flood water**

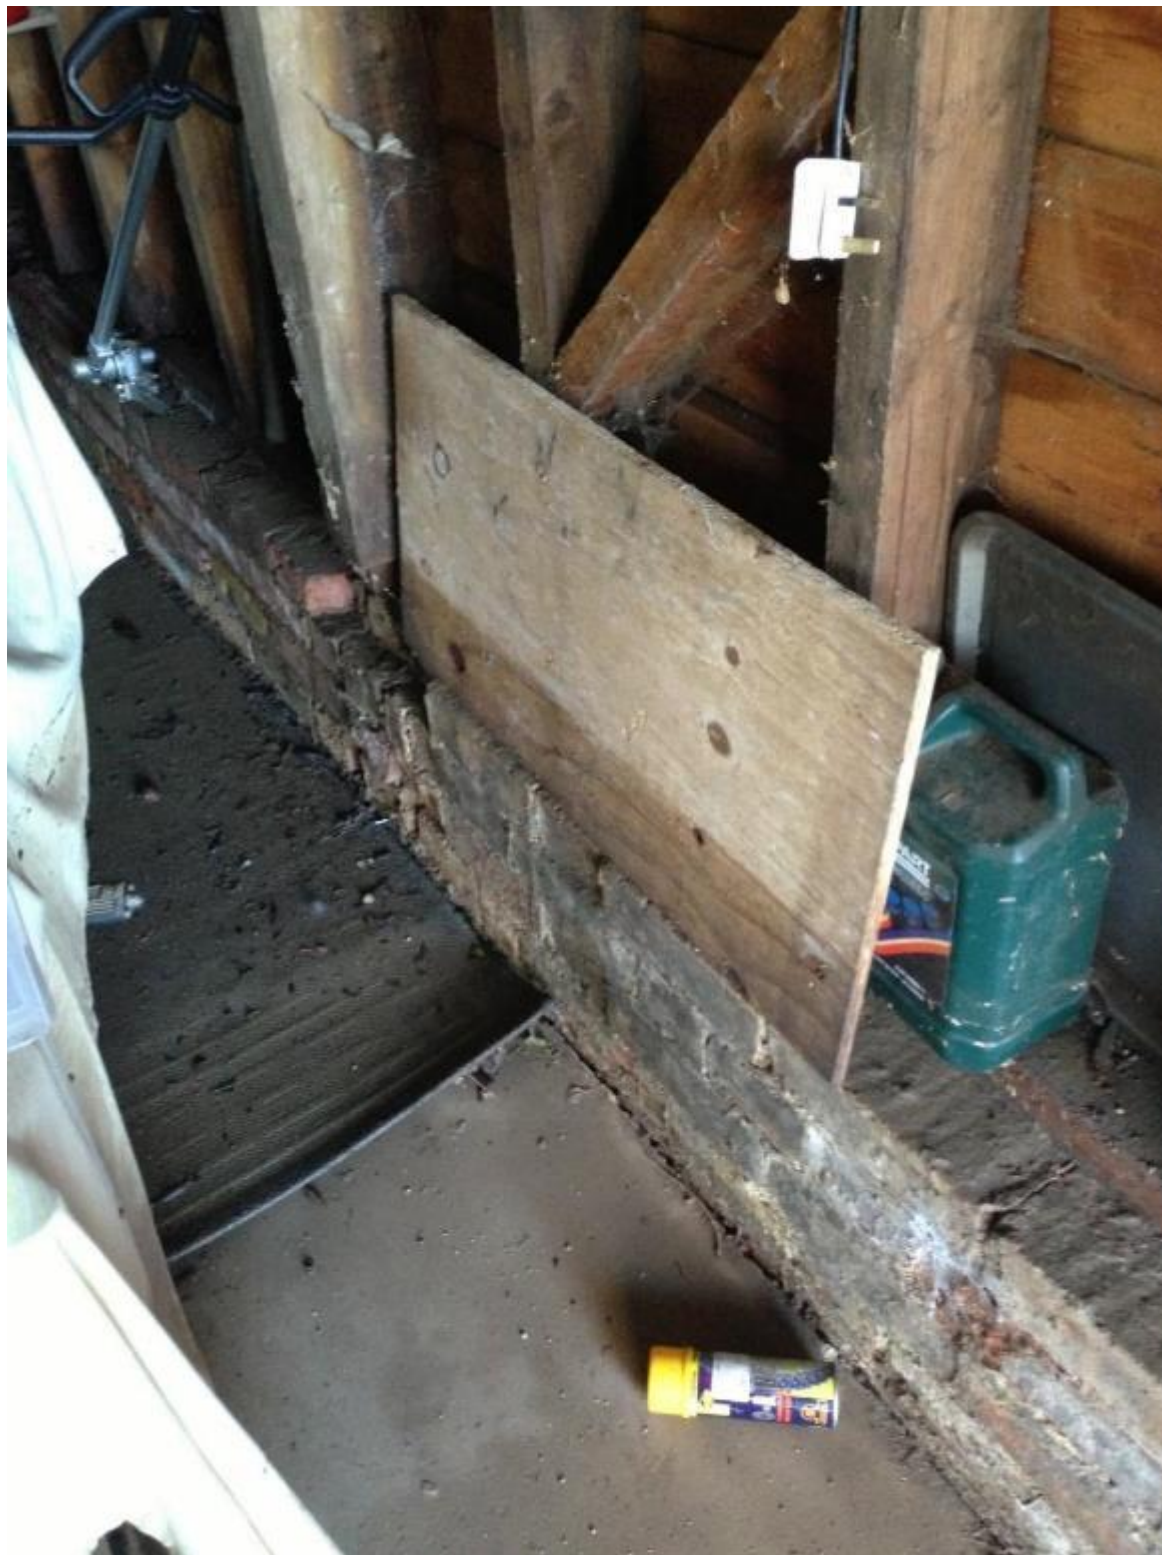
**Christmas eve + 5 days. Sodden board showing garage flood level of 500mm**

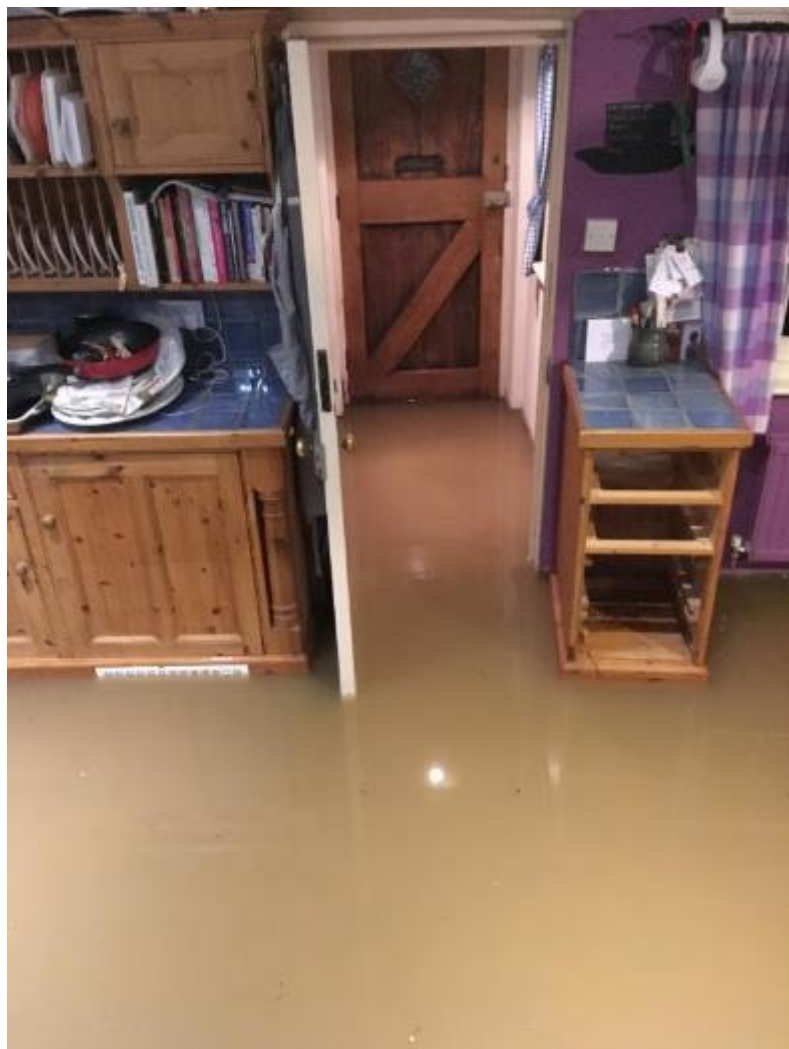
**Floodwater in the kitchen. Shortly after maximum level.**

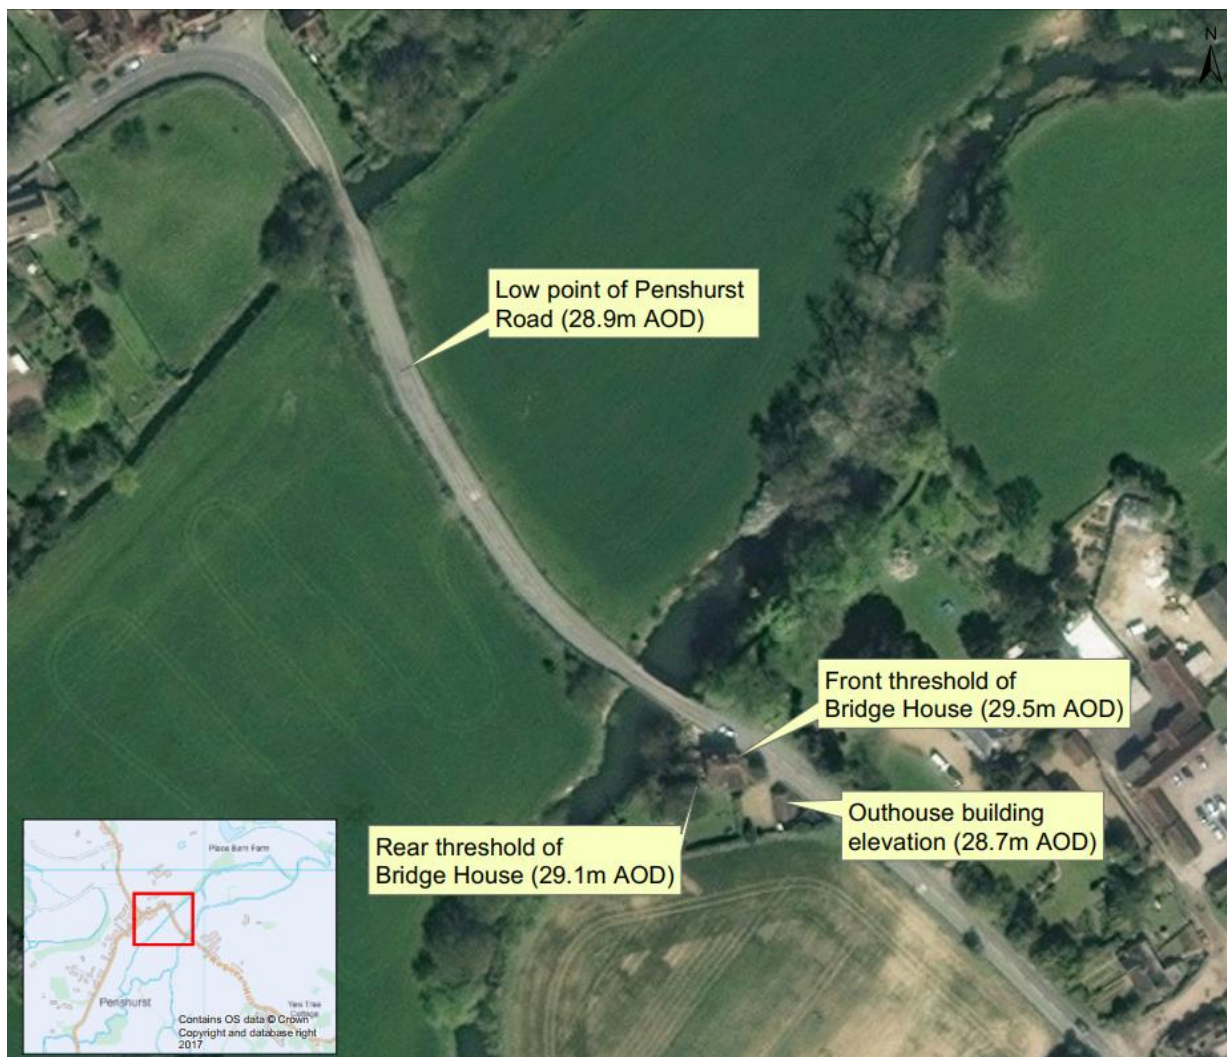
- Front threshold of [REDACTED]: 29.5m AOD
- Rear threshold of [REDACTED]: 29.1m AOD
- Outhouse building at [REDACTED]: 28.7m AOD

**Figure 1.** Locations of key ground and threshold elevations against which modelled flood levels are compared
