Job Title
**RVR Level Crossing
Highway Works**

Drawing Title
**C18 Northbridge Street
Existing Statutory Utilities**

I have the pleasure of enclosing our Rother Valley Railway Level Crossing – C18 Northbridge Street, Robertsbridge Stage 1 Road Safety Audit report. In addition to the enclosed report the Audit Team noted the following points outwith the remit of the audit. I would be grateful if you would bring these issues to the attention of the Designer and/or Maintainer as appropriate.

Annex D. Road Crossings. Narrative safety report.

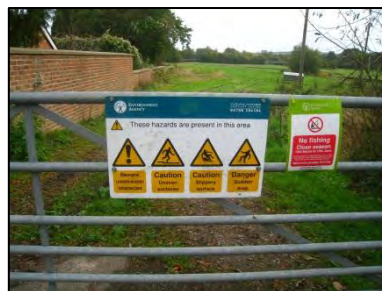
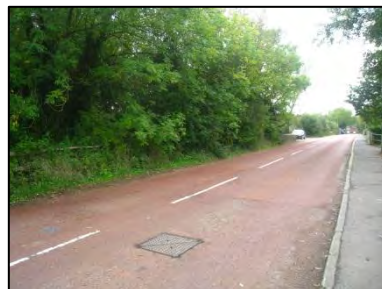
IMG_2962.jpg

- There is an Environment Agency access situated immediately north of the proposed level crossing site on the north bank of the River Rother. The railway will truncate this access and it is not clear how suitable, safe access to the riparian environment will be maintained.
- It is not clear whether the existing verge width (especially on the eastern side of the road) is able to safely accommodate the required traffic sign infrastructure.

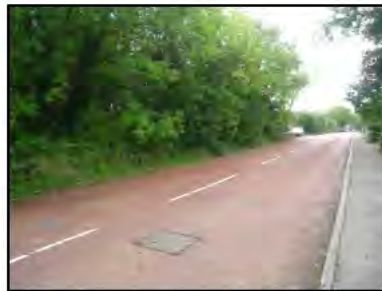
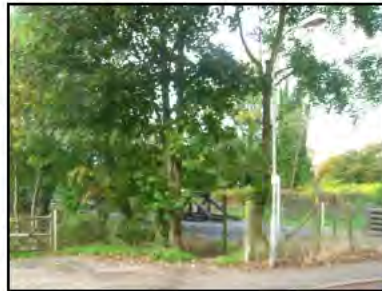
IMG_2947.jpg

- The drawing provided does not show the extent of the vegetation clearance required in order to provide the appropriate visibility envelope for the level crossing as set out in Railway Principles and Guidance.

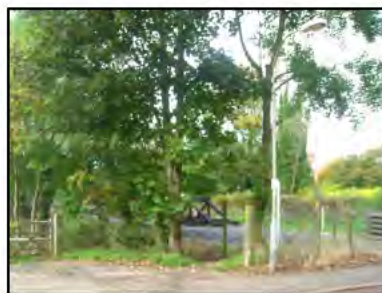
IMG_2940.jpg

- Northbridge road is lit, and the construction of the crossing may necessitate the removal of an existing lighting column, reducing illumination levels. The provision of consistent street lighting levels will need to be addressed in the detailed design.

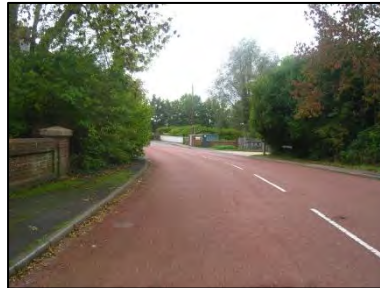
IMG_2951.jpg

Location:	Northbridge Street, southbound approach
Summary:	Limited forward visibility to level crossing leading to shunt type collisions.
Description:	The approach to the level crossing is situated on a bend in the road

There is a cottage located close to the road limiting drivers' forward visibility on the bend. In the same location there is on-street residents' parking, which requires traffic to cross the carriageway centreline. This could draw drivers' attention away from downstream hazards such as a stationary queue of vehicles at the level crossing, leading to shunt collisions.

S1.1.1 Recommendation:	Move the northern-most warning signs to TSRGD Diagrams 770 and 773 to the northern side of the drainage culvert to provide additional advanced warning.
-------------------------------	---

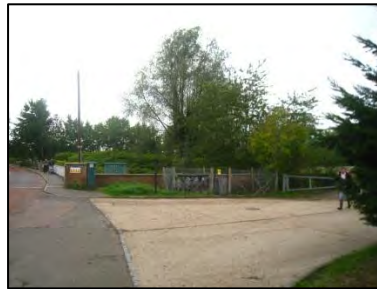
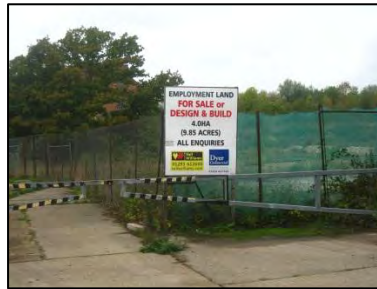
IMG_2975.jpg

- Location:** Northbridge Street, carriageway
- Summary:** Adjacent accesses increase the risk of blocking back at the level crossing.
- Description:** There are a number of accesses close to the proposed level crossing location, not least that of a four hectare industrial development site, which could generate a significant volume of additional traffic movements.

- S1.1.2 Recommendation:** Introduce a yellow box marking to TSRGD Diagram 1045 to deter traffic from queuing over the crossing.
-

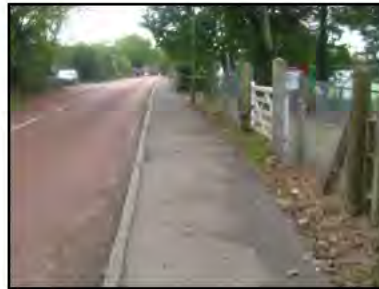
IMG_2946.jpg

Location:	Northbridge Street, footways
Summary:	Insufficient warning for the visually impaired could lead to pedestrian injuries.
Description:	Footways are provided along both sides of Northbridge Street in the vicinity of the proposed level crossing.

The visually impaired use tactile warning surfaces to identify hazards ahead. A visually impaired pedestrian could enter the level crossing zone without realising the hazardous nature of the environment, placing them at risk of being trapped by the barriers.

SS1.1.3 Recommendation:	Introduce tactile warning surfaces, in line with national guidelines, on each footway approach to the crossing.
--------------------------------	---

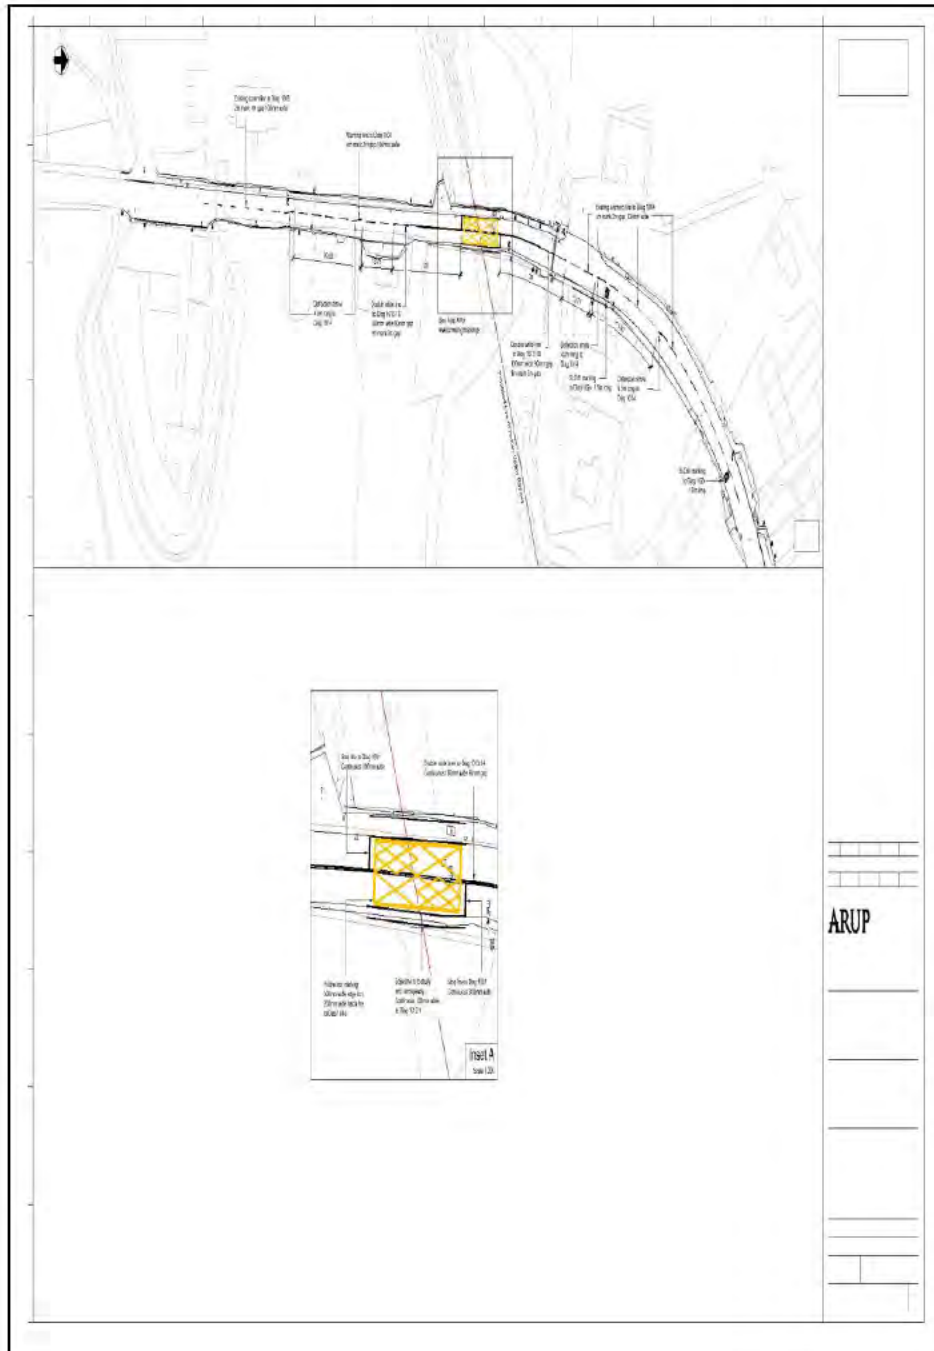
Diagram of the proposed railway Alignment

The new level crossing to be constructed is an automatic locally monitored fully gated level crossing on C18 Northbridge Street, Robertsbridge, East Sussex. The road approach speed is 30 mph. The profile of the railway line in the vicinity of the crossing has been provided (below), as well as the appropriateness of the proposed warning signs in this regard.

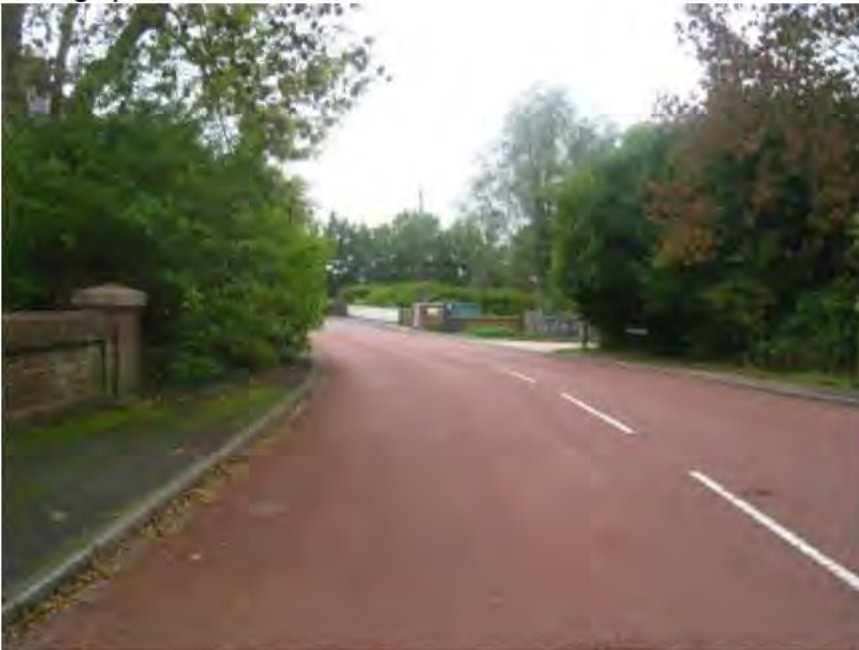
Photograph 1

There is a cottage located close to the road limiting drivers' forward visibility on the bend. In the same location there is on-street residents' parking, which requires traffic to cross the carriageway centreline. This could draw drivers' attention away from downstream hazards such as a stationary queue of vehicles at the level crossing, leading to shunt collisions.

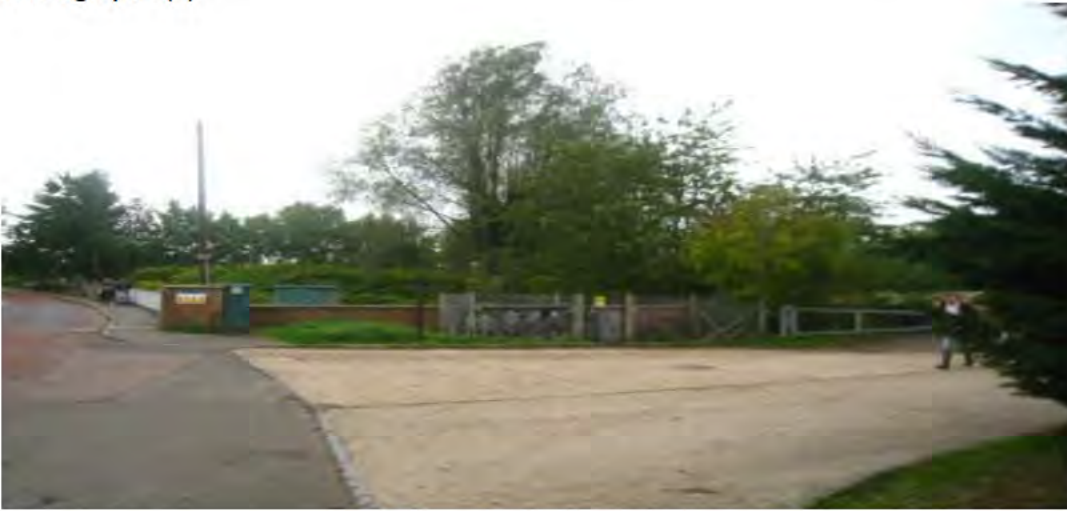
Photograph 2(a)

- The adjacent access increases the risk of blocking back at the level crossing (Photograph 2a & 2b) below.

The limited carriageway width and on-street parking could result in traffic waiting on the carriageway by the level crossing and will increase the risk of vehicles queuing over the level crossing, leading to potential vehicle / train conflict.

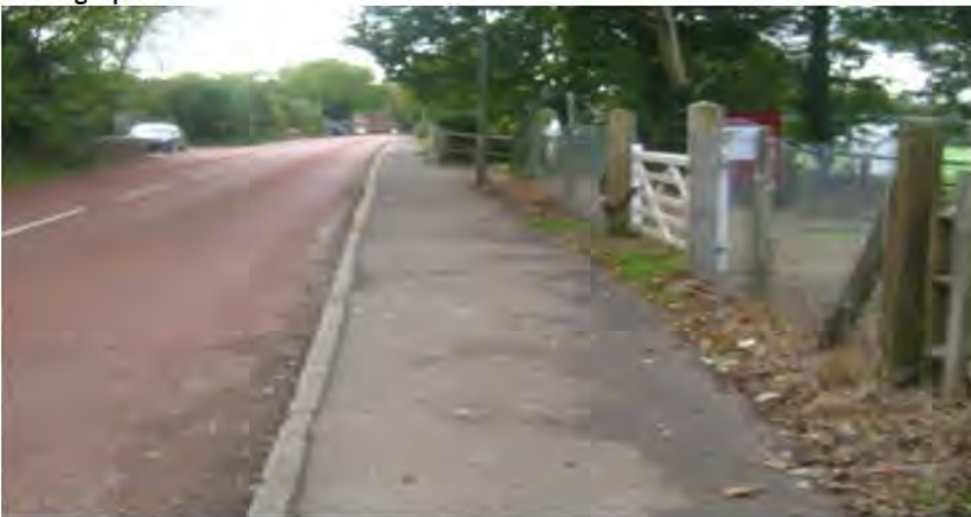
Photograph 3

Footways are provided along both sides of Northbridge Street in the vicinity of the proposed level crossing (Photograph 3).

The visually impaired use tactile warning surfaces to identify hazards ahead. A visually impaired pedestrian could enter the level crossing zone without realising the hazardous nature of the environment, placing them at risk of being trapped by the barriers.
