The Northumberland Line Order

APP-W5-1: Darren Lord – Level crossing closures

PROOF OF EVIDENCE

NORTHUMBERLAND LINE

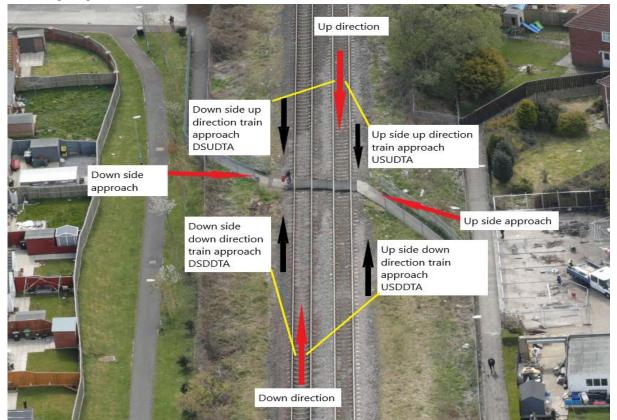
FIGURE 1 TYPICAL LAYOUT OF A LEVEL CROSSING

6.1 The figure below is a typical layout of a crossing to help explain the terminology used to assess sighting distances.

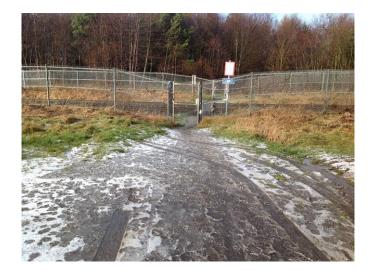
Name of Crossing: Dairy (Palmersville)

Type of crossing: Footpath with wicket gates Date of NRA: 11th February 2020

Name of crossing	Dairy
Туре	Footpath with wicket gates (FPW)
Engineers Line Reference (ELR)	BNE
Mileage	0m 34ch
OS grid reference	NZ287694
Number of lines crossed	Two
Maximum Line speed (mph)	25mph
Electrification	None
Signal box	Tyneside IECC
Risk assessment next due date	12/05/2022
ALCRM Risk Details	
Risk Score	D5
FWI	0.000725575

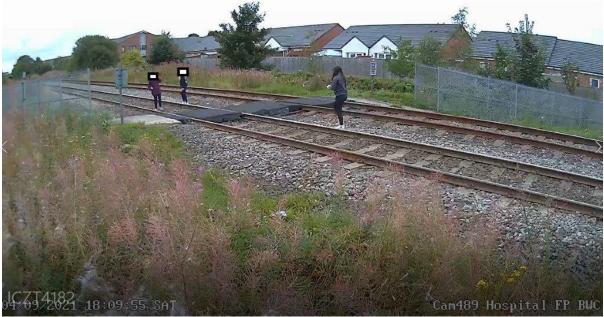
FIGURE 24 HOSPITAL CROSSING MISUSE IMAGE 1

- 29.1 Network Rail's internal safety management information systems (SMIS) disclose that during the period of the previous 4 years, there were no reported incidents at the crossing. This does not mean that there has been no misuse of the crossing within this period. However, there is no recordable CCTV, which would have proven to the contrary.
- 29.2 In September 2021 a CCTV camera was placed at the crossing to identify the types of users and evidence has been gathered that proves that misuse at this crossing does take place regularly i.e.: school children walking up the track to the crossing, young people riding mopeds over the crossing, and also young people hanging around/sitting on the crossing environment. See photos below of misuse, additional video evidence can be provided.

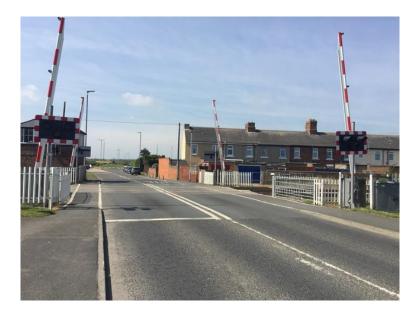
Name of Crossing: Newsham

Type of crossing: User Worked Crossing with telephones Date of NRA: 11th June 2019

Name of crossing	NEWSHAM
Туре	MCB/MB
Engineers Line Reference (ELR)	EJM
Mileage	12m, 45ch
OS grid reference	NZ305789
Number of lines crossed	2
Maximum Line speed (mph)	45 Up, 25 Down
Electrification	No
Signal box	Newsham
Risk assessment next due date	31 July 2022
ALCRM Risk Details	
Risk Score	L6
FWI	0.000315523

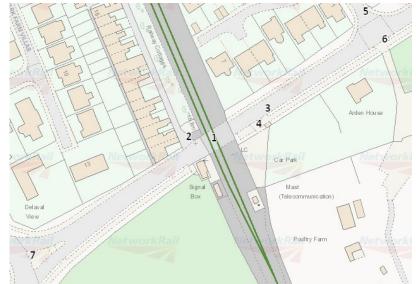
- 48.1.1 Both approaches are long and straight with a 30mph speed limit of the road over the crossing.
- 48.1.2 As can be seen on the image below there are several distractions on the approaches to the crossing.

- 1. Newsham Level Crossing
- 2. Access road to houses, parking area and garages (2m)
- 3. Bus stop (15.5m)
- 4. Access to parking area (9.5m)
- 5. Blagdon Drive (85m)

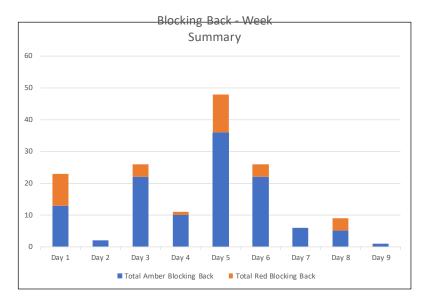
- Red 3: Similar to Red 2, but where no escape route is available, either forwards or backwards.
- 48.2.3 Blocking Back incidents are greater in number during weekdays, with an average of about 23 Blocking Back incidents per day. On weekend days the number of trains is reduced, with an average of about 9 Blocking Back incidents per day. A graph of Blocking Back incidents per survey day, for both amber and red incidents, is shown below

48.2.4 Newsham level crossing is monitored by the signaller when activating the crossing which reduces the risk of a user being trapped on the crossing.

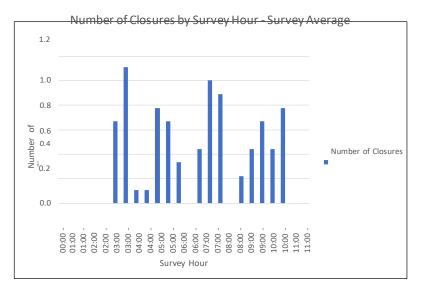
48.3.3 During the survey, the road was closed an average of 9 times each survey day. The road was most frequently closed between the hours of 06:00 - 07:00, with an average of 1.2 closures during this hour each day over the survey period.

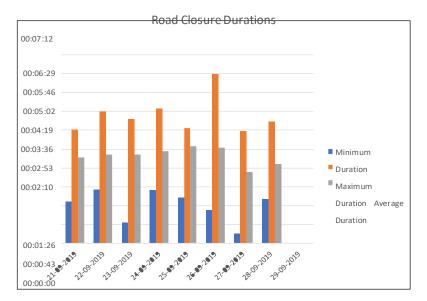
48.3.4 The minimum duration of closure was 00:00:21, the maximum duration of closure was 00:06:28, and the average duration of closure was 00:03:20 over the survey period.

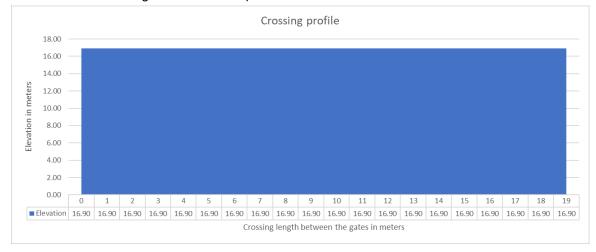
- 48.4.1 The visual evaluation of the vertical profile of the road indicates that it does not create a risk of vehicles grounding on the crossing. Risk of grounding signs have not been provided at the crossing.
- 48.4.2 As can be seen from the crossing profile chart below there isn't a risk of a vehicle getting stuck on the crossing due to the road profile.

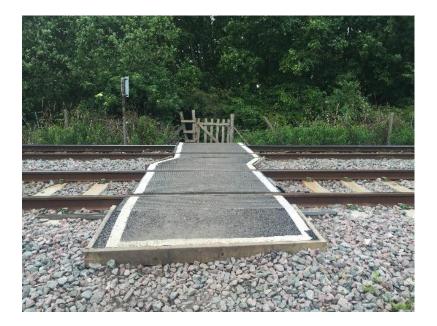
Name of Crossing: Chase Meadows

Type of crossing: Footpath with Wicket Gates Date of NRA: 11th June 2019

Name of crossing	CHASE MEADOWS
Туре	FPW
Engineers Line Reference (ELR)	EJM
Mileage	14m, 12ch
OS grid reference	NZ288807
Number of lines crossed	2
Maximum Line speed (mph)	45
Electrification	No
Signal box	Newsham Bedlington South
Risk assessment next due date	11 September 2022
ALCRM Risk Details	
Risk Score	D7
FWI	0.000055785
