Risk Assessment for Dullingham MCB Level Crossing

Doc: J1171-138/Doc14

No: 157001-SRK-REP-ESS-000008

Date: 17th June 2019

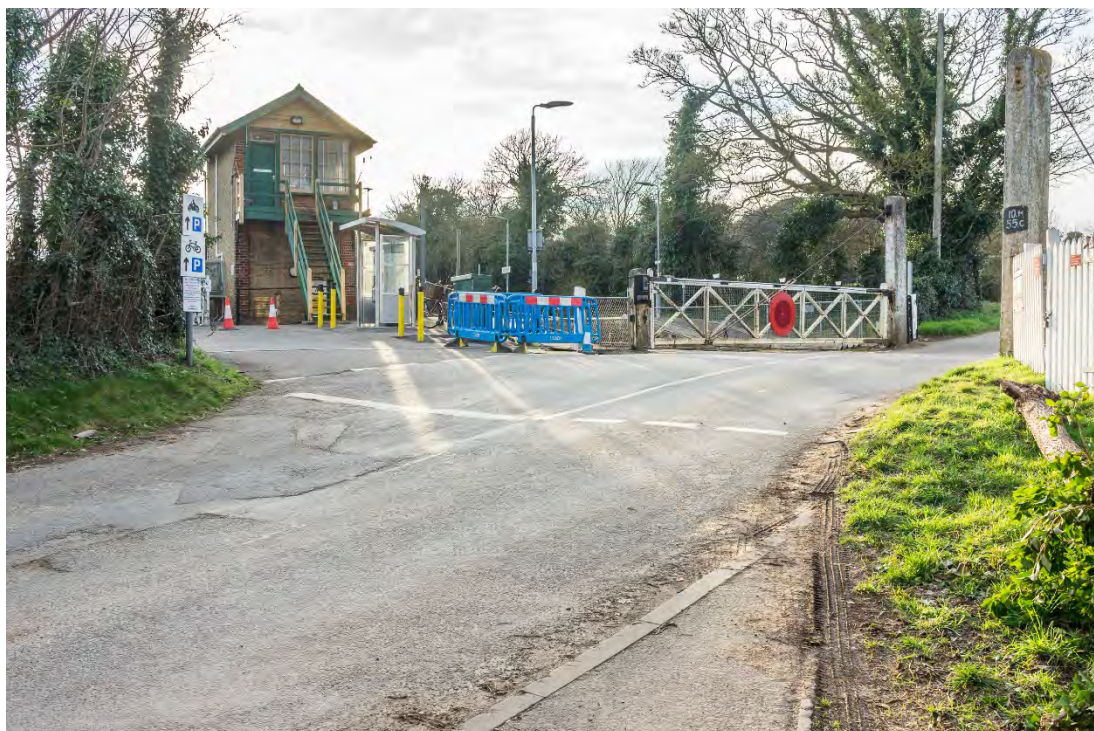
Figure 1 Current crossing equipment

Figure 1 shows the configuration of the crossing, viewed from the south. *Figure 2* provides the relevant extract from the sectional appendix covering the crossing. *Table 1* presents details of the location and operation of the crossing.

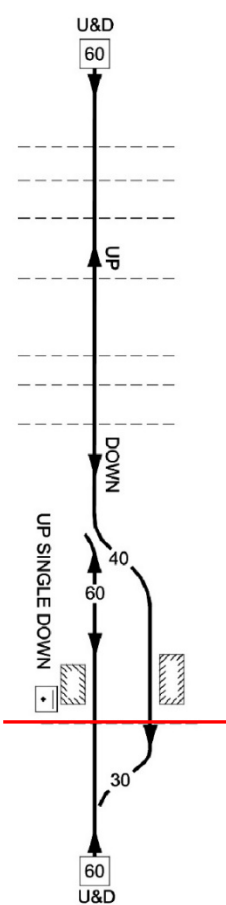
Figure 2 Extract from the sectional appendix

TCB RA8 Cambridge SB (CA) GSM-R	
Fulbourn LC (AHBC)		4 36				
Home Farm LC (FPS)		5 31				
Hicks LC (UWC)		5 38				
Six Mile Bottom LC (AHBC)		7 65				
Brinkley Road LC (AHBC)		7 78				
Cassells LC (FPG)		8 05				
Westley Road LC (R/G) (UWC)		8 74	T			
Single line		10 07			Up platform - 94m (102 yds) Down platform - 103m (111 yds)	
DULLINGHAM		10 54			TB Dullingham SB (DH)	
Dullingham (DH) SB		10 54				
Dullingham LC (MCG)		10 56				
Single line		11 09

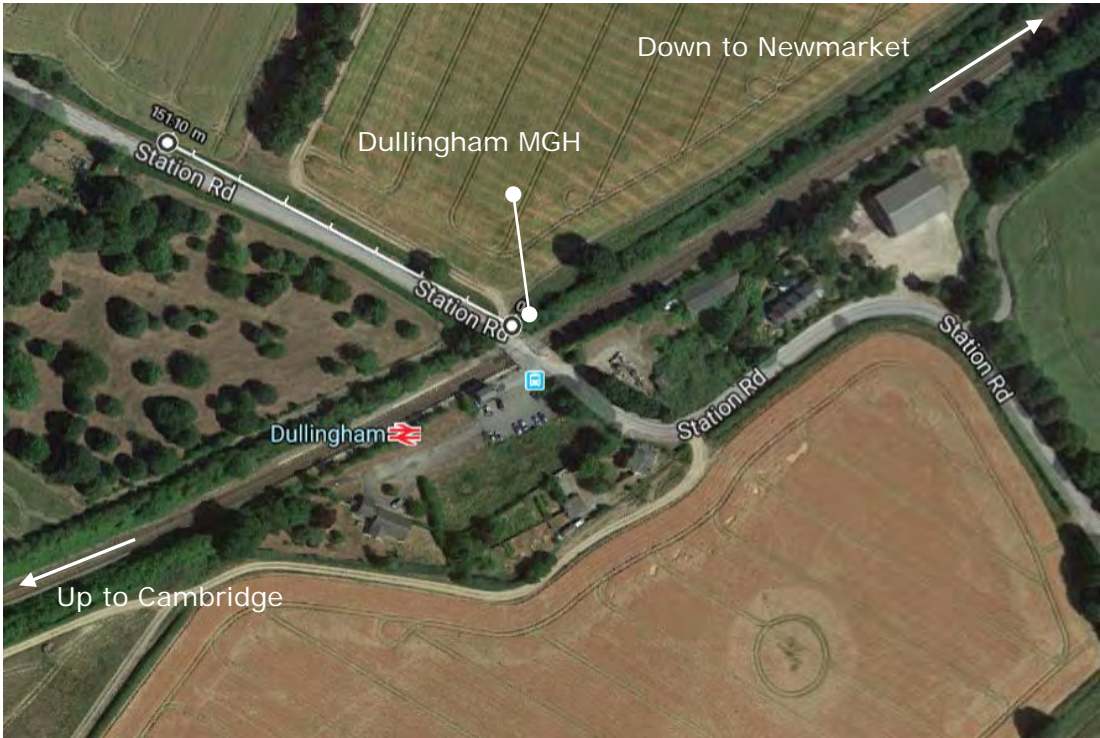
Figure 4 Satellite view showing the location of the crossing

A satellite view of the location is shown in *Figure 4*.

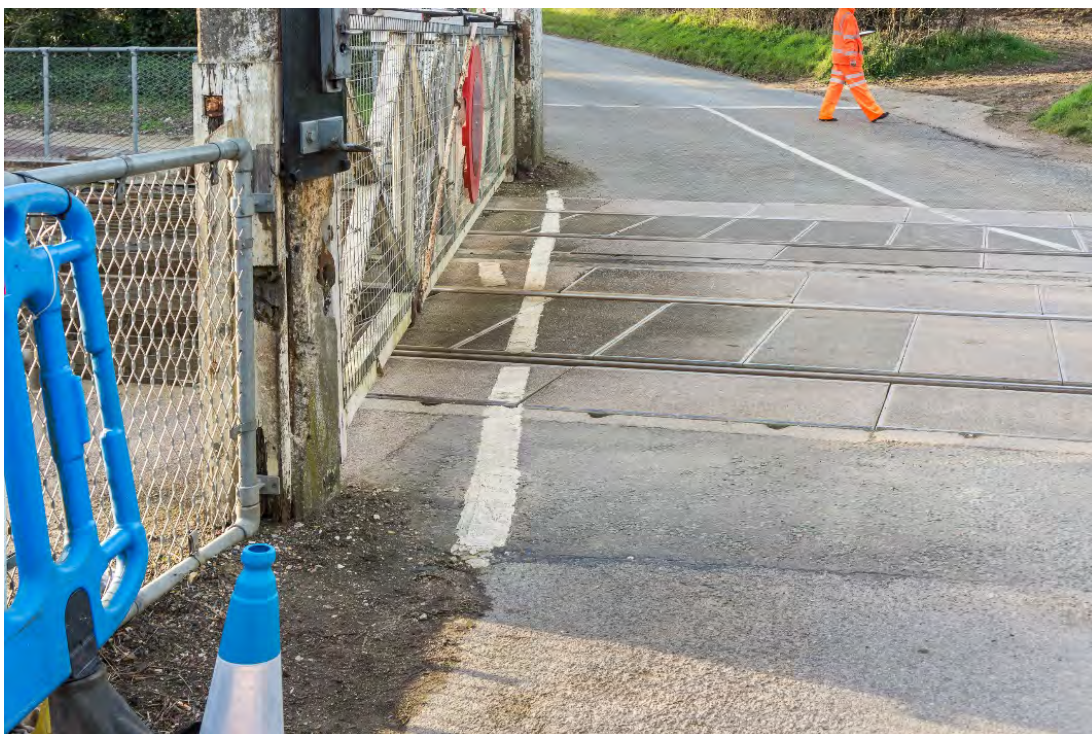
Figure 6 No footway on west side

There are no footways on either sides of the crossing as seen in *Figure 1*, *Figure 6* and *Figure 7*. The barrier to barrier distance is currently 8.3m.

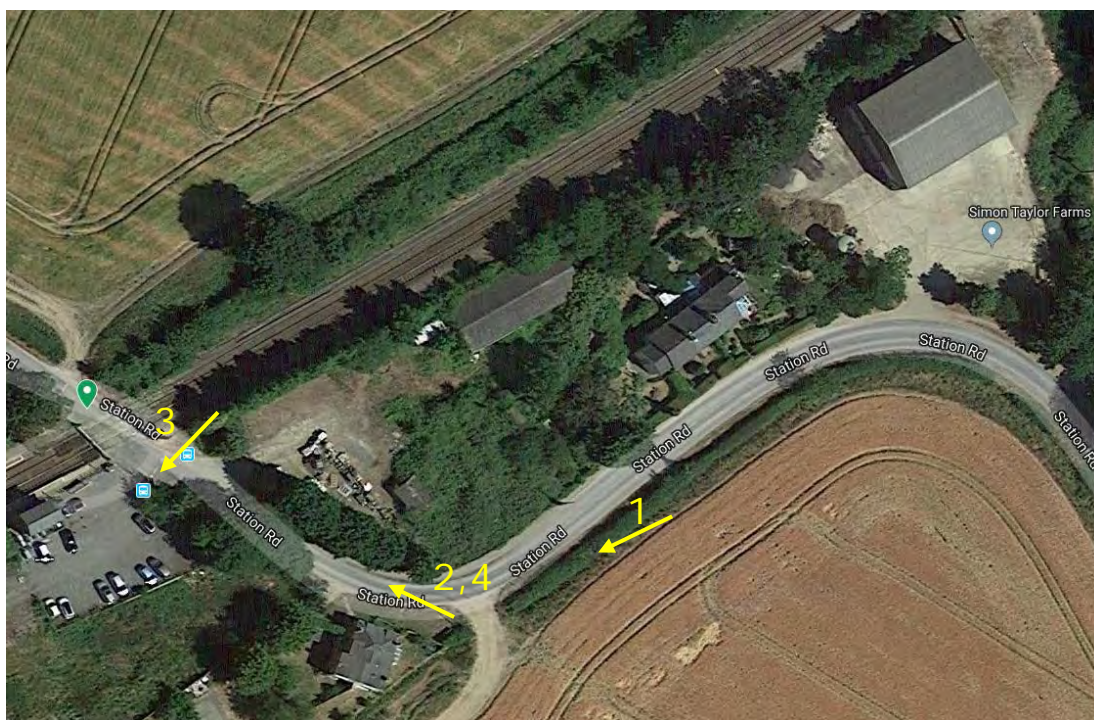
Figure 8 Key features on the southern approach to the crossing

A plan of the key features is shown in *Figure 8*; the numbers in the figure refer to the above numbered list of features.

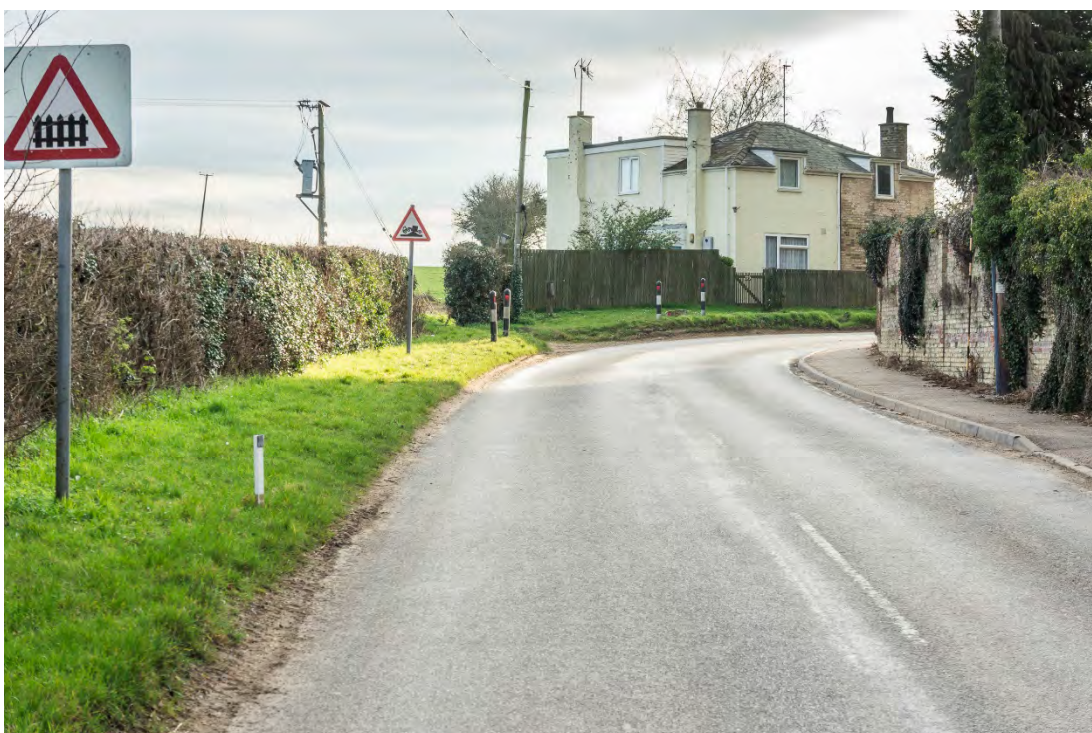
Figure 9 Road approach to crossing (east approach)

1. The road bends sharply 60m before the crossing as shown in *Figure 9* and the crossing is not visible from the distant signage.
2. The crossing comes into view about 65m from the crossing (see *Figure 10*). The road has a speed limit of 60mph, although due to the narrow road, hill and bends near the crossing, observed vehicles were travelling relatively slowly. The 85th percentile vehicle was measured travelling at 38.3mph at the distant signage

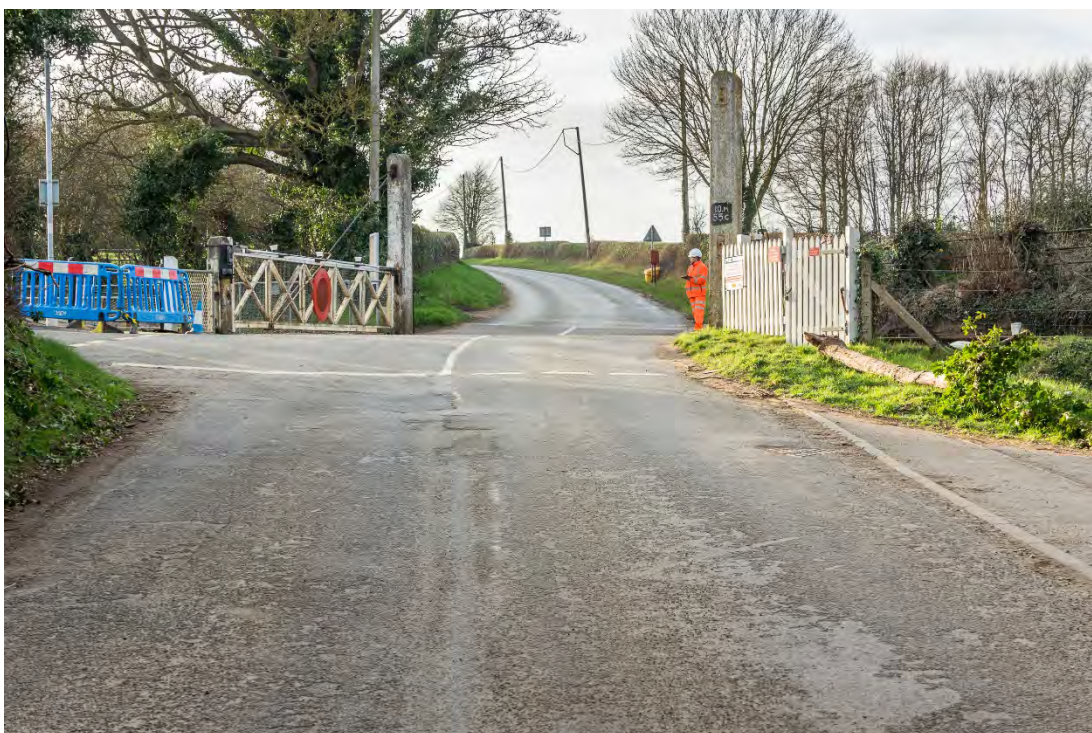
Figure 11 Near view from Crossing of road approach (east approach)

The distant, intermediate and close road approaches from the east are shown in *Figure 9* to *Figure 11*.

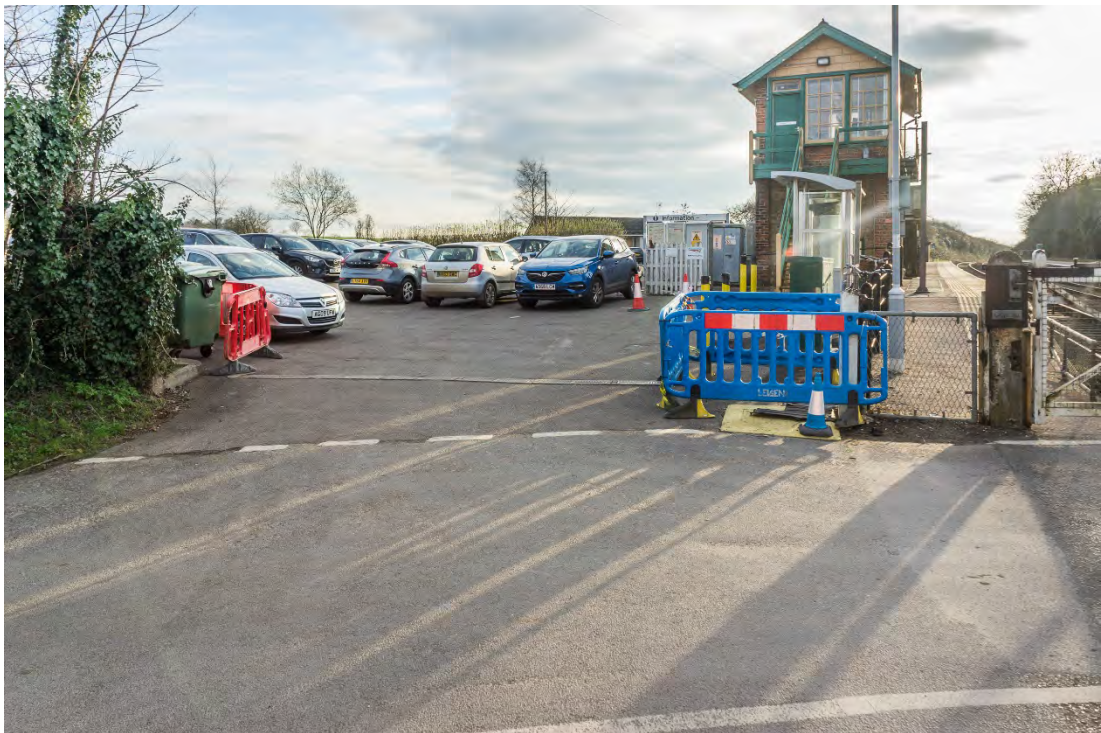
Figure 12 Station car park entrance

3. The entrance to the station car park is just before the crossing, as can be seen in *Figure 12*. This is a potential cause of blocking back as it is a right turn for vehicles that have traversed the crossing. The main car park is well used and is on the same side as the platform normally used, which limits the pedestrian usage of the level crossing. The platform (the loop line) opposite the station car park is only currently scheduled to be used once per day.

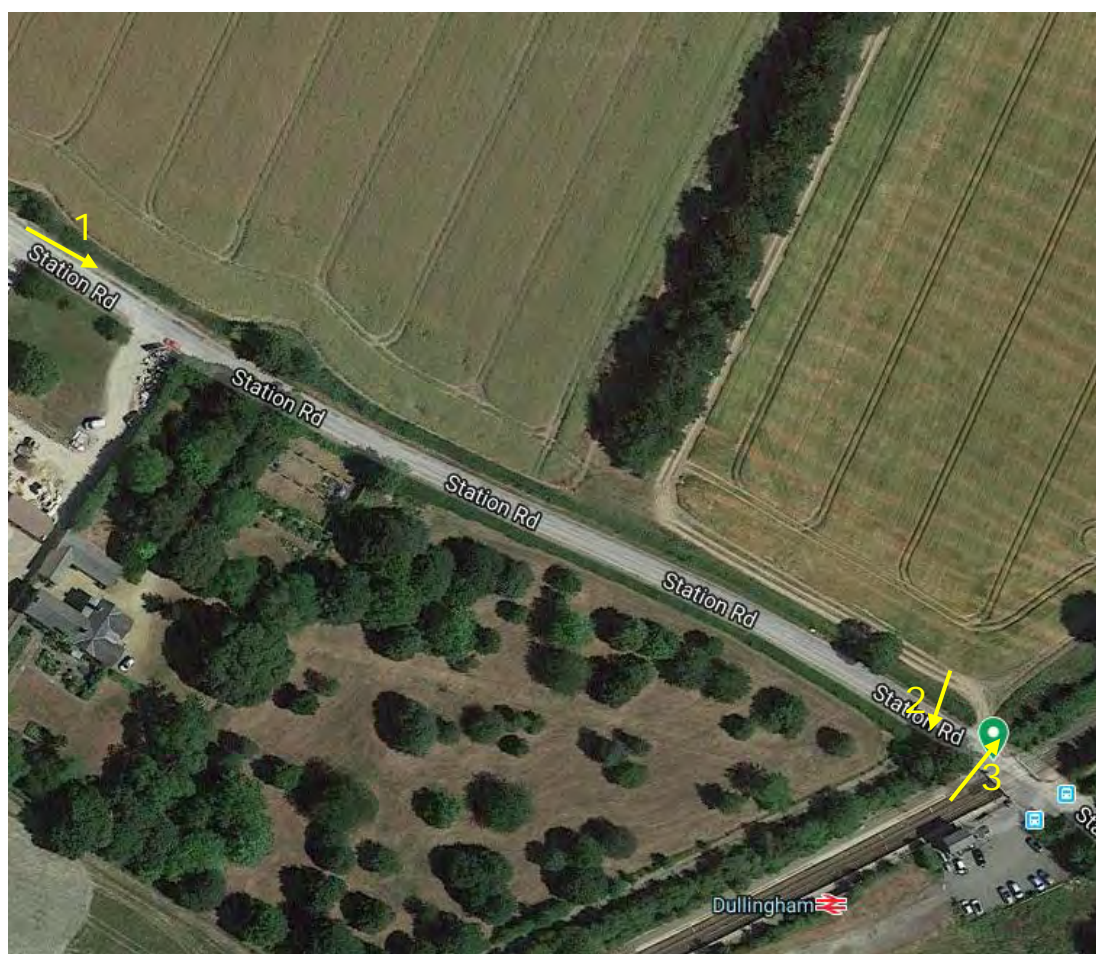
Figure 13 Key features on the northern approach to the crossing

A plan of the key features is shown in *Figure 13*; the numbers in the figure refer to the above numbered list of features.

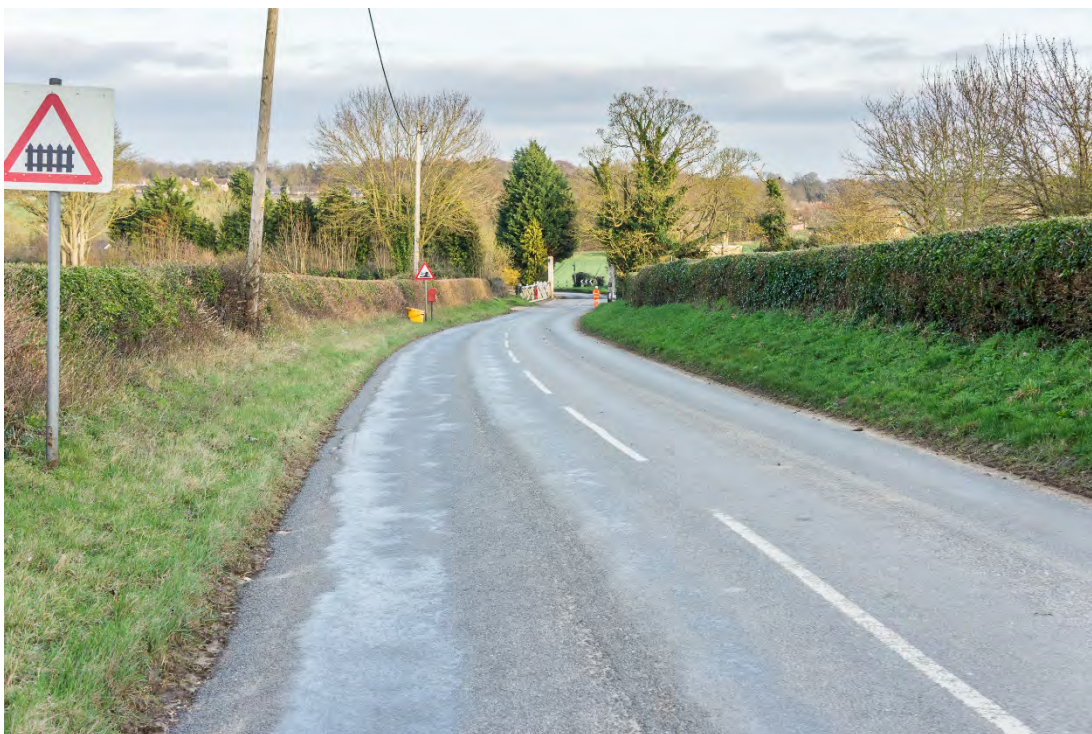
Figure 14 Distant View of Crossing (north approach)

1. The approach curves gently to the right and runs downhill to the crossing as shown in *Figure 14*. The 85th percentile speed is 28.9mph and the crossing is visible about 160m from the crossing. There is a significant gradient down to the crossing. There is no anti-slip surface to stop cars sliding down hill into the gates on the Down side. This is currently a risk to the signaller operating the gates and will be a potential cause of barrier strikes if the crossing is upgraded.

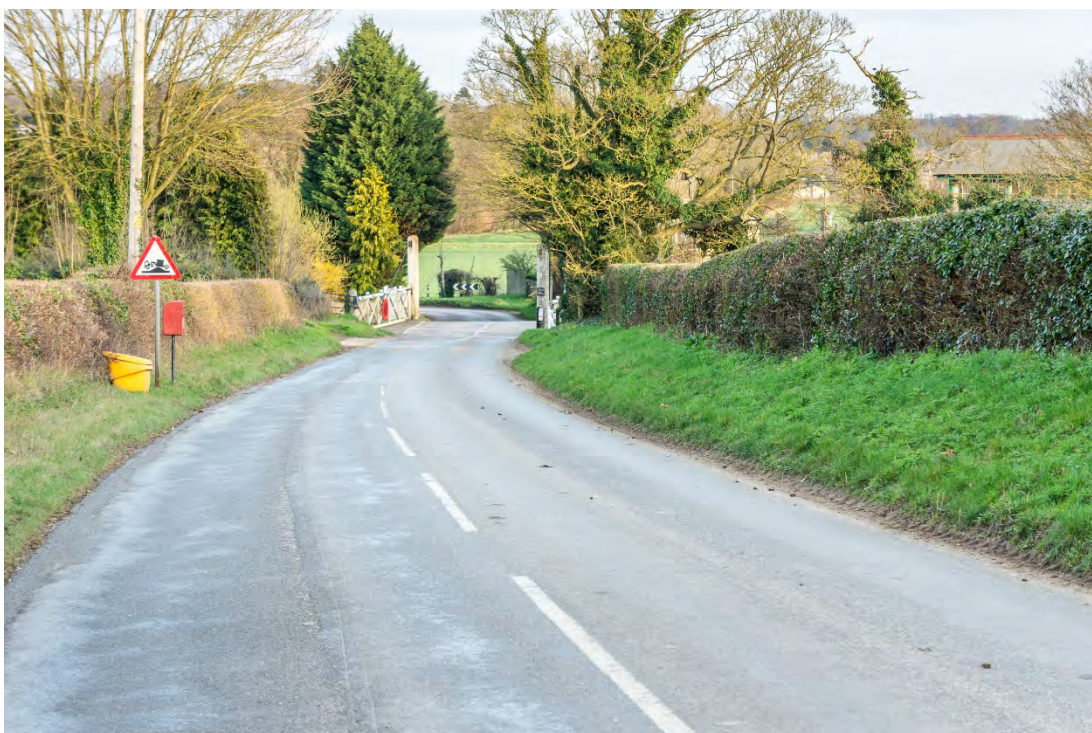
Figure 15 Intermediate View of Crossing (north approach)

The distant, intermediate and close road approaches from the northwest are shown in *Figure 14* to *Figure 16*.

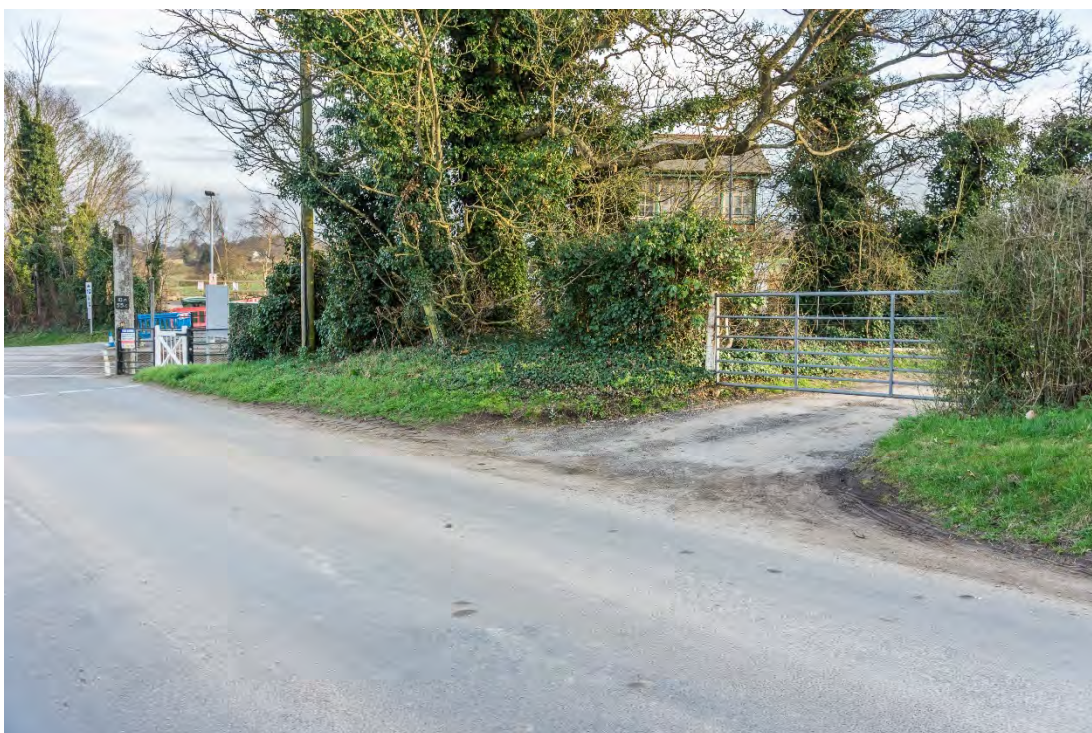
Figure 17 Field entrance 20m beyond crossing

2. There is a farm entrance with a gate 20m from the crossing as shown in *Figure 17*. A westbound agricultural vehicle stopped while the gate is unlocked could block back vehicles over the crossing although no blocking back was noted in the census.

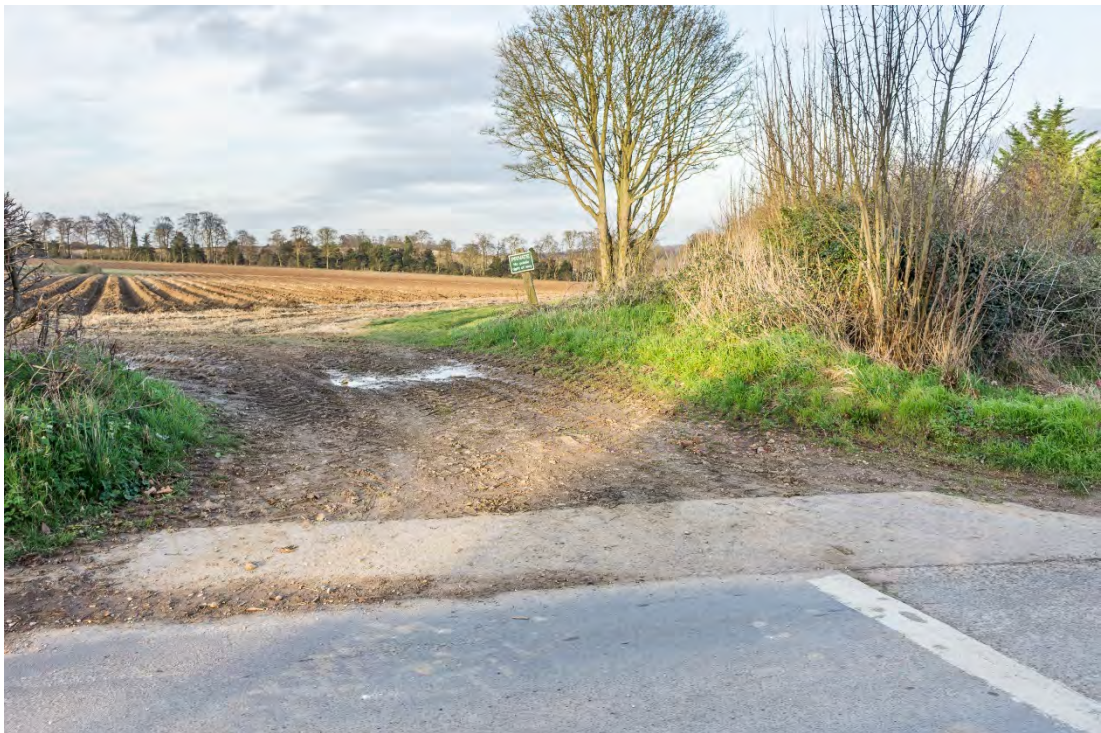
Figure 18 Field entrance 10m beyond crossing

3. There is a farm entrance 10m from the crossing as shown in *Figure 18*. A westbound agricultural vehicle seeking to turn right into the field could block back vehicles over the crossing although no blocking back was noted in the census.

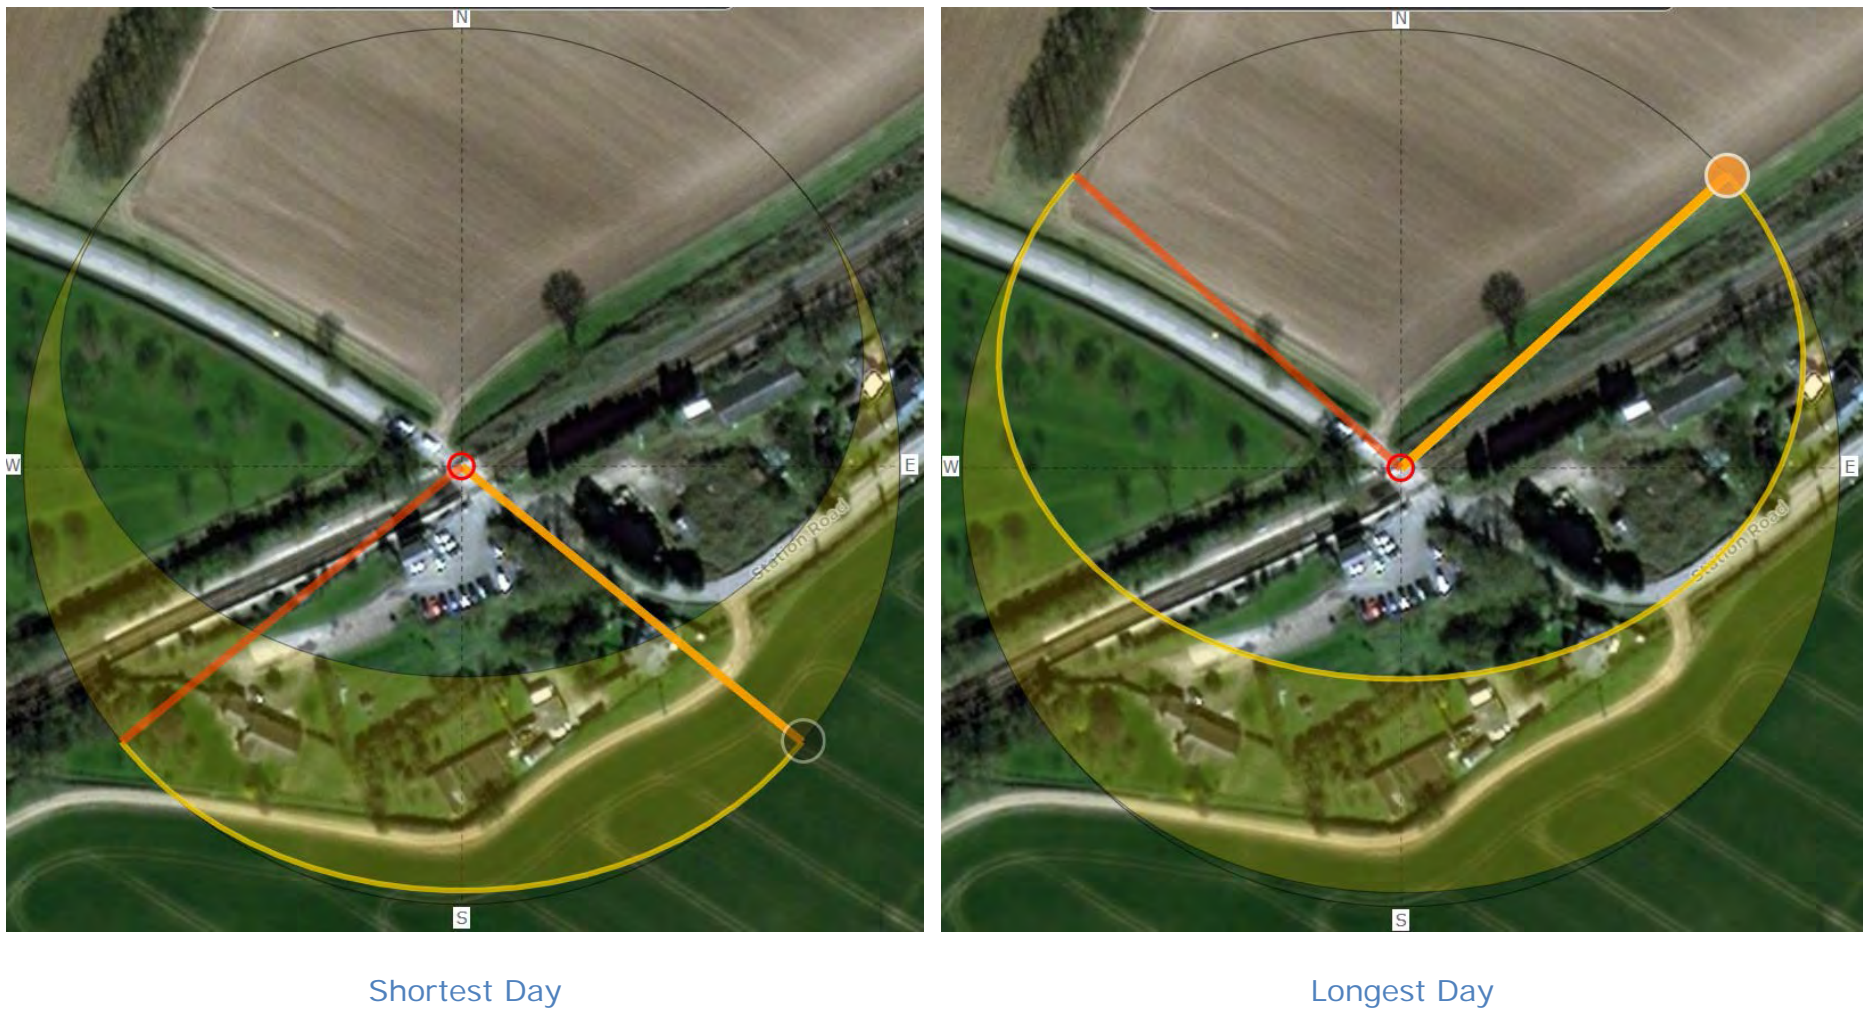
Figure 19 Suncalc diagrams

Dullingham level crossing is a northwest-southeast facing crossing (for the road), therefore road users are potentially affected by sun glare.

The yellow line shows the direction of sunrise; the dark orange line the direction of sunset.

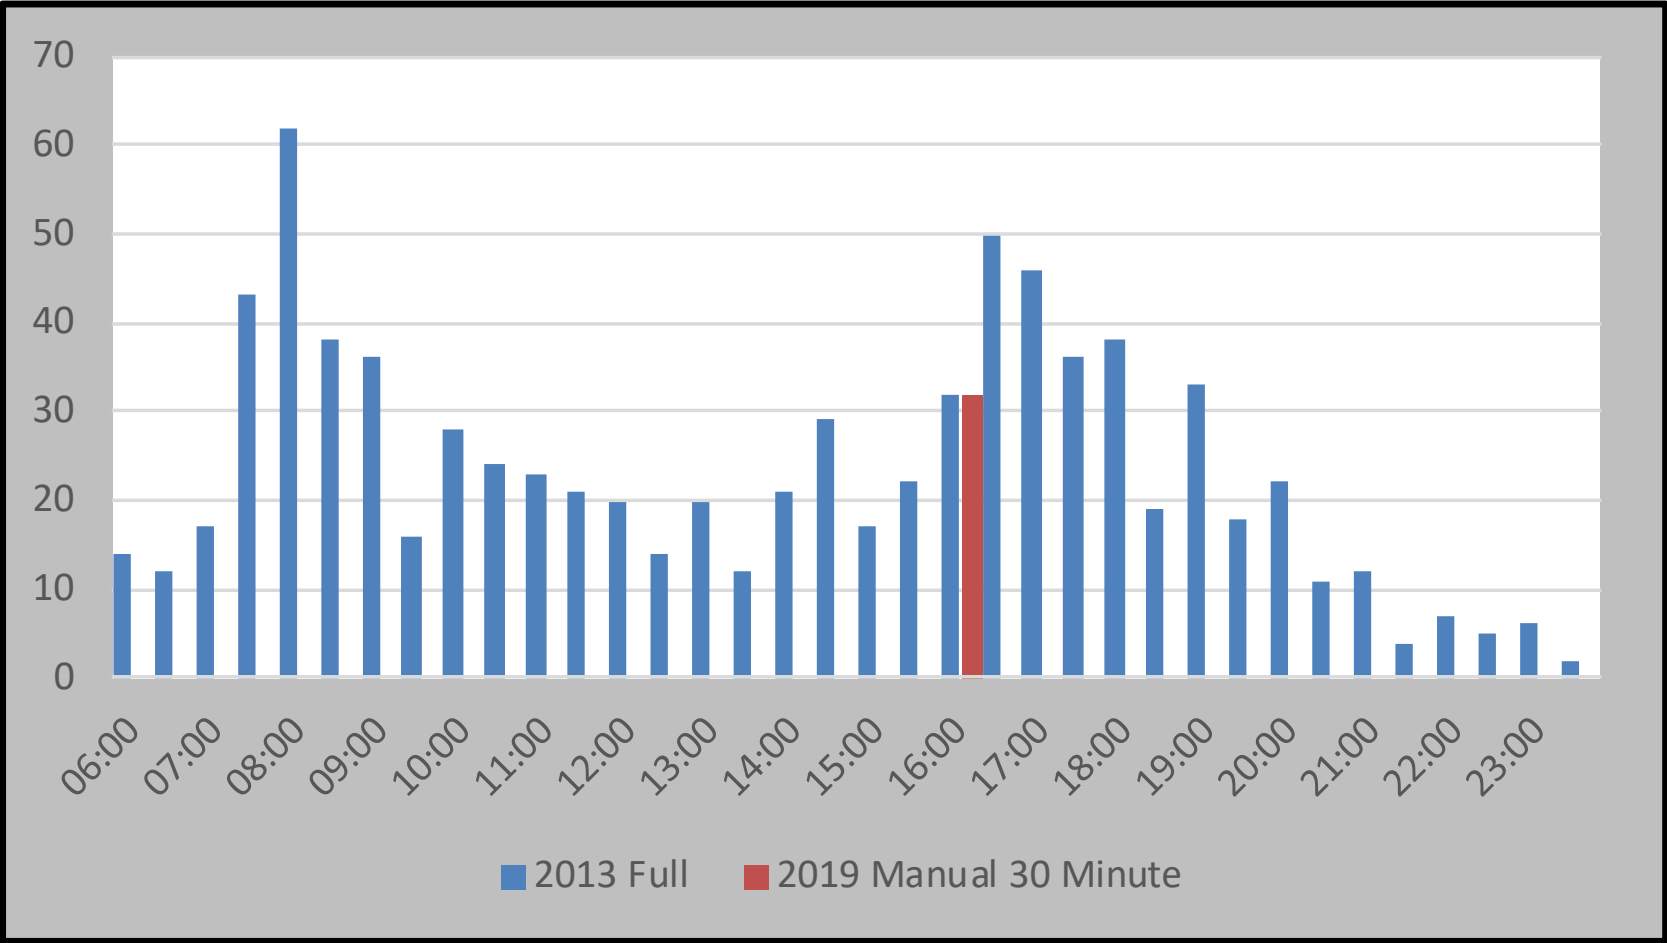
Figure 20 Comparison to 2019 30 minute census - vehicles

The observed train, vehicle and pedestrian usage is presented in *Table 2* and a comparison with a 30 minute census in 2019 is shown graphically for vehicles in *Figure 20*, and for pedestrians in *Figure 21*.

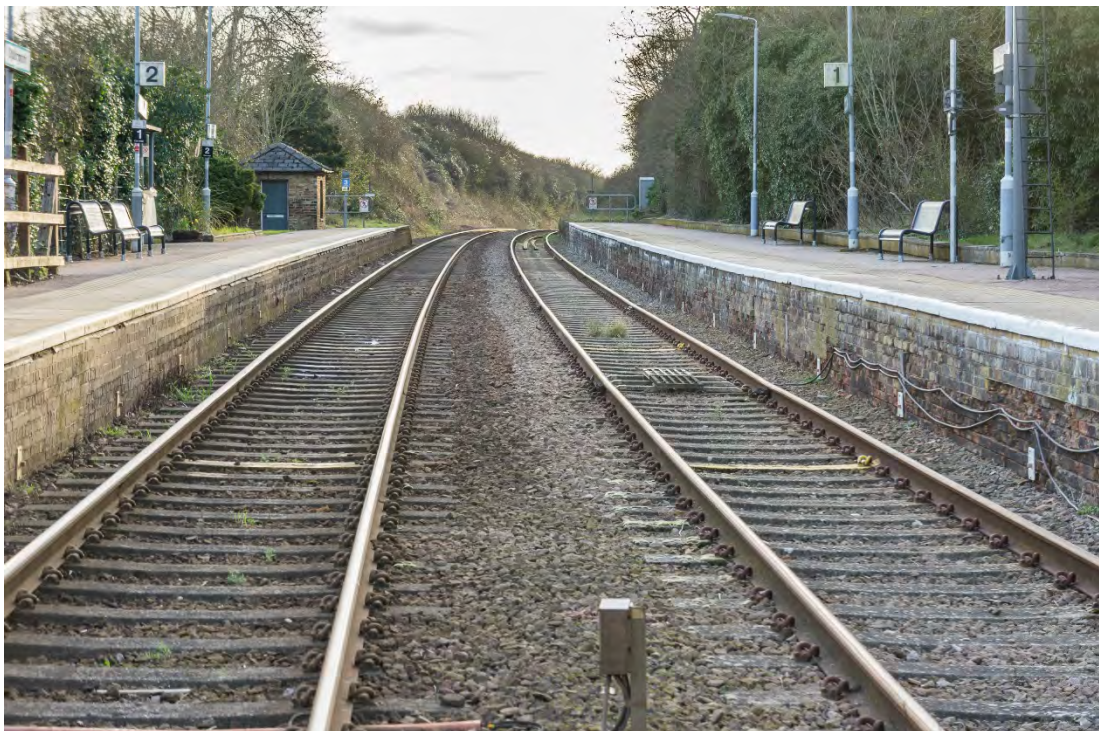
Figure 22 View of Down rail approach (looking towards Coldham Lane Jn)

The track is slightly curved in this direction giving the train driver limited advance sighting of the crossing as shown in *Figure 22*.

For trains travelling in the up direction and derailing after hitting a vehicle on the crossing, the station platform could exacerbate the potential derailment consequences. The line speeds are likely to be low due to the station and the location being a passing point on the line, although not all trains stop at the station.

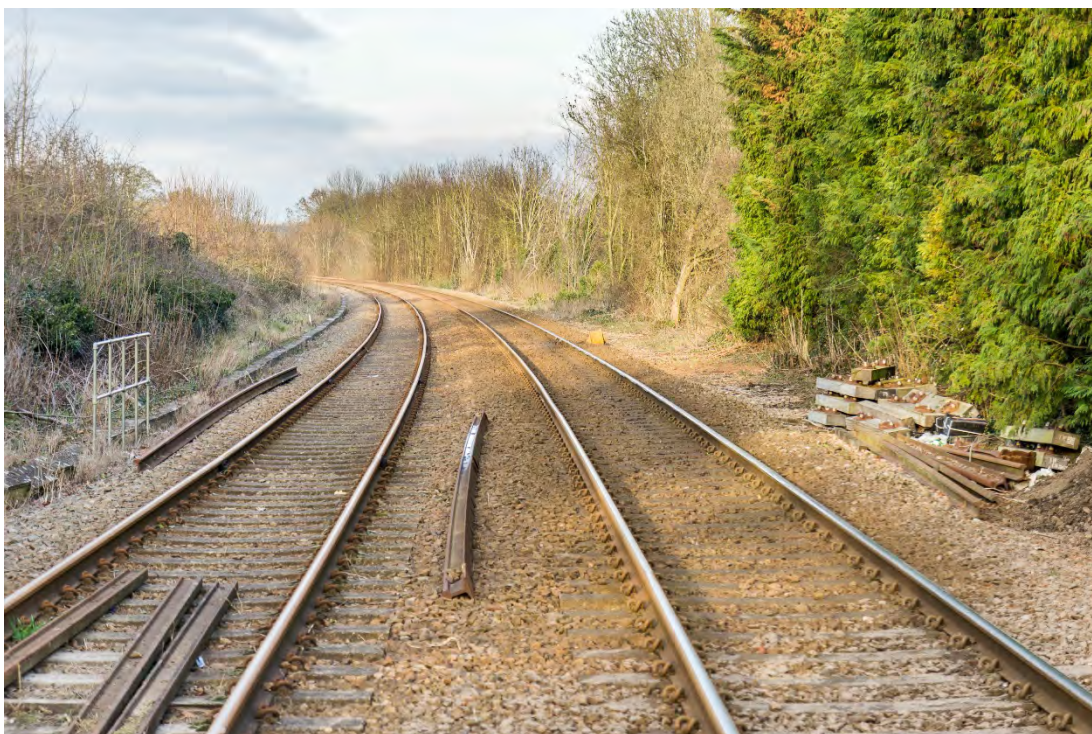
Figure 23 View of Up rail approach (looking towards Haughley Junction)

The track is also curved in this direction giving the train driver limited advance sighting of the crossing as shown in *Figure 23*.

For trains travelling in the down direction and derailing after hitting a vehicle on the crossing, only the track curvature might result in escalation of the incident.

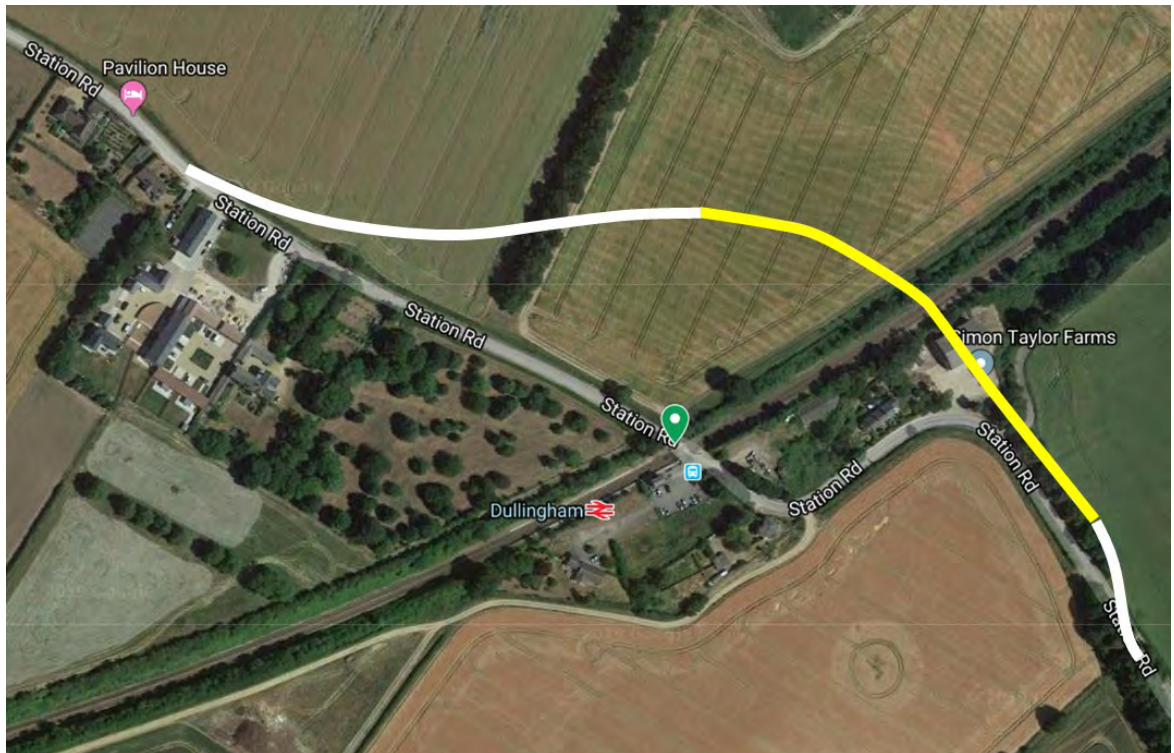
Figure 25 Scheme to close Dullingham level crossing

The first priority should be to close the crossing where possible. The only option identified that could be feasible is a major scheme to bypass the existing crossing with new link roads and provide step free access at the Dullingham station with an accessible bridge or underpass (*Figure 25*).

Since this scheme would likely cost £12m or more, the cost would be grossly disproportionate to the safety benefit compared with the alternative of renewing Dullingham as MCB-OD with a cost of about £3.2m and a moderate residual risk.
