## **Risk Assessment for Meldreth Road AHB Level Crossing**

Doc: J1171-138/Doc17

No: 157001-SRK-REP-ESS-000010

### **Sotera Risk Solutions Limited**

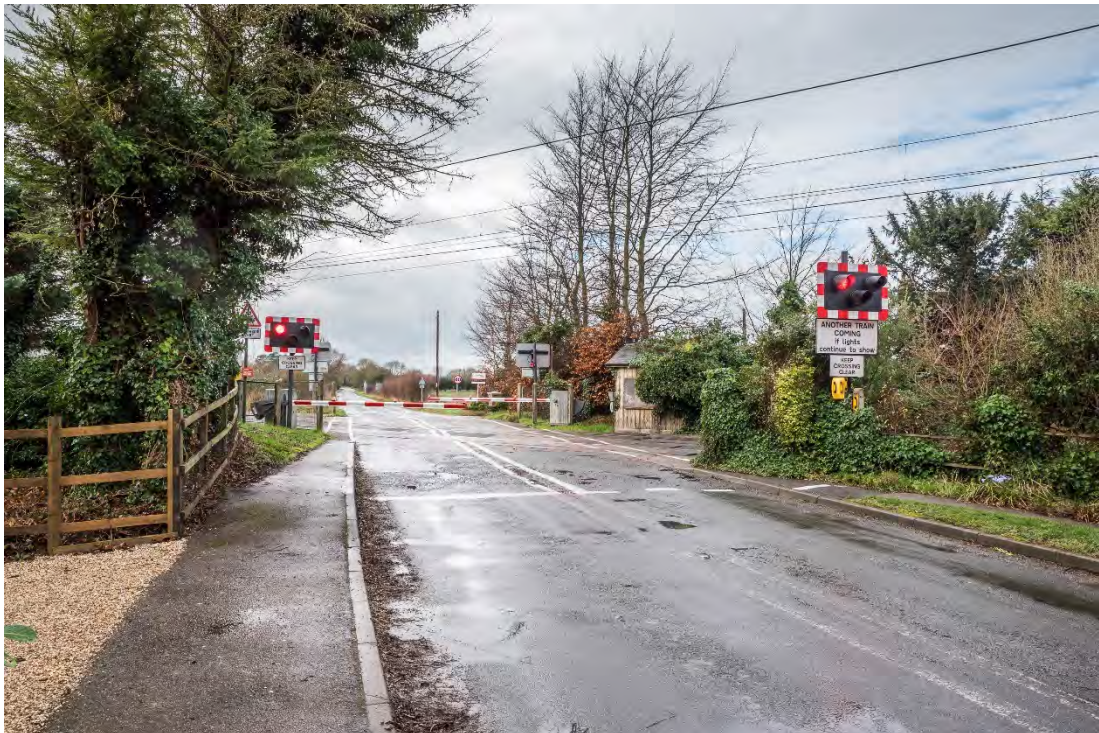
Figure 1 **Current crossing equipment**

*Figure 1* shows the configuration of the crossing, viewed from the south. *Figure 2* provides the relevant extract from the sectional appendix covering the crossing. *Table 1* presents details of the location and operation of the crossing.

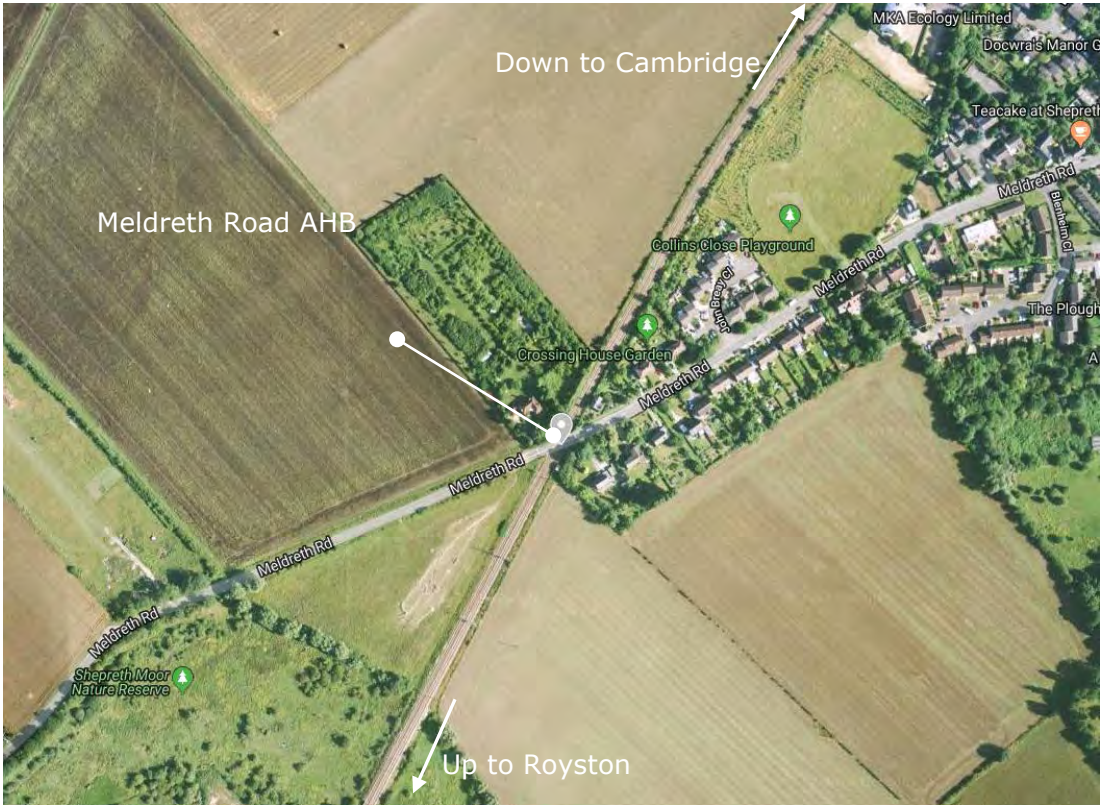
Figure 4     **Satellite view showing the location of the crossing**

A satellite view of the location is shown in *Figure 4*.

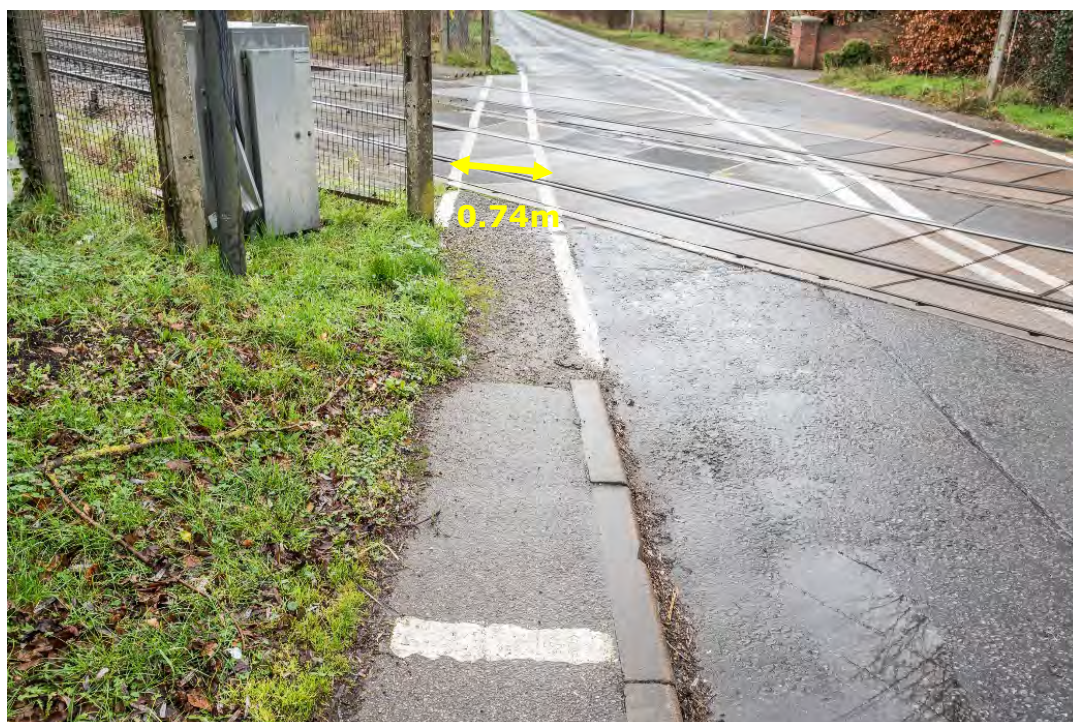
Figure 6 **Footway – south side**

There are footways on both sides of the crossing as seen in *Figure 1*. The footway on the south side (*Figure 6*) varies between 0.69m and 0.74m wide (the narrowest point is where the fence encroaches in the ZO corner). The footway on the east side (*Figure 7*) varies between 0.6m and 0.91m wide as the footway is narrowed by the fence and vegetation at the YO corner. The panel edges encroaches near to the footway as shown in (*Figure 8*) and there is vegetation growing over footway on north-east side (*Figure 9*).

- The current footway widths are not sufficient to meet ORR guidance, especially in areas where they narrow towards the ends. At least one 1.5m footway and ideally two are recommended. Parts of the edge markings are close to the deck edge on the south footway. A wider deck to properly accommodate pedestrian footways is recommended.

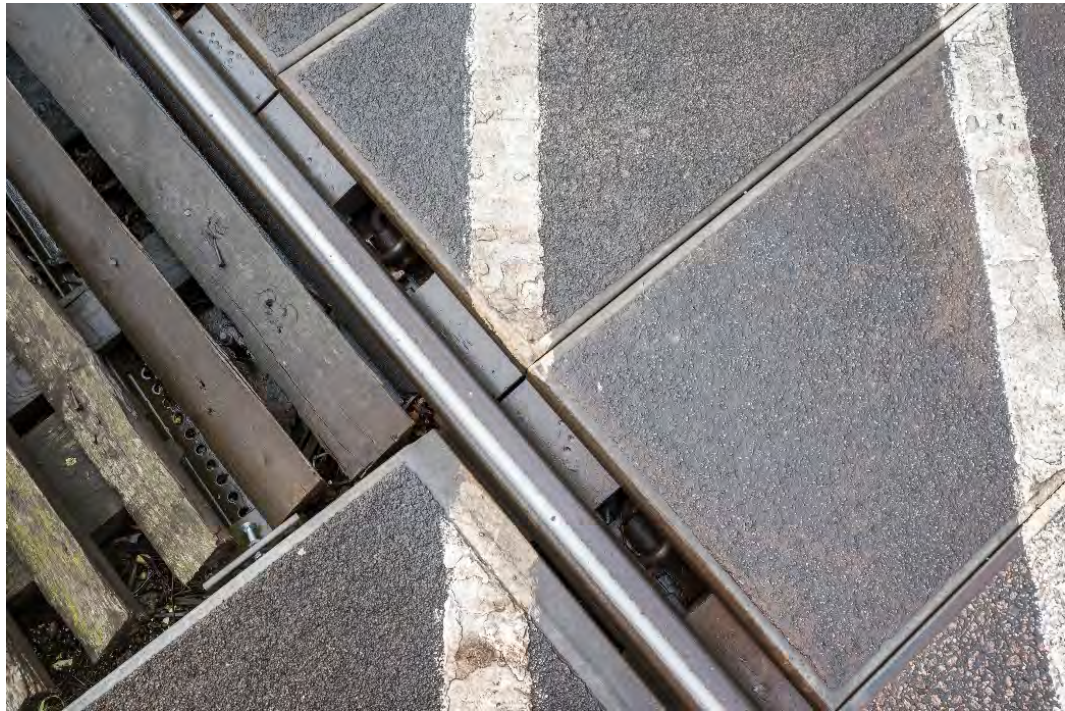
**Figure 8 Footway marking near edge of deck – south side**

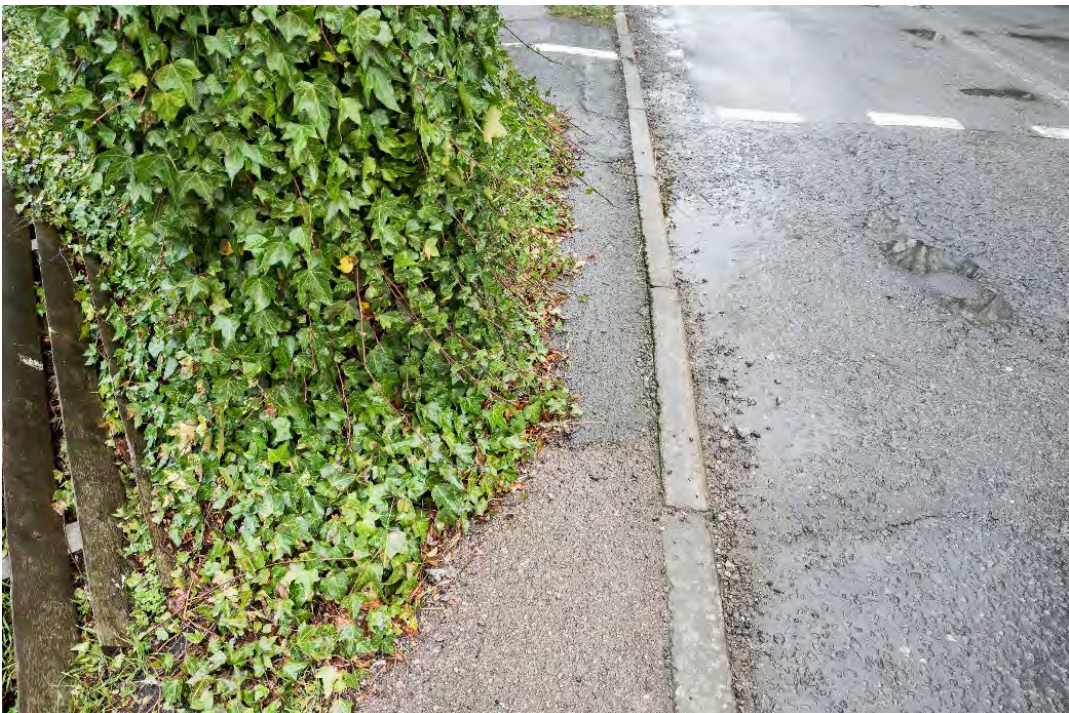
**Figure 9 Vegetation growing over footway – north east side**

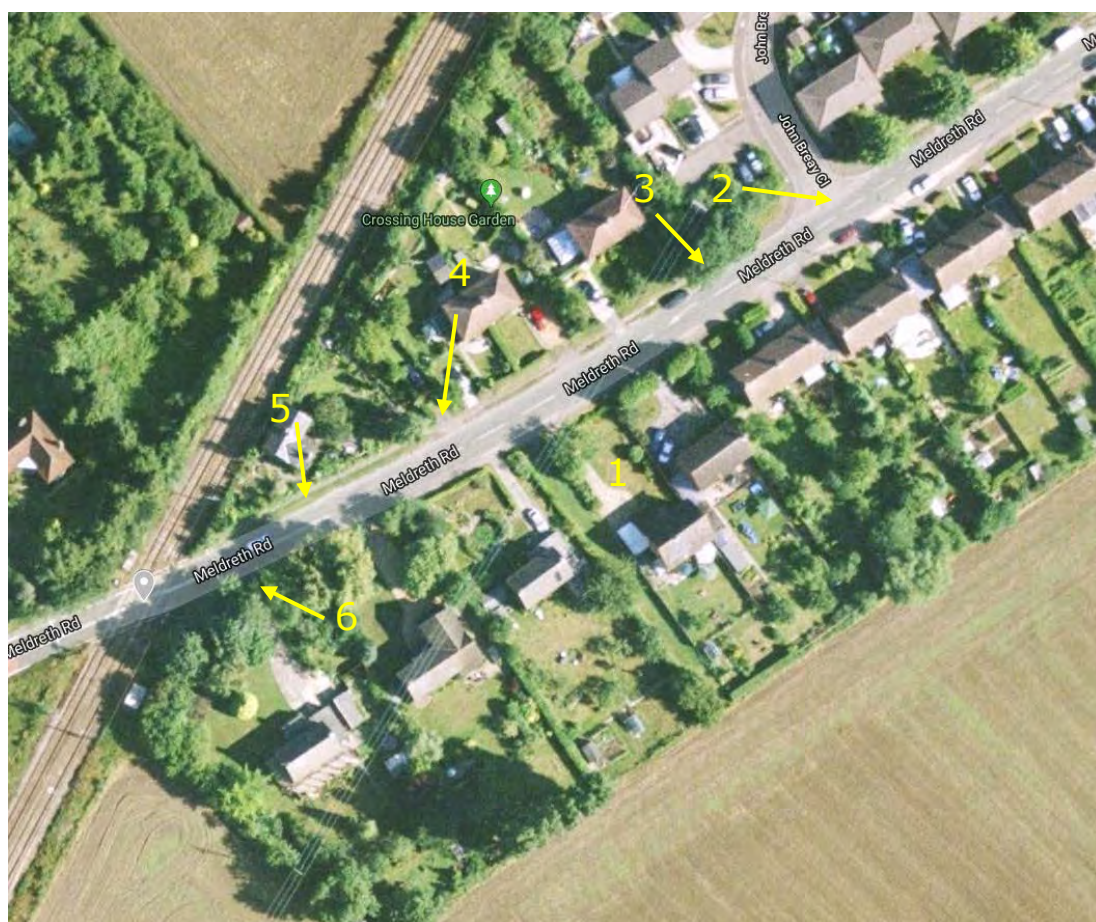
Figure 10 **Key features on the eastern approach to the crossing**

A plan of the key features is shown in *Figure 10*; the numbers in the figure refer to the above numbered list of features.

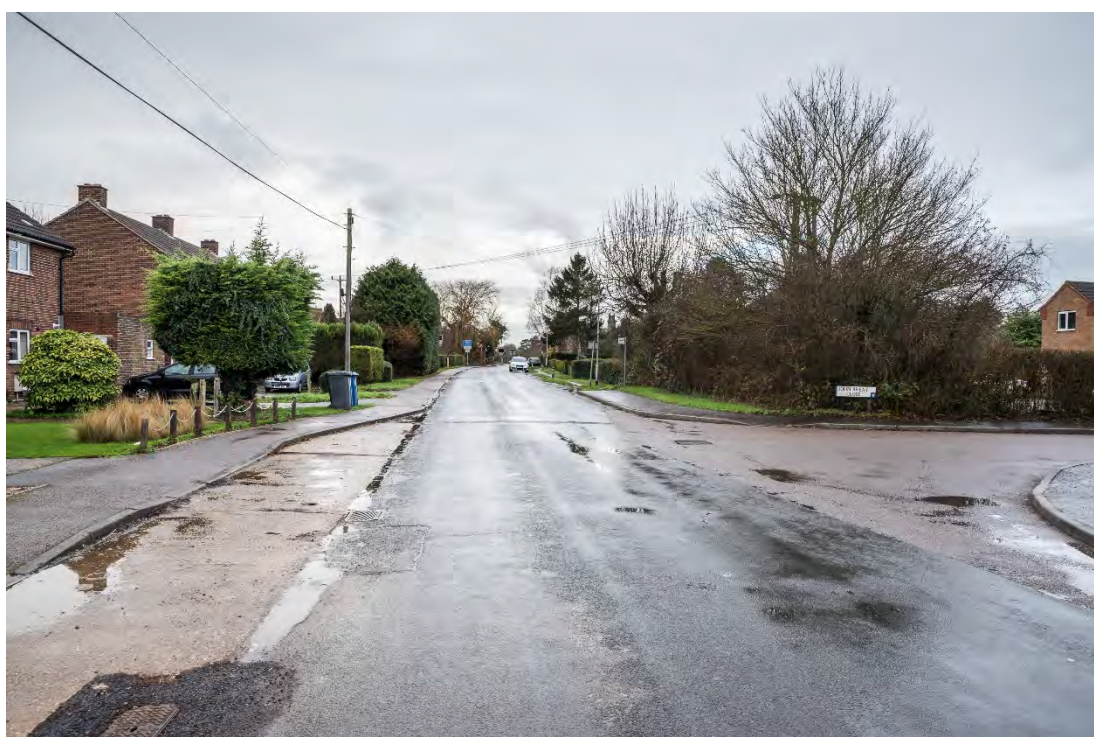
Figure 11 **View approaching crossing from the east - distant**

The distant, intermediate and close road approaches from the east are shown in *Figure 11* to *Figure 13*. It can be seen in *Figure 11* that the crossing is visible from the distant signage.

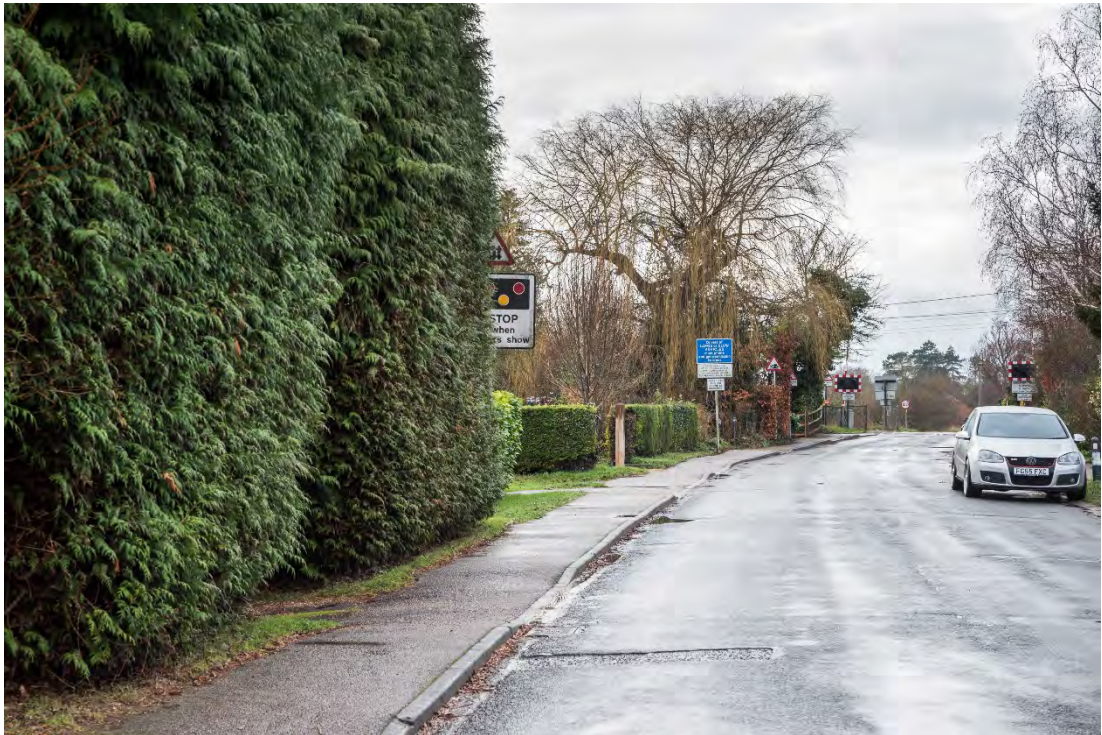
**Figure 14 Level Crossing sign partially hidden by hedge**

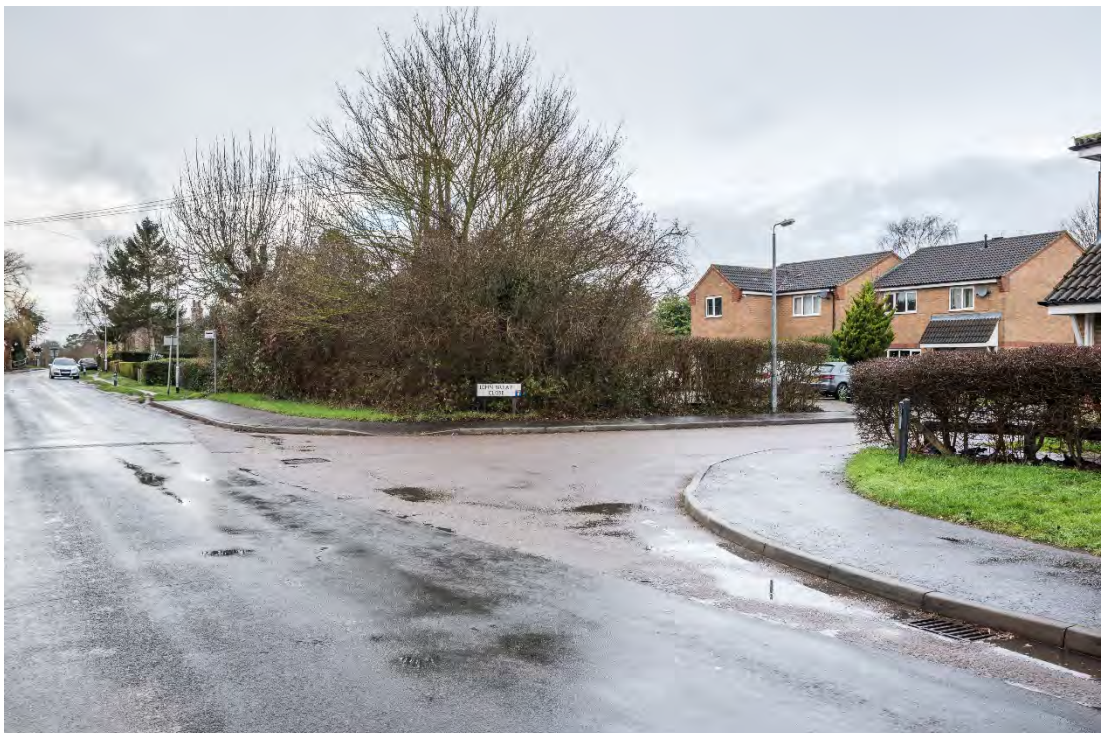
**Figure 15 John Breay Close on right**

1. The road has is straight on the approach.
2. There is a junction with John Breay Close on the right 115m east of the crossing (*Figure 15*). This is a left turn for vehicles that have traversed the level crossing.

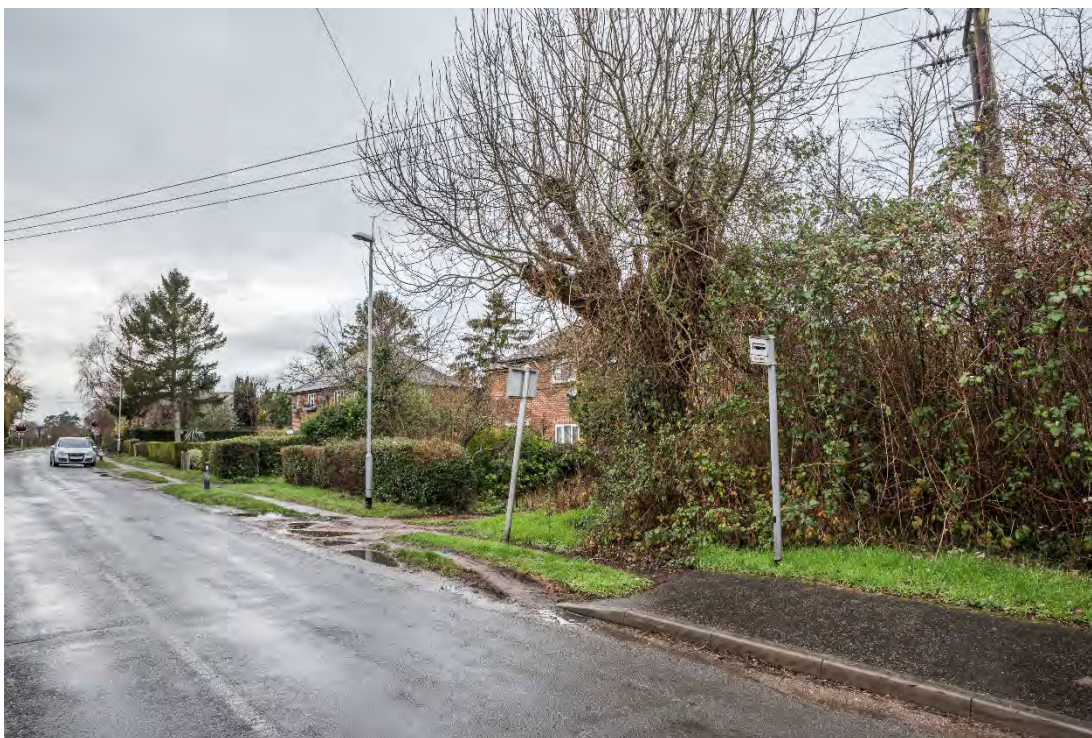
Figure 16 **Bus stop on right**

3. There is a bus stop on the right, 115m beyond the crossing (*Figure 16*)
4. There are driveways on the right on the approach. The nearest is 45m east of the crossing (*Figure 17*). This is a left turn for vehicles that have traversed the level crossing.

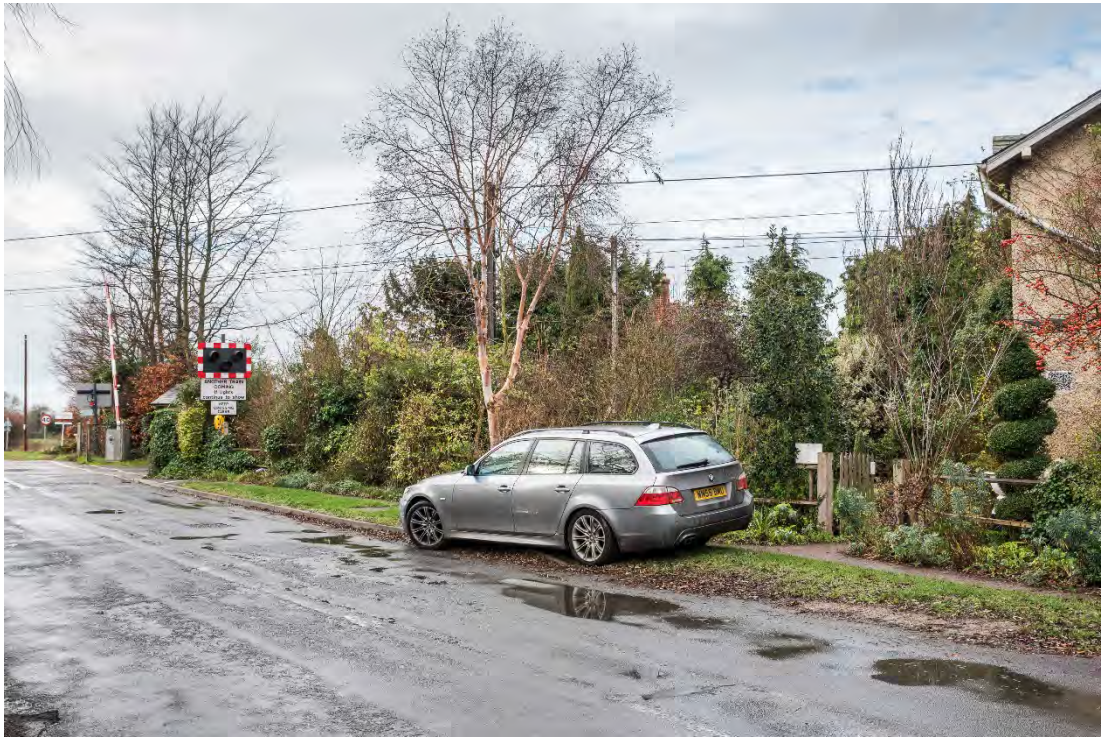
Figure 18 **Parking on right**

5. There is an area where cars tend to park on the right, 18m east of the crossing (*Figure 18*).
6. There are driveways on the left on the approach. The nearest is 3m east of the crossing (*Figure 19*), which due to its proximity to the crossing could be a cause of blocking back. This is a right turn for vehicles that have traversed the level crossing.

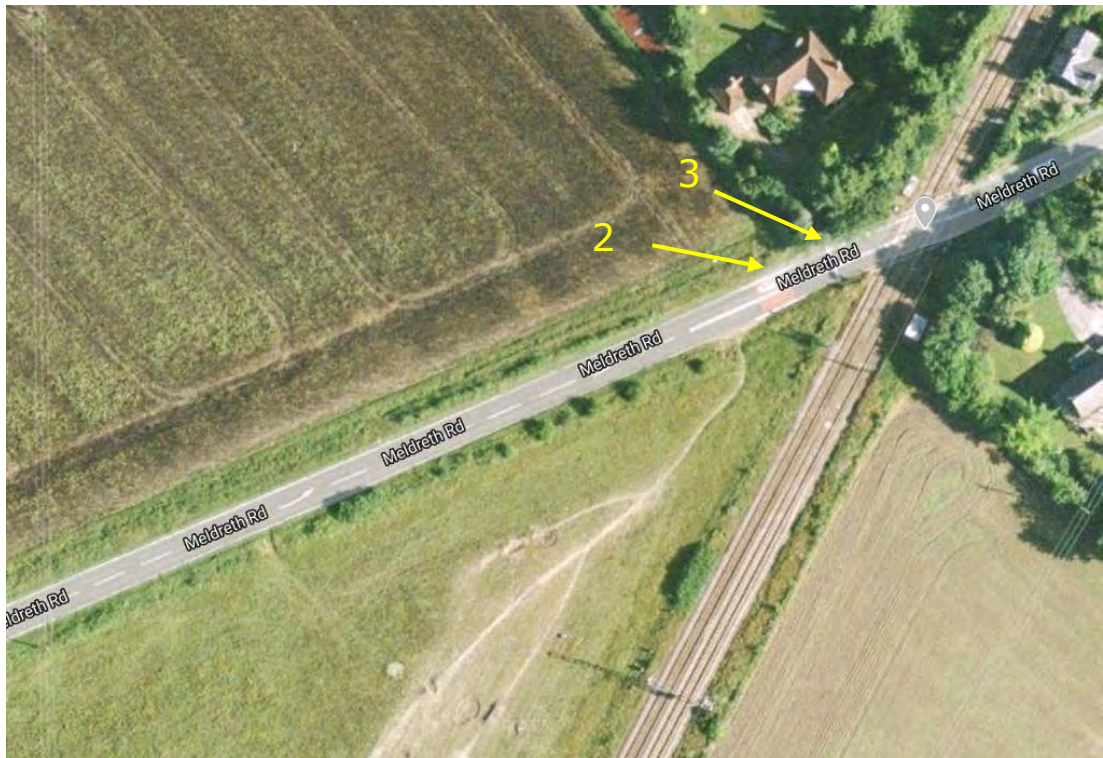
Figure 20 Key features on the western approach to the crossing

1. The road is straight on the approach.
2. There is field entrance on the left, 7m west of the crossing (*Figure 24*). This is a right turn for vehicles that have traversed the level crossing.
3. There is a driveway on the left by the white line of the crossing (*Figure 25*). This is a right turn for vehicles that have traversed the level crossing. Due to the proximity of this driveway to the crossing, it could very occasionally be a cause of blocking back.
4. The offside RTL is visible from over 170m on the approach; the near side RTL is not, however, visible due to a hedge. The near side RTL becomes visible at 120m from the crossing.
5. The level crossing signage had good conspicuity at the time of the site visit.
6. The crossing has a skew of 45°.

A plan of the key features is shown in *Figure 20*; the numbers in the figure refer to the above numbered list of features.

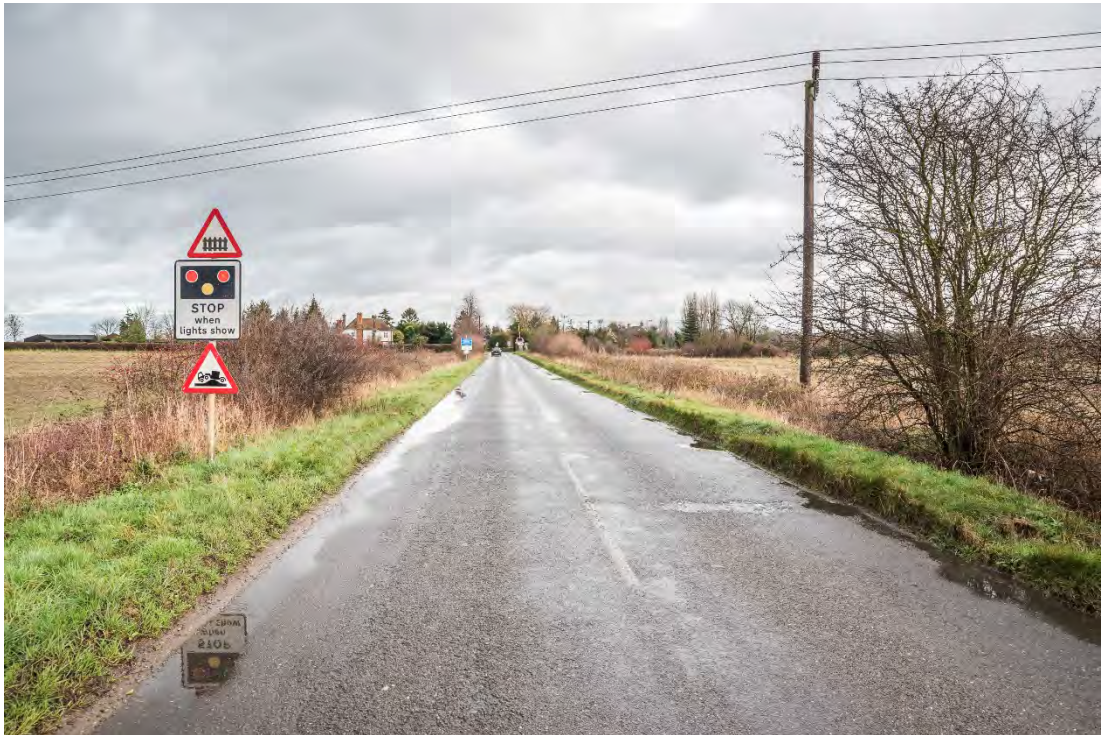
Figure 21 **View approaching crossing from the west - distant**

The distant, intermediate and close road approaches from the northwest are shown in *Figure 21* to *Figure 23*.

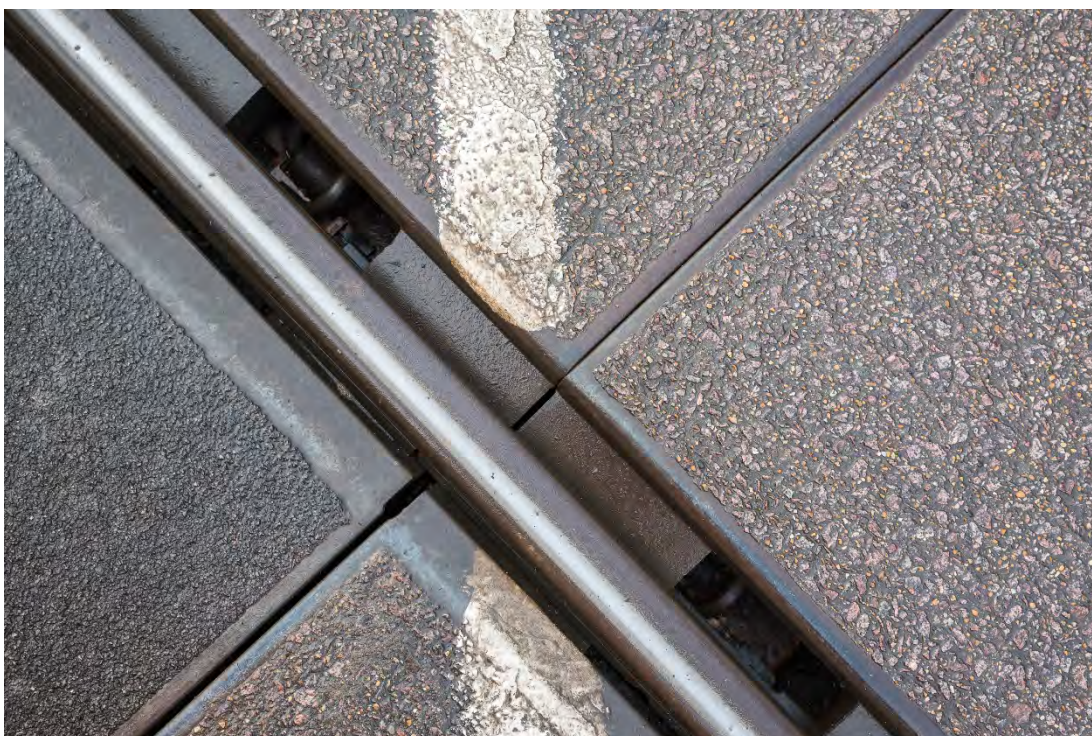
Figure 28 **Crossing skew 45°**

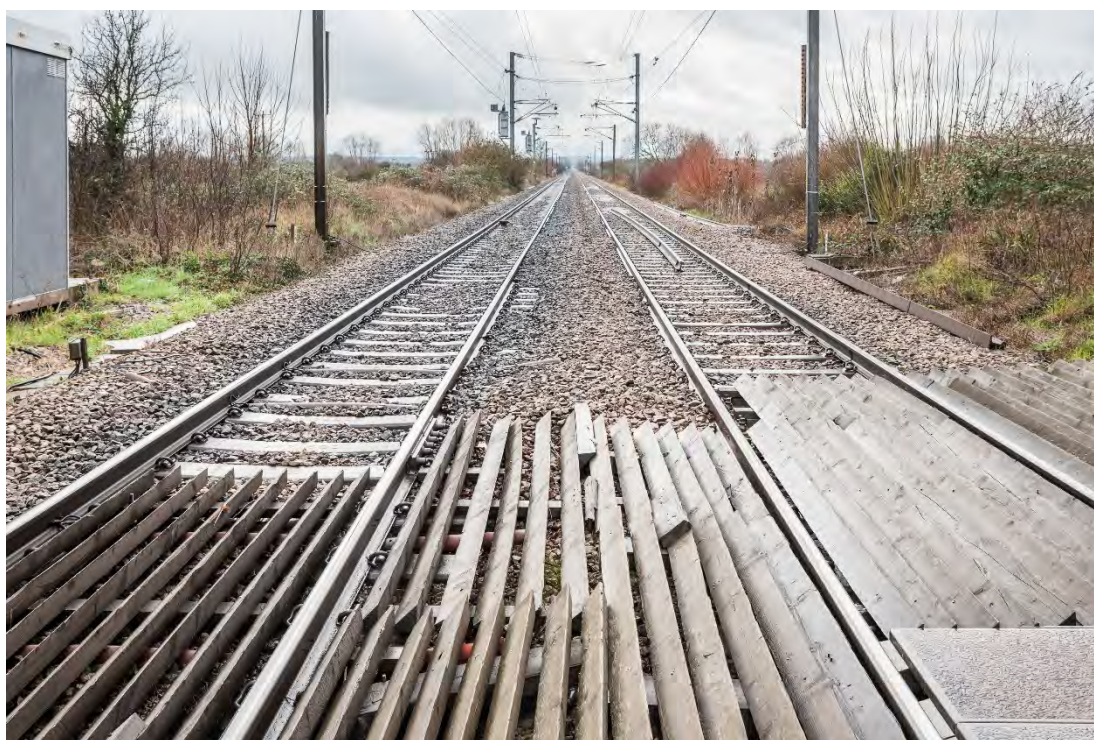
**Figure 32 View of Down rail approach (looking towards Royston)**

For trains travelling in the Up direction, in the unlikely event of a derailment following hitting a vehicle on the crossing, the overhead line stanchions may exacerbate the potential derailment consequences.

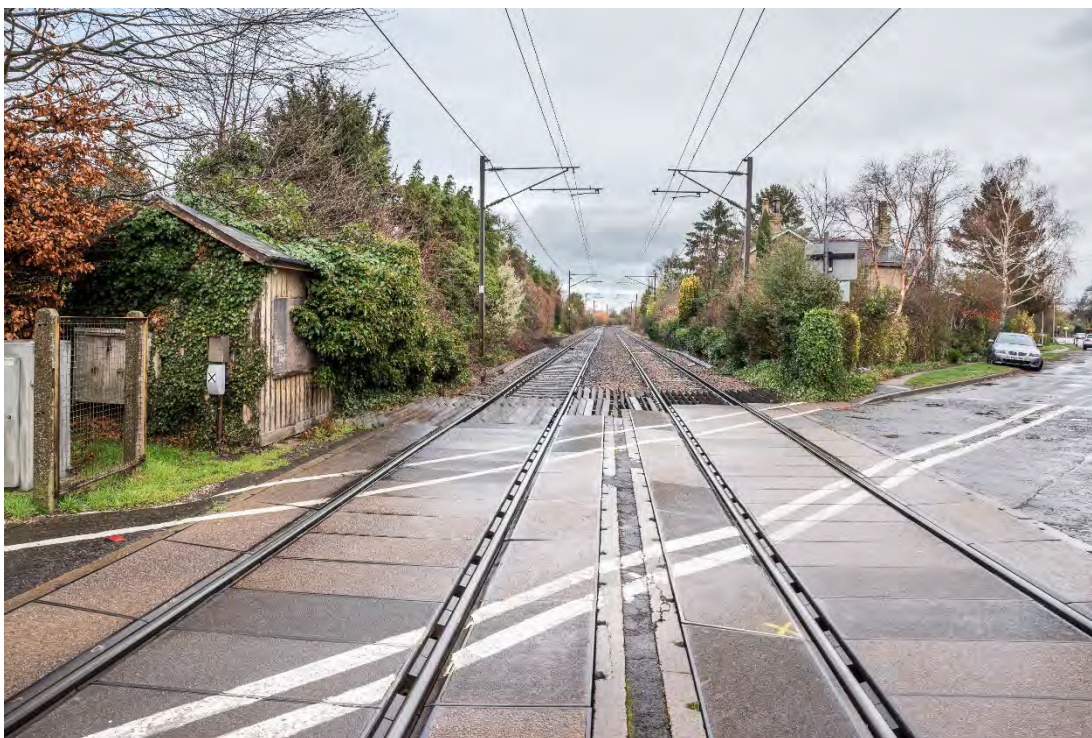
Figure 33 **View of Up rail approach (looking towards Cambridge)**

Trains travelling south are travelling in the Up direction towards Royston. The view from the crossing looking north is shown in *Figure 33*. The track has a distant curve on this approach.

For trains travelling in the Down direction, in the unlikely event of a derailment following hitting a vehicle on the crossing, the features that could exacerbate the potential derailment consequences are houses close to the crossing and the overhead line stanchions.

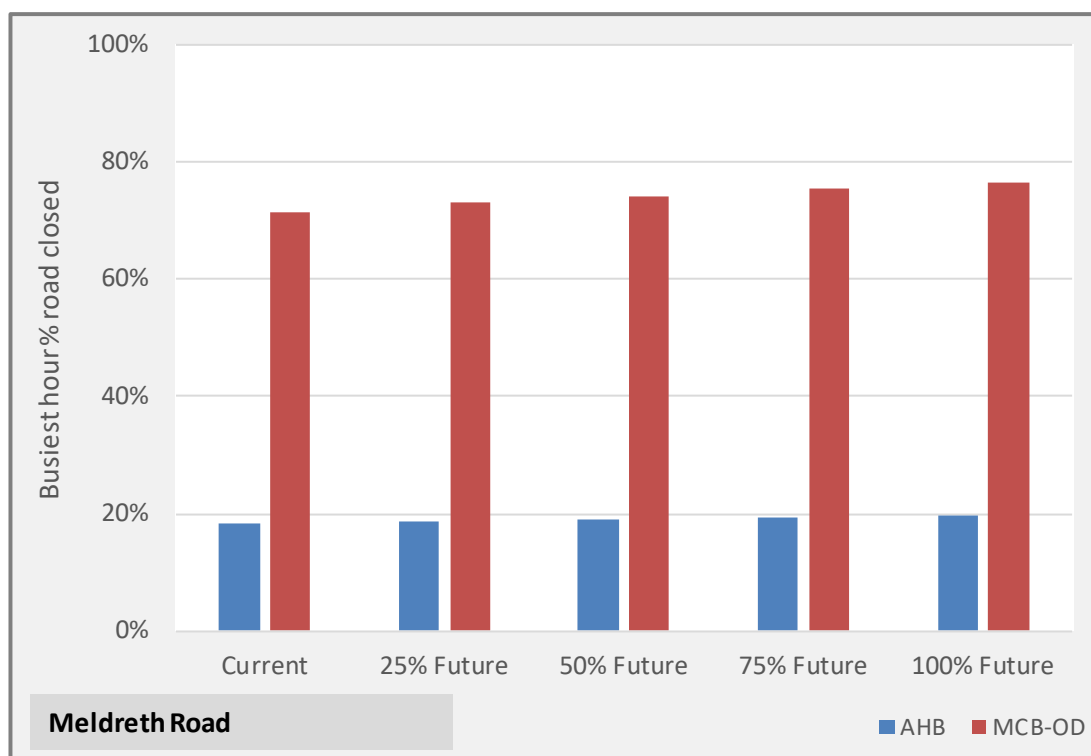
**Figure 36 Road closure time in the busiest hour**

Sotera has used a fairly simple model to estimate the potential impact of any upgrade to an MCB-type fall barrier crossing (MCB-OD or MCB-CCTV). For Meldreth Road, this suggests that the busiest hour road closure time would increase from about 18% currently as an AHB level crossing to about 71% as shown in *Figure 36*. The average daytime road closure time is shown in *Figure 37*.

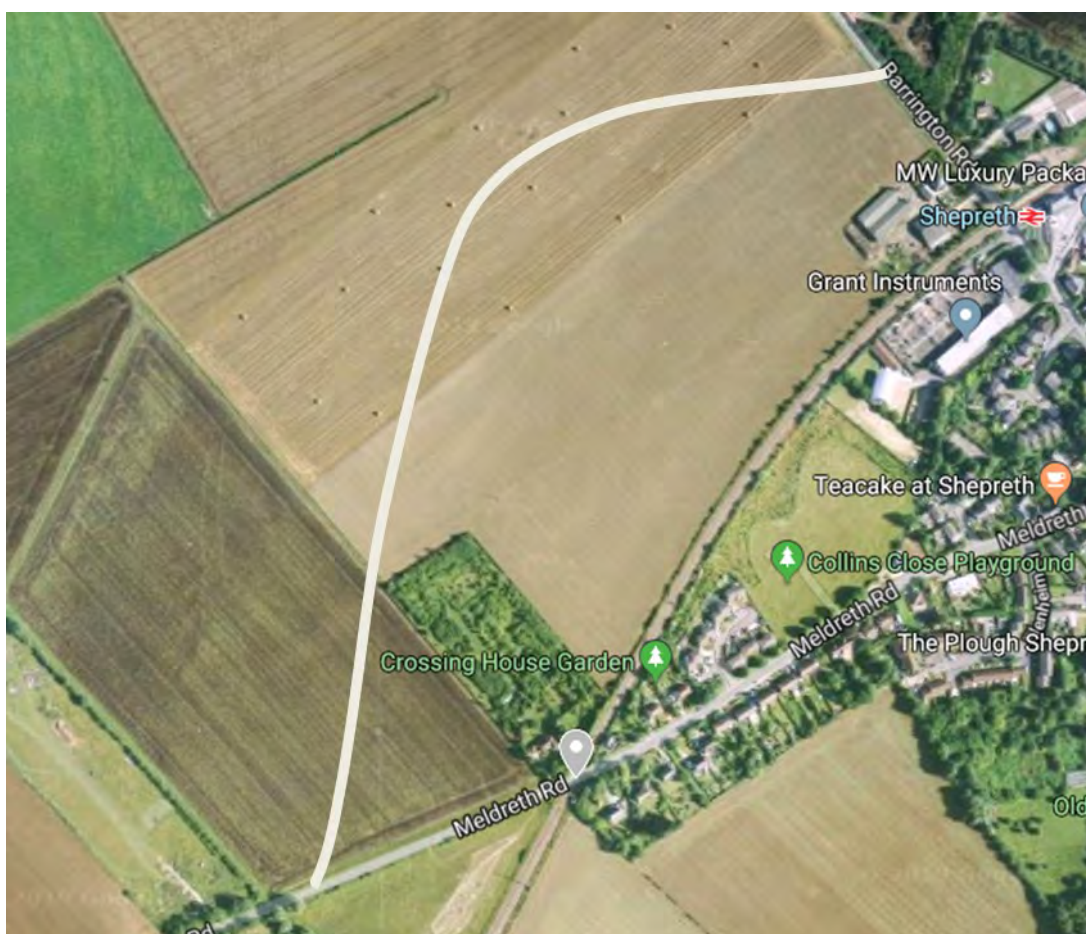
Figure 39 Scheme to close Meldreth Road crossing

The first priority should be to close the crossing where possible. The only option identified would be to divert Meldreth Road to Barrington Road via a new link road (*Figure 39*) and users can utilise Shepreth level crossing. This has the disadvantage of increasing the usage over an already busy level crossing. Need to build about 800m of new road. There would need to be an additional ramped footbridge at Meldreth Road and significant local objections are likely and so such a scheme may not be deliverable. The link road would divert additional vehicles to Shepreth Station CCTV crossing so would not eliminate the risk.

Since this scheme would likely cost an estimated £4.5m, the short-term capital cost is higher than the alternative of renewing Meldreth Road as MCB-OD with a cost of about £2m and a similar residual risk.
