THE NETWORK RAIL
(ESSEX AND OTHERS
LEVEL CROSSING REDUCTION)
ORDER

#### **SUSAN TILBROOK**

SUPPLEMENTARY PROOF OF EVIDENCE RELATING TO MATTERS RAISED IN JOHN RUSSELL'S LETTER DATED 12TH OCTOBER 2017

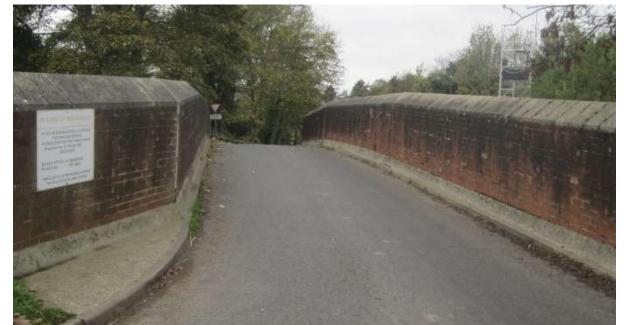
Summary: Restricted carriageway width over railway bridge.

The carriageway width over the railway bridge narrows to single carriageway with no footway or verge meaning pedestrians would have to share the carriageway with vehicles. Forward visibility of pedestrians could be restricted (particularly eastbound) and although vehicles are travelling slowly over the bridge, this could result in conflict between pedestrians and vehicles.

Figure 2.2: Restricted width on Debden Road over railway line.

It is recommended that measures are provided to either warn motorists of pedestrians within the carriageway or to further slow vehicles on the approach. However, if suitable remedial measures cannot be provided then an alternative route should be identified.

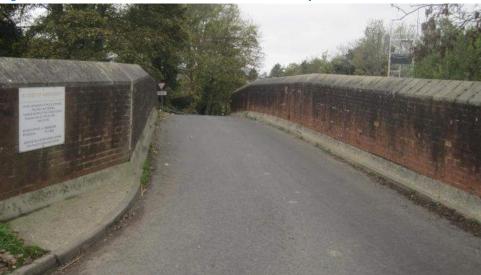
The carriageway width over the railway bridge narrows to single carriageway with no footway or verge meaning pedestrians would have to share the carriageway with vehicles. Forward visibility of pedestrians could be restricted (particularly eastbound) and although vehicles are travelling slowly over the bridge, this could result in conflict between pedestrians and vehicles.

Figure 2.2: Restricted width on Debden Road over railway line.
