**KEATS HOUSE,
26-28 ST THOMAS'S STREET
LONDON**

**PROPOSED FAÇADE DISMANTLING
METHODOLOGY**

ROBERT GREER – PAYE

29th November 2018

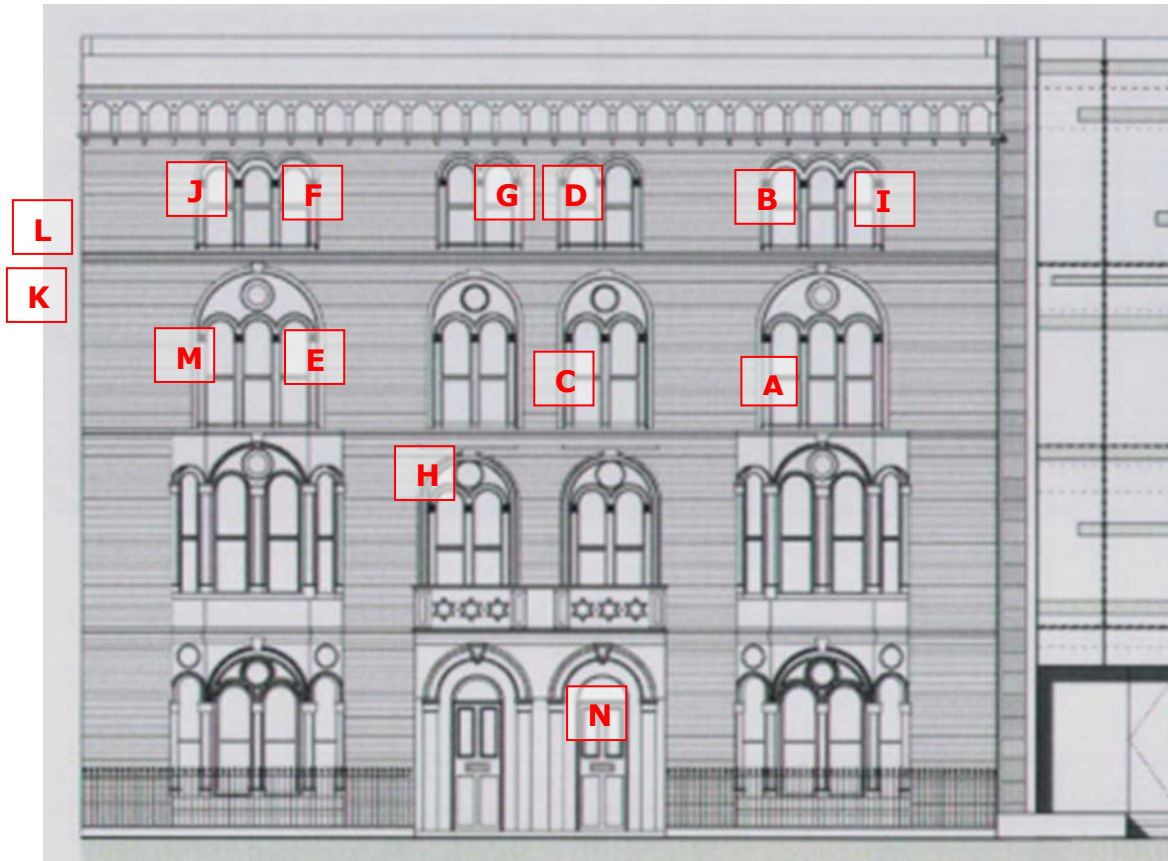
- A Window jamb
- B Window jamb
- C Window jamb
- D Window jamb
- E Window jamb
- F Window jamb
- G Window jamb
- H Jamb column capital
- I Window jamb
- J Window jamb
- K Elevation view
- L Elevation view
- M Window jamb
- N Entrance portico

On the photographs on the following pages fractures and masonry displacement have been highlighted in red
