PROTECTED LEVEL CROSSING RISK ASSESSMENT

This is a risk assessment for Croxton AHB level crossing.

Crossing Details	
Name	Croxton AHB
Type	AHB
Crossing status	Public Highway
Overall crossing status	Open
Route name	ANGLIA
Engineers Line Reference	ETN – 96m 46ch
OS grid reference	TL902868
Number of lines crossed	2
Line speed (mph)	40 (TSR)
Electrification	No electrification present
Signal box	Cambridge PSB – Thetford workstation

Risk Assessment Details	
Name of assessor	Darren Lincoln
Post	LCM
Date completed	25-10-2021
Next due date	24-01-2023
Email address	darren.lincoln@networkrail.co.uk
Phone number	07824411923

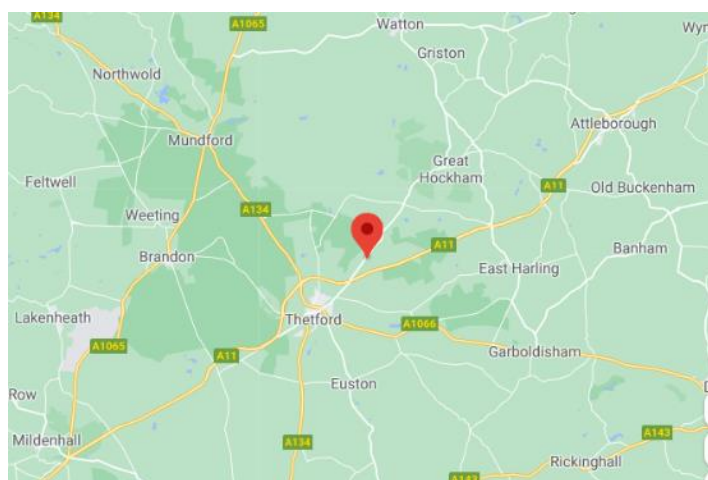
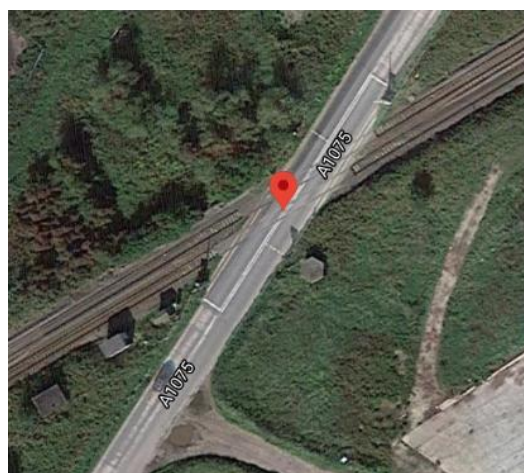
Impact of low sun on the crossing

At Croxton AHB level crossing the orientation of the road/path from the north is 205°; the orientation of the railway from the north to the up line in the up direction is 260°. Crossing is in the top 100 of crossings at risk of sun glare list.

Below is the output from the Sun Calc application, which shows the lines of sunrise and sunset angles at two times of year (longest day June 21st & shortest day December 21st) when low sun would align with the rail approaches and might impact on the sighting.
