Preliminary Phase 1 Land Quality Assessment to Inform Proposed Development for 12 mppa Planning Application

Bristol Airport Limited

Preliminary Phase 1 Land
Quality Assessment to Inform
Proposed Development for
12 mppa Planning Application

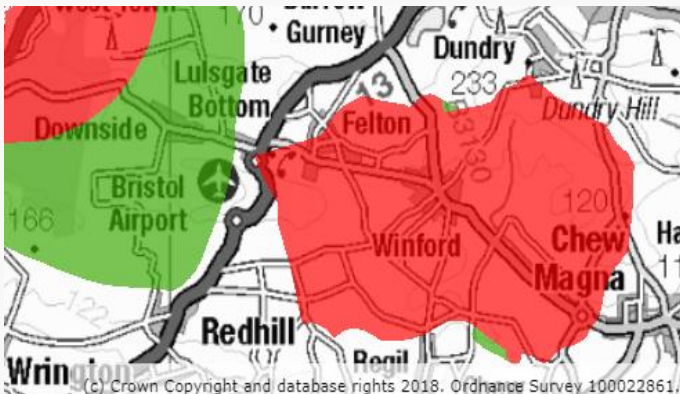
Radon	Bedrock geology is a source of naturally occurring radon (radioactive gas). The Envirocheck 2017 ² (presented in Appendix B) reports that the BGS has designated the area of the BAL site as a higher probability radon area, with 10-30% of homes above the action level.				
Hydrogeological sensitivity	The majority of the site lies within a Zone 2 Outer Source Protection Zone (SPZ) (shown in green on the map below) associated with the designated outer catchment of Chelvey Well to the north west of Broadfield Down (located approximately 4.3km north west of the BAL site). There is also a Zone 1 Inner SPZ immediately to the east of the A38 and farther away to the north west (shown in red on the map below).
