New City Court

2018 Scheme / 2021 Scheme

Listed Building Consent
BREEAM / Upgrades to Existing Fabric

July 2022

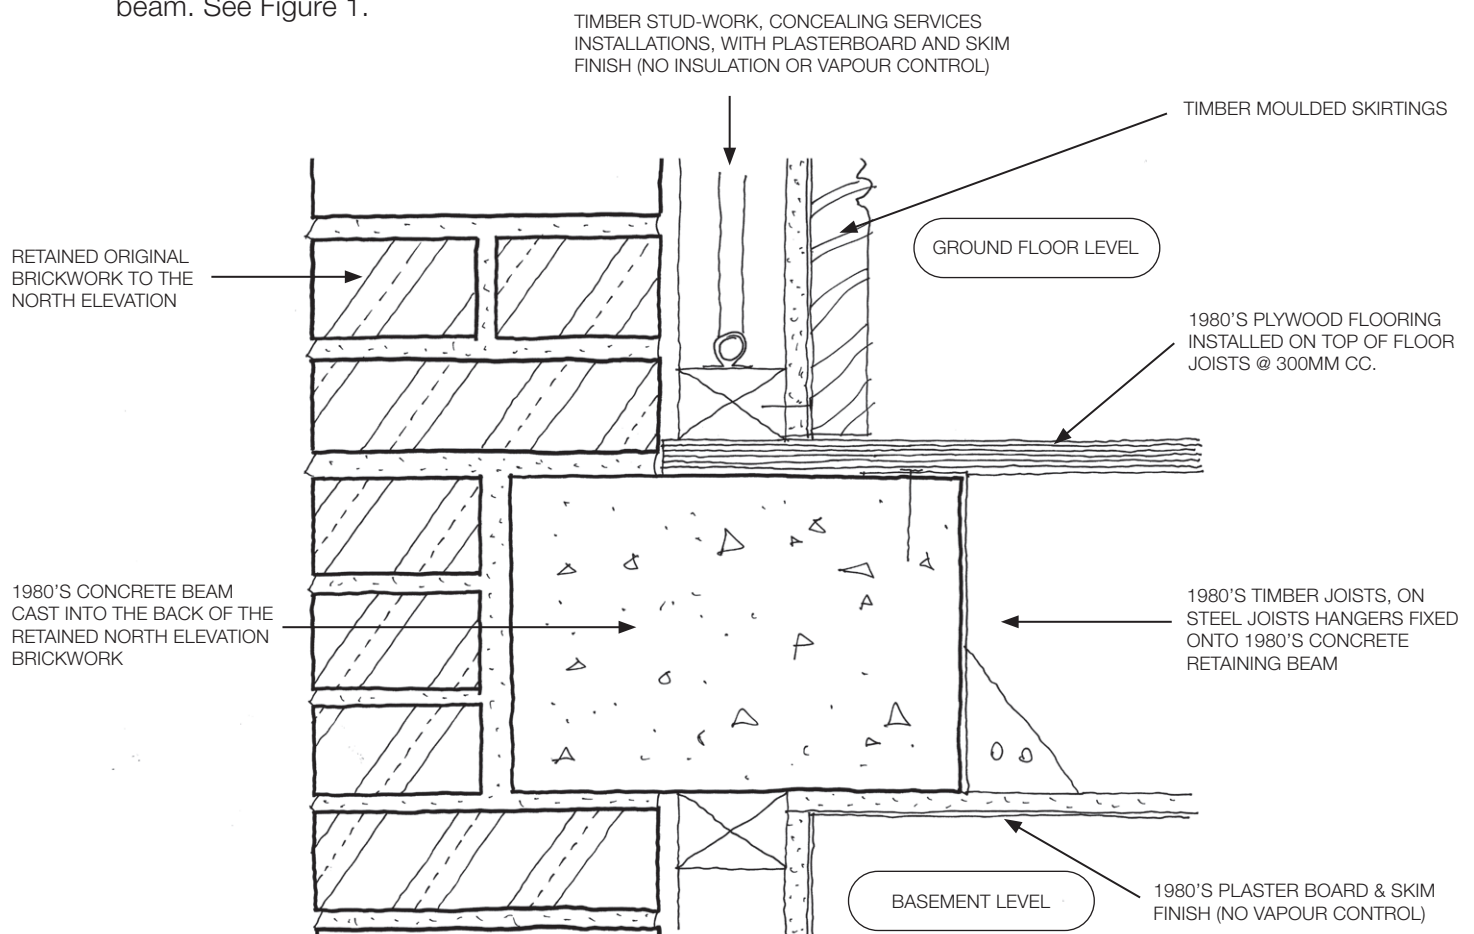
Fig. 1: Existing junction between the original fabric of the north elevation and 1980's retaining / floor structures

2.1.1 The existing primary street facing elevation of the Georgian Terrace is constructed of monolithic brickwork fronting onto St. Thomas Street. This was dry lined internally in the 1980's, but is both uninsulated and has no vapour control layer. The void behind the plasterboard is used primarily for running containment to electrical systems. This wall also has concrete retaining beams cast into the rear of the original fabric, with 1980's timber joists hung on steel joist hangers from this concrete beam. See Figure 1.

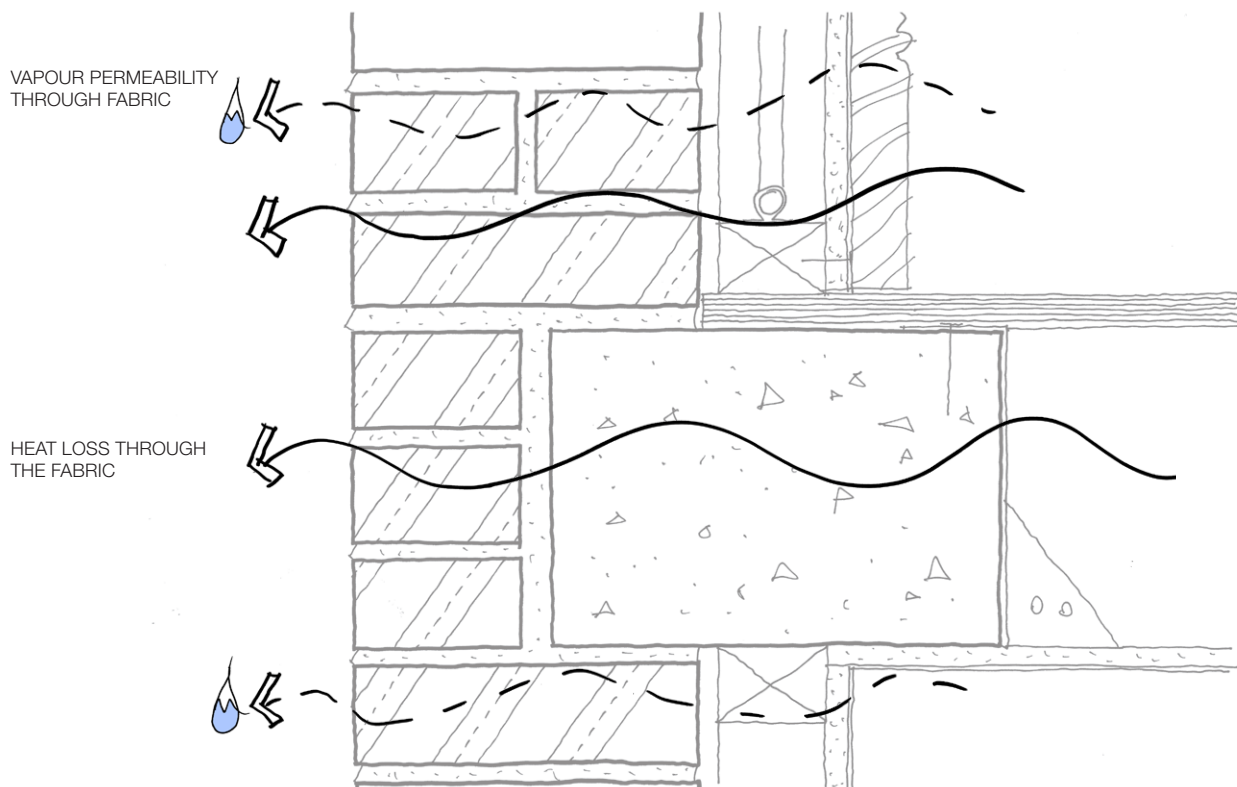
Fig. 2: Heat loss and vapour movement through existing north elevation

2.1.2 Given how this wall is currently constructed, water vapour movement is possible from inside to outside. The lack of insulation also means that heat is lost through the fabric. The combination of free vapour movement and heat loss internally, help to ensure that the brickwork can dry out, especially where subject to high levels of precipitation externally. See Figure 2

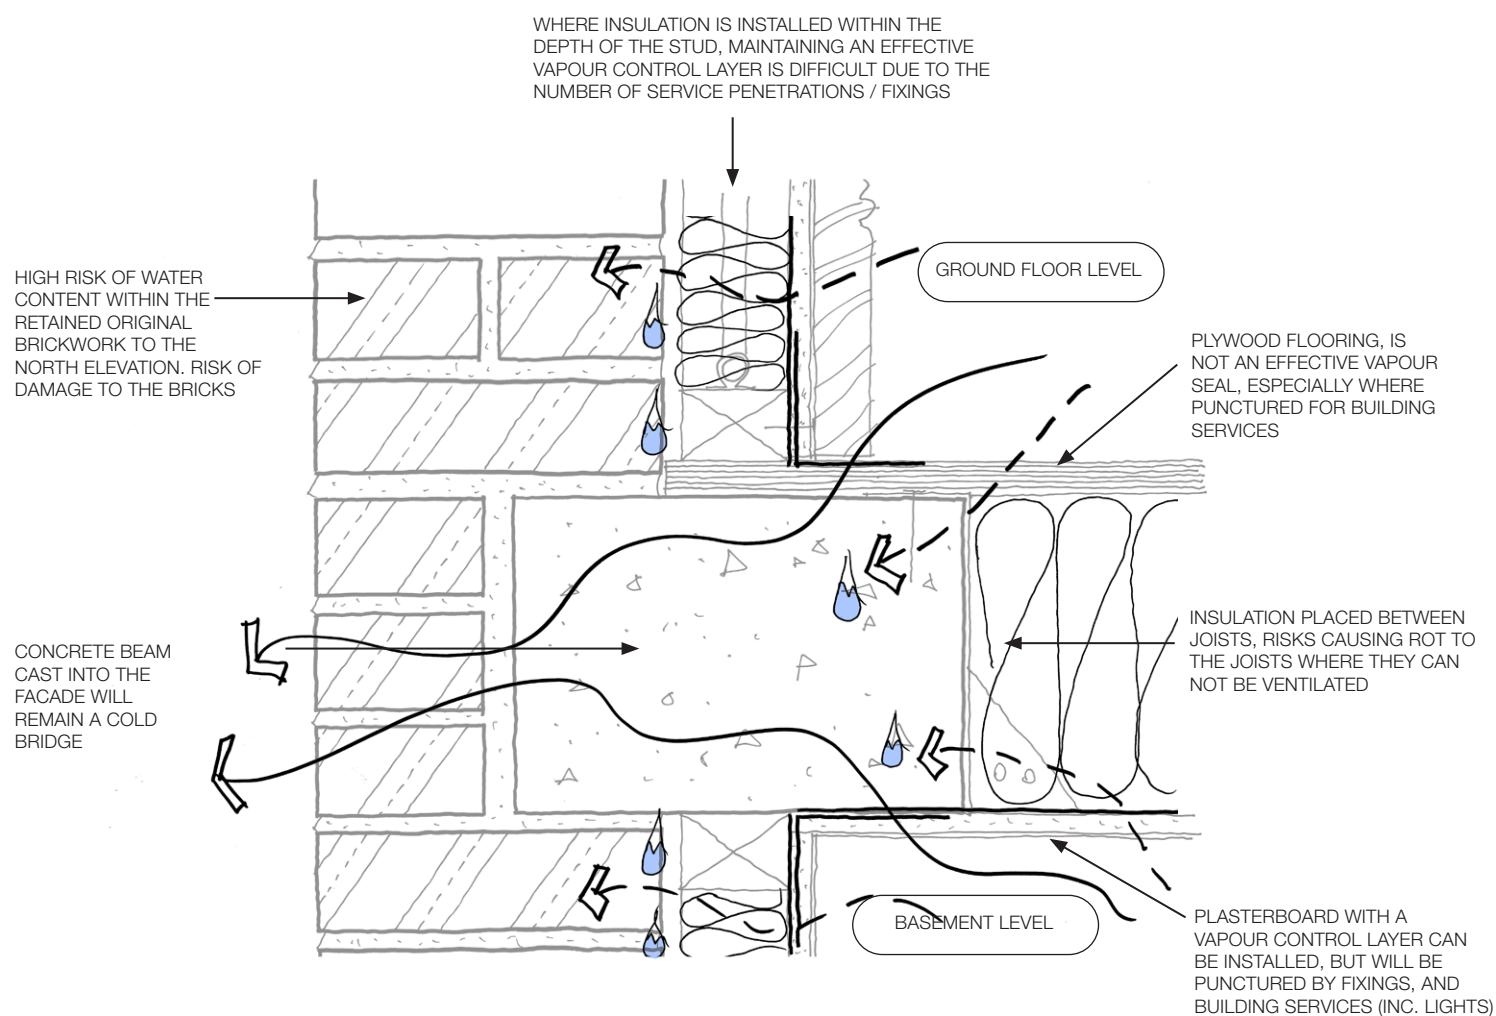
Fig. 3: Implications of attempting to insulate / install vapour control layers to the existing construction.

2.2.3 Analysis of the alterations made in the 1980's to the stability systems of the terrace (removal of spine walls / removal of chimney breasts), have defined an approach of proposing limited alteration to these floors, to ensure that the stability of the retained original fabric of the north elevation is maintained. Given the concrete beams cast into the rear of the brickwork elevation - this limits the potential for insulation at the rear if of the façade and adjoining floor zones. This would result in considerable cold bridging where connecting into the north façade. See Figure 3.

2.2.6 The alternative is to consider internal insulation. However, this is considered a high-risk (*red*) activity in the HE guidance (noted above). This is due to the difficulty in maintaining an insulated line, and in achieving an effective internal vapour seal. This introduces the high risk of interstitial condensation / increased moisture retention to the Georgian brickwork. An increased presence of water and over a prolonged period, has the potential to cause failure of the retained historic fabric, during freeze / thaw cycles and the potential to cause the mortar / brickwork to become friable. Once products are used to try and stabilise the outer face of the brickwork (to treat the problem), this then tends to lock greater moisture behind in the fabric of the bricks and exacerbate the problem.
