**THE COUNCIL OF THE CITY OF
COVENTRY (CITY CENTRE SOUTH)
COMPULSORY PURCHASE ORDER 2022**

**PROOF OF EVIDENCE OF ALEC
PHILPOTT IN RESPECT OF SERVICING**

**The Council of the City of Coventry (City Centre South) Compulsory Purchase
Order 2022. APP/PCU/CPO/3299063
Proof of Evidence of Alec Philpott in Respect of Servicing**

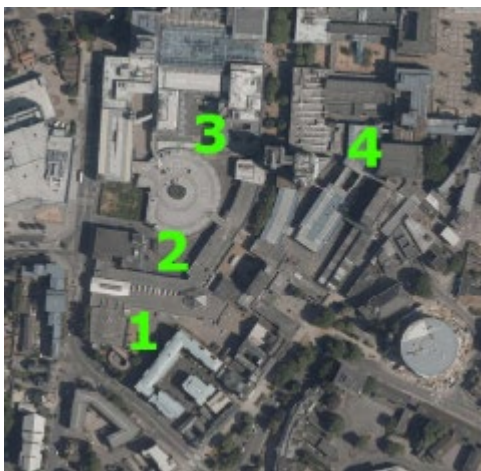
- 4.6 The planning application to which the CPO relates was accompanied by a Transport Assessment (TA) prepared by Transport Planning Practice (TPP) dated November 2020.
- 4.7 Chapter 3 of the TPP TA included baseline surveys of four service yards, comprising:
- Service Yard 1: City Arcade (not relevant to my evidence)
 - Service Yard 2: Rover Road, south of Coventry Market (herein called Yard D)
 - Service Yard 3: Rover Road/Lower Precinct, north of Coventry Market (herein called Yards A1/A2/B & C). Due to survey techniques, TPP were not able to consider precisely how A1/A2/B were used independently of each other.
 - Service Yard 4: Barracks (not relevant to my evidence)
- 4.8 The TA was supplemented at Appendix C with a summary of the surveys of these yards in addition to Figure 7 of the TA identifying survey locations (extract below).

Figure 4.1: TPP Service Yard Survey Locations (Source: Figure 7 of TPP TA)

- 4.9 The service yard surveys were undertaken on Thursday 21st and Saturday 23rd November 2019.
- 4.10 In addition to submission of the TA and following Mayer Brown raising a series of concerns relating to the proposals on behalf of Royal London, TPP entered a dialogue during the application process which culminated in a Draft Servicing Management Plan (SMP) (May 2022) being prepared by TPP which is contained at Appendix AP2.
- 4.11 At page 11 (paras 4.3.6-4.3.7) the TPP SMP provides details on the likely future accumulation of servicing activity to the south of Coventry Market (Yard D), indicated in 15 minute intervals, to demonstrate that Yard D was suitably sized to accommodate activity during its opening hours.

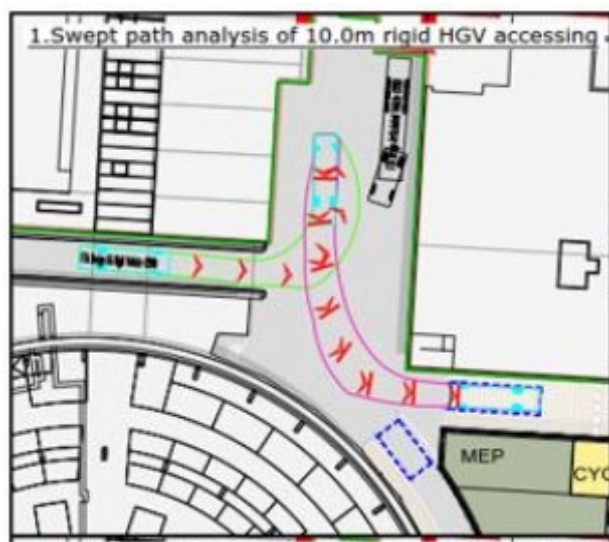
- 4.18 Proposed Block A2 is located to the northeast of CM, cited partly on Service Yard C.
- 4.19 In relation specifically to proposed Block A2, Appendix I of the TA sets out an estimate of the anticipated light goods vehicle/ordinary goods vehicle (LGV/HGV) activity associated with the new elements of the proposed development based on a TRICS [Trip Rate Information Computer System] analysis.
- 4.20 On the basis of this analysis, TPP conclude within the TA (para 5.6.6) that two loading bays will be sufficient to serve the proposed block and the existing demand arising from CM adjacent to Block A2, as loosely illustrated in **Figure 4.2** prepared by TPP below (contained within their Draft Service Management Plan, May 2022).

Figure 4.2: TPP Service Strategy for Block A2 (Source: TPP Draft SMP)

- 4.21 As per the TPP tracking in **Figure 4.2** above, TPP are promoting servicing adjacent to Block A2 (within Yard C), sandwiched between Block A2 and either CM (to its west) or Poundland (to its north).

- 5.59 The above identifies a peak accumulation of **three** servicing vehicles and a relatively consistent demand for two bays throughout a weekday.
- 5.60 As set out earlier in my evidence, The TPP Draft SMP [May 2022] suggests there may be two loading bays adjacent to Block A2 as shown on **Figure 4.2**. Based on the above accumulation (using TPPs data), these would be largely fully utilised throughout the day solely by Block A2 activity, which has been underestimated by TPP. There would be no scope to serve any other purpose, with any consequential overspill likely to result in increased demand in the LPSC yards and increased conflict with pedestrians.

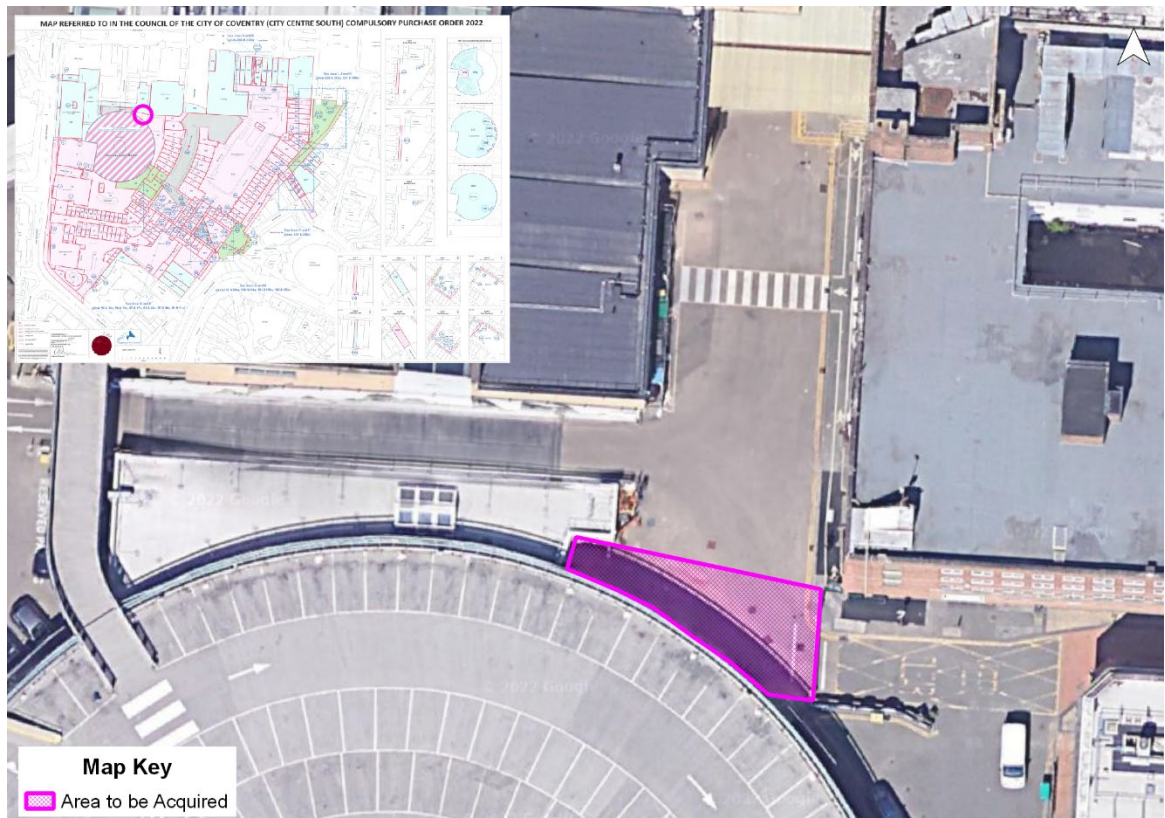
- 5.1 The Compulsory Purchase Order map identifies an area of the LPSC service yard “to be acquired”, immediately adjacent to the northeast corner of CM as shown in **Figure 5.1** below. This area forms part of plot 54 on the CPO plan.

Figure 5.1: Area of Land to be Acquired, Required for LPSC Service Vehicle Manoeuvring

- 5.2 The area identified is presently used to enable delivery and servicing to occur to the LPSC and acts as essential manoeuvring space to permit vehicles to back up to the 3no. dock levellers at the north of this service yard.
- 5.3 **Drawing AP1** appended hereto illustrates the swept path manoeuvres which are presently possible and, for ease, identifies the “area to be acquired” in question.
- 5.4 The AA’s intention with this area to be acquired is presently unclear, but any development which would prohibit its use by delivery vehicles trying to access LPSC would prejudice the retailers operations.

- 7.1 The AA should be required to ensure that service vehicles utilising Yard B are able to pass over the area identified in **Figure 5.1**, or be required to remove this area from the CPO in order to preserve appropriate servicing for LPSC retailers.

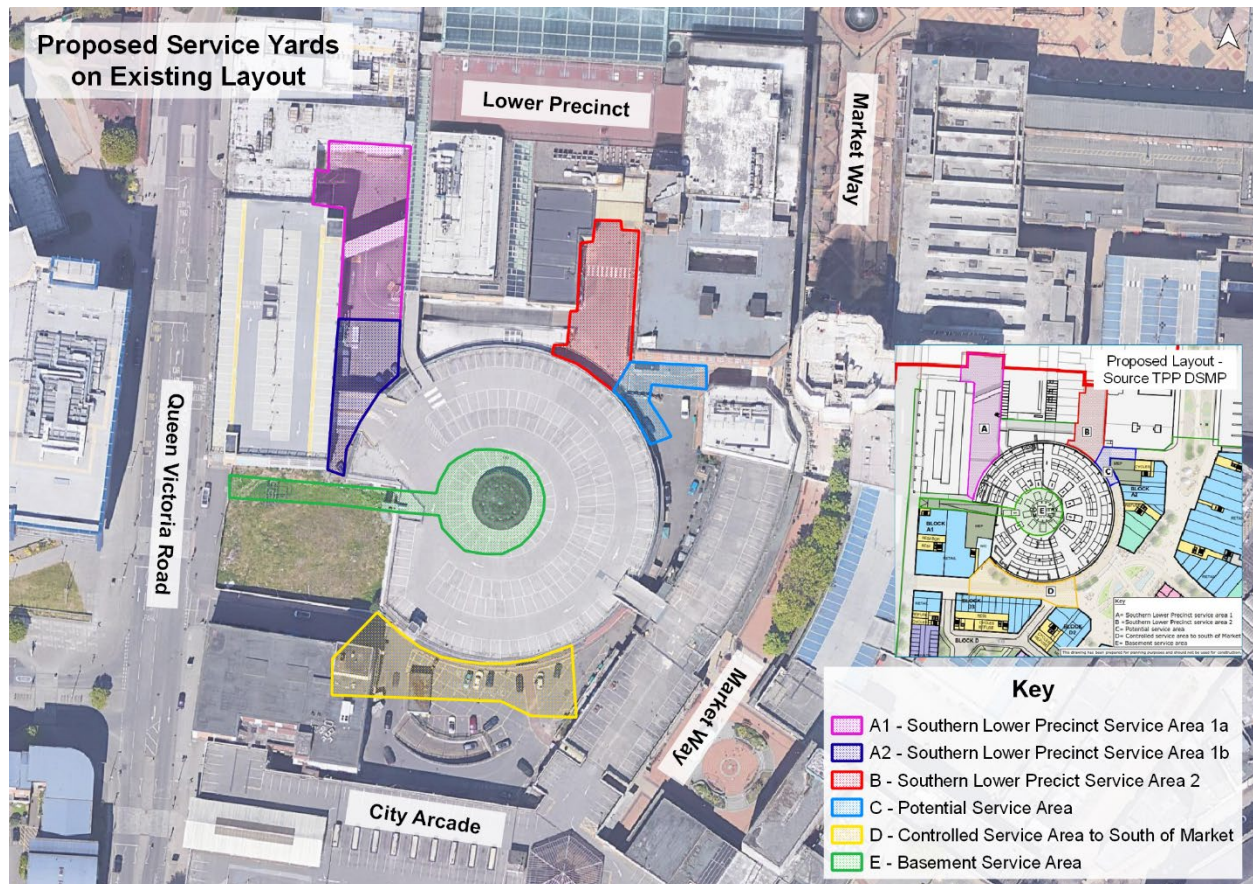
5.7 **Figure 5.2** below identifies the approximate areas of each of the service yards, post development with a description of the changes below:

Figure 5.2: Proposed Service Area Locations

- Yard A – No Change from existing
- Yard B – No Change from existing
- Yard C – reduced in scale to accommodate footprint of Block A2 and intended to also serve solely proposed Block A2
- Yard D – reduced in size and servicing access time restricted to 0600/0700-1000 hours only
- Yard E – 4no. small basement service bays proposed, accessed from a new ramp from Queen Victoria Road

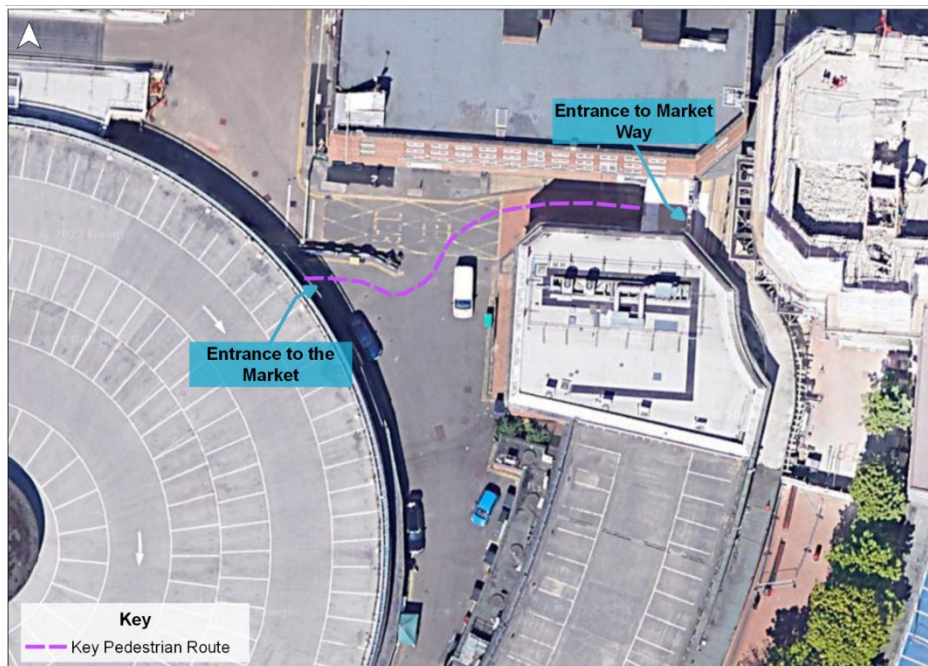
Figure 5.3: Key Pedestrian Desire Line between CM and Markey Way

- 5.61 These bays are located immediately adjacent to one of the main Market entrances which acts as a key pedestrian link between the Market and Market Way (and beyond) as illustrated at **Figures 5.3 and 5.4** below.

- 5.62 This area carries in excess of 2,000 pedestrian movements between the hours of 0700 and 1800, confirming that this is a heavily trafficked area by foot.

- 5.64 While it is acknowledged that there is a level of servicing activity already occurring in proximity to this area, the entrance to the Market (and consequently emerging pedestrians) are presently offered some protection by a retaining structure and associated armco barrier shown in the photograph above.

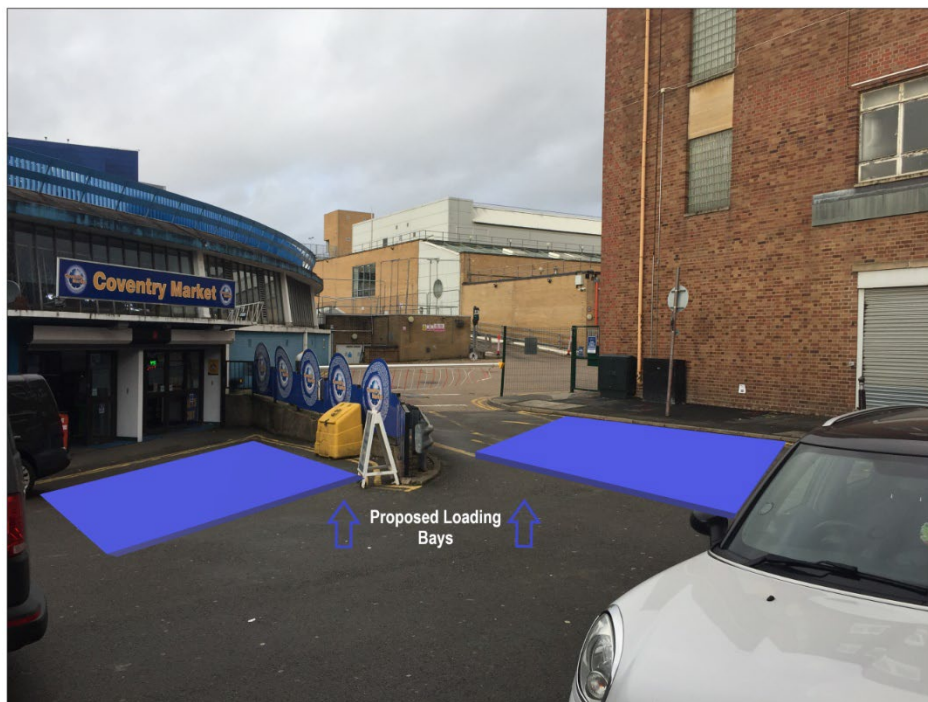
Figure 5.4: Block A2 Proposed Loading Bay Locations

- 5.63 The proposed northernmost bay sits on an area linking Market Way with the Market and Service Yards, (which is currently delineated with a yellow box and "Keep Clear" markings). This route has previously been illustrated by TPP as an area to be kept clear for emergency access. It would therefore follow that the provision of servicing in this location would be prejudicial to emergency access unless alternative access has been arranged.
