Arboricultural Survey

6 Avonmouth Street London SE1

7th June 2021

PJC ref: 5810/21-01 Rev 1

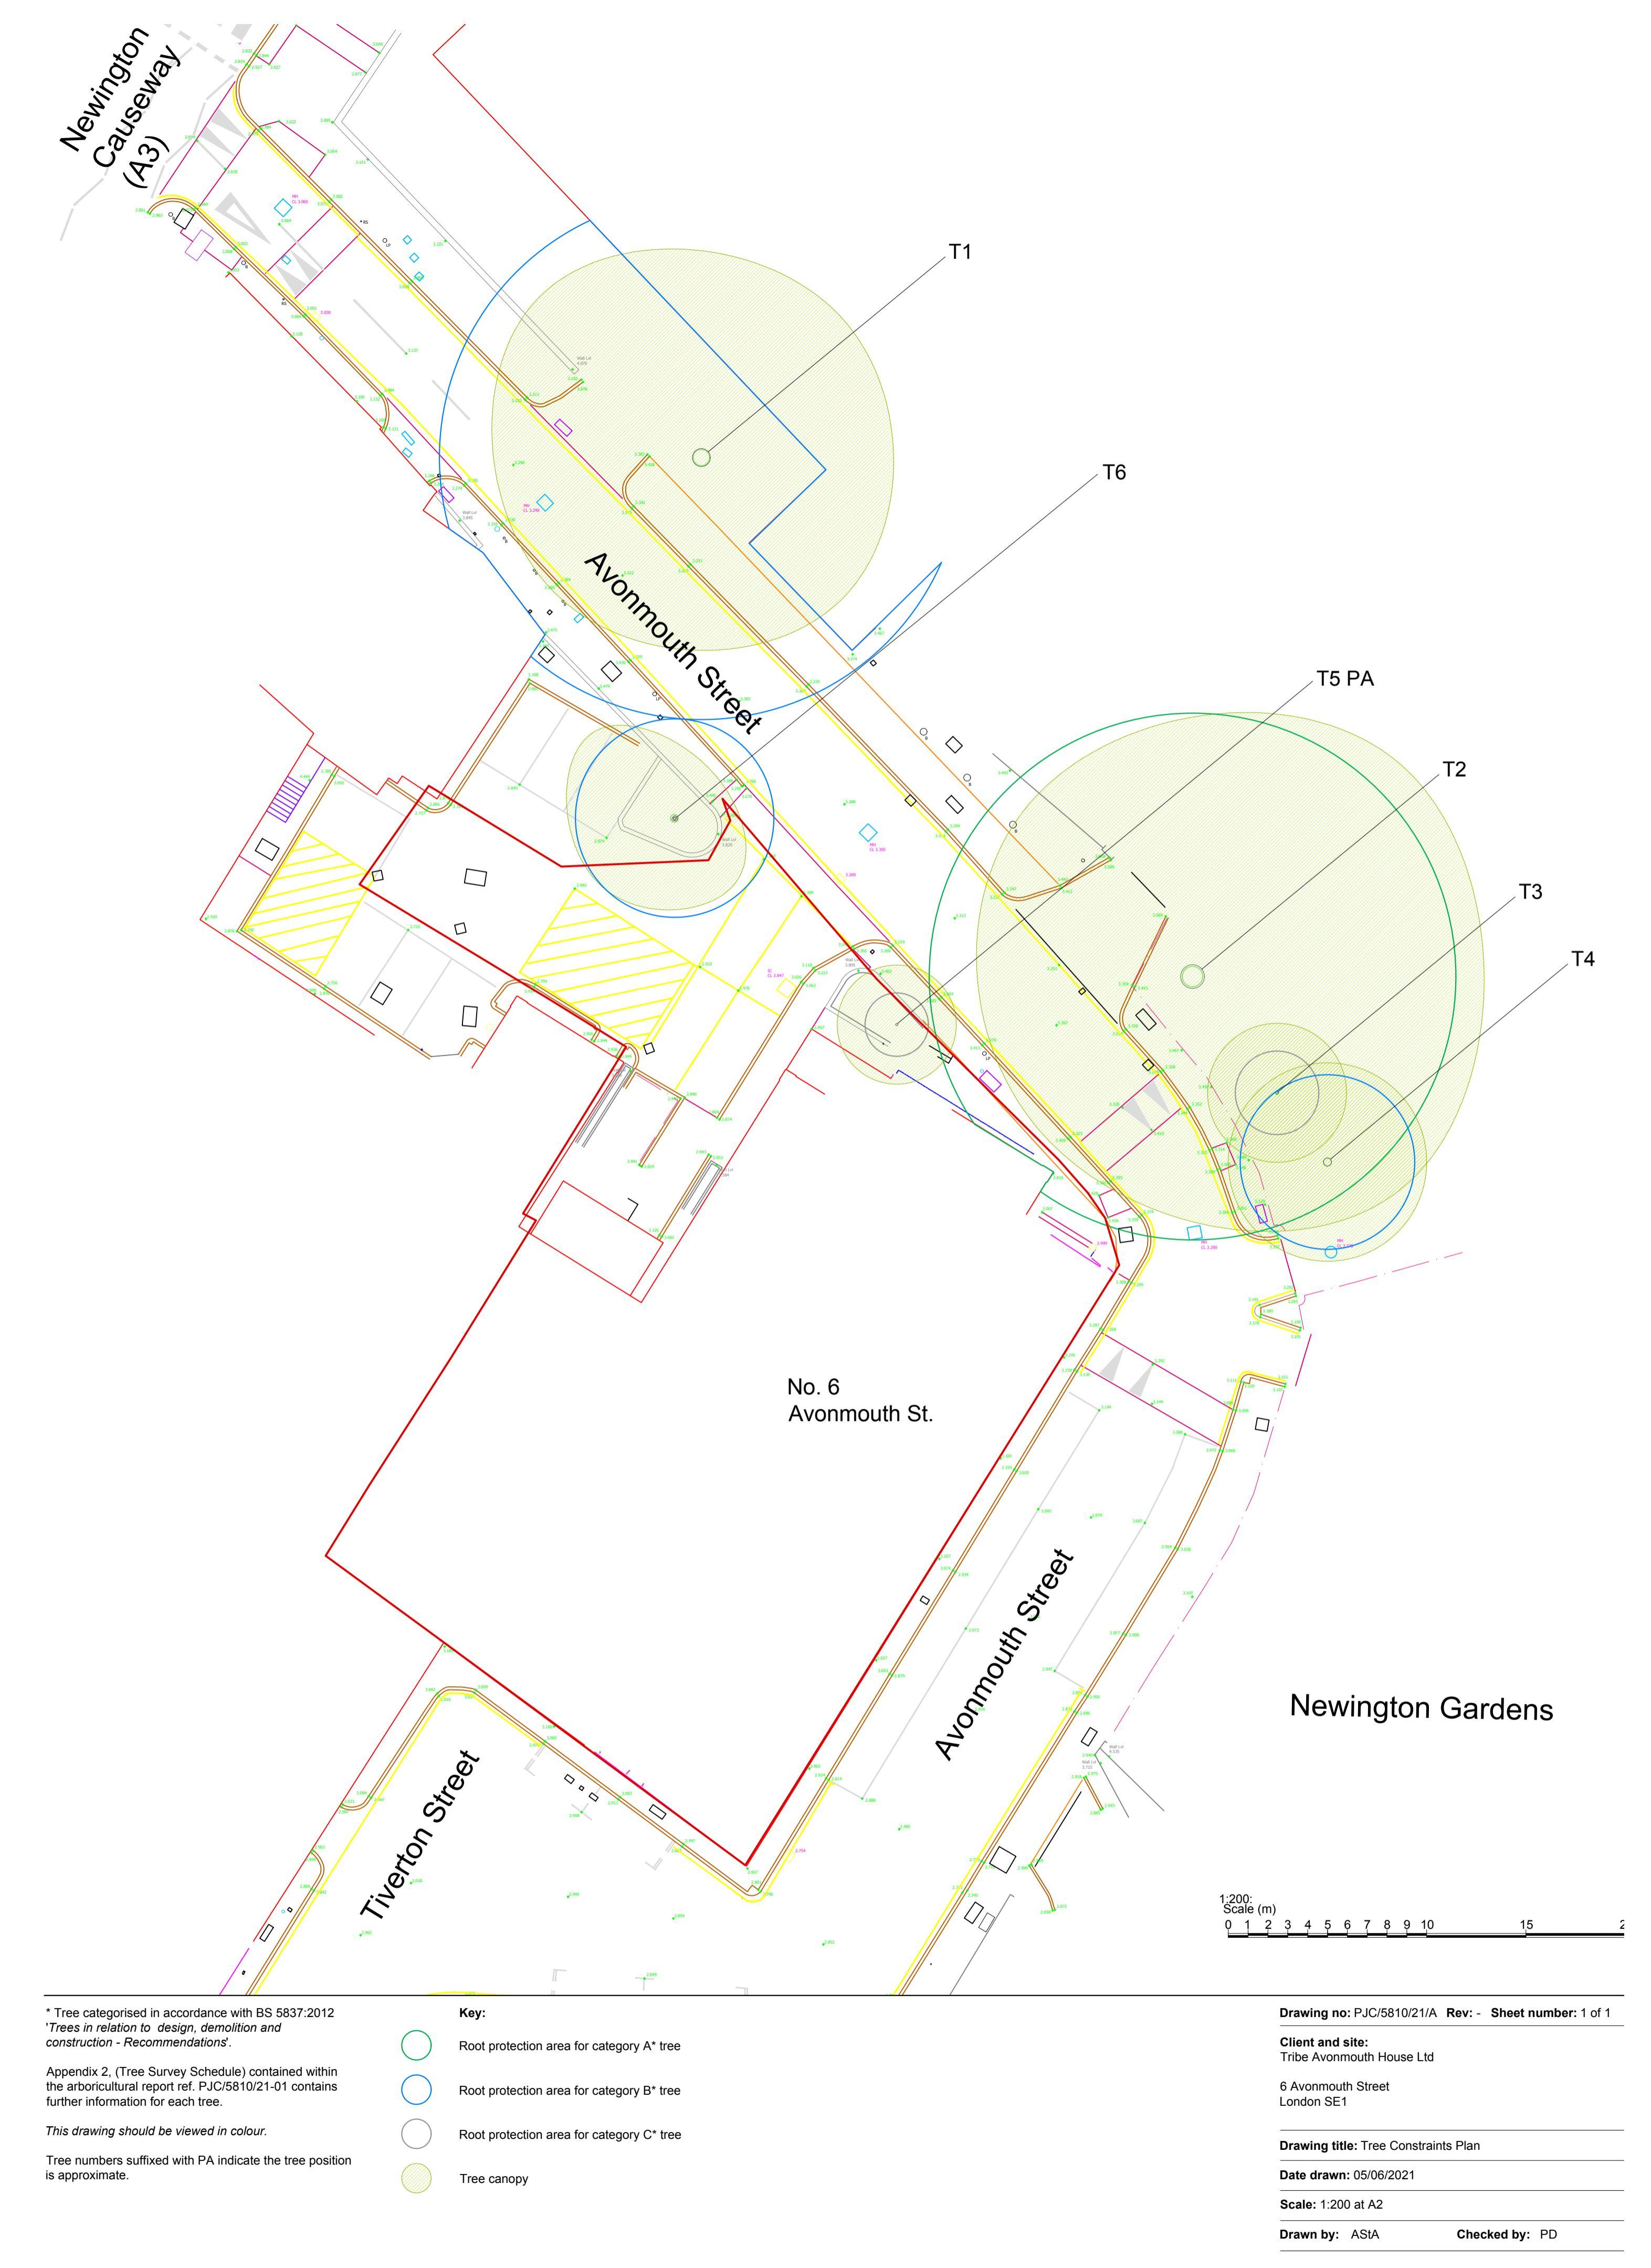
Appendix 1: Tree Constraints Plan

2.4.2 The root protection areas are plotted onto the Tree Constraints Plan in Appendix 1 and are recorded in the Tree Survey Schedule in Appendix 2. These are represented as a circle on the plan (unless significant rooting constraints are present), and are colour coded depending on the category the tree has been awarded. Where existing site conditions/features are present that are deemed likely to have affected the root morphology, the root protection areas have been represented as a polygon of equivalent area.

- 3.3.1 A total of six trees were surveyed. Their locations are shown on the Tree Constraints Plan at Appendix 1 and their details and measurements are shown in the Tree Survey Schedule at Appendix 2.
- 3.3.2 A summary of their British Standard categorisation is shown at Table 2 below.

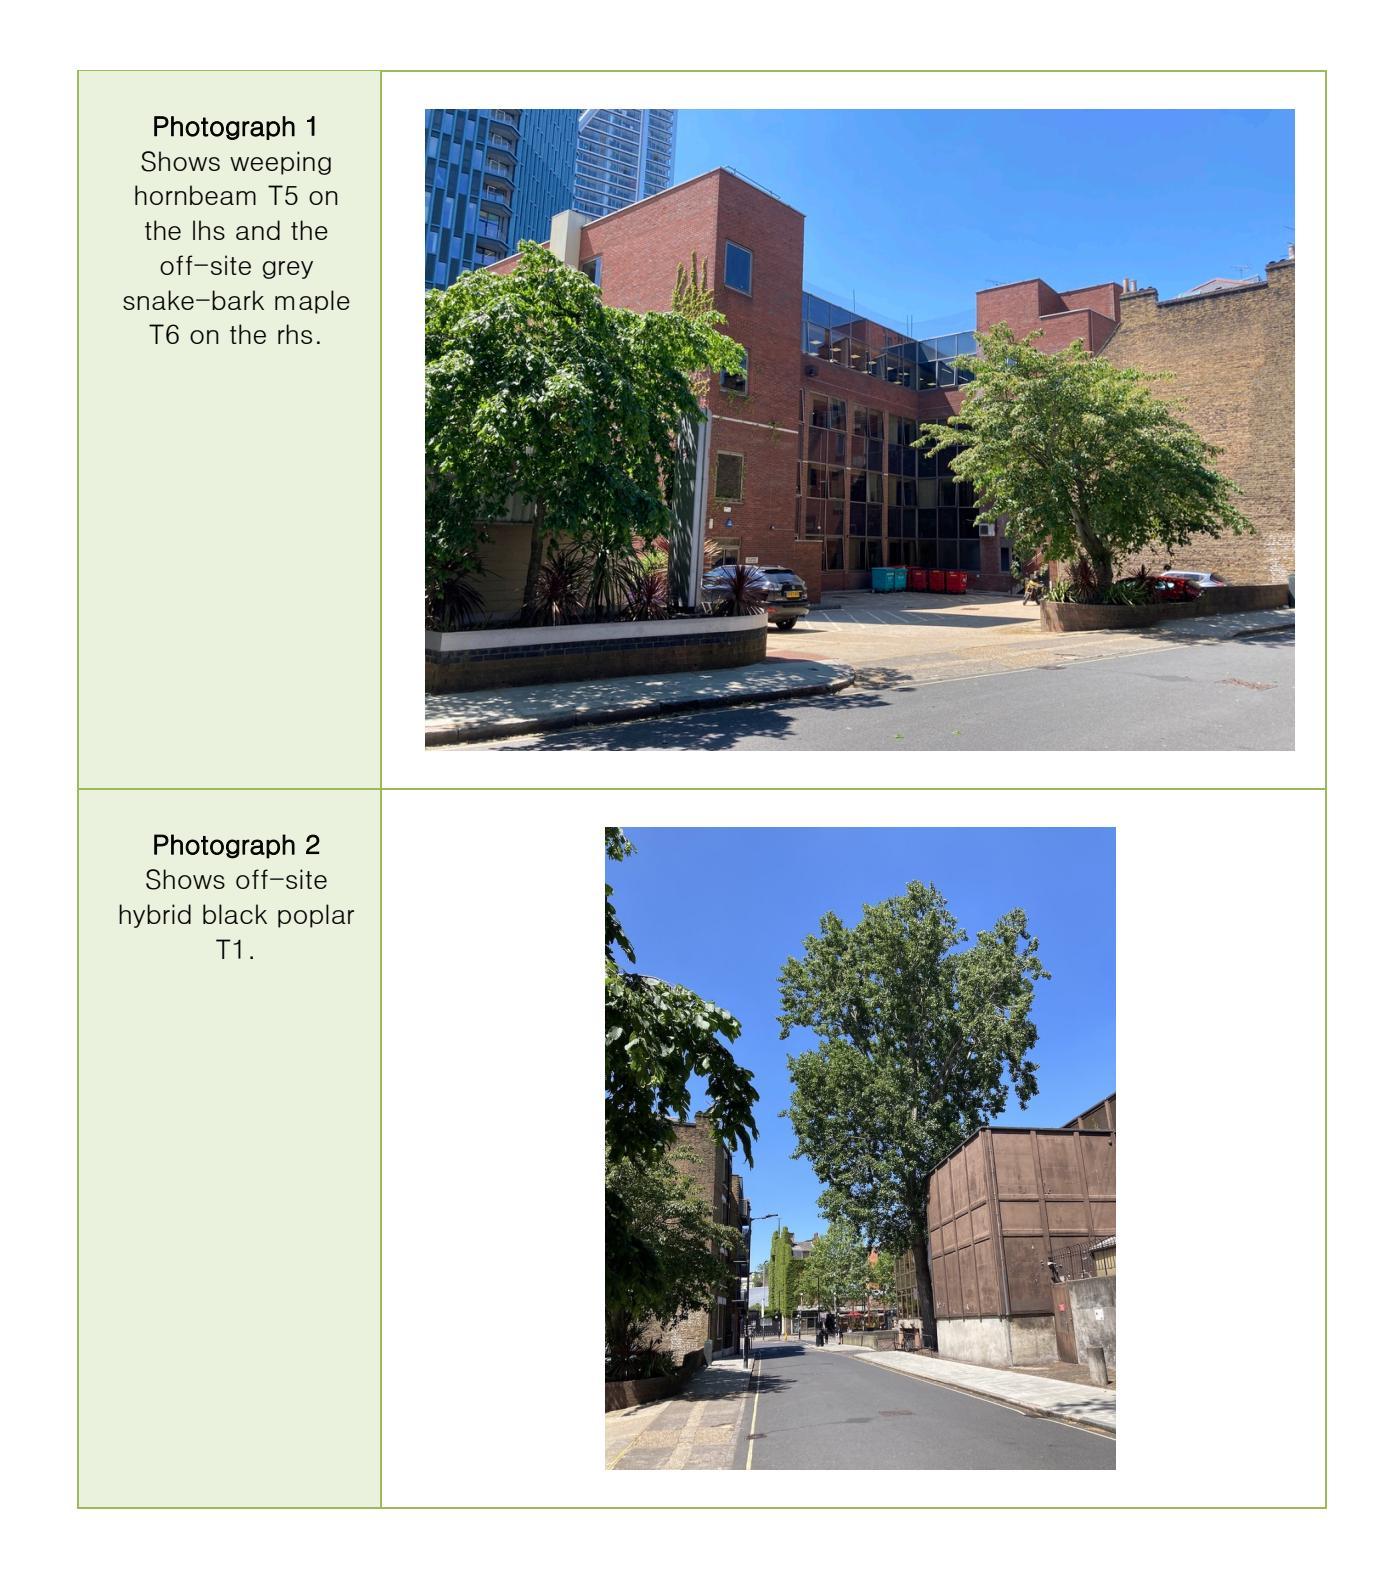
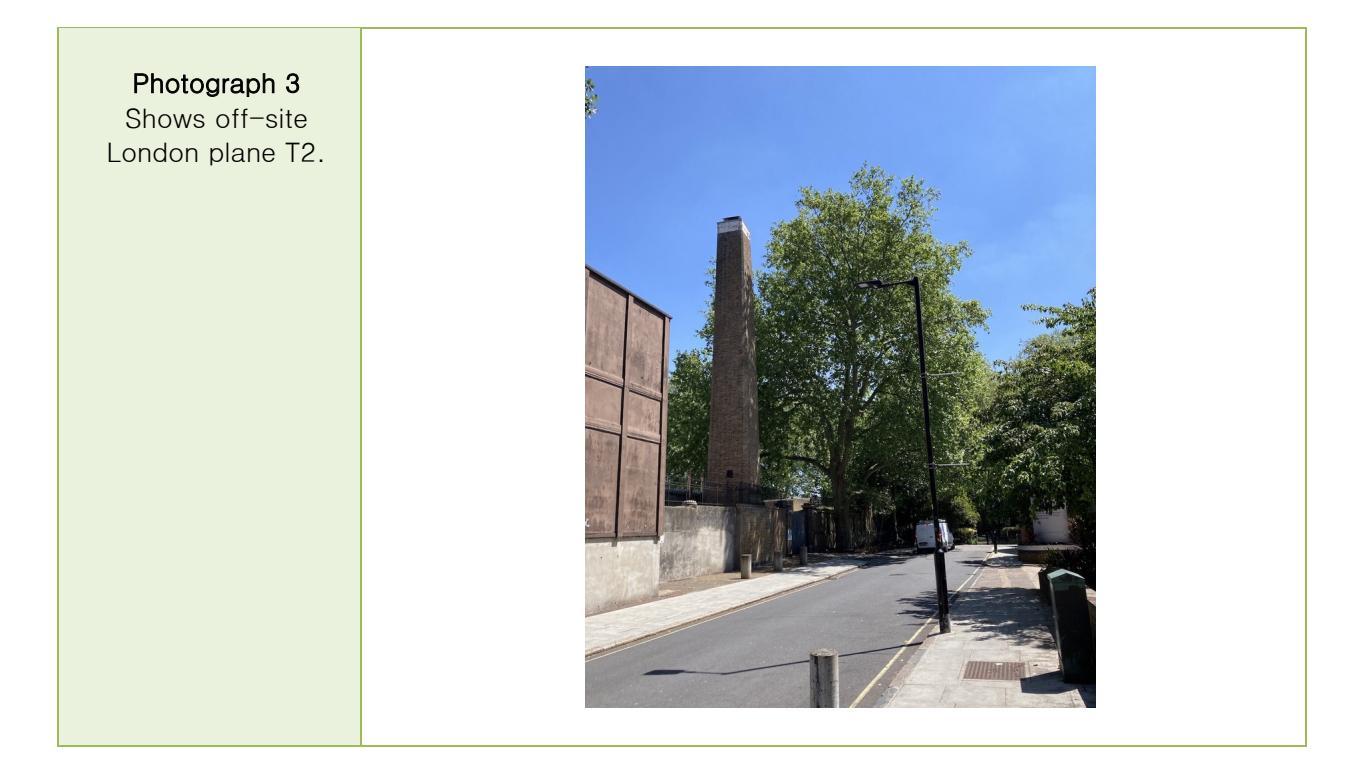
Appendix 3: Photographs

- 3.3.3 There are no key arboricultural features within the site.
- 3.3.4 The key arboricultural features of the immediate area are the hybrid black poplar T1 (category 'B') and the London plane T2 (category 'A'). Both of these are large trees which are highly visible in the street scene and make a significant contribution to the character and appearance of the locality.
- 3.3.5 Also, the large London plane trees growing within Newington Gardens to the south-east of the site, although too far to be included in this survey, are important visually due to their large size and are key arboricultural features of the locality.
