M4 Corridor around Newport

Appendix SS10.3

Bat Roost Surveys of Buildings and
Structures 2016

M4CaN-DJV-EBD-ZG_GEN-AX-EN-0048

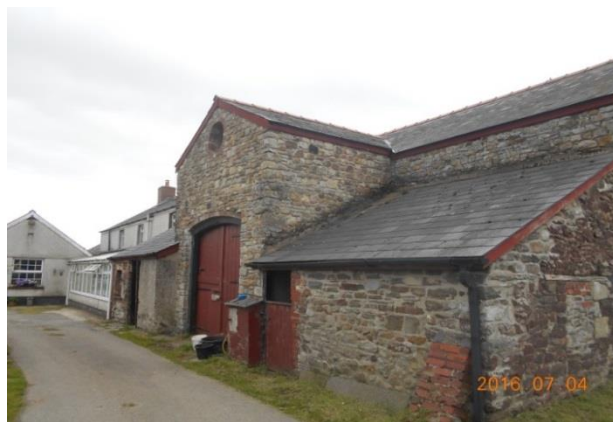
<i>Plate 5 north facing gable end and west facing wall of B2</i>

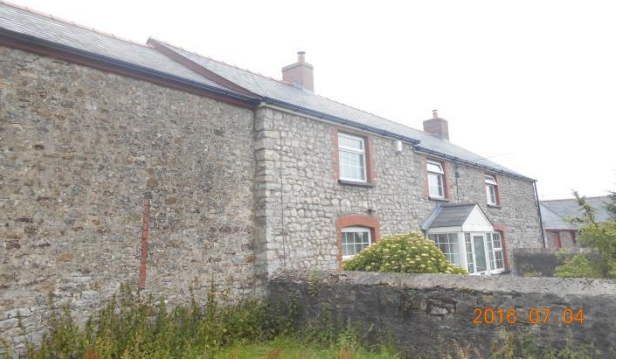
<p><i>Plate 8 east facing elevation of B4</i></p>

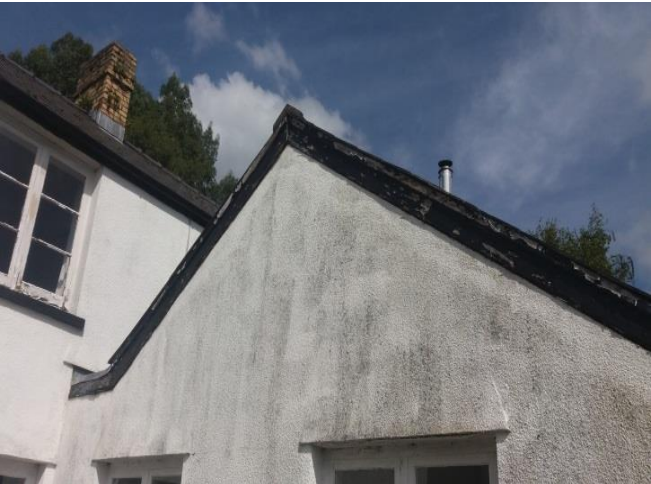
- Building 2 is considered likely to be a long-eared maternity roost (up to eight bats observed) and a summer day roost for a single soprano pipistrelle bat and a single *Myotis* bat.

<p><i>Plate 16 west and south facing elevations of B2</i></p>

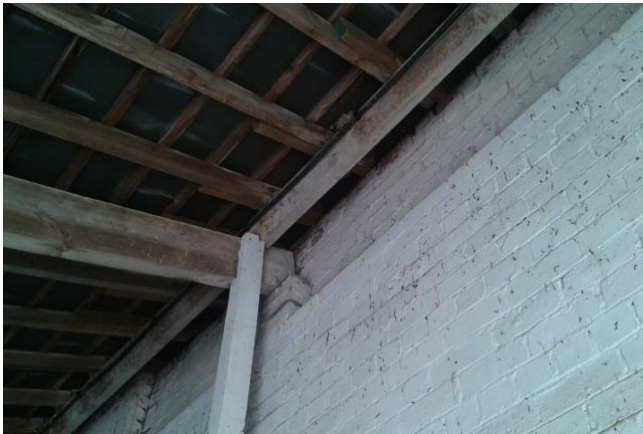
<p><i>Plate 17 roof inside garage of B2</i></p>

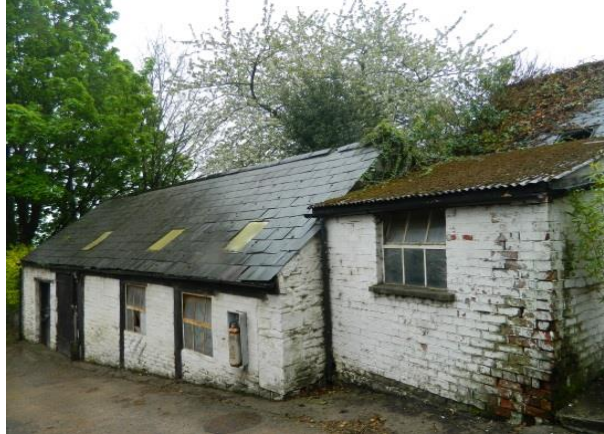
- Building 4 is considered to be a summer day roost for common pipistrelle bats (up to two bats observed).
- 4.1.4** For the long-eared bats in B2, droppings were collected and were sent off for eDNA analysis; however, the results were returned inconclusive. Brown long-eared bats have been recorded in the study area and are much more common than grey long-eared bats, which have not been recorded from the study area. Therefore, it is extremely likely that the bats were brown long-eared.

<p><i>Plate 18 east facing elevation of B4</i></p>

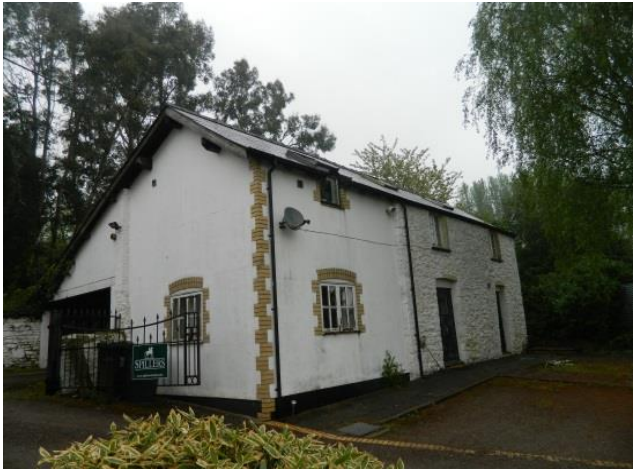
<p><i>Plate 19 south and west facing elevations of B4</i></p>

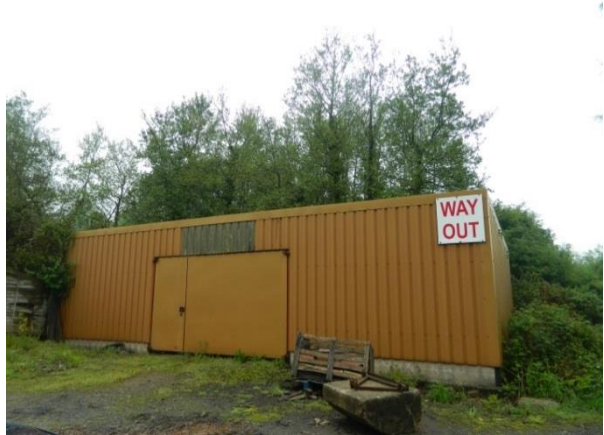
<p><i>Plate 20 steel storage shed</i></p>

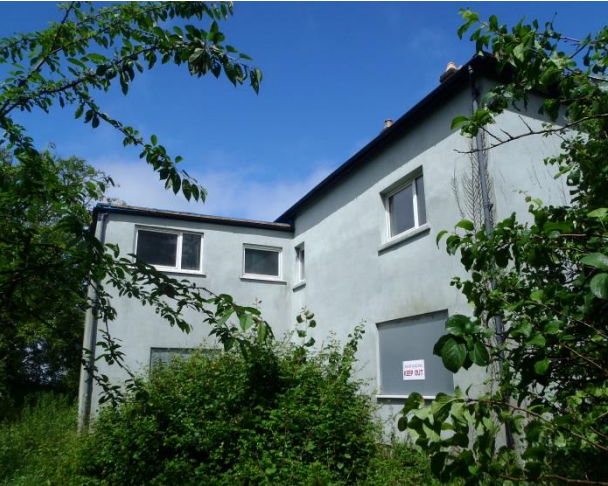
<p><i>Plate 28 south eastern elevation of B1</i></p>

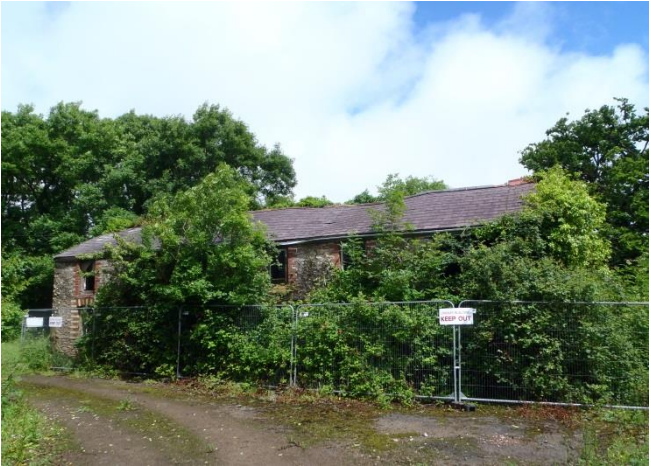
<p><i>Plate 29 southern elevation of B2</i></p>

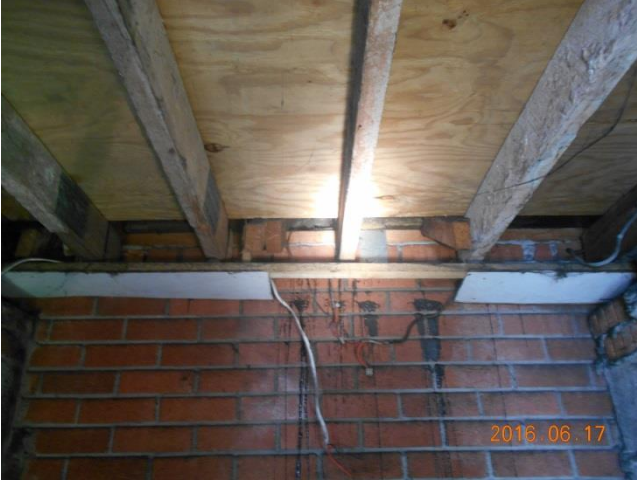
Building Name	Roost assessment	Notes	Photographs
San Remo	<p>Confirmed roost</p> <p>Common pipistrelle summer day roost (up to eight bats observed during surveys)</p>	<p>Residential property disused at time of survey (<i>Plate 30</i>). Roof tiles are generally tight with little access potential, however missing hanging tiles and lead flashing around both the east and west dormers are features that provide potential for roosting bats. Other features on this building included openings (through wood rot) into soffit box on both north and south sides; under plastic fascia; and into open door on west side that allow access into space between roof tiles and lining (<i>Plate 31 / Plate 32</i>).</p>	<div><p><i>Plate 30 southern elevation</i></p>

</div> <div><p><i>Plate 31 in lean to at western side of building</i></p>

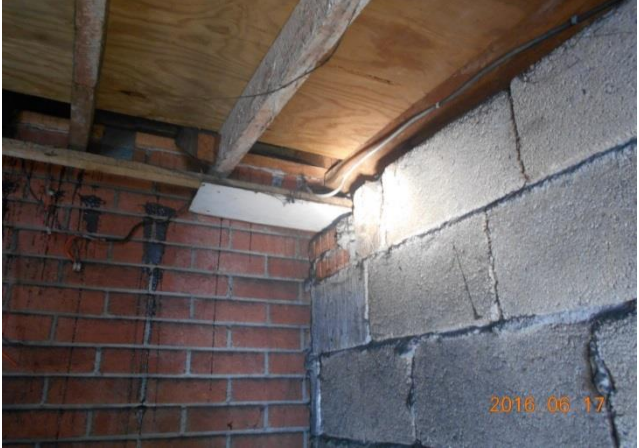
</div> <div><p><i>Plate 32 in lean to at western side of building</i></p>

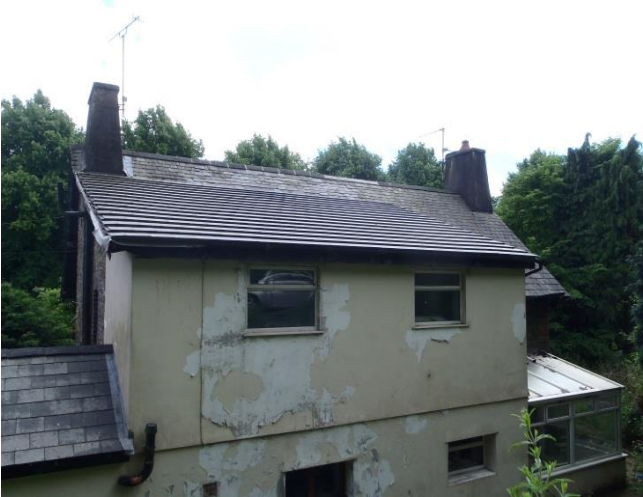
Building Name	Roost assessment	Notes	Photographs
Berryhill Cottage	<p>Confirmed roost</p> <p>Common pipistrelle summer day roost (up to four bats observed);</p> <p>Soprano pipistrelle summer day roost (one bat observed)</p>	<p>Building under renovation following long term neglect (<i>Plate 33</i>). During 2015 roof tiles were reportedly stolen causing significant rain damage within the building that has subsequently been fully gutted by the owner. During early 2016 the tiles were recently replaced however soffit and barge boards have not been fitted allowing access throughout building (<i>Plate 34</i>). Soffit box on north west side of building has partially collapsed provide access into roof lining and tiles through eaves. Other potential bat roost features were numerous including openings into soffit box on northwest side (<i>Plate 35</i>); broken and raised tiles; and gaps between eaves and supporting walls.</p>	<div><p><i>Plate 33 northern elevation</i></p>

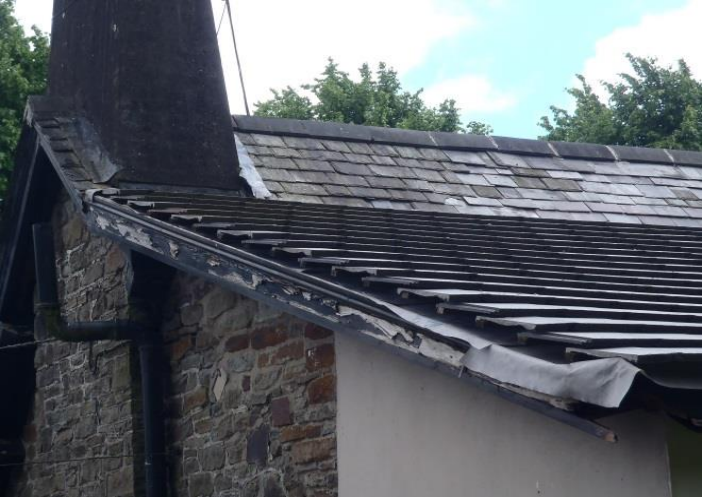
</div> <div><p><i>Plate 34 eastern elevation</i></p>

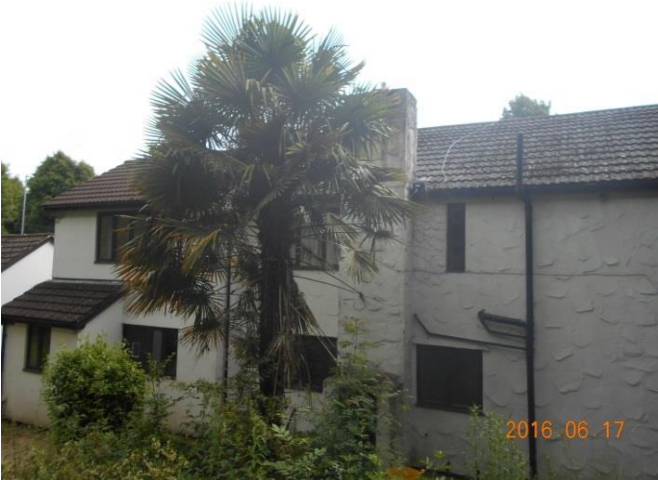
Building Name	Roost assessment	Notes	Photographs	
White Cottage	High suitability	<p><u>Main residential building</u></p> <p>The empty building had tightly fitting roof tiles on both north (<i>Plate 36</i>) and south elevations (<i>Plate 37</i>). Openings into soffit box on the north side are features with high potential for roosting bats (<i>Plate 38</i>) with good connectivity to mosaic of woodland and grassland habitats within the gardens to the north.</p> <p><u>Garage</u></p> <p>This garage (<i>Plate 39</i>) adjacent to the east side of the main building has tears within the roof lining along both the north and south elevations that provide suitable roost features for bats (<i>Plate 40</i>).</p>	<p><i>Plate 36 northern aspect of main building</i></p>

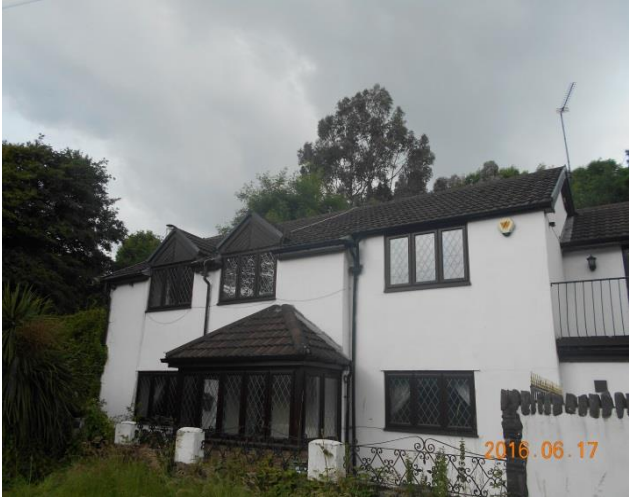
<p><i>Plate 37 southern aspect of main building</i></p>

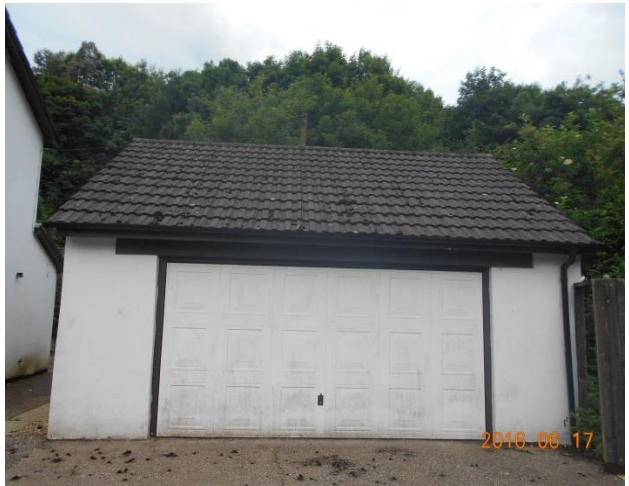
<p><i>Plate 40 opening into roofing felt under eaves of garage</i></p>

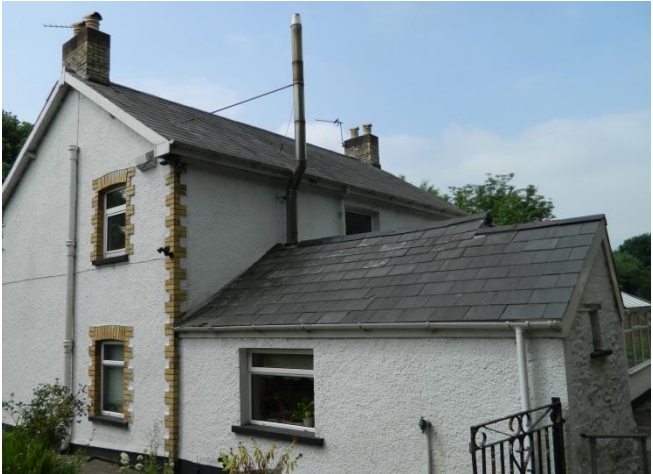
<p><i>Plate 48 raised ridge tile</i></p>

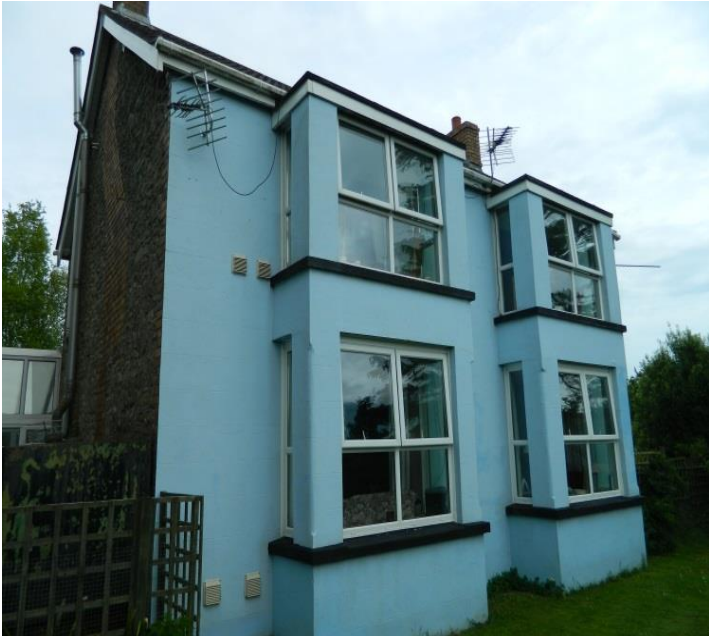
</div> <div><p><i>Plate 41 fascia boards above windows on the western elevation</i></p>

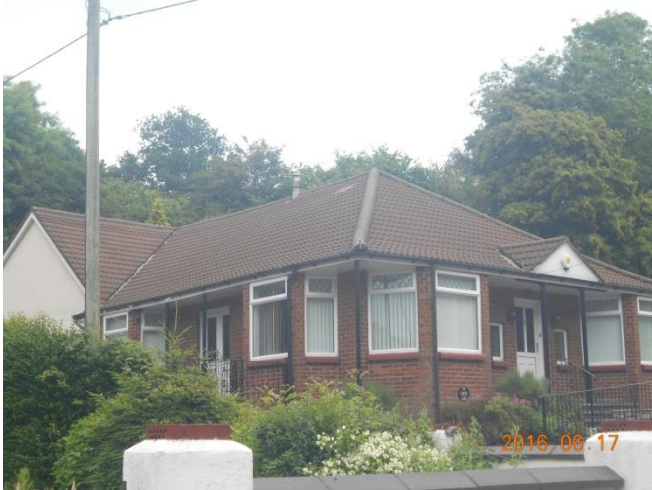
Building Name	Roost assessment	Notes	Photographs	
The Glen	Low suitability	Modern bungalow (<i>Plate 53</i>). Very tight with modern eaves and fascia providing no internal access (<i>Plate 54</i>). Features with potential for roosting bats were noted on the north side at the intersection between tiles and lead flashing within the valley between two pitched roofs.	<p><i>Plate 53 southern and eastern elevation</i></p>

<p><i>Plate 54 tight barge boards and fascia around south facing</i></p>
